EL DORADO HYDROELECTRIC PROJECT

OYSTER CREEK STABILIZATION PLAN

REVISED April 2012

**Oyster Creek Stabilization Plan
Observations from August 2011 Field Inspection**

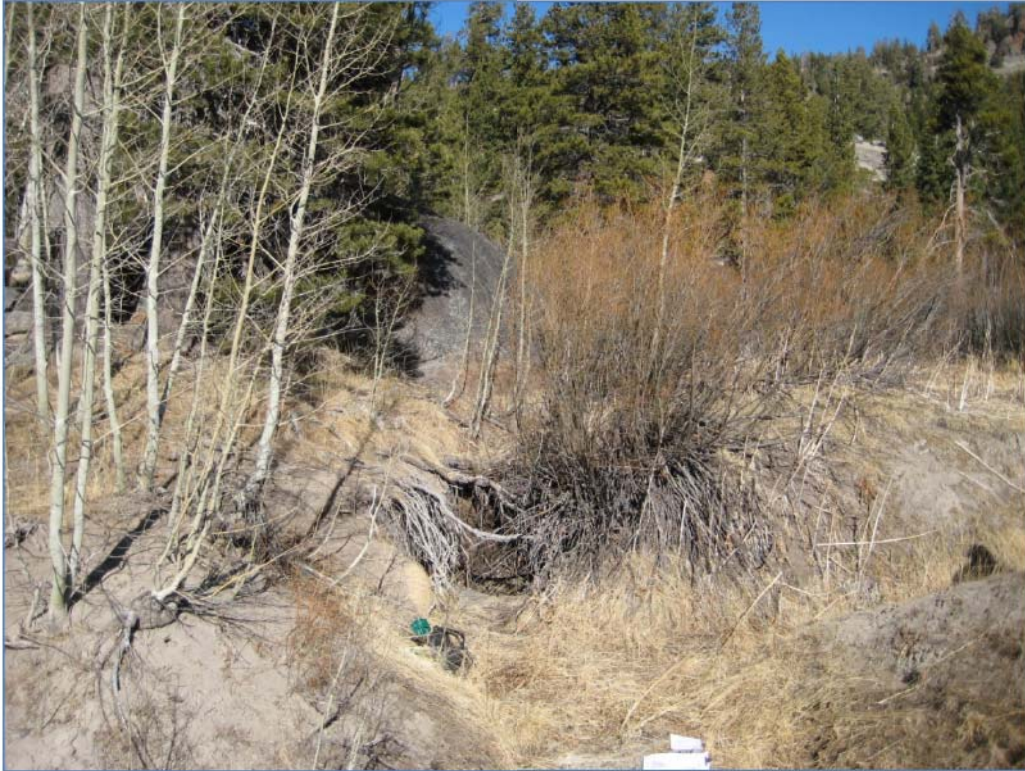
Potentially unstable, erosion features in the North Tributary, located primarily on private property, include the main headcut in the gullied section of the channel (Photo 1), and a few small drainages that feed into the North Tributary from the adjacent meadow (Photo 2). Erosion at the main headcut appears to be controlled by a bedrock outcrop and/or roots of woody vegetation. This headcut has not shown significant headward advance since monitoring began in 2007, but it is potentially vulnerable to erosion through flanking or scour. Small drainages that convey surface flow and groundwater discharge from the adjacent wet meadow to the gullied portion of the North Tributary are also eroding at a relatively slow rate. Continued erosion of these drainages could alter the ecological functions and values of the meadow because it could result in desiccation of adjacent areas and a corresponding shift in plant community composition. Stabilization in the North Tributary focuses on controlling erosion at these locations.

Photo 1. Main headcut in North Tributary

At the main headcut, a live “brush pack” treatment will be used to control erosion, provide energy dissipation, and trap sediment. The brush pack will consist of logs, branches, live cuttings, and graded stone (rock). These materials will be placed in lifts at the face of the headcut (See Sheet C5 of Attachment C). If available, native soil will be placed in the brush pack to fill the voids between stones and logs. It is anticipated that the cuttings will establish and the wood will decompose, leaving a dense thicket of woody vegetation in the vicinity of the headcut. An apron of launchable rock will be placed in the channel directly upstream of the headcut. If the headcut migrates upstream, the rock will fall (or launch) into the brush pack, thereby filling voids and dissipating energy. A biodegradable coir log will be placed at the downstream end of the brush pack. The coir log will trap sediment that may erode from the headcut and will act to “backwater” the headcut, thereby promoting deposition of sediment. Over time, sediment stored behind the coir log will be stabilized by natural recruitment of woody and herbaceous vegetation.

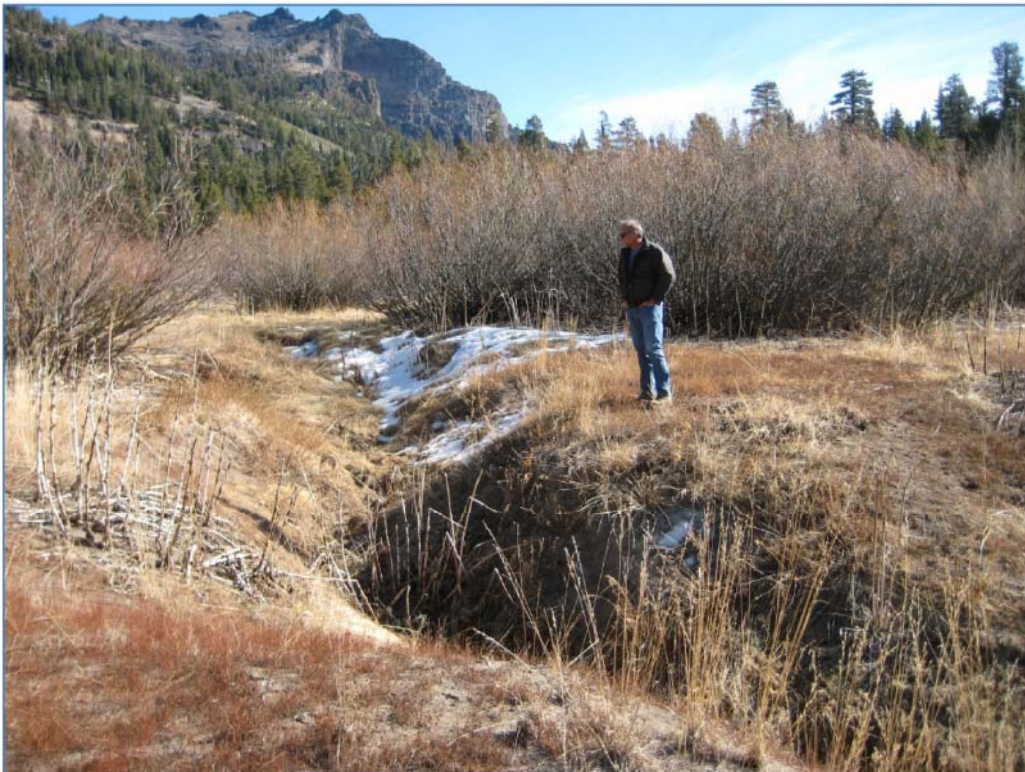
Photo 2. Small drainage feeding into North Tributary

Live fascines will be used to stabilize two small gullies that enter the North Tributary (Sheet C3 of Attachment C). Live fascines consist of bundles of woody cuttings placed parallel and perpendicular to the direction of flow. These measures will establish preferential drainage pathways, and increase bed resistance and roughness. This treatment will reduce the potential for further scour and will trap sediment delivered from upstream areas.

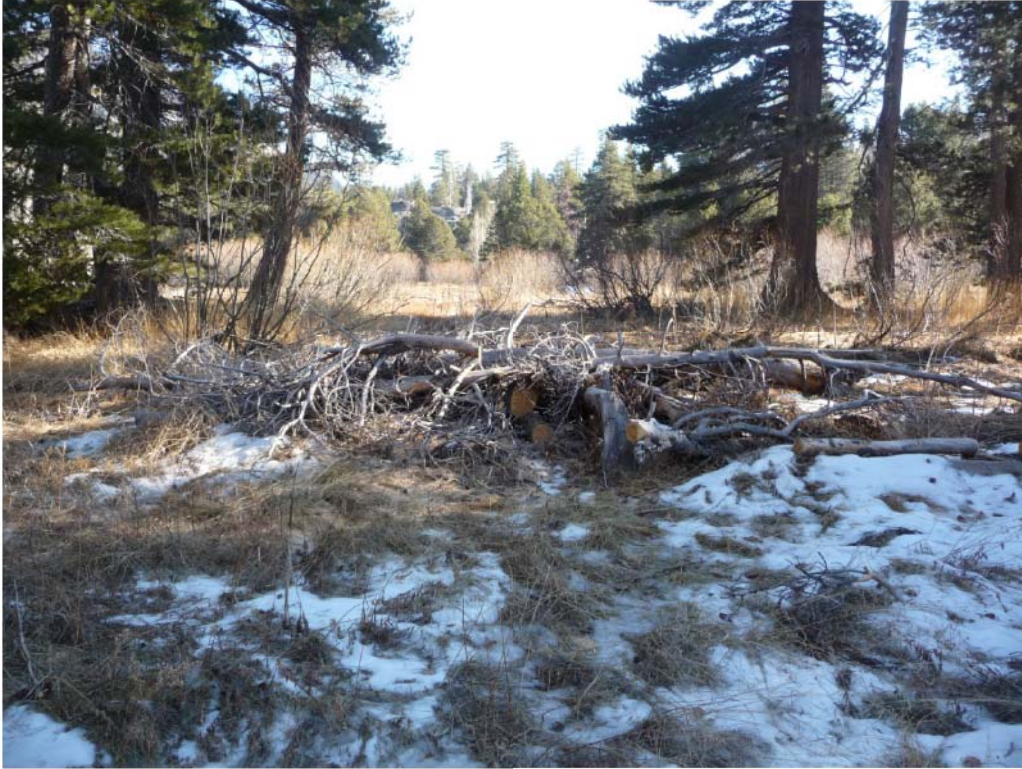
Photo 3. Example of dead wood to be collected for use in brush pack treatment.

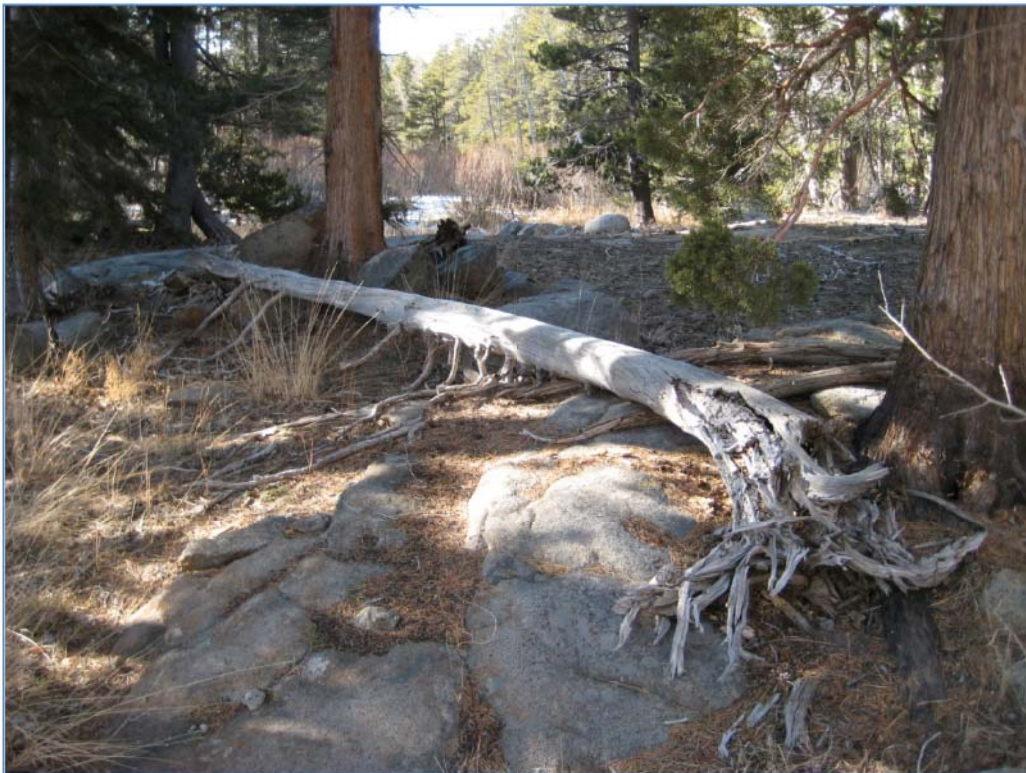
Photo 4. Example of dead wood to be collected for use in brush pack treatment.

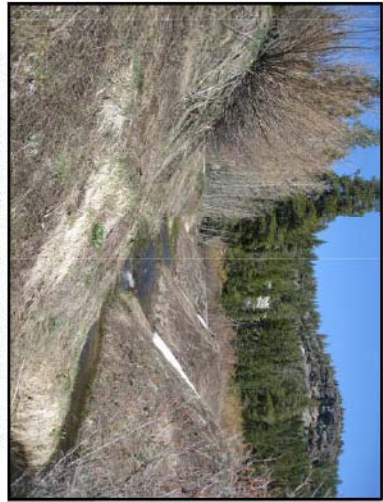
PHOTO 1 VIEW LOOKING UPSTREAM WITHIN NORTH TRIBUTARY

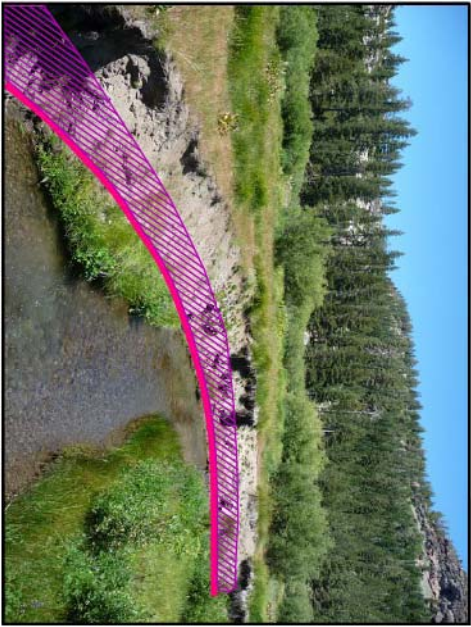
Overall, the mainstem Oyster Creek is on a trajectory to recover, but there remain isolated areas of instability, hence the need for active restoration/stabilization. Active bank erosion is occurring between River Station (RS) 37+00 and 40+00 (See photolog in Attachment A). Erosion at this location is caused by toe scour and groundwater sapping (Blue Line Consulting, 2009). Although erosion rates are relatively slow, this appears to be the most unstable portion of the Oyster Creek channel. Sheet C4 of Attachment C shows the proposed biotechnical stabilization treatments for this area. The proposed treatment includes installing a biodegradable coir roll and planting live woody cuttings. The coir roll will be installed near the toe of the bank; the precise elevation will be determined in the field. Woody cuttings (willow and alder) will be planted on the eroding bank upslope from the coir roll. Woody cuttings develop dense, deep root systems that help protect banks from erosion. Woody vegetation also increases roughness, which reduces streamflow velocity and helps trap sediment. Woody vegetation planting will improve aquatic habitat by providing additional shade and cover; increasing hydraulic complexity and bank resistance, which can induce the formation of scour pools; and increasing organic matter inputs, which is important for macroinvertebrate production.

PHOTO 2: EROSION STEPS/BANK (STA. 39140 - 39140)
