# SWANSON HYDROLOGY + GEOMORPHOLOGY

DRAFT Final Report

## ESMERALDA CREEK RESTORATION AND STABILIZATION PLAN for El Dorado Irrigation District

June 2008

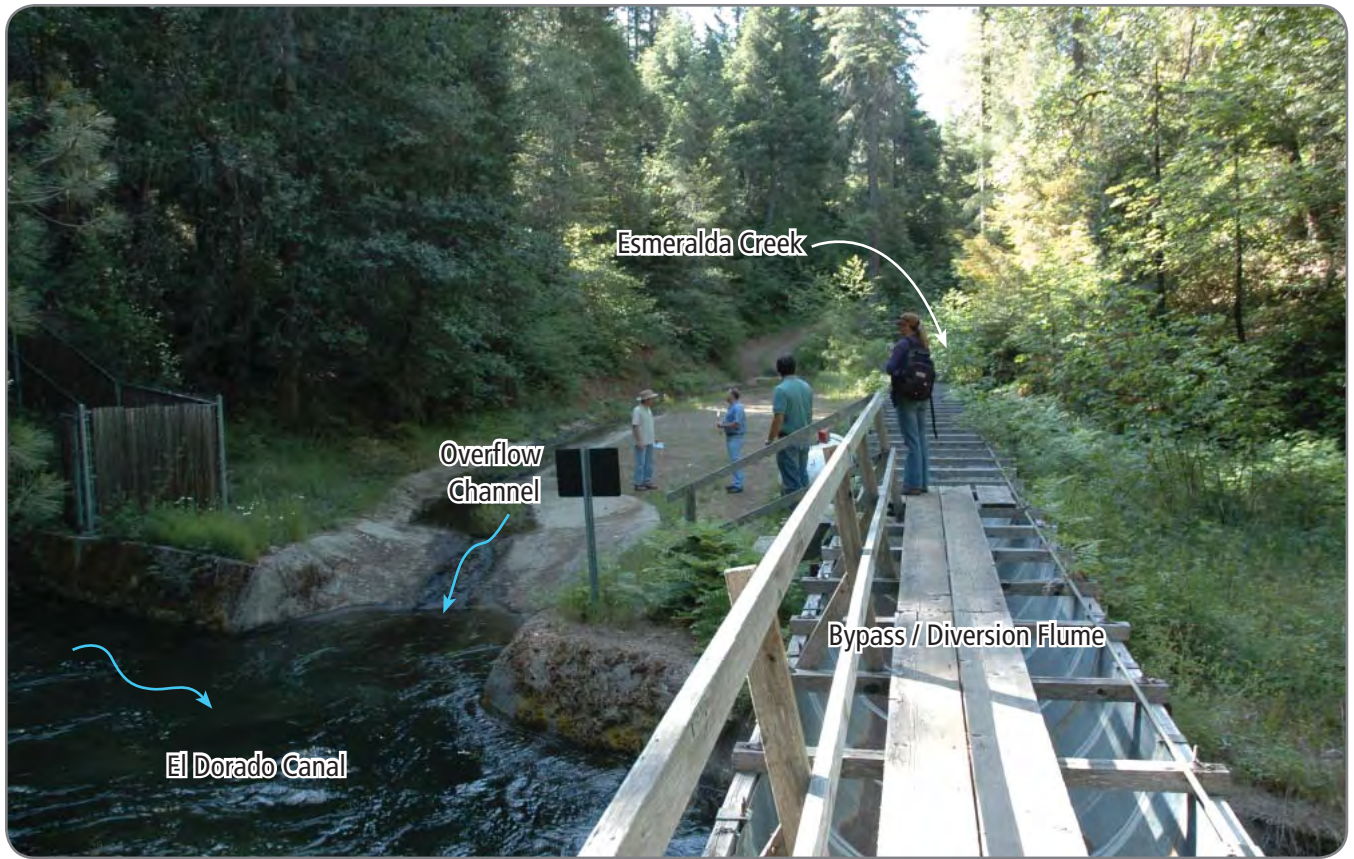
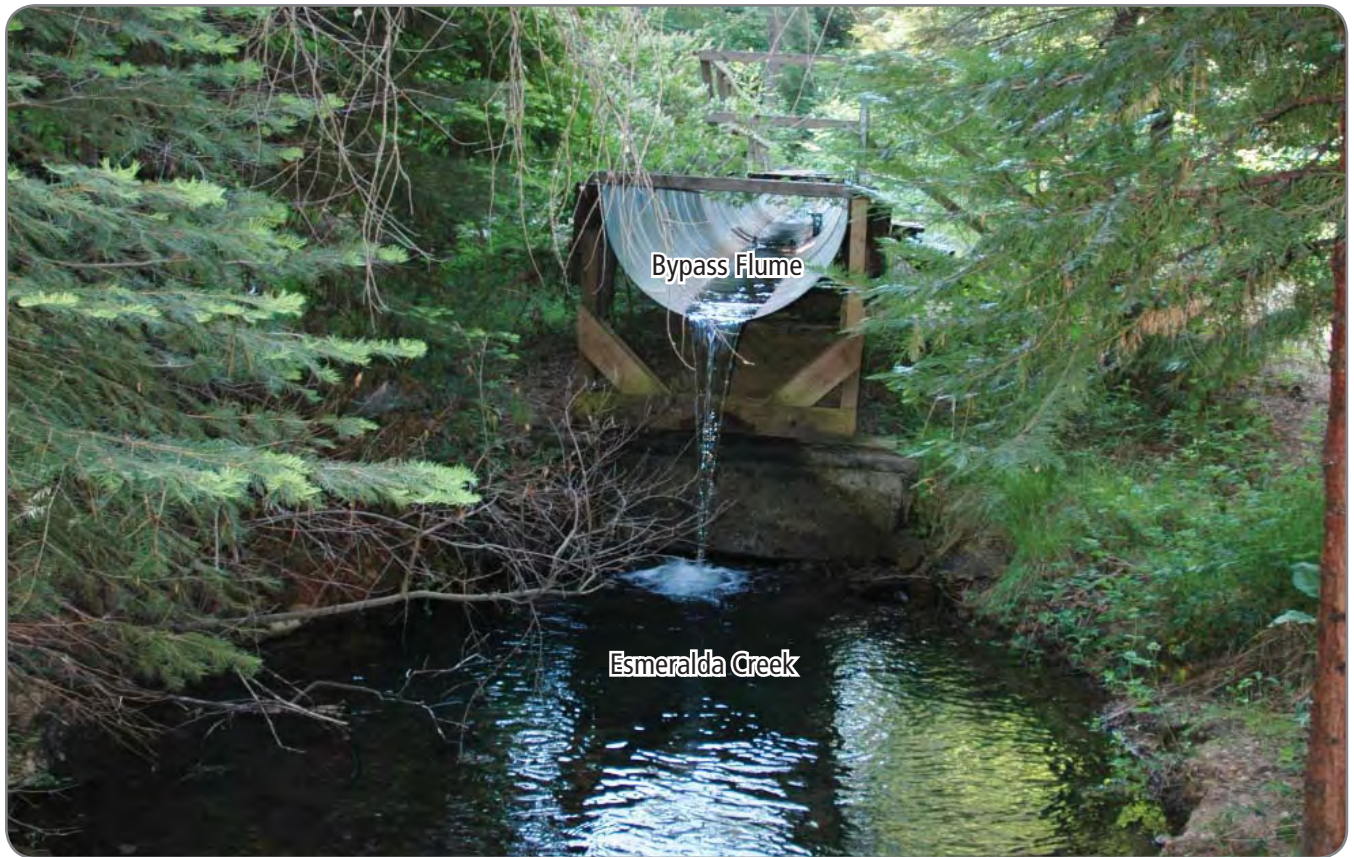
**FIGURE 2a:** Photo (top) of the El Dorado Canal, Esmeralda Creek diversion and bypass flume (looking upstream). Bypass flume outlet (bottom).

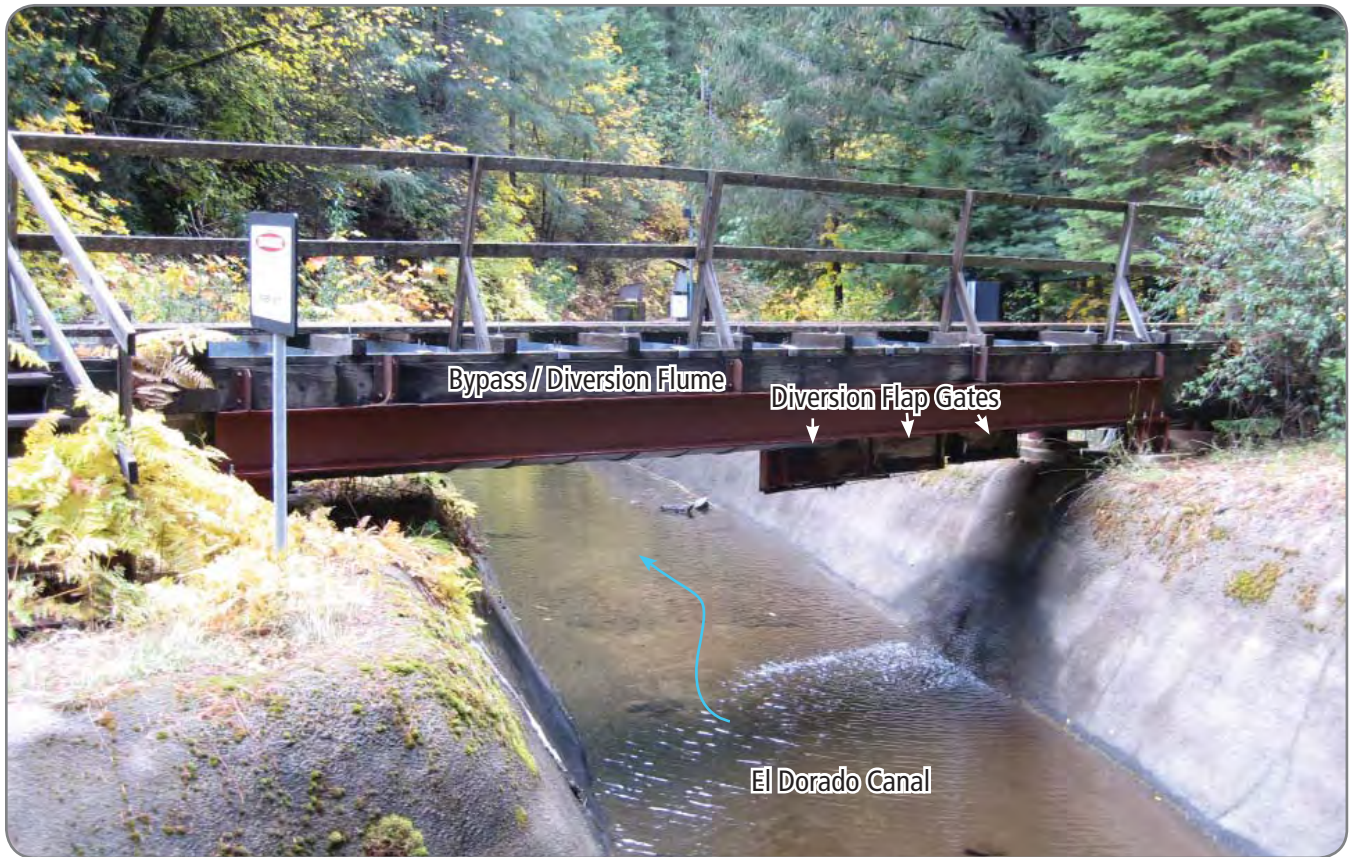
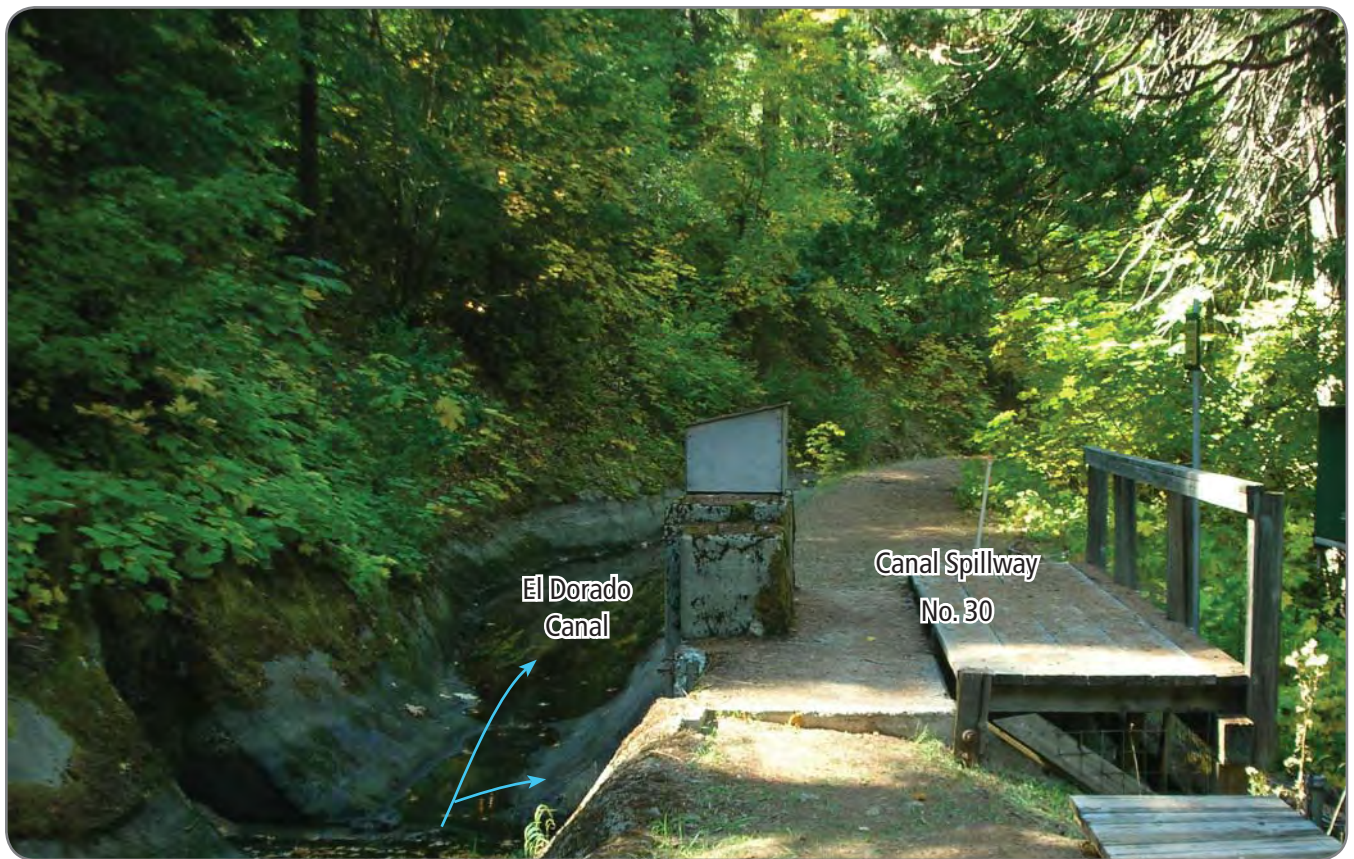
**FIGURE 2b:** Photo (top) of the bypass flume and flap gate diversion mechanism. Photo (bottom) of Canal Spillway No. 30.

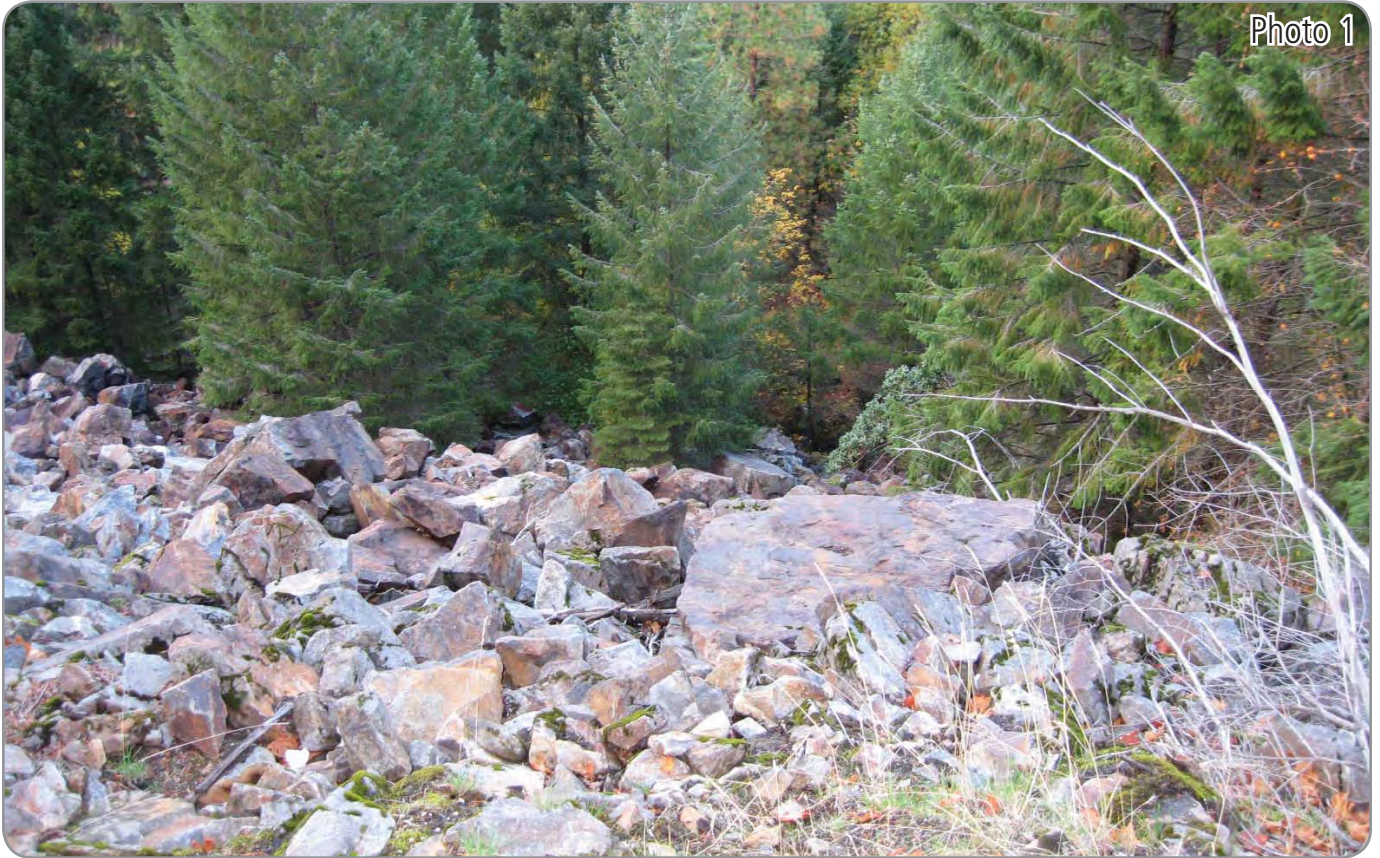
Photo 1

**PHOTO 1:** From Highway 50 looking downstream at the Esmeralda Creek alignment (Reach 1).

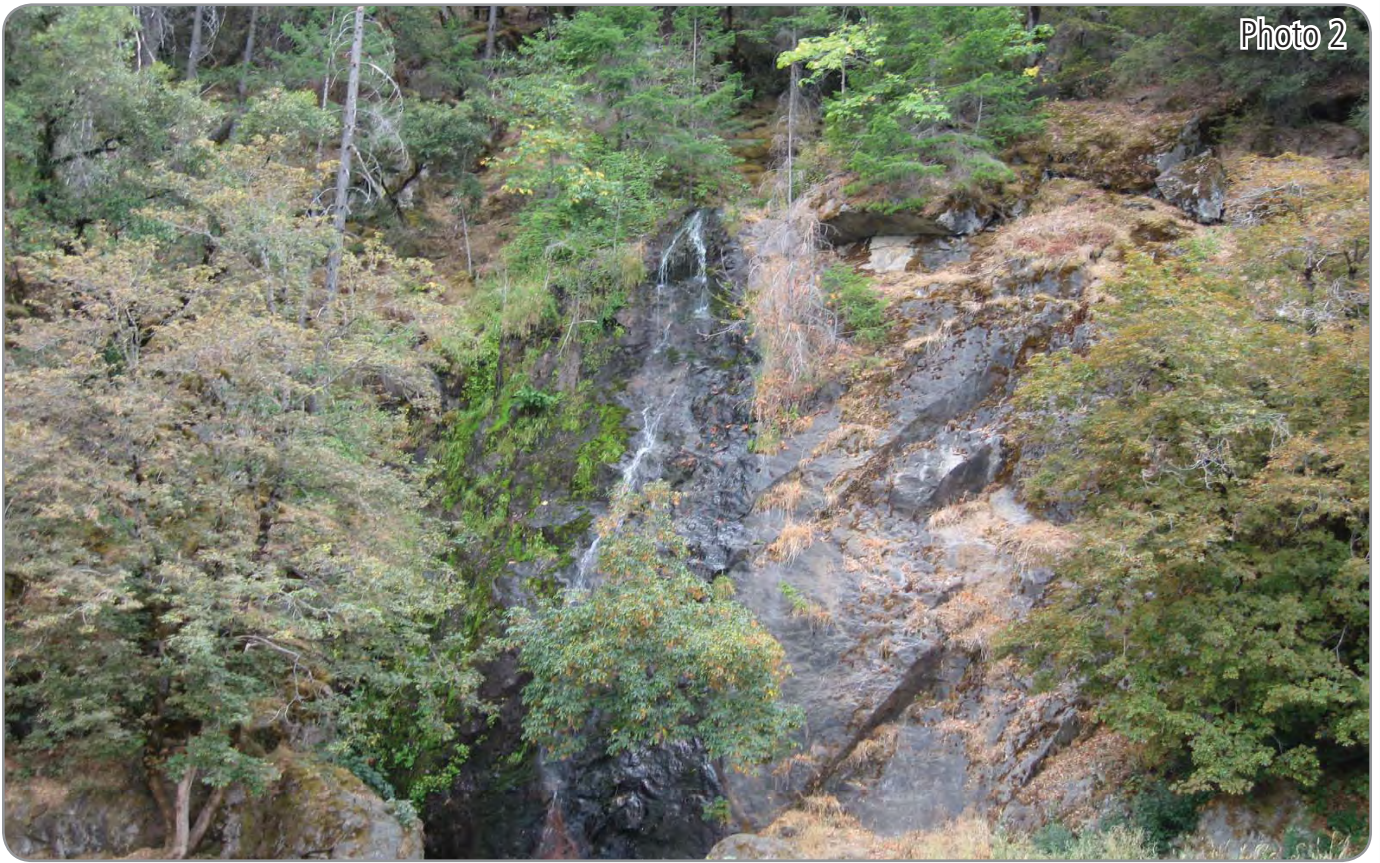
Photo 2

**PHOTO 2:** Bridal Veil Falls (approximately 150 vertical ft) adjacent to Highway 50 (Reach 2).

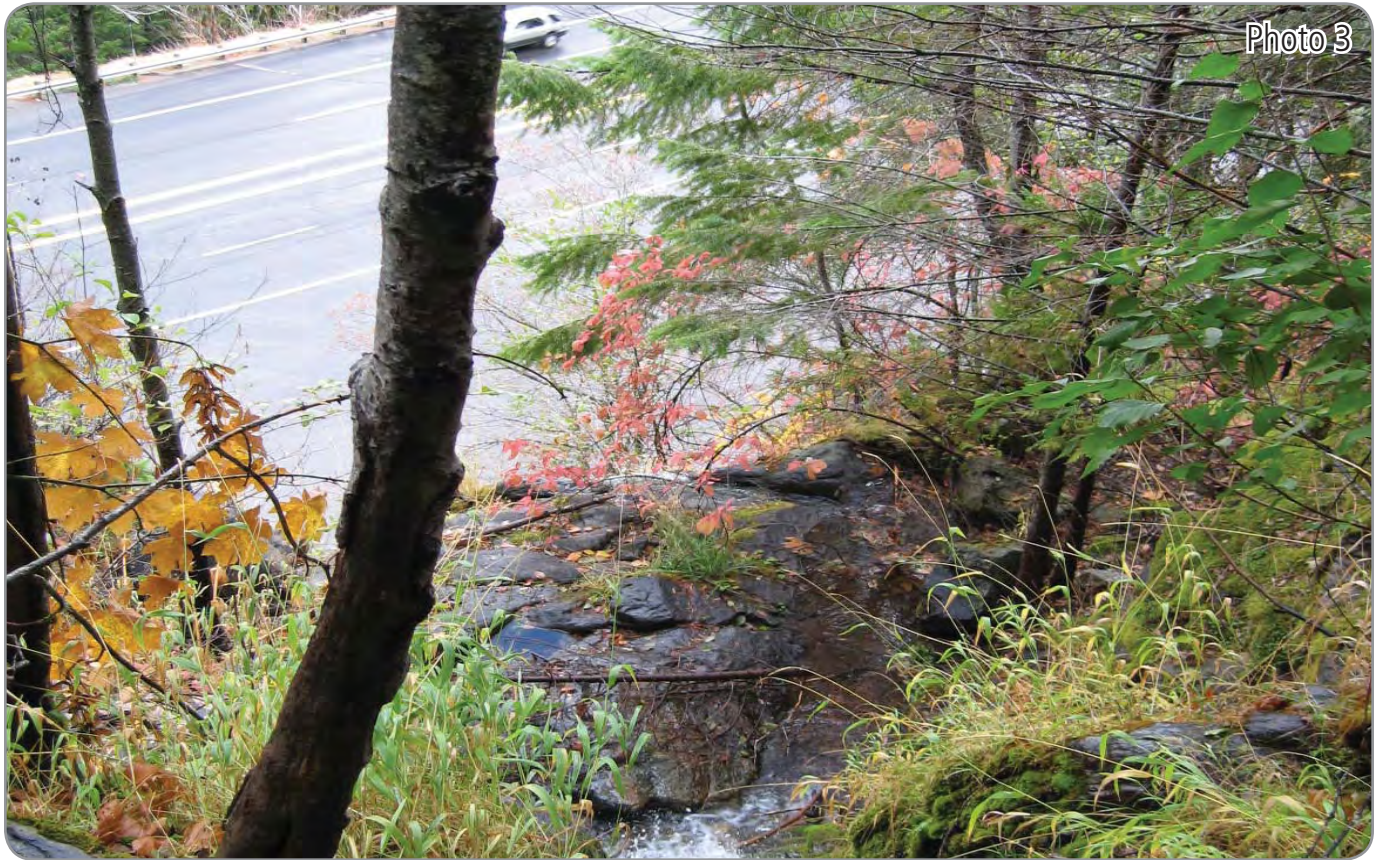
**PHOTO 3:** Looking down Bridal Veil Falls to Highway 50 (Reach 2).

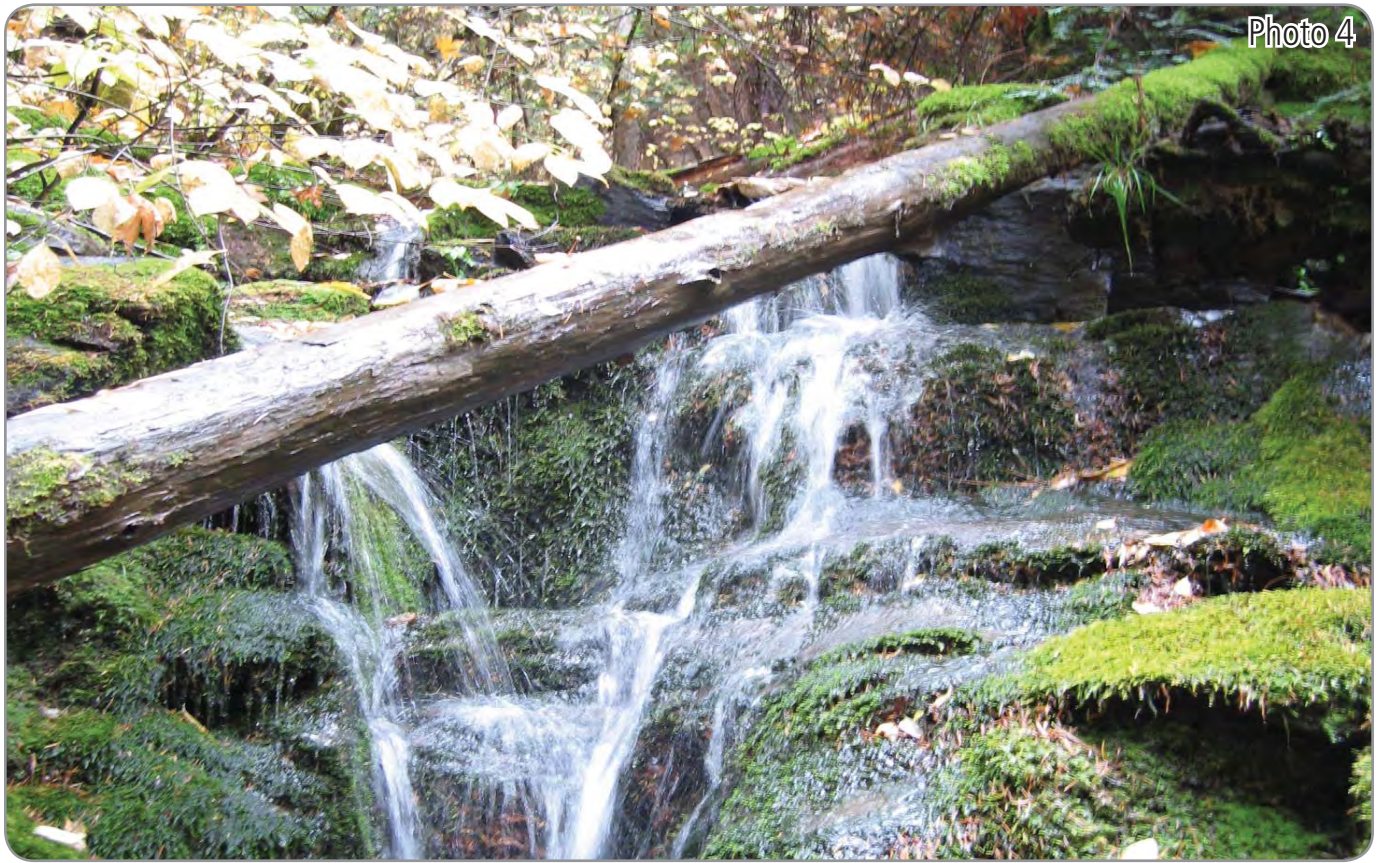
**PHOTO 4:** Bedrock cascades and large woody debris upstream of Bridal Veil Falls (Reach 3).

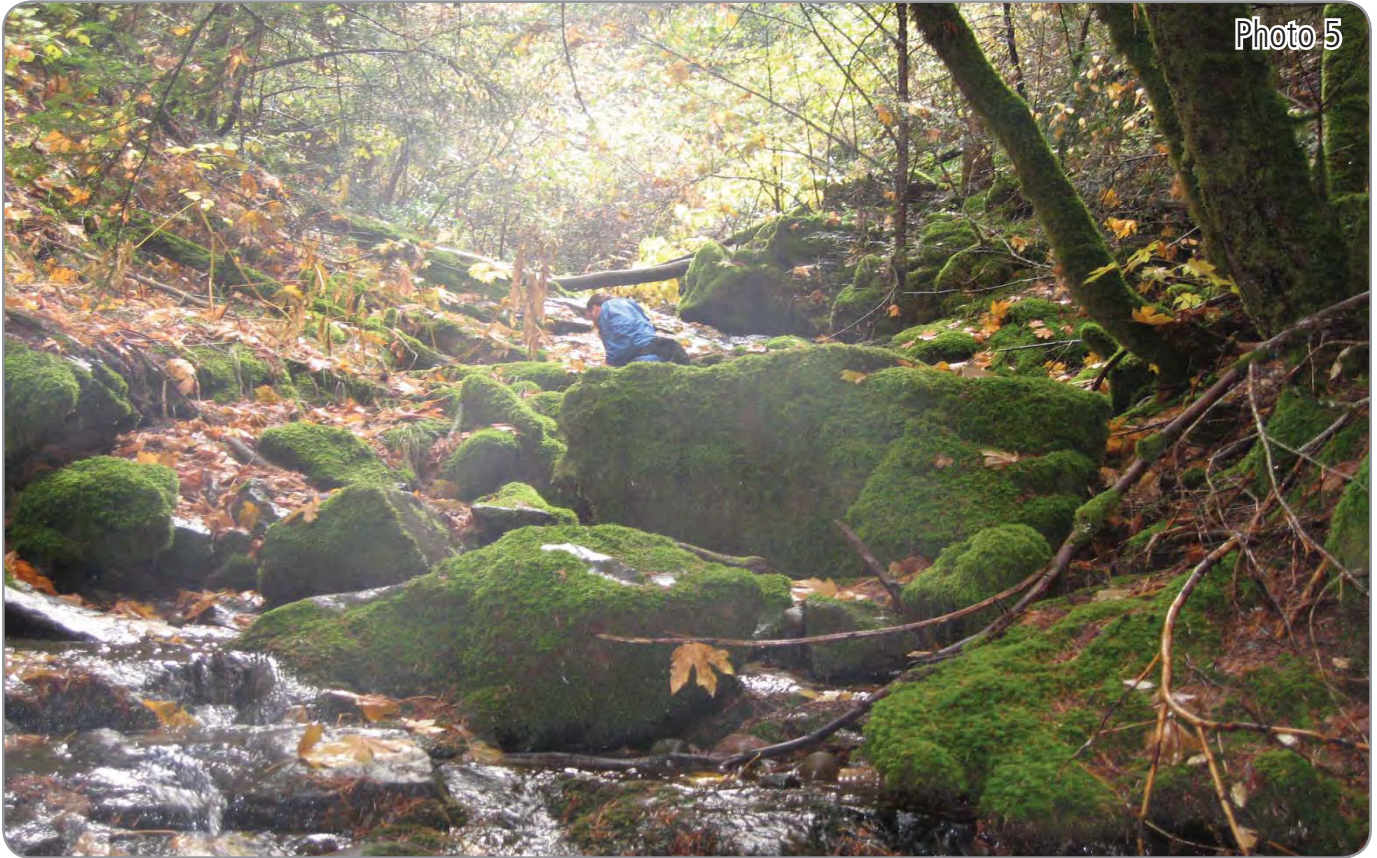
Photo 5

**PHOTO 5:** The Reach 4 channel (~20% slope) consists of bedrock and large boulders.

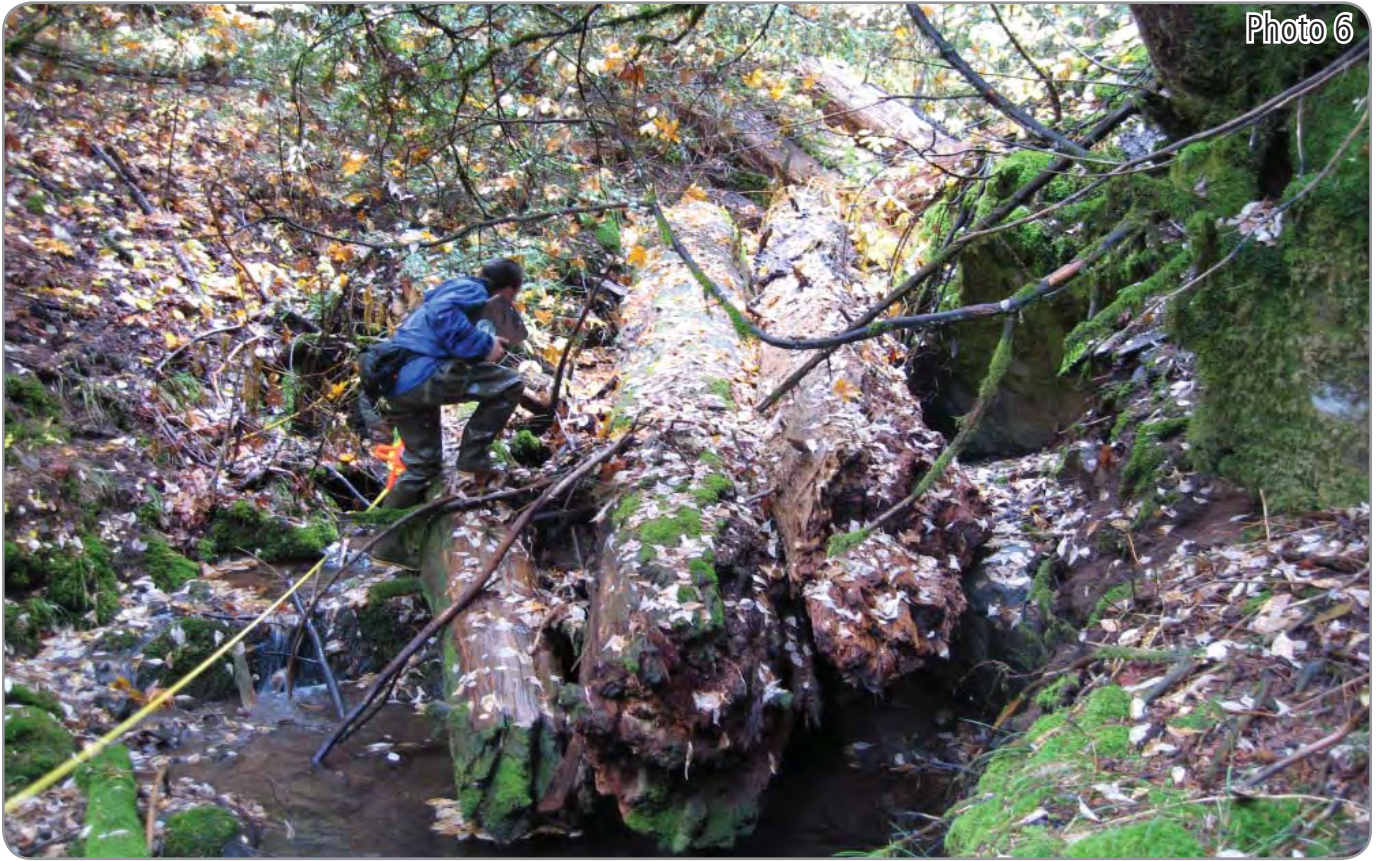
Photo 6

**PHOTO 6:** Debris jam in Reach 4 composed of 8 to 10 large logs.

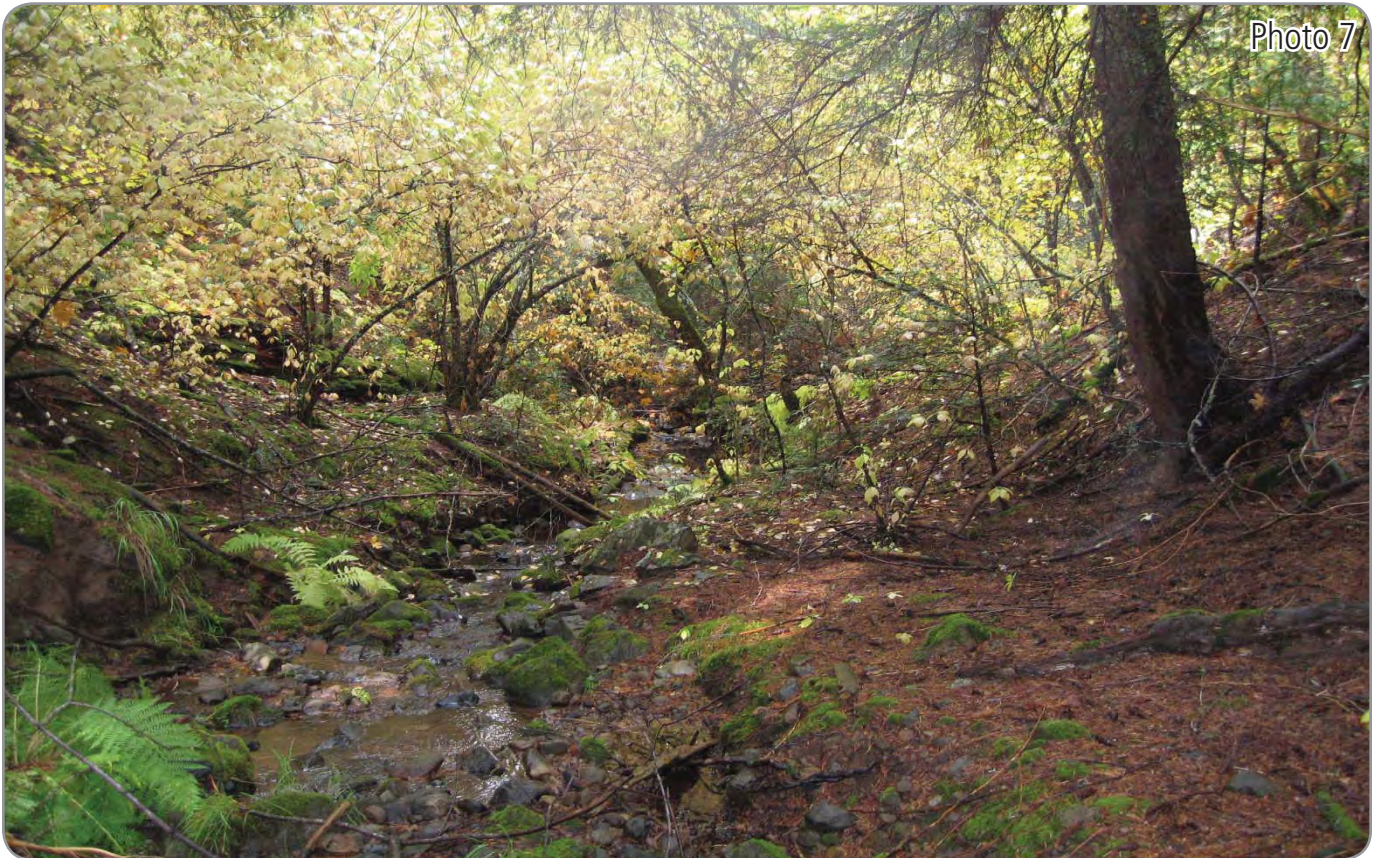
Photo 7

**PHOTO 7:** Reach 5 (~10% slope) consists of predominantly gravel/cobble alluvium.

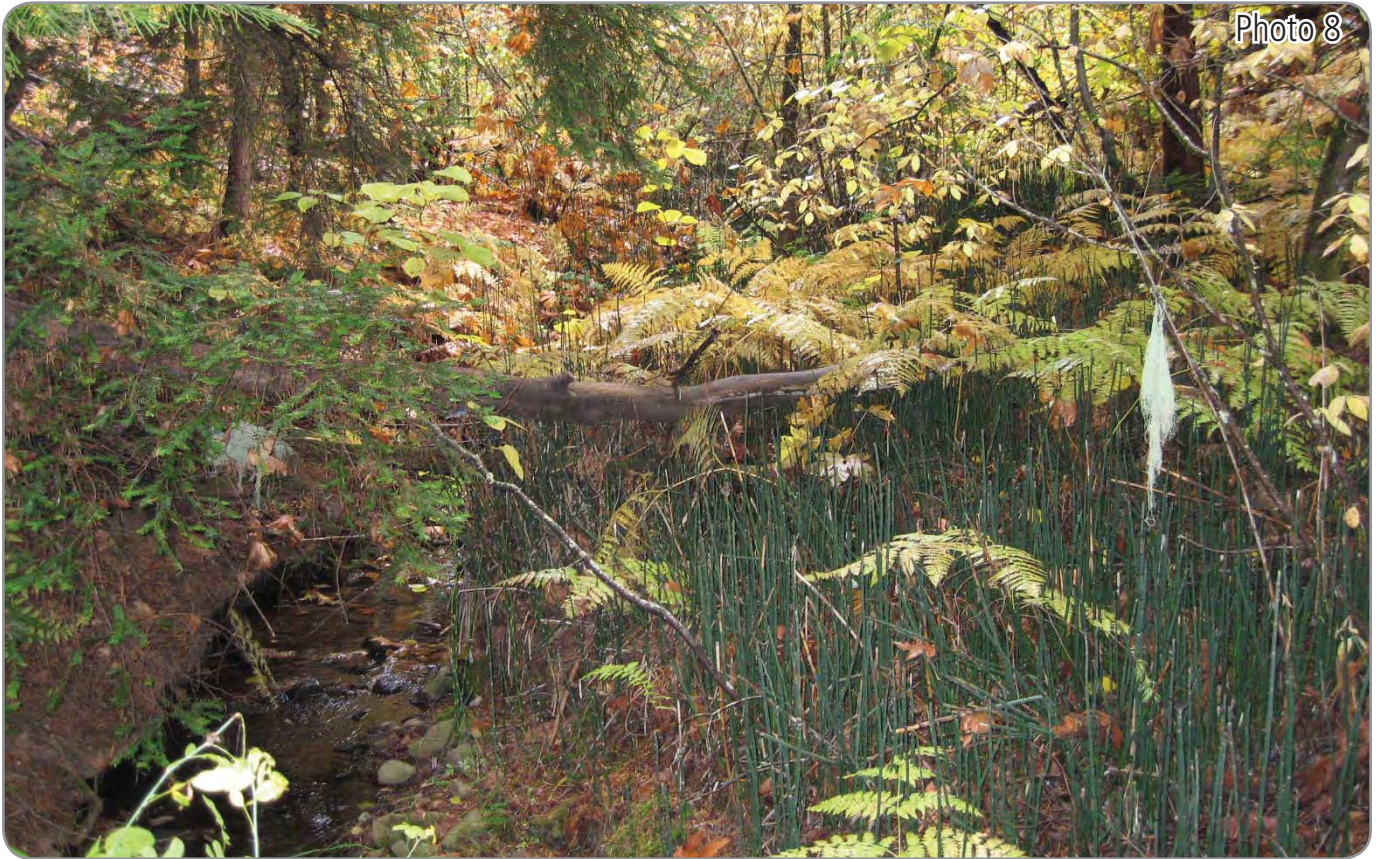
Photo 8

**PHOTO 8:** Horsetail and ferns have colonized the landslide toe near the upstream end of Reach 5.

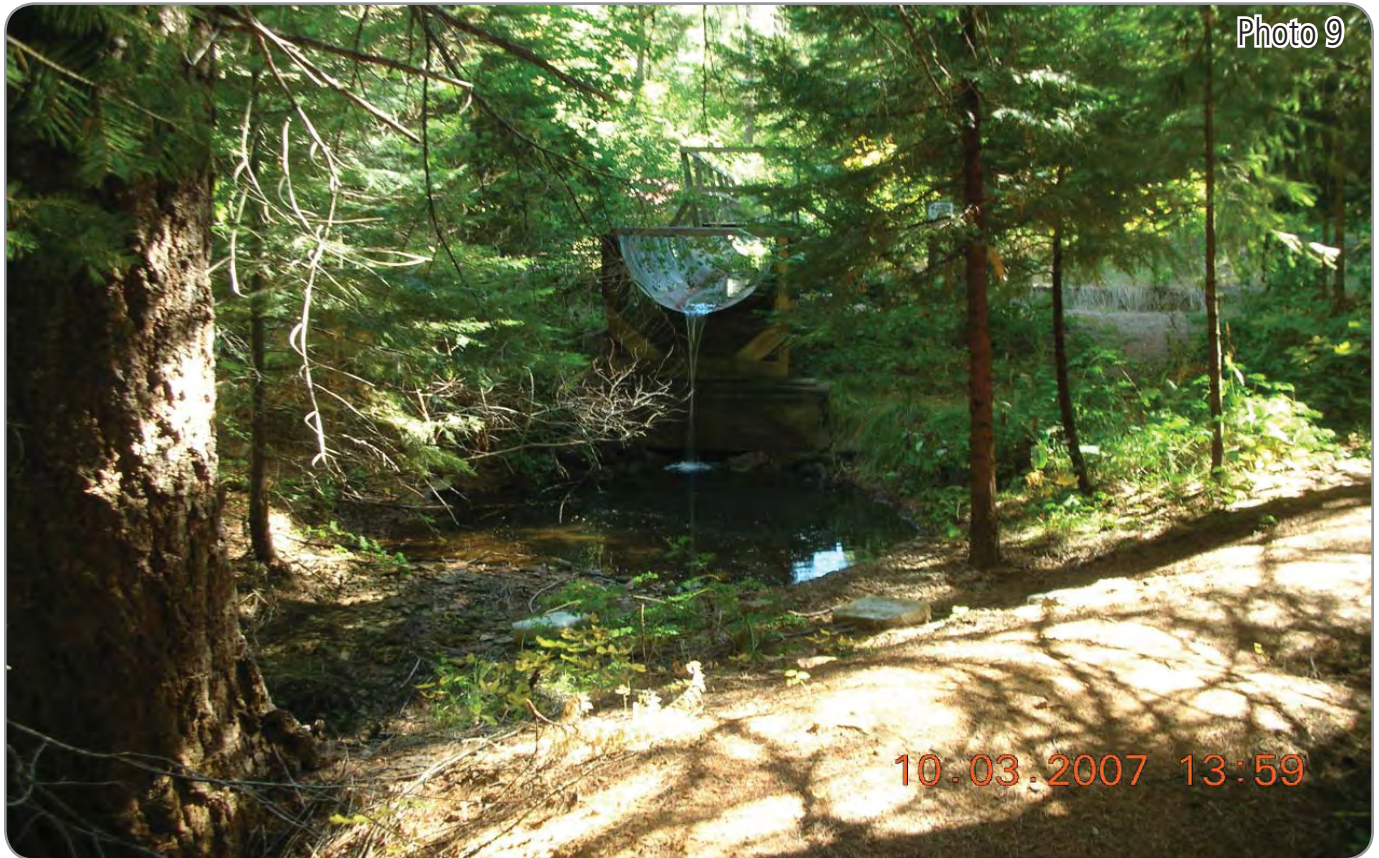
**PHOTO 9:** Downstream end of the Esmeralda Creek bypass flume (Reach 6).

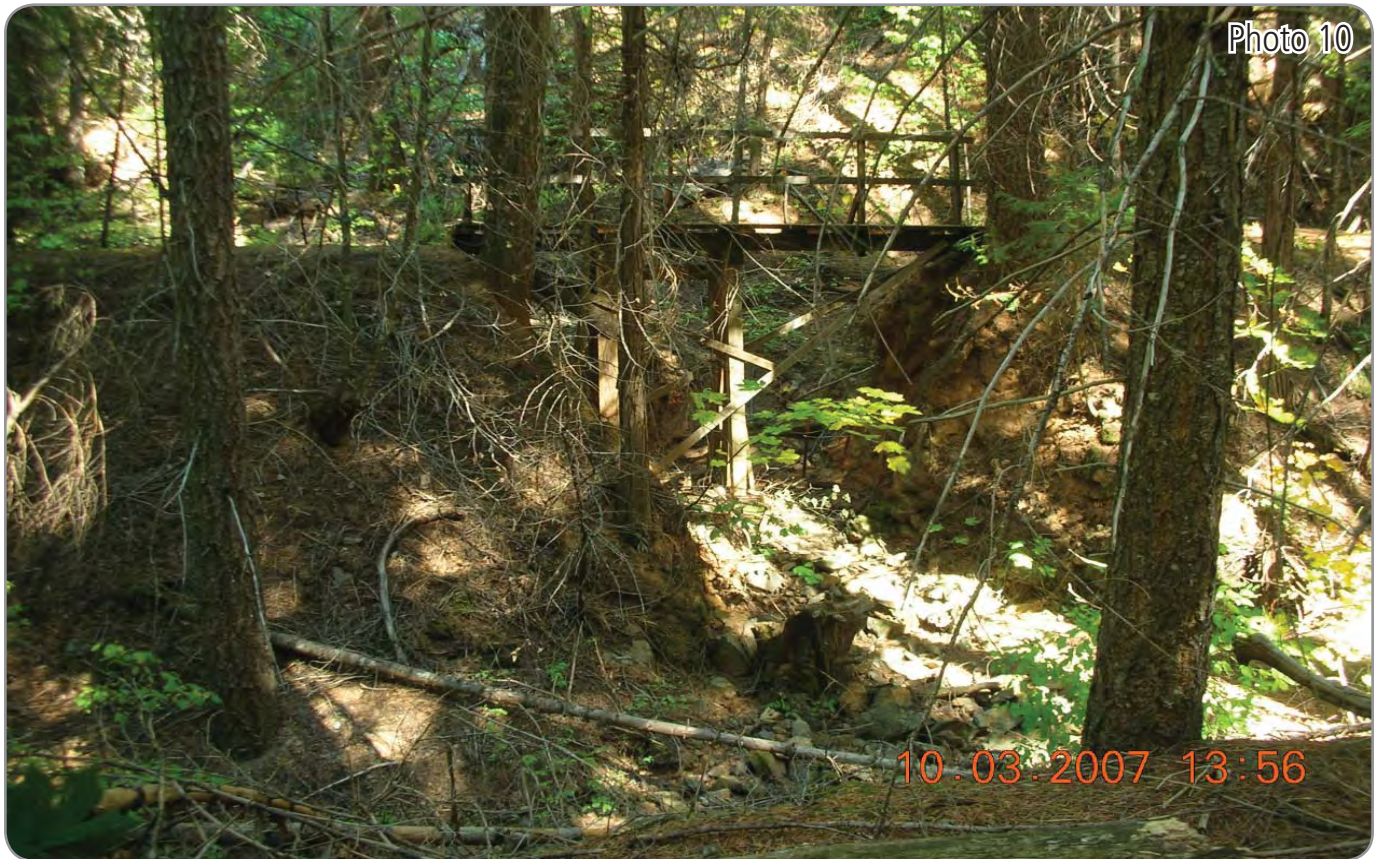
**PHOTO 10:** Confluence of the East and Central Channels (Reach 6).

Once the alignment of Esmeralda Creek is restored, the existing Central and East channels would be stabilized to prevent further erosion and head cutting. Although the channels would no longer be preferential flow paths of Esmeralda Creek, they would be subject to erosion caused by overland flow during large storm events. The most efficient way to stabilize these channels would be to fill them with the tunnel spoils that are stockpiled between the channels. Filling the channels with the stockpiled spoils would accomplish two objectives: it would stabilize the channels and restore the valley morphology that is believed to have existed before the spoils were placed. There are approximately 2,500 cubic yards of tunnel spoils stockpiled on site. The preferred grading plan would balance the cut of the stockpile with the fill of the channels to minimize the need to import or remove material from the site. Grading the spoils pile would require removal of many small to medium sized trees (12 to 24 inch diameter). This temporary impact would be off-set with a revegetation plan for the restored area.

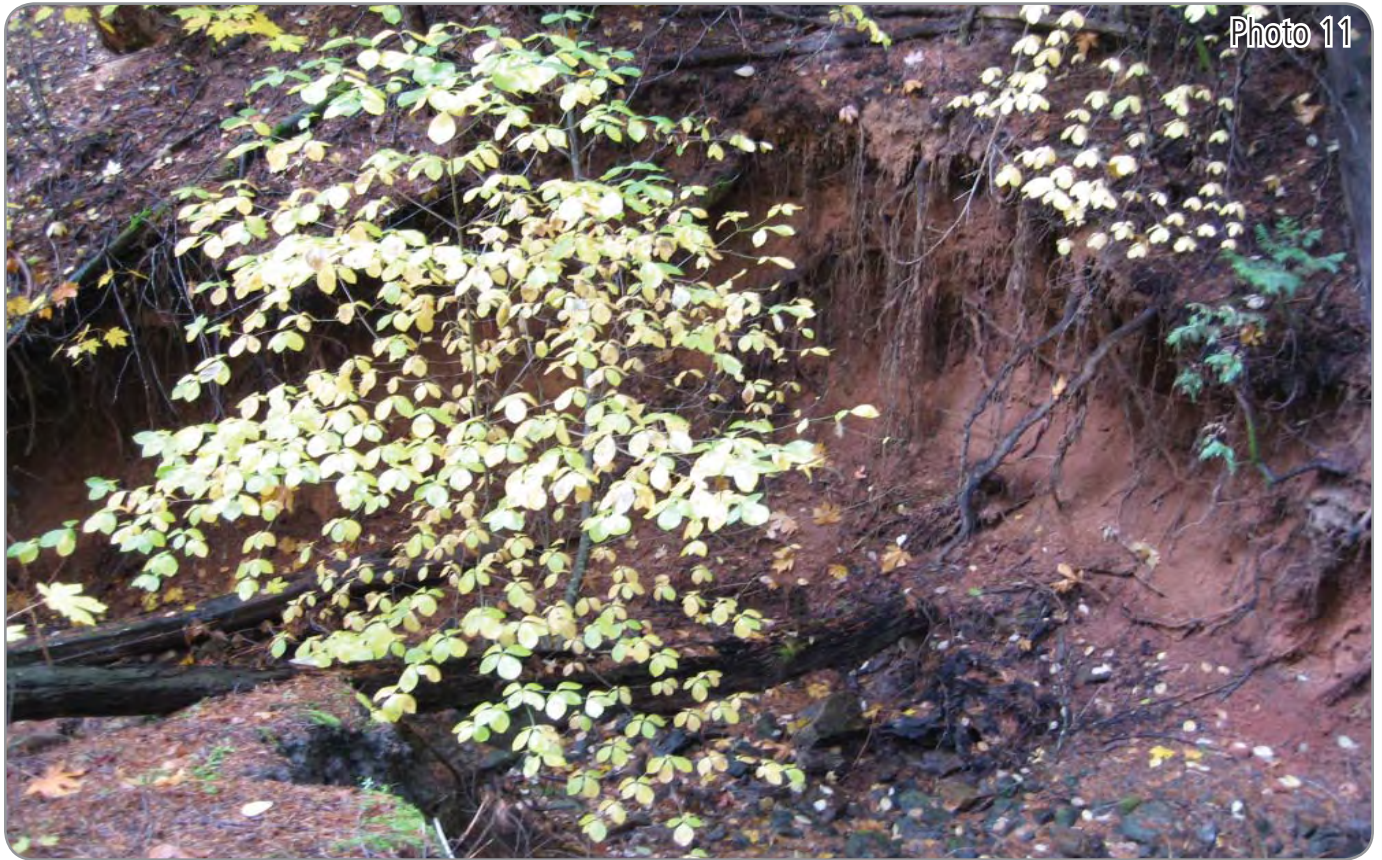
**PHOTO 11:** Large unstable headcut approximately 50 ft downstream of the confluence of the East and Central Channels.

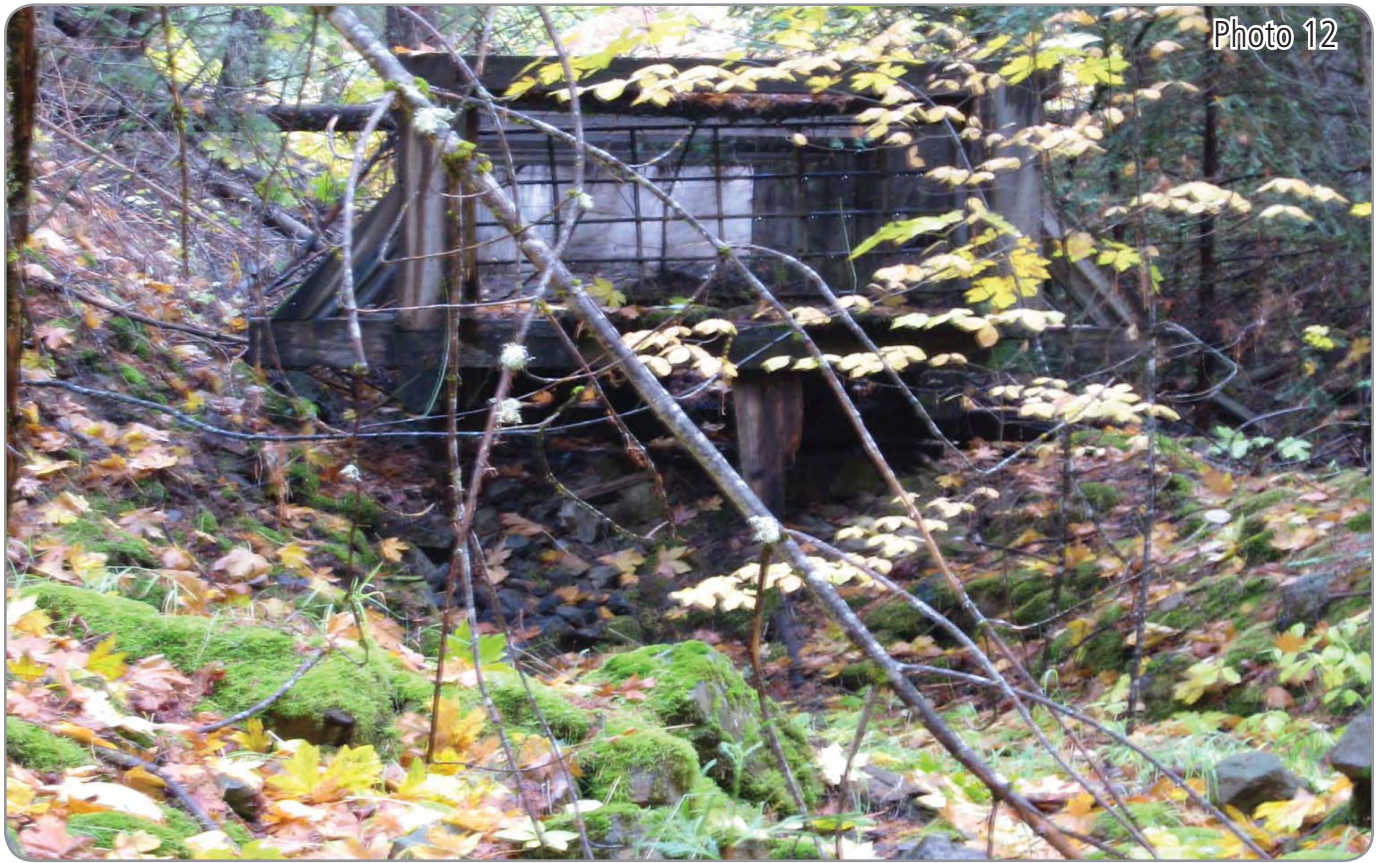
Approximately 120 feet downstream of the East-Central confluence, the Central Channel joins the West Channel, which emanates from the canal spillway (**Photo 12**). This juncture is at the downstream end of the reach and the Esmeralda Creek channel is in good, functioning condition at this location. It is important note that throughout Reach 6 most of the stream flow goes subsurface, resurfacing at the downstream end. This is likely because the channel alignments have been highly altered and there has been a significant amount of porous fill material placed in this reach. A more thorough description of channel morphology is provided in Section 2.4.

**PHOTO 12:** Downstream end of the wood flume in the canal spillway channel (Reach 6).

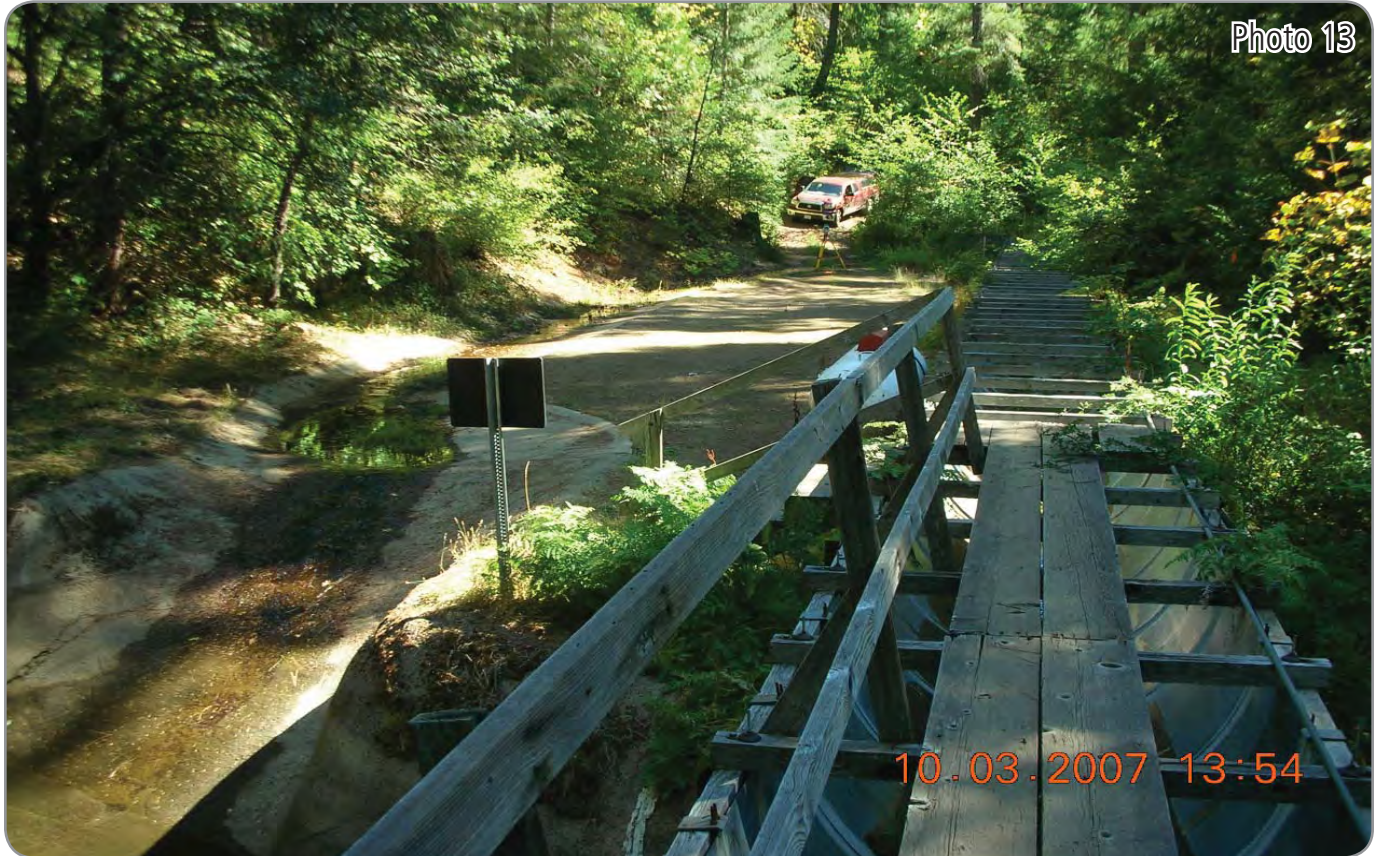
**PHOTO 13:** Bypass flume (Reach 7) crossing over the El Dorado Canal (right) and the overflow channel (left).

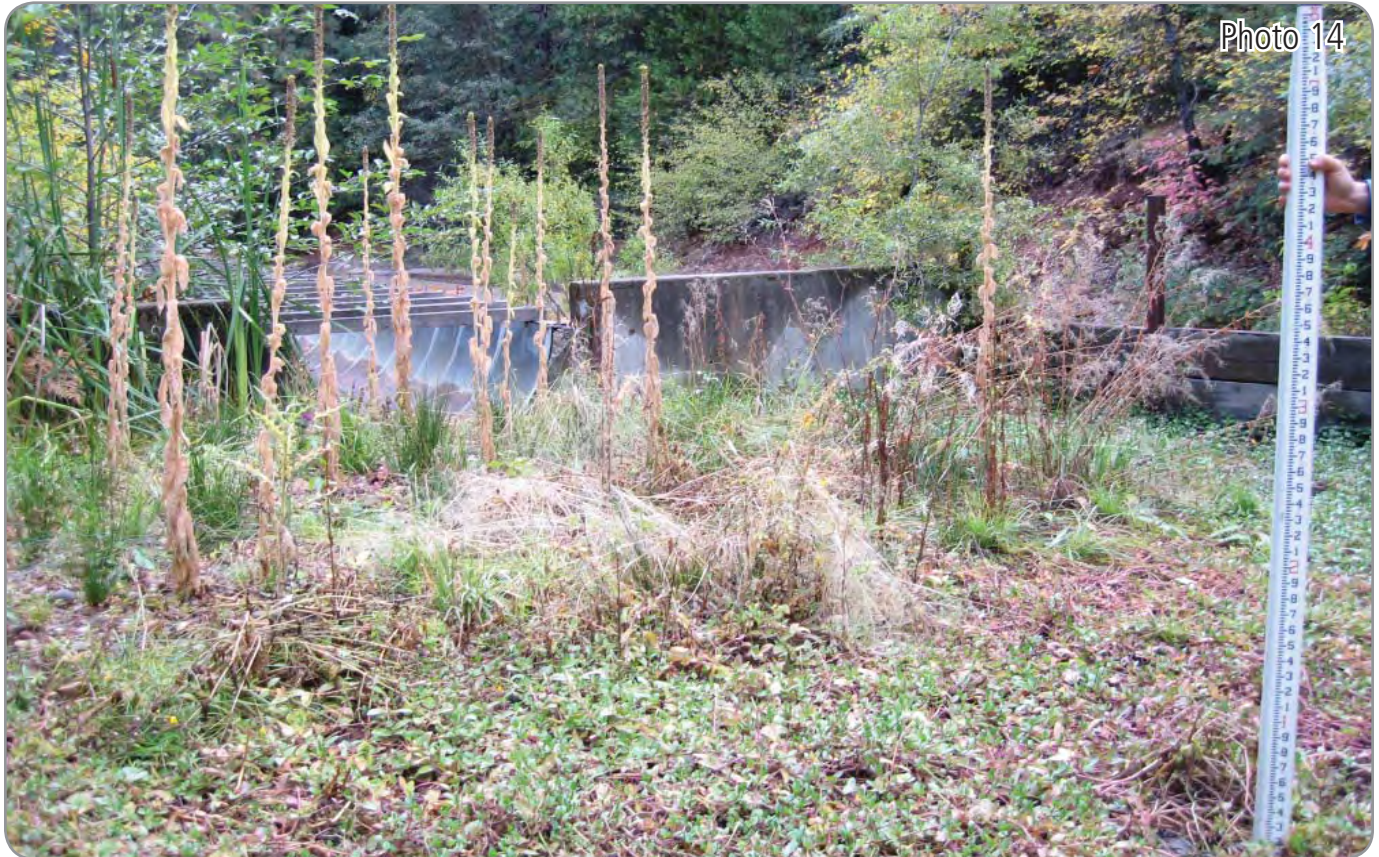
**PHOTO 14:** Flashboard-controlled impoundment upstream of the bypass flume (Reach 7).

Under the proposed conceptual plan the existing impoundment, bypass/diversion and overflow channel in Reach 7 would remain intact. The existing impoundment would be cleared of sediment and the flashboards would be replaced so that they no longer leak into the overflow channel.
