Oyster Creek Stabilization Project
Post-construction Monitoring Report – Year 1

Prepared for:
El Dorado Irrigation District

Prepared by:
Horizon Water and Environment
Contact: Robin Hunter
(510) 986-1854
robin@horizonh2o.com

February 2021

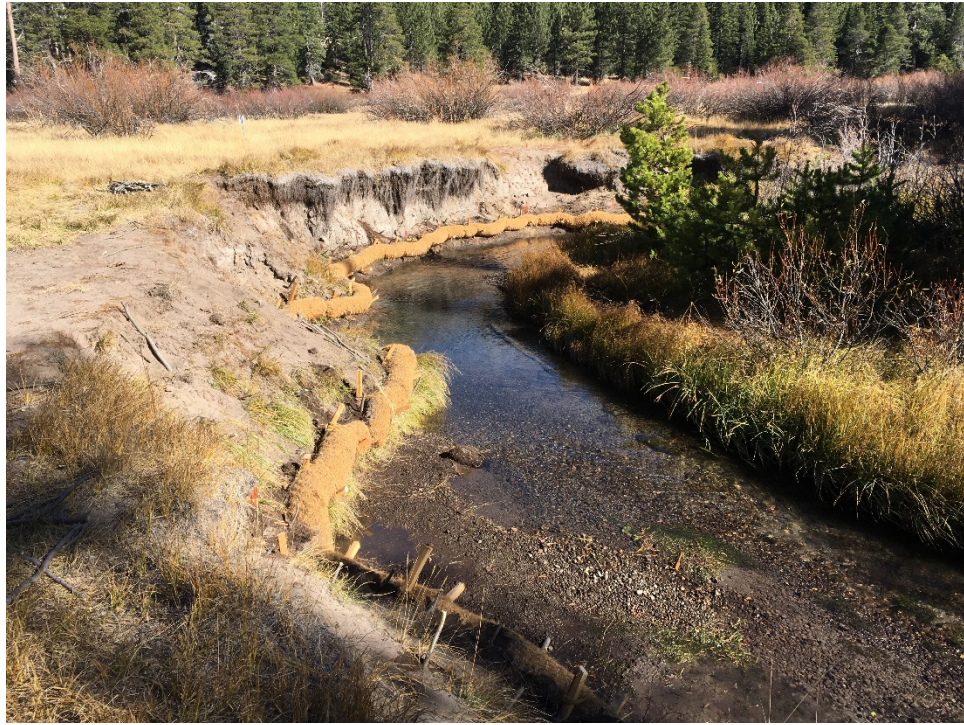
Photo No. 1	Date: 10/24/2019

Description: Oyster Creek post-construction, facing north.		
Photo No. 2	Date: 8/28/2020

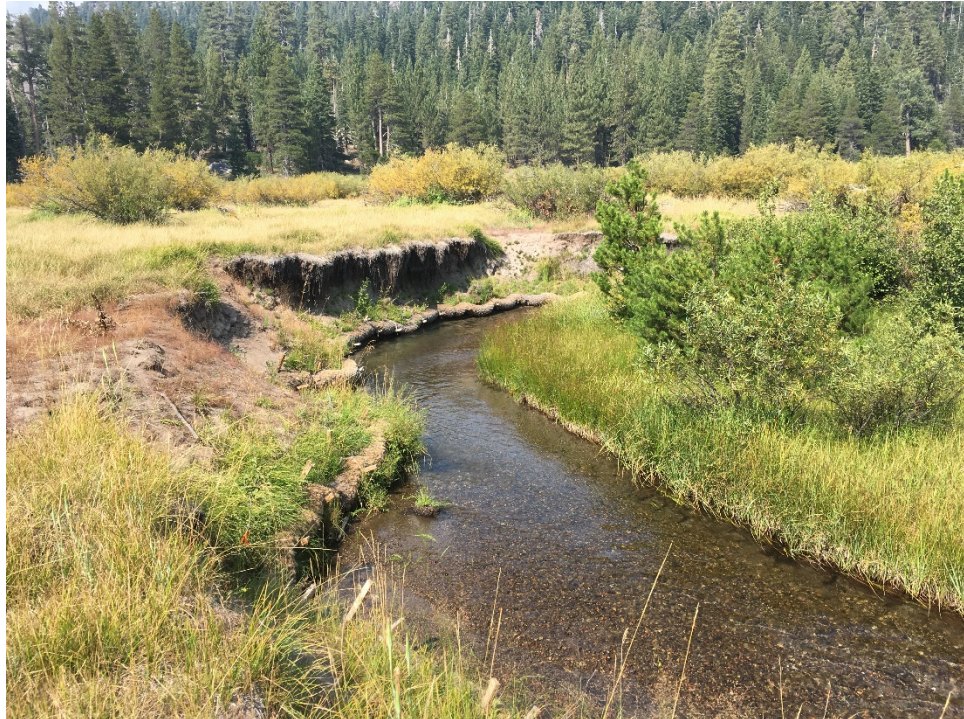
The coir roll installed at the toe of the Oyster Creek bank has remained in place. It is collecting material on its upslope side, and herbaceous vegetation has colonized this area (see Photos 2 and 4 in Attachment A).

Some slumping of the top of bank has occurred at the Oyster Creek restoration site. However, the toe of the bank has remained stable. Sediment is accumulating behind the coir log at the toe of the slope. Erosion rates at the restoration site are currently meeting the performance standard. Overall change in erosion pin lengths was minor during Year 1 monitoring.

Description: Oyster Creek during year 1 Monitoring, facing north.

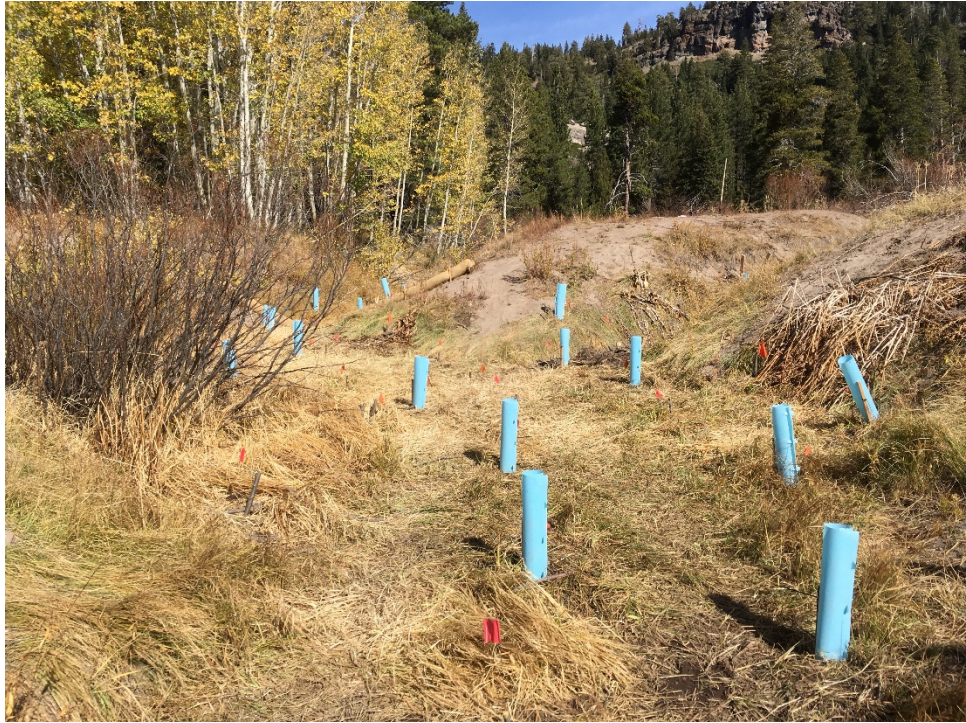
Photo No. 9	Date: 10/24/2019
Description: North tributary, pre-construction, downstream extent of project, facing upstream.

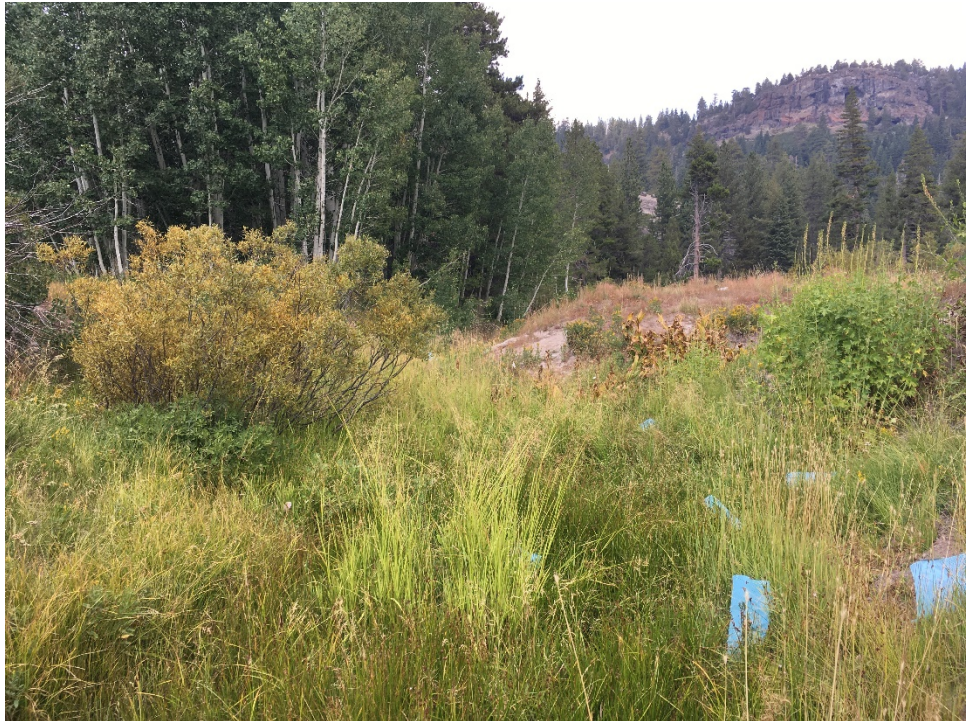
Photo No. 10	Date: 8/28/2020
Description: North tributary during Year 1 monitoring, downstream extent of project, facing upstream.

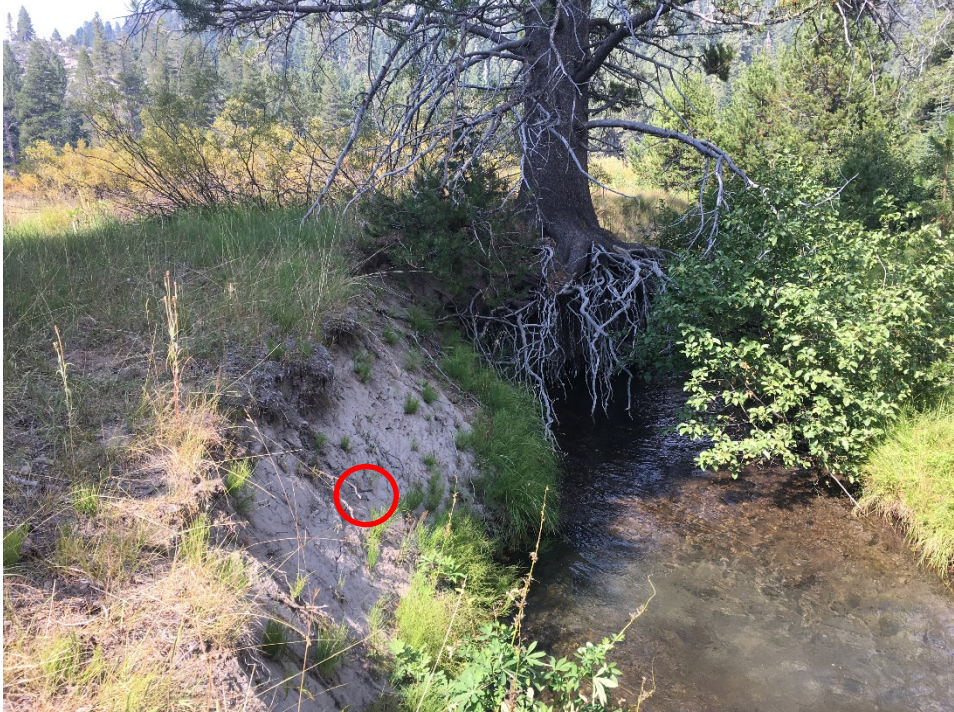
Photo No. 13	Date: 8/28/2020

Erosion pins were installed at various bank elevations in 2019 at the Oyster Creek restoration and reference sites. The erosion pins were measured to determine the rate of erosion at the reference and restoration sites. If restoration sites experience similar erosion rates as reference sites or less (within 25 percent), the restoration will be considered successful. Table 5 provides results from Year 1 erosion pin monitoring. Erosion pin numbers are from upstream to downstream. Photo 13 in Attachment A shows a reference site erosion pin.

Length at Installation (Inches)	Year 1	
		Length (Inches)	Length Change (Inches)
Restoration Site			
Erosion Pin 1	5.75	N/A	N/A
Erosion Pin 2	5.00	5.25	+0.25
Erosion Pin 3	6.10	4.00	-2.10
Erosion Pin 4	6.00	5.00	-1.00
Average			-0.95
Reference Site			
Erosion Pin 5	6.00	4.00	-2.00
Erosion Pin 6	6.00	5.00	-1.00
Average			-1.50

Description: Oyster Creek reference site. Erosion control pin location is circled in red.
