Oyster Creek Stabilization Project
Post-construction Monitoring Report – Year 3

August 2022

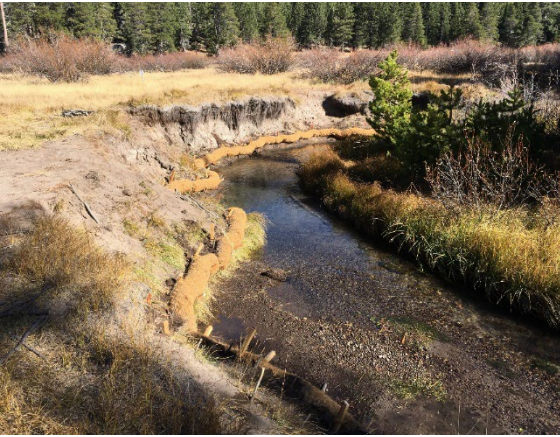
Photo No. 1A	Photo No. 1B	Photo No. 1C
Date: 10/24/2019	Date: 8/28/2020	Date: 6/8/2022
Description: Oyster Creek post-construction, facing north.	Description: Oyster Creek during Year-1 Monitoring, facing north.	Description: Oyster Creek at Year-3. The bank appears to be evolving to a more gradual slope.

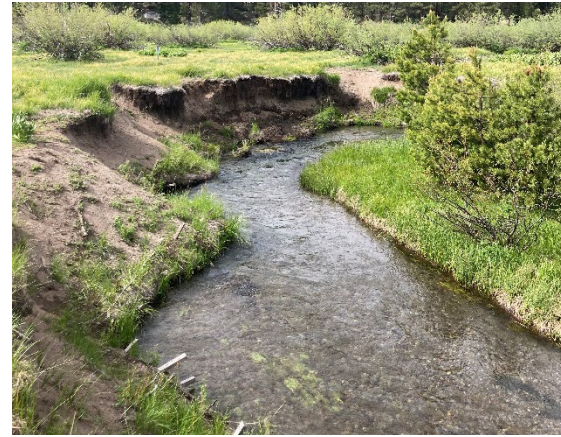
The streambank along the Oyster Creek restoration site appears to be naturally adjusting laterally as the site is evolving to a more stable condition (see Appendix A, Photos 1c and 2c). This is supported by visual evidence that portions of undercut, hanging vegetation along the upper edge of the bank has fallen into the channel, on top of the reinforced coir log toe, or is laying between the top of bank and the coir log. The coir roll has remained in place. It is collecting material on its upslope side, and herbaceous vegetation has colonized this area. This has resulted in a more gradual, stable bank slope in areas that were previously steepened and undercut. The lateral adjustment of the upper bank is moving the restoration site to a more stable equilibrium.

Steps to increase percent vegetative cover may include manually cutting undercut vegetation at the top of bank into blocks of sod and placing the blocks on the mid- and lower slopes above the coir log. The intent of this action is to control the loss of densely vegetated overhanging sections that may otherwise naturally shear off and drop into the creek channel where they become buried or wash away. The blocks should be as large as feasible in order to increase the likelihood vegetation would survive and thereby increase the herbaceous percent vegetative cover at the restoration site.

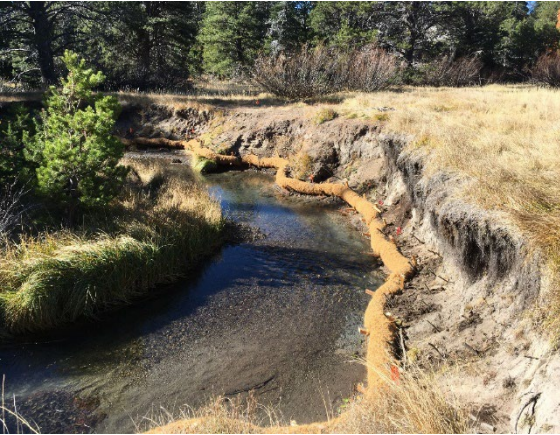
Photo No. 2A	Photo No. 2B	Photo No. 2C
Date: 10/24/2019	Date: 8/28/2020	Date: 6/8/2022
Description: Oyster Creek post-construction, facing south.	Description: Oyster Creek during Year-1 Monitoring, facing south.	Description: Oyster Creek at Year-3. The bank toe appears to be in a similar position as Year-0.

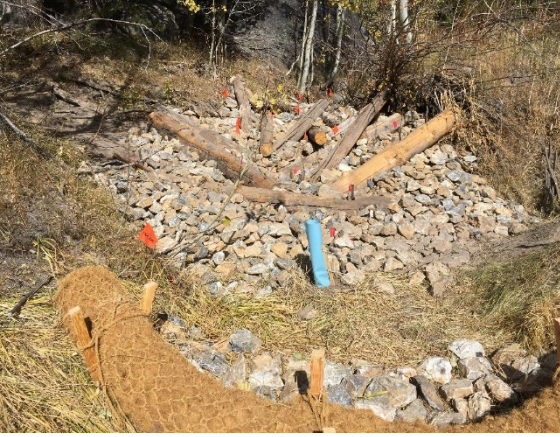
Photo No. 3A	Photo No. 3B	Photo No. 3C
Date: 10/24/2019	Date: 8/28/2020	Date: 6/8/2022
Description: North tributary, main head cut, post-construction. Facing northeast.	Description: North tributary, main head cut during Year-1 monitoring. Facing northeast.	Description: The main head cut on the north tributary remains stable at Year-3.

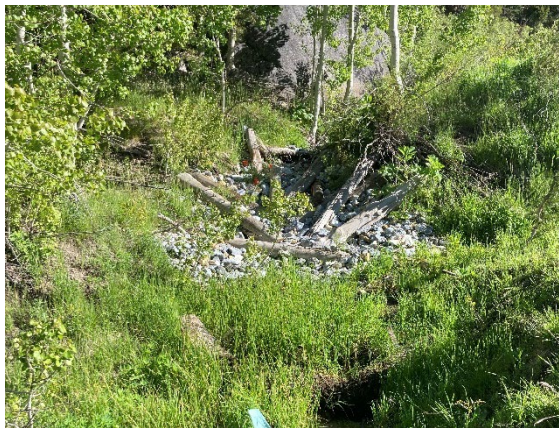
Where visible, planted Lemmon’s willow poles and fascines are currently surviving well at the North Tributary restoration site. Willows installed in the brush pack (rocked channel) appeared most vigorous (see Appendix A, Photo 3c). However, significant sedimentation has occurred behind several fascines and directly downstream of the rocked channel. These features are performing as designed by creating sediment sinks and aggrading the channel thus creating a more gradual bed slope. However, this aggradation has buried significant portions of the willow fascines. In general, these areas are densely vegetated with herbaceous species, but the aggradation unintentionally lowers the survivorship of woody species. Natural recruitment has significantly expanded the aspen stand on the right bank near the rocked channel (see Appendix A, Photos 4c and 5c). Dozens of shoots and saplings were detected along the top of the right bank down to near the toe of the channel. The surviving willow cuttings together with the natural aspen recruitment along the North Tributary restoration site result in this site currently meeting its percent survival performance standard.

No upstream advancement has occurred in the headcut in the main portion of the North Tributary, where the brush pack was installed. The brush pack has remained stabled and sediment aggradation is visible (Photos 3c and 4c in Appendix A). The smaller headcuts in the upstream and downstream tributaries have not advanced since Year-1. The biotechnical stabilization methods used in these portions of the North Tributary do not provide as much immediate erosion control as the brush pack does, as the root systems of plantings are still becoming established. The reference site headcut has advanced by 2 inches since Year-1. North Tributary headcuts are meeting the performance standard, and headcut advancement is less than or equal to headcut advancement at the reference headcut.

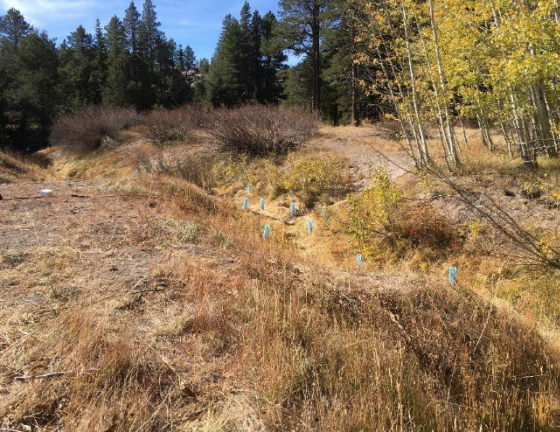
Photo No. 4A	Photo No. 4B	Photo No. 4C
Date: 10/24/2019	Date: 8/28/2020	Date: 6/8/2022
Description: North tributary, pre-construction, facing southeast.	Description: North tributary, during Year-1, facing southeast.	Description: North tributary in Year-3. Dense vegetation covers both banks.
