Oyster Creek Stabilization Project
Post-construction Monitoring Report – Year 4

Prepared for:
El Dorado Irrigation District

Prepared by:
Horizon Water and Environment
Contact: Robin Hunter
(203) 848-9977
rohunter@montrose-env.com

January 2024

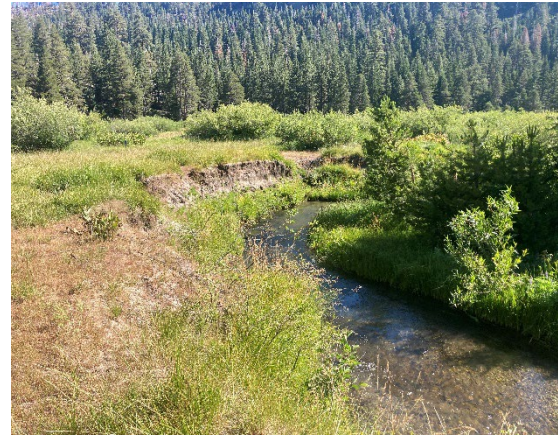
All of the approximately 25 linear feet of sod blocks repositioned along the bank remained intact and appeared to be functioning as intended by increasing the vegetation cover along the mid- and lower bank and increasing the stability of the lower bank and toe. Fine materials appear to be accumulating behind the coir log allowing herbaceous vegetation to establish around the sod blocks and create a near-continuous band of vegetation along the lower bank through the restoration site (see **Appendix A**, Photos

Photo No. 1A		Photo No. 1B		Photo No. 1C	
Date: 10/24/2019	Year: 0	Date: 8/28/2020	Year: 1	Date: 8/7/2023	Year: 4
Description: Oyster Creek post-construction, facing north.		Description: Oyster Creek facing north.		Description: Bank vegetation density has increased along the lower bank.

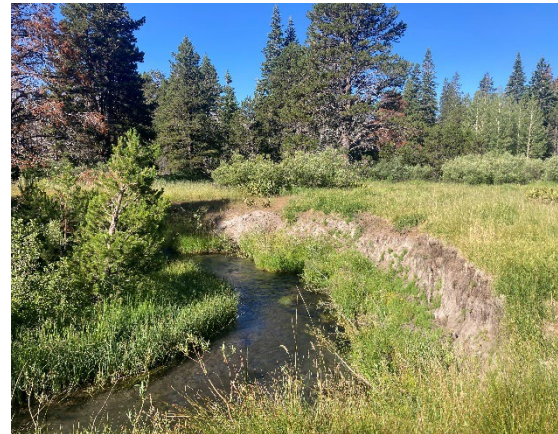
1C and 2C). As shown in Table 1, the restoration site is exceeding the performance criteria for vegetative cover.

Photo No. 2A		Photo No. 2B		Photo No. 2C	
Date: 10/24/2019	Year: 0	Date: 8/28/2020	Year: 1	Date: 8/7/2023	Year: 4
Description: Oyster Creek post-construction, facing south.		Description: Oyster Creek facing south.		Description: The bank toe appears to be aggrading with the upper slope stable.

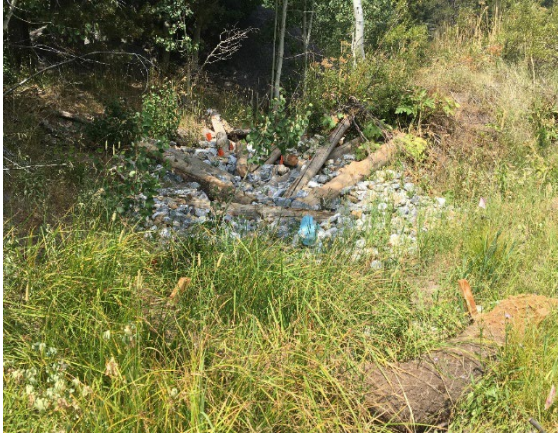
No upstream advancement has occurred in the headcut in the main portion of the North Tributary, where the brush pack was installed. The brush pack has remained stabled and sediment aggradation is visible (Photos 3c and 4c in Appendix A). However, a 2-foot wide by 2-foot long by 18-inch deep hole was observed at the downstream end of the rock channel at the transition point to earthen streambed. The rock itself appeared to be in stable condition and no erosion was apparent in the channel downstream of the scour hole. The scour hole was repaired on November 2, 2023 to prevent the potential for future undercutting of the upstream rock riprap. Repairs were made using a mixture of rock and native soil under the supervision of Montrose biologist Jessica González. See Appendix A, Photos 8A and 8B.

Photo No. 3A		Photo No. 3B		Photo No. 3C	
Date: 10/24/2019	Year: 0	Date: 8/28/2020	Year: 1	Date: 8/7/2023	Year: 4
Description: North tributary, main head cut, post-construction. Facing northeast.		Description: North tributary, main head cut, facing northeast.		Description: The main head cut on the north tributary remains stable at Year-4.

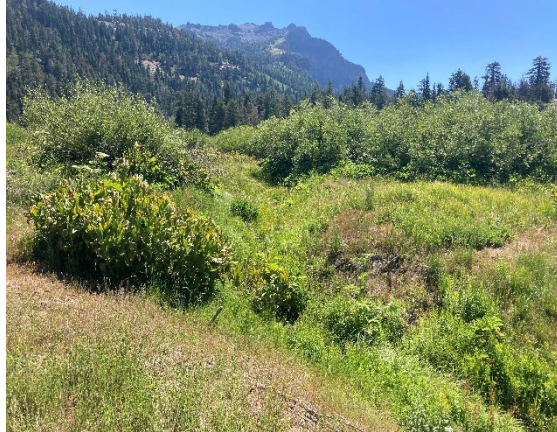
Significant sedimentation has occurred behind several fascines in the upstream and downstream tributaries and in the main tributary downstream of the rock channel. These fascine features are performing as designed by creating sediment sinks and aggrading the channel thus creating a more gradual bed slope. However, this aggradation has buried significant portions of the willow fascines. In general, the tributary channels are densely vegetated with herbaceous species, as shown in Table 3, but the aggradation has unintentionally lowered the survivorship of the live willow cuttings (see Appendix A, Photos 3C, 4C, 5C, and 6C).

Photo No. 4A		Photo No. 4B		Photo No. 4C	
Date: 10/24/2019	Year: 0	Date: 8/28/2020	Year: 1	Date: 8/7/2023	Year: 4
Description: North tributary, pre-construction, facing southeast.		Description: North tributary, facing southeast.		Description: North tributary – dense herbaceous vegetation covers both banks.

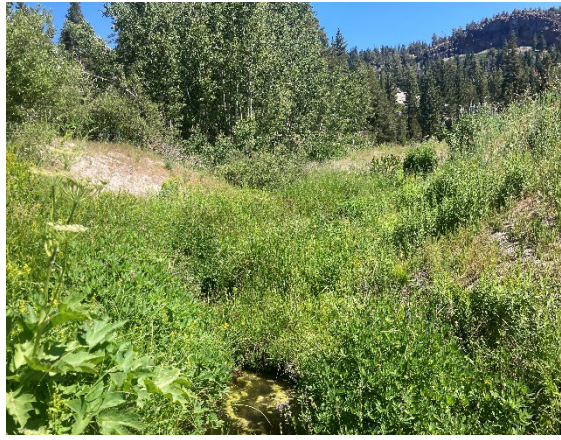
Photo No. 5A		Photo No. 5B		Photo No. 5C	
Date: 10/24/2019	Year: 0	Date: 8/28/2020	Year: 1	Date: 8/7/2023	Year: 4
Description: North tributary, pre-construction, downstream extent of project, facing upstream.		Description: North tributary at the downstream extent of project, facing upstream.		Description: An aspen stand continues to expand on the right bank and into the main tributary.

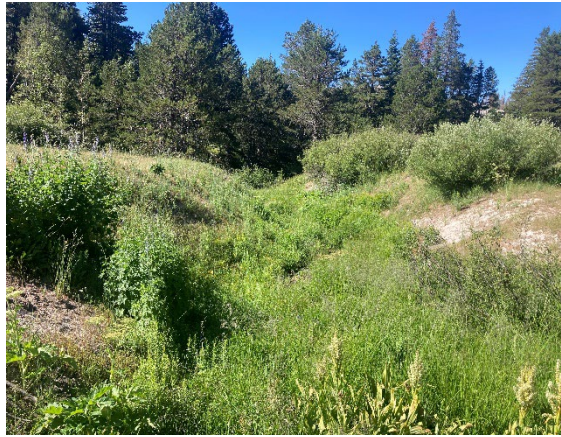
Photo No. 6A		Photo No. 6B		Photo No. 6C	
Date: 10/24/2019	Year: 0	Date: 8/28/2020	Year: 1	Date: 8/7/2023	Year: 4
Description: North tributary, post-construction, facing east.		Description: North tributary, facing east.		Description: North tributary is densely vegetated with a mix of native herbaceous species.

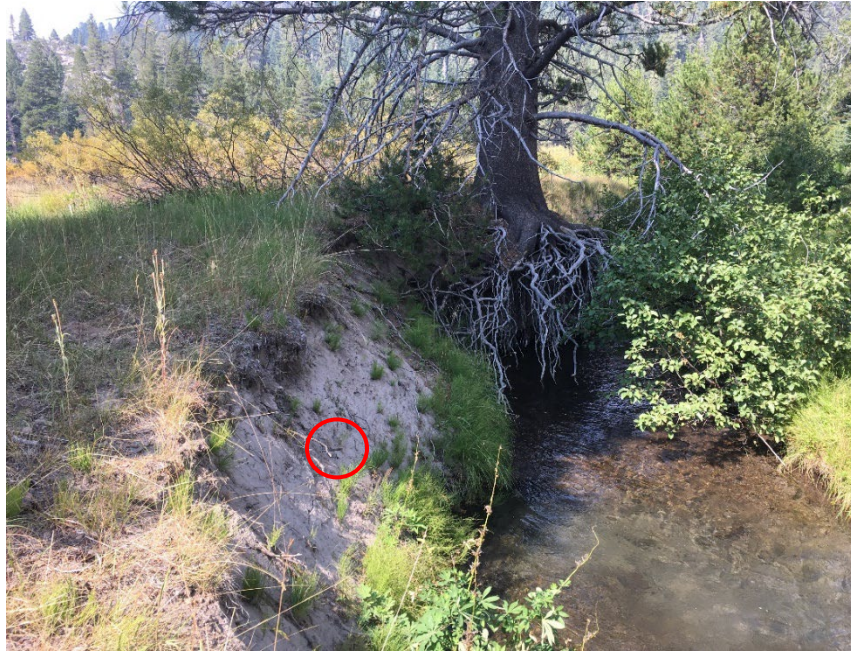
Erosion pins were installed at various bank elevations in 2019 at the Oyster Creek restoration and reference sites. The erosion pins were measured to determine the rate of erosion at the reference and restoration sites. If restoration sites experience similar erosion rates as reference sites or less (within 25 percent), the restoration will be considered successful. **Table 5** provides results from Year-1 and Year-4 erosion pin monitoring. Erosion pin numbers are from upstream to downstream. Photo 7B in Appendix A shows a reference site erosion pin.

Photo No. 7A		Photo No. 7B	
Date: 8/28/2020	Year: 1	Date: 8/7/2023	Year: 4
Description: Oyster Creek reference site. Erosion control pin location is circled in red.		Description: Conditions at the reference site appears relatively unchanged in Year-4 as compared to Year-0.

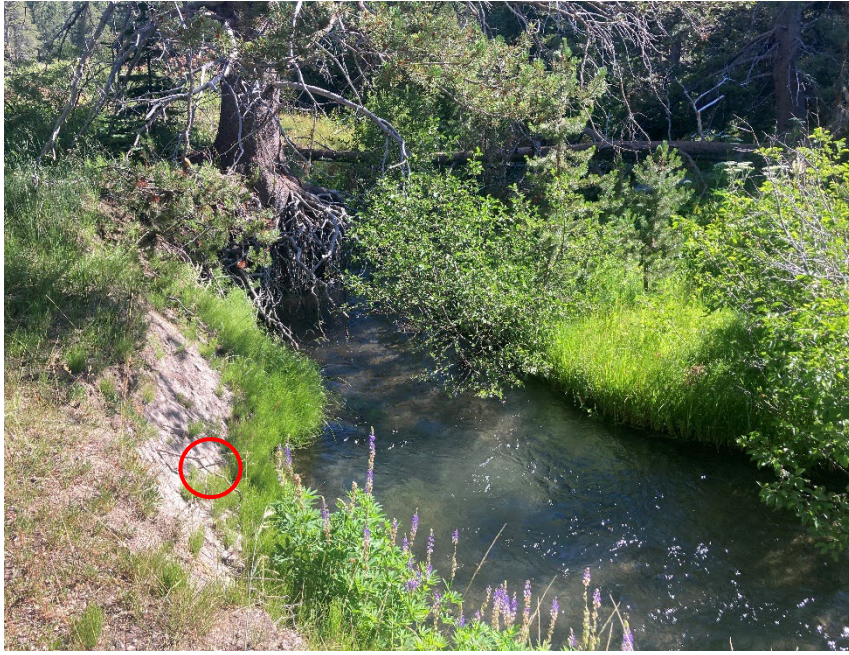
Conditions at the Oyster Creek reference site remained relatively similar to previous years in terms of erosion and species composition, but with a slight decrease in overall herbaceous cover site (see Appendix A, Photos 7A and 7B).
