EL DORADO IRRIGATION DISTRICT

Caples Spillway Channel Sensitive Site Investigation Project 184 Geomorphology Monitoring

FEBRUARY 2010

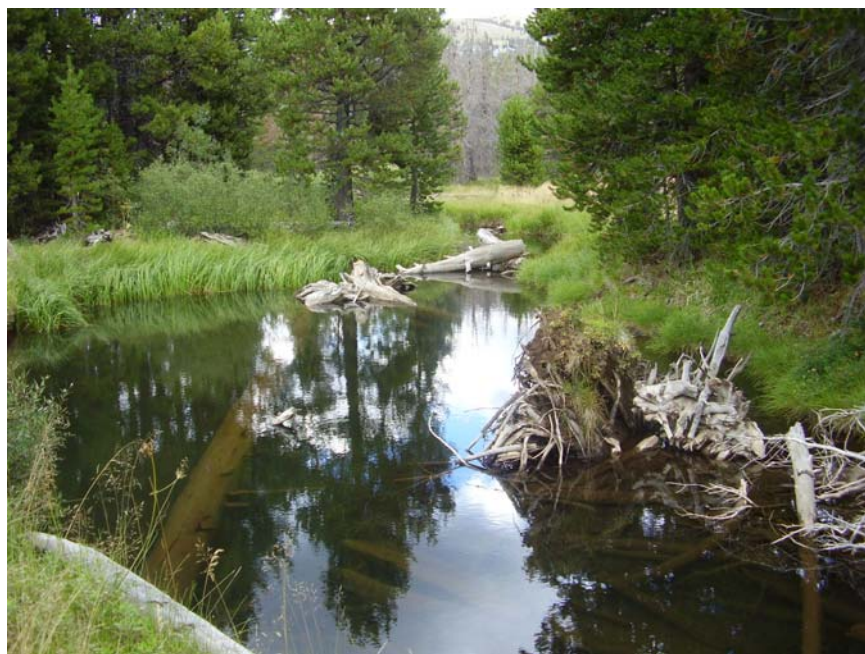
Figure 2-5 Pool-Riffle channel type in backwater section of spillway channel, approximately 150 ft upstream from Caples Creek. Note the low banks that allow a floodplain connection

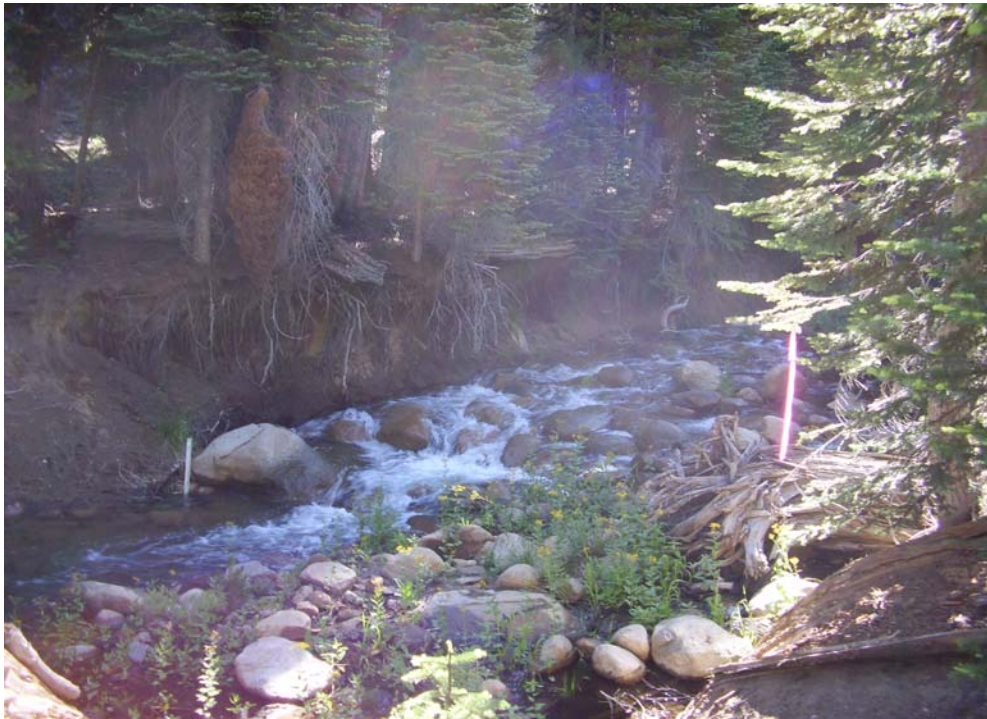
The upstream erosion site (see Table 2-1, Station 850-1200) is located beginning approximately 850 ft downstream from the auxiliary dam. The site is about 350 ft long, although about 250 ft is unstable. Banks are 6-8 ft tall, comprised of fine-grained material, with most of the bank height eroding. Approximately 150 ft of the channel length at the upstream end of the site is actively eroding along both the right and left banks. Another 100 ft of the channel is actively eroding on the right bank at the lower end of the site where bedrock is sloping on the left bank and forcing flow against the right bank (Figure 2-7). There is also a short section of more moderately stable channel bank between these two eroding sections.

Figure 2-6 Upper Erosion Site, view upstream of right bank (left bank also eroding, not in view)

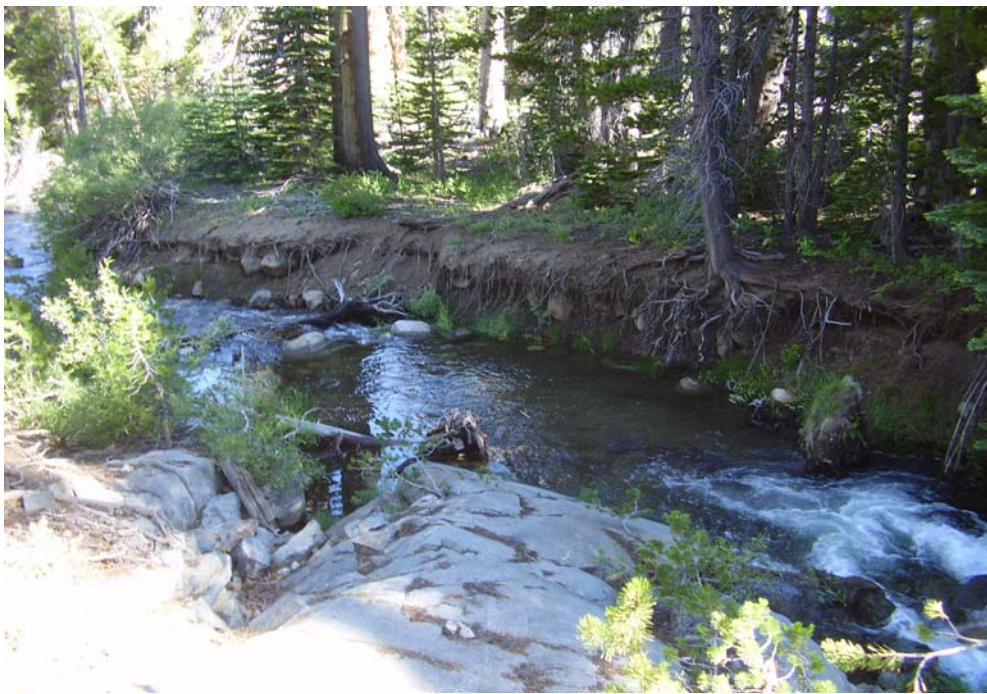
Figure 2-7 Upper Erosion Site right bank, with sloping bedrock on left bank

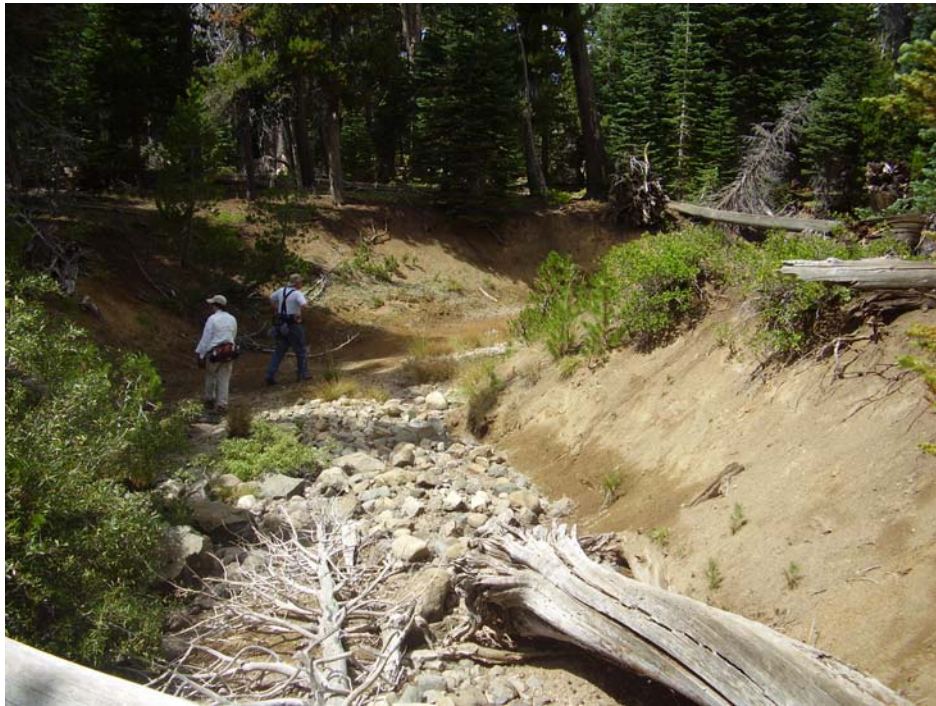
All of the lower pool-riffle reach upstream from the backwater area see Figure 2-1 has been subjected to past bank erosion, and remains vulnerable to future erosion (see Table 2-1, Station 2197-2600). Approximately 500 ft of channel length along most of both the right and left banks, which average about 6 ft high, are eroding (Figure 2-8). Undercutting of the fine-grained bank material and subsequent slumping and collapse are apparent, leaving standing trees with exposed roots (Figure 2-9). There is a large woody debris jam close to the upstream end of the lower erosion site, with about 50 ft of erosion along the right bank just upstream of the debris jam. Below the most downstream portion of the lower erosion site (see Table 2-1, Station 2600-3000), within the 350 ft backwater section to the confluence with Caples Creek, is relatively stable with only localized bank erosion. This is probably due to the influence of the backwater on channel hydraulics, which dissipates energy and allows high flows to spread out over the top of banks onto the floodplain. This provides a “hydraulic release” from the shear forces that occur during high flows.

Figure 2-8 Lower Erosion Site, view downstream

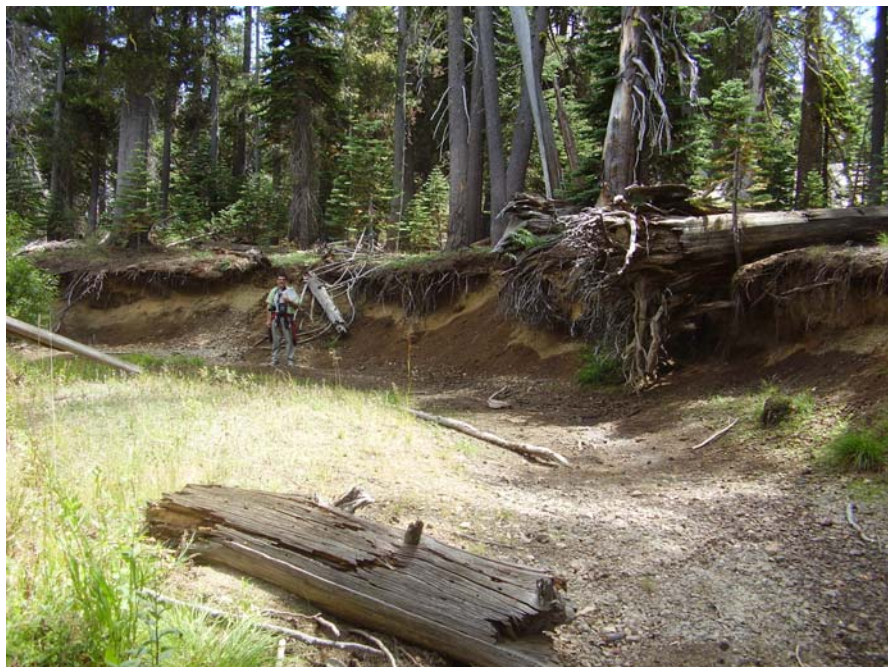
Figure 2-9 Lower Erosion Site. Left Bank, view upstream

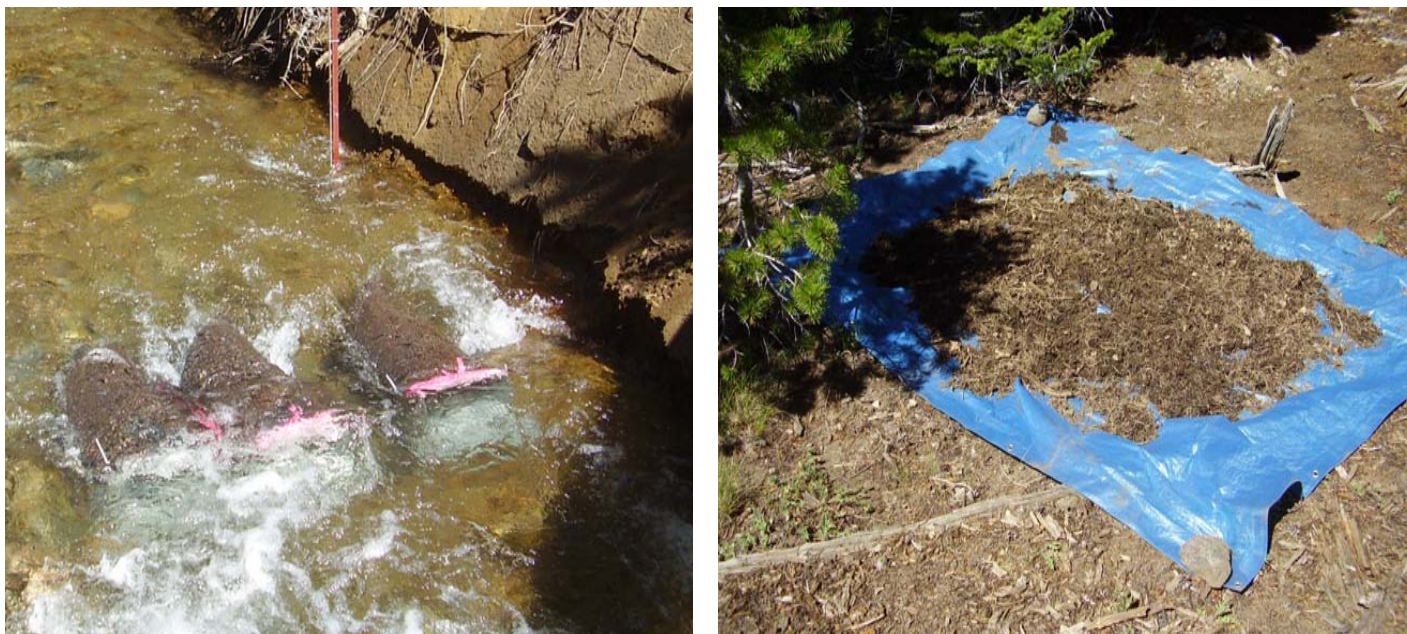
For this monitoring study, the bedload traps were not an effective method of sampling bedload. Following their deployment and each of the controlled flow releases, the nets quickly filled up with pine needles, pine cones, and other woody organic debris (Figure 4-3). As the nets filled with organic debris their ability to accurately trap the sediment load in transport diminished until ultimately the nets were completely full of organic debris and could not trap any sediment. The problem with the organic debris was likely exacerbated by the unique circumstances of the spillway channel. Years can pass without the spillway channel conveying any substantial flow yet organic debris is constantly shedding from the bordering pine forest and collecting in the channel. As such, each of the flow releases washed the accumulated debris downstream where it clogged the sampler nets. Organic debris was a problem for the entire duration of all three flow releases, including the much shorter 2-3 hour release at 58 cfs. When the bedload trap nets were emptied onto tarps on the bank, well over 90% of the material was organic debris. Because the hydraulic function of the bedload traps were so impaired by the organic debris, the small amount of sediment collected in the nets could not be considered a reliable sampling of the actual bedload, and was therefore not used to calculate bedload transport.

Figure 4-3 Deployed bedload trap samplers full of organic debris following the 30 cfs release (left), and trapped organic debris (e.g., needles, pine cones) with a small amount of intermixed sand and gravel emptied from one sampler drying onto tarp (right)

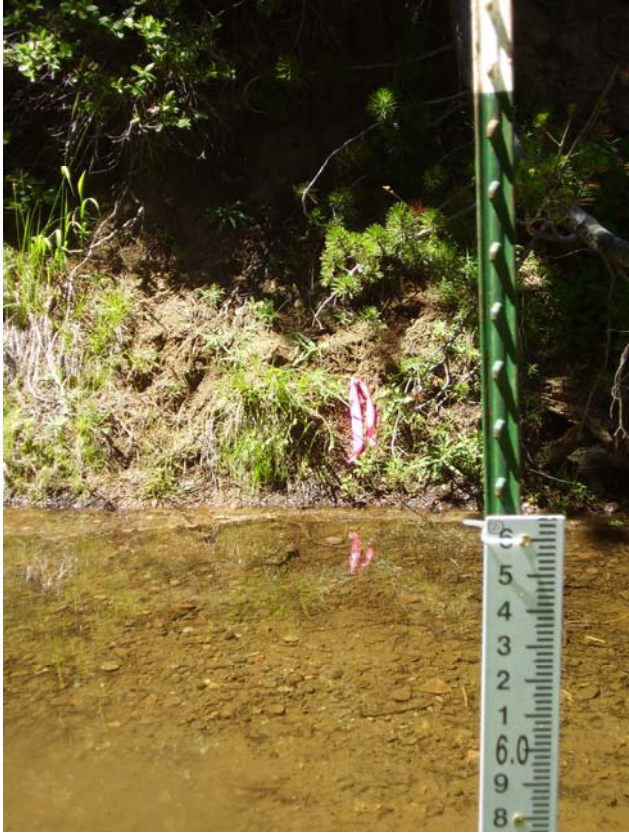
Pin 1 installed. There was virtually no bank retreat at Pin 1 after all of the flow releases

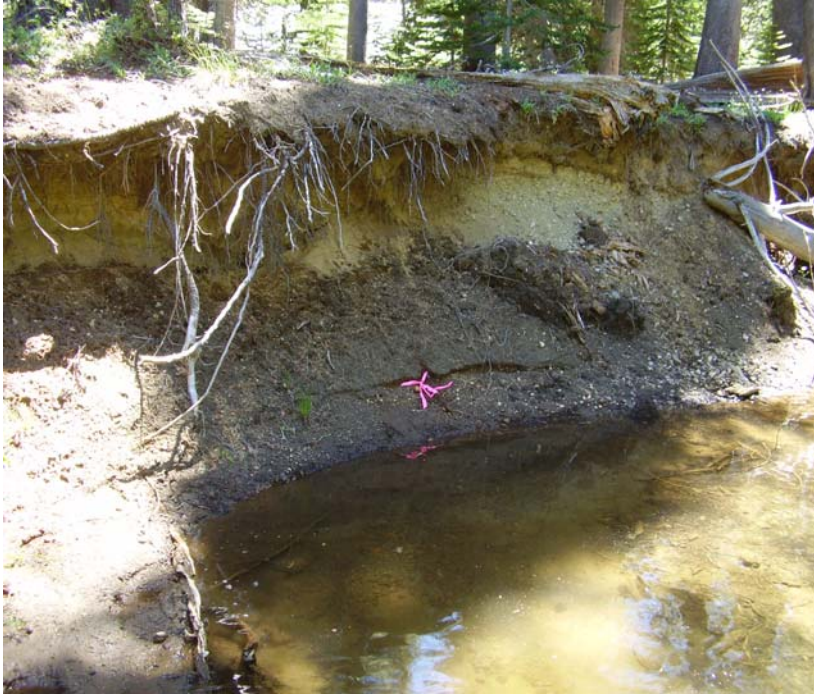
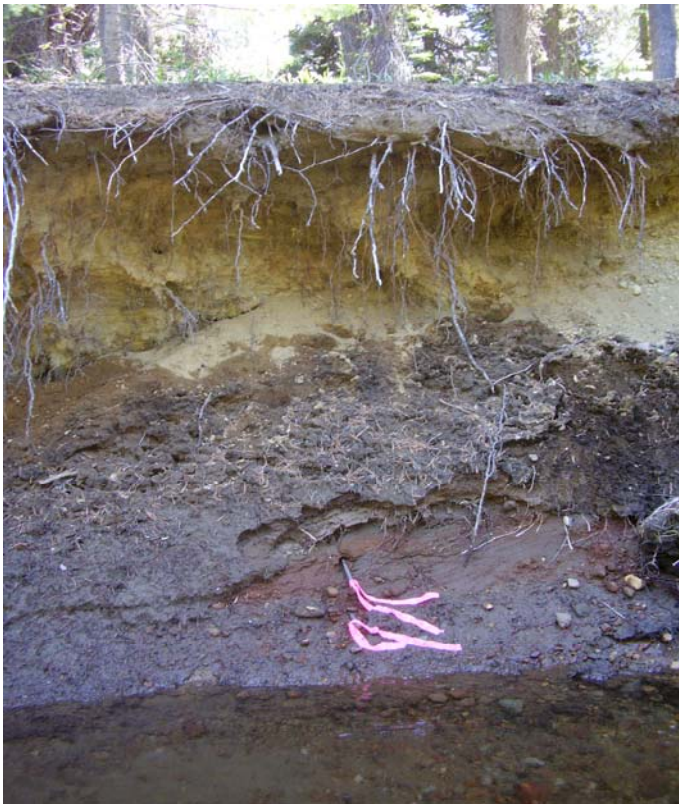
.26 ft bank retreat at Pin 3 and .13 ft at Pin 2 after 24 cfs flow release

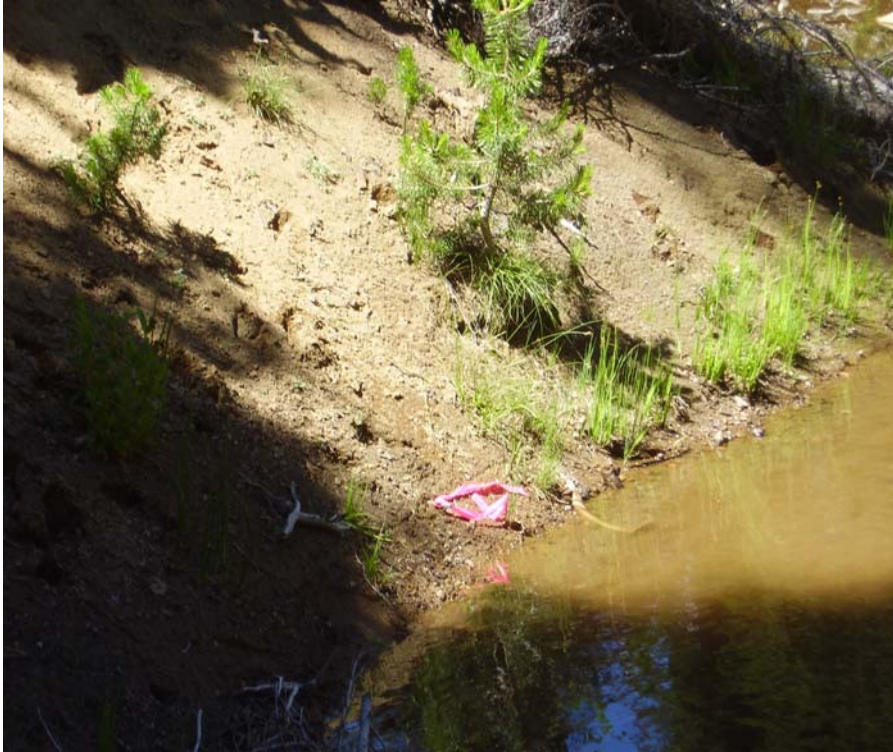
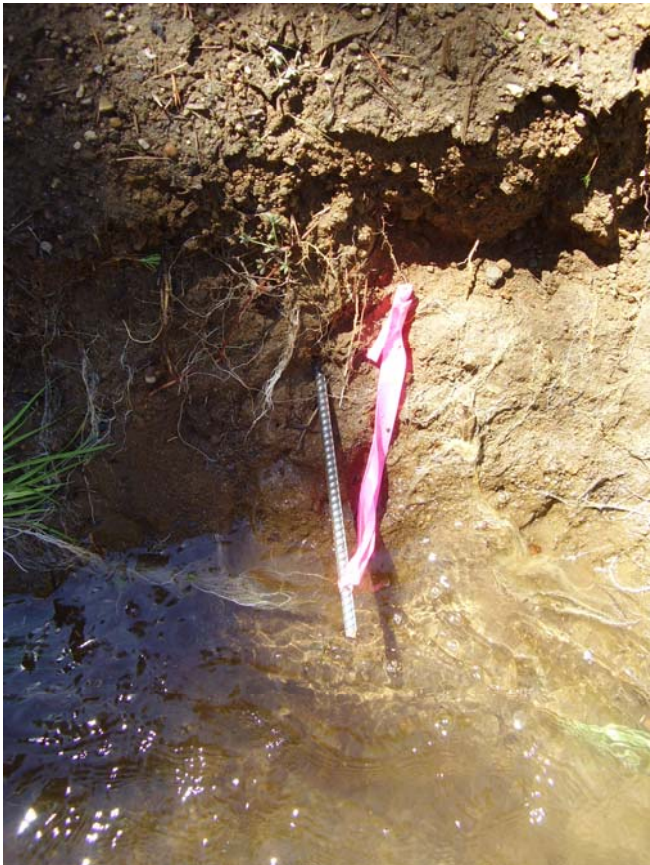
.55 ft bank retreat after 24 cfs release

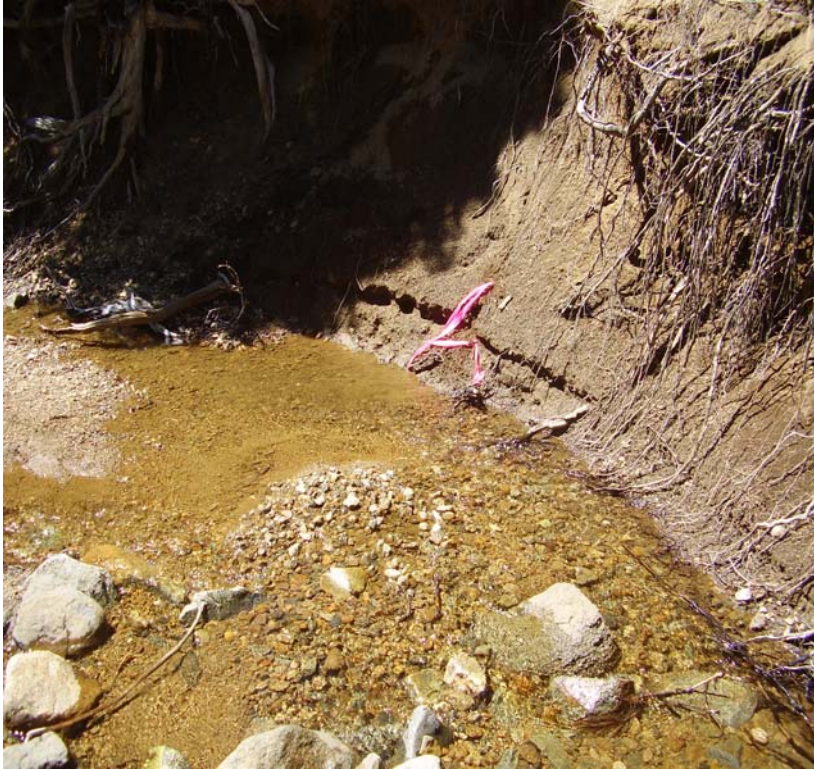
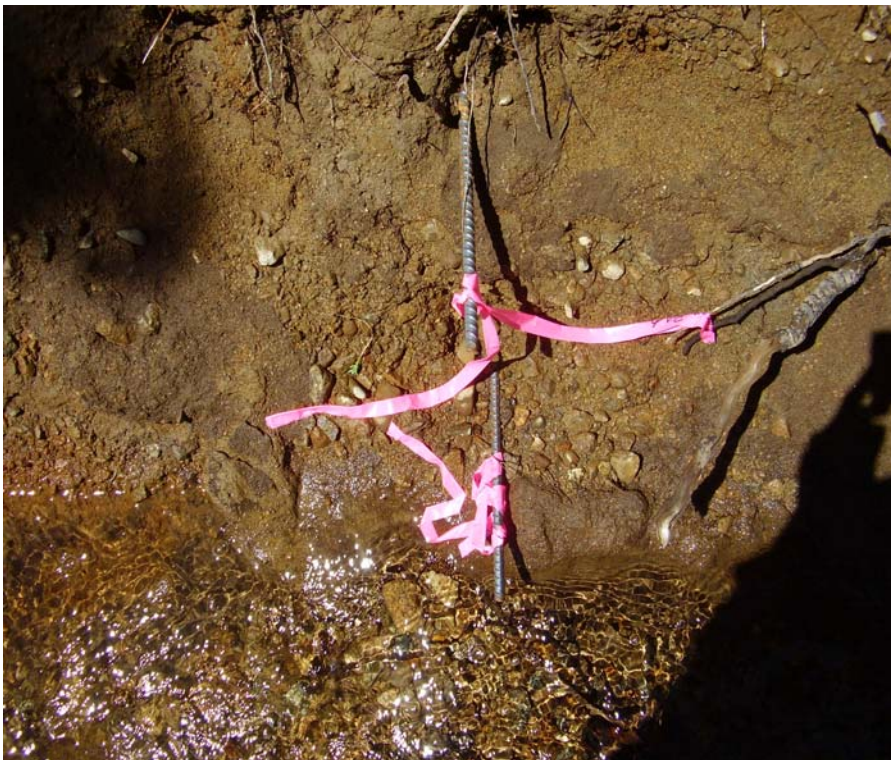
Approximately .5 ft bank retreat for both pins after 24 cfs release
