Oyster Creek Sensitive Site Monitoring Report

prepared for
El Dorado Irrigation District

August 2009

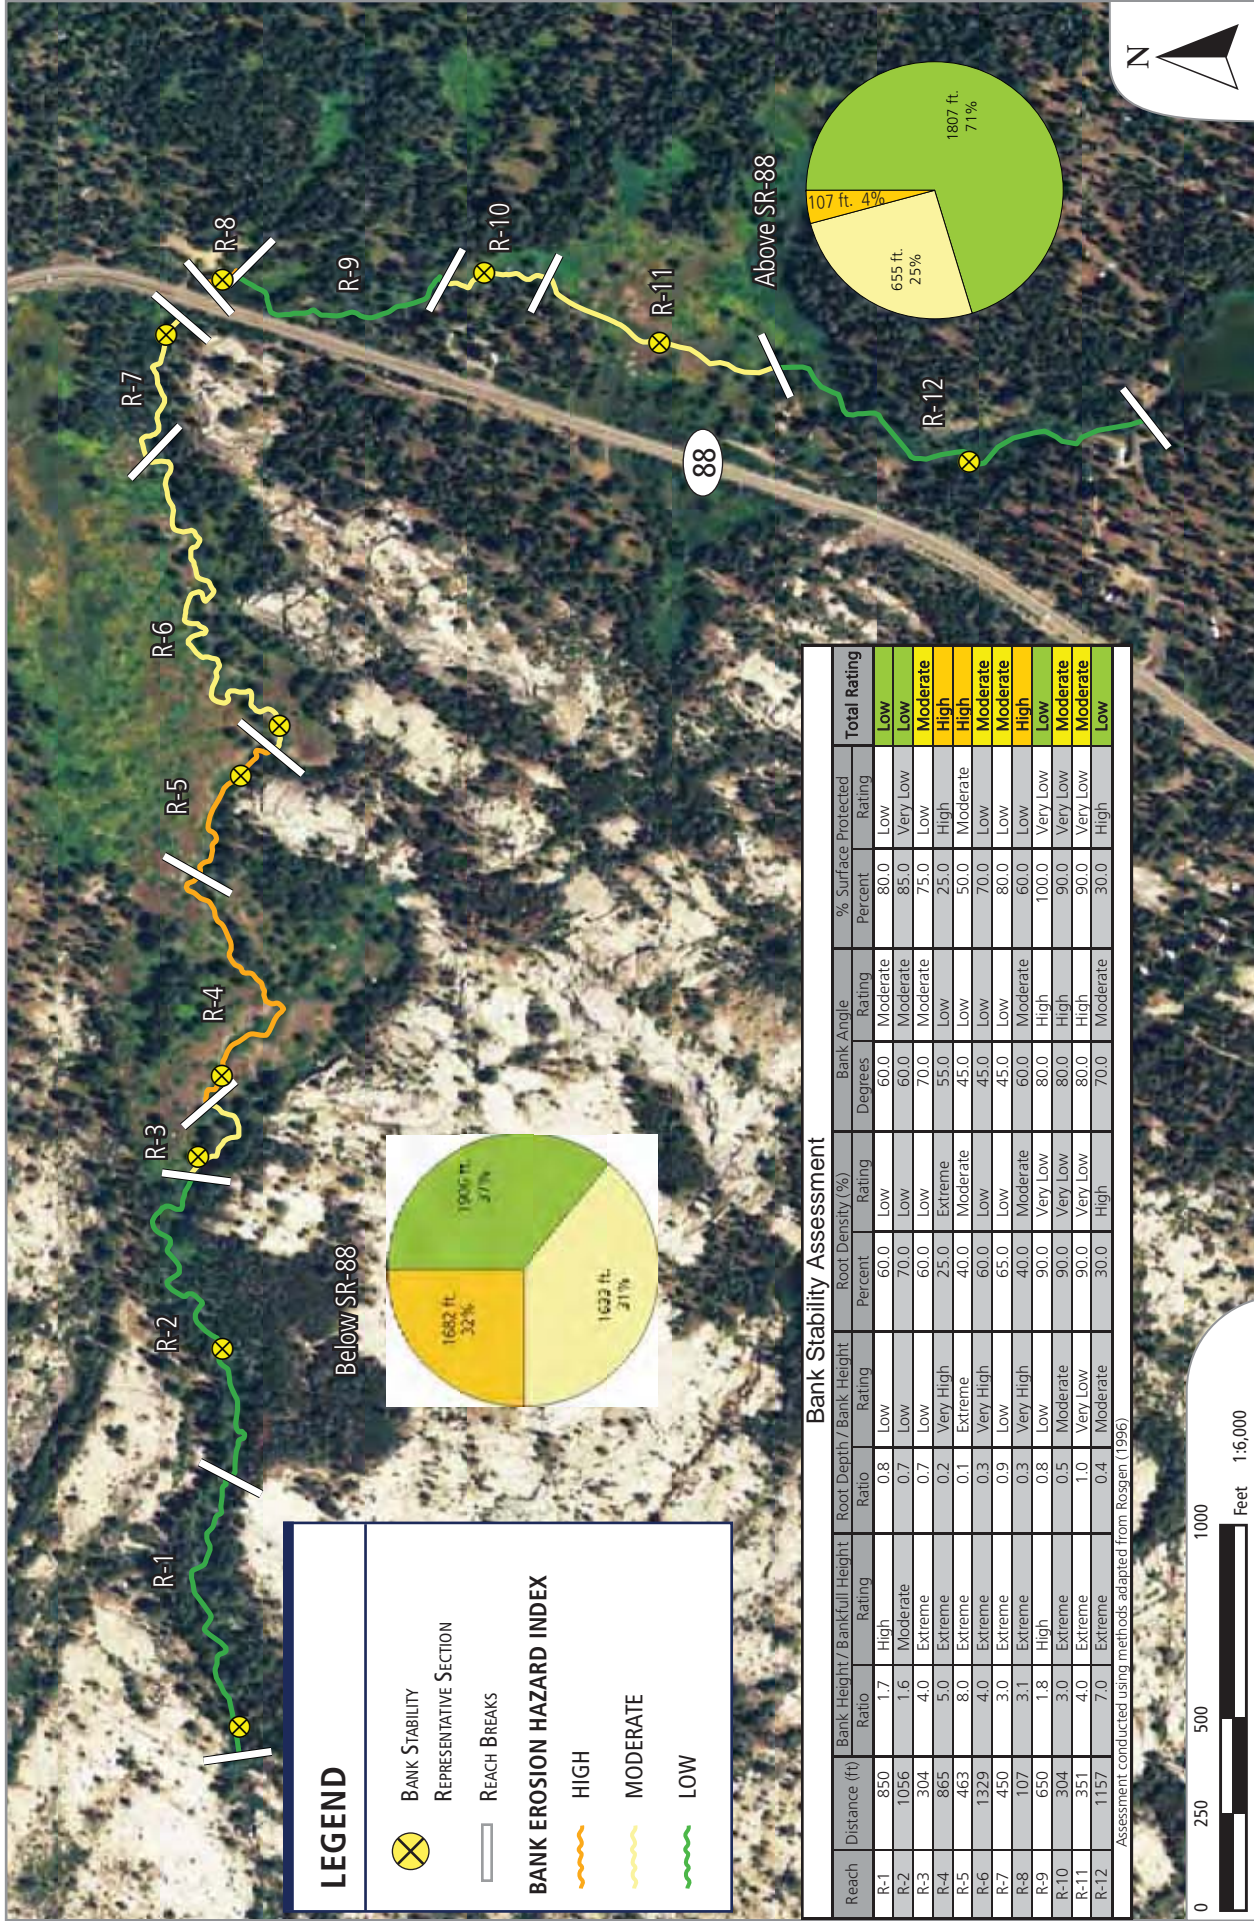
In Reach 6 the BEHI rating is “moderate” because the banks are more protected by vegetation than in Reaches 4 and 5. However, it is important to note that this rating represents the general condition over the entire reach and that there are discrete areas (i.e., cutbanks on the outer bends of meanders) where erosion potential is extreme (See cutbanks on Figure 4-4). Upstream of the meadow (Reaches 7 through 12) BEHI rating is either “low” or “moderate”. No signs of significant recent bank erosion were observed in these reaches.

FIGURE 4-3: Bank stability assessment for the study area. Assessment conducted using methods adapted from Rosgen, 1996.

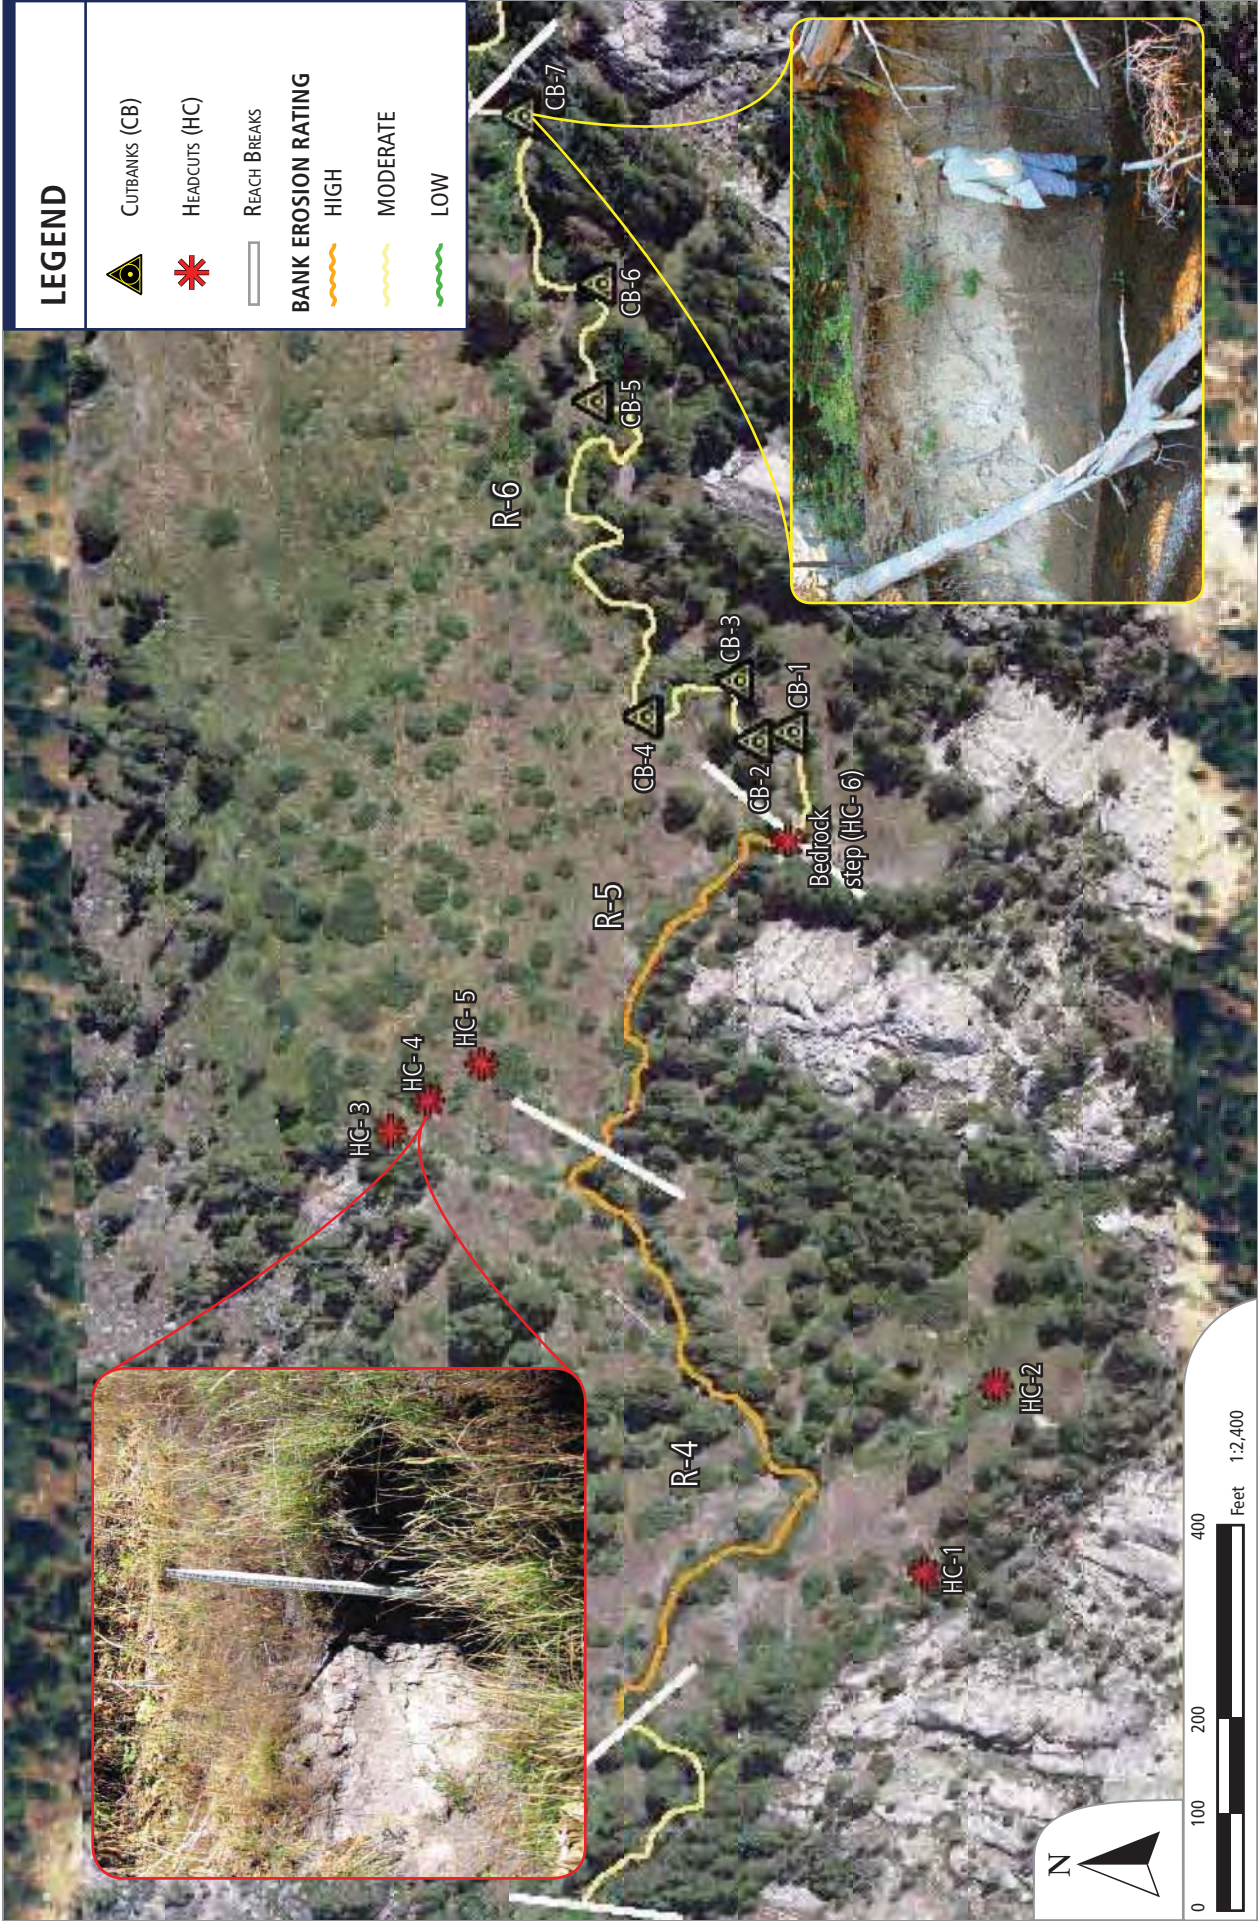
Headcuts are abrupt changes in channel profile that are indicative of potentially unstable geomorphic conditions. Headcuts migrate in the upstream direction until resistant substrate (e.g., bedrock) is encountered or the channel profile achieves equilibrium conditions with respect to slope, sediment size and water discharge. Headcuts in the project area were mapped with a GPS receiver; their locations are shown on Figure 4-4.

The two headcuts in the downstream portion of the project area on the south side of Oyster Creek are associated with an abandoned tributary (Figure 2-2). As mentioned in Section 2, this tributary was captured by the formation of the leakage channel. Headcut HC-1 (Figure 4-4) is formed in an historical alignment of the abandoned tributary and is only a minor feature that does not represent significant geomorphic instability. The headcut that has formed in the main channel of the abandoned tributary (HC-2, Figure 4-4) has migrated to bedrock, which has arrested its upstream movement.

FIGURE 4-4: Headcuts and cutbanks mapped in the project area.

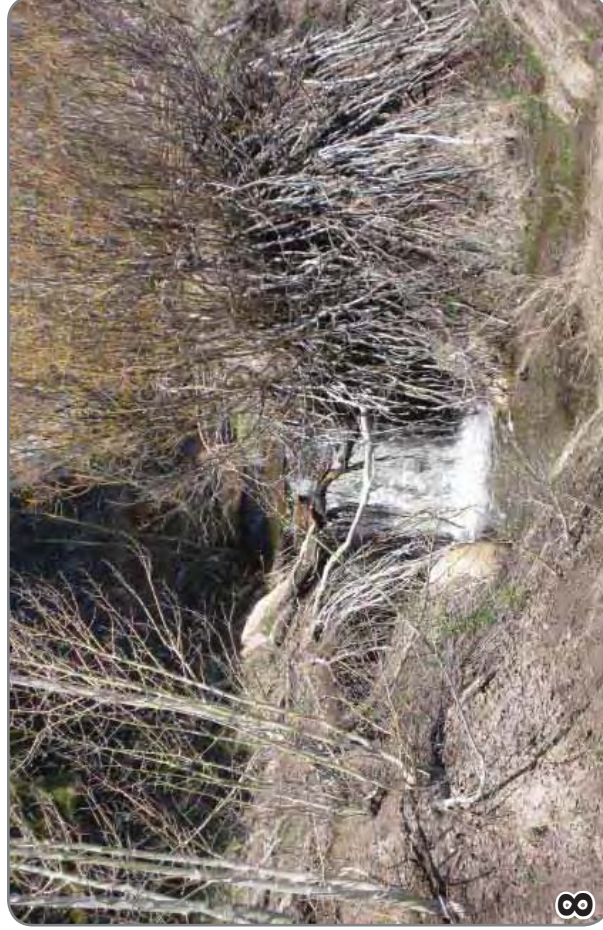
headcuts threatens the ecological function of the Oyster Creek meadow and provides a chronic source of fine sediment that may impact downstream aquatic resources. Measures to stabilize the headcuts in the North Tributary will be presented in the Stabilization Plan, which is being completed in fulfillment of separate Project 184 license conditions.

PHOTOS: (5) Reach 2 representative section (6) Aspen and alder are co-dominant on the banks of Reach 2 (7) North Tributary, Reach 4/5 boundary (8) Active headcut in the North Tributary main channel.

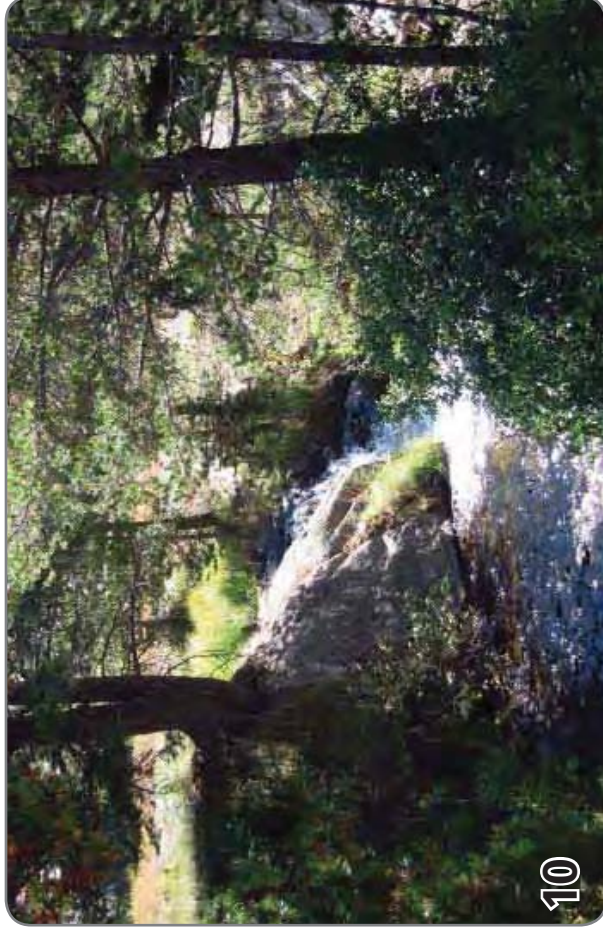
PHOTOS: (9) Typical section in Reach 5 (10) Bedrock step marking the Reach 5/6 boundary (11) Recruitment of large woody debris in Reach 6 due to local bank erosion (12) Steep cutbank opposite point bar in Reach 6.

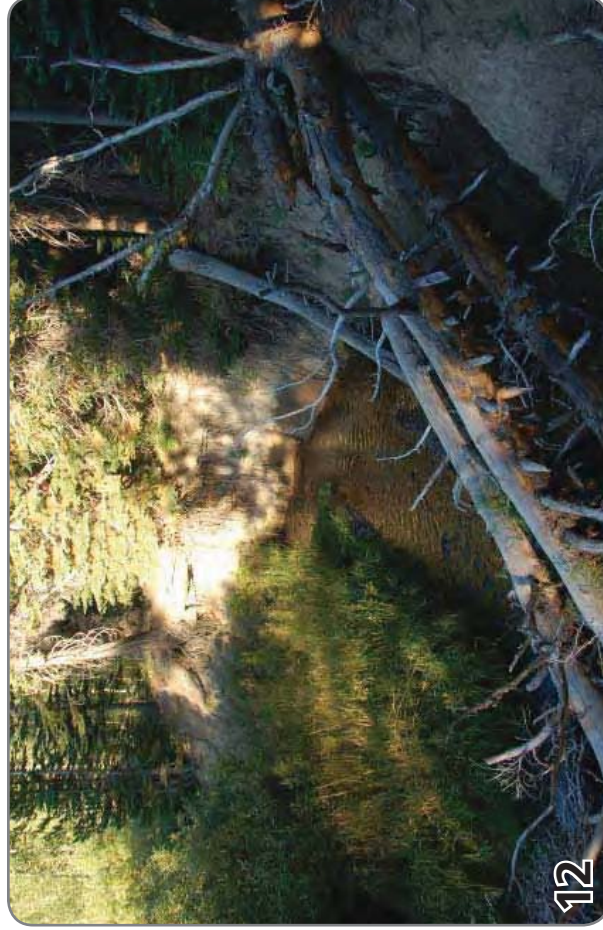
Reach: Upper Meadow (1,330 feet). Reach 6 is highly sinuous, low gradient, and has a well developed inset floodplain. Riffles and runs are the dominant aquatic habitat, with a few large scour pools in the channel. The bed is composed primarily of large gravel and cobble, and appears well armored and vertically stable. No major grade breaks or knickpoints were observed. LWD is present in the upstream portion of the reach and is comprised mostly of large conifers recruited locally through bank failure (Photo 11). Point bars have formed throughout the reach with dense herbaceous (e.g., sedges, rushes) vegetation cover. Woody riparian vegetation species (e.g., alder and willows) are colonizing the point bars along with lodgepole pine. Steep cutbanks have formed opposite the point bars because the channel is incised and flowing through erodible bank material (Photo 12).

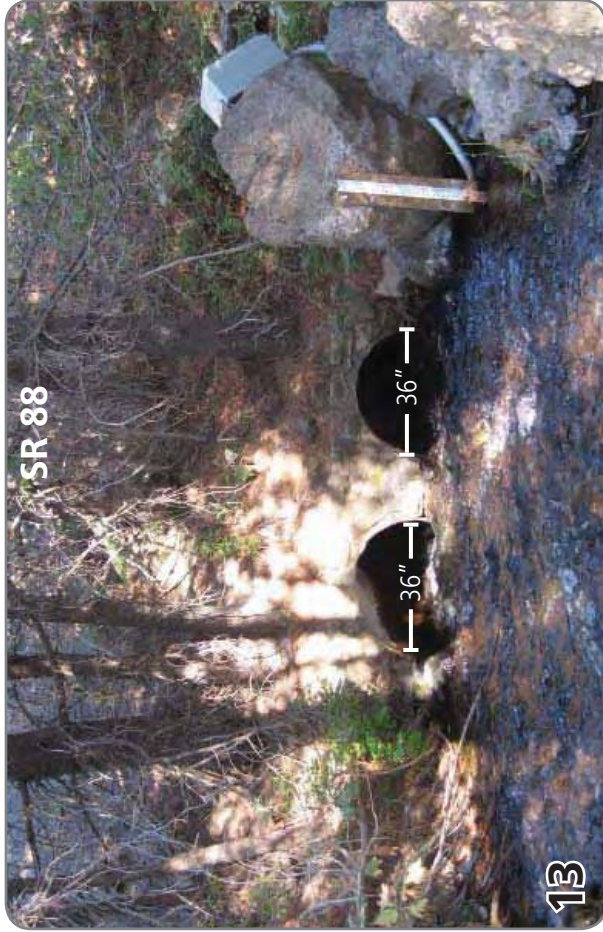
PHOTOS: (13) Oyster Creek crosses under SR 88 through two 36-inch corrugated metal pipes (14) Riparian meadow upstream of SR 88 (15) Oyster Lake (16) Example of bed particle size in middle and upper sampling sites (primarily medium sized gravels).

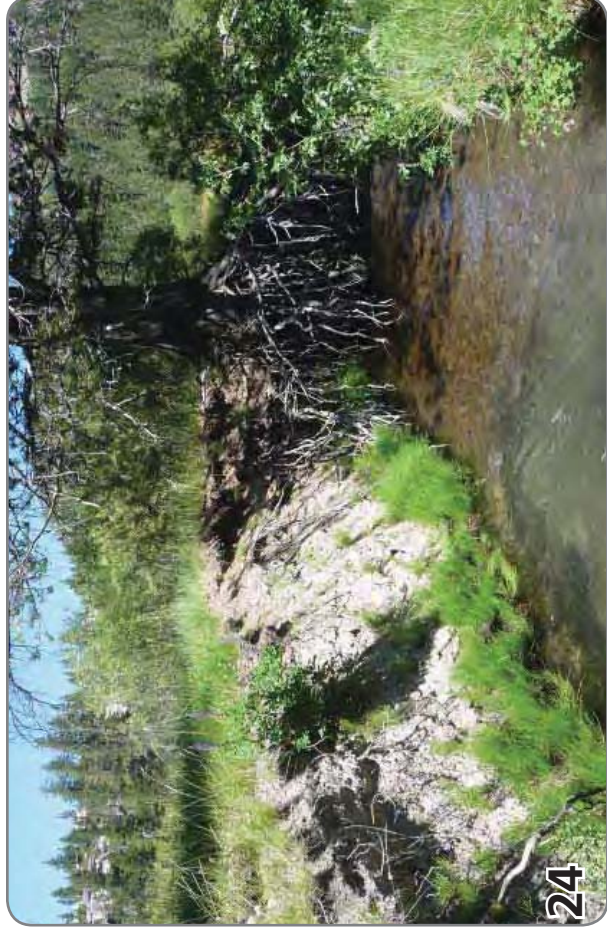
24

PHOTOS: (21) Mature trees rooted near the base level of the channel in Reach 5. (22) Trees rooted near the base of the channel in Reach 6 are significantly younger than those in Reach 5. Bank failure at this location (right side of photo) appears to be the result of toe scour. (23) Bank failure due to sapping. (24) Evidence of lateral migration (widening) in Reach 6.
