Re: FERC Project 184, Geomorphology

EID Project 184 Geomorphic Sites Assessment

Prepared for
El Dorado Irrigation District

December, 2002

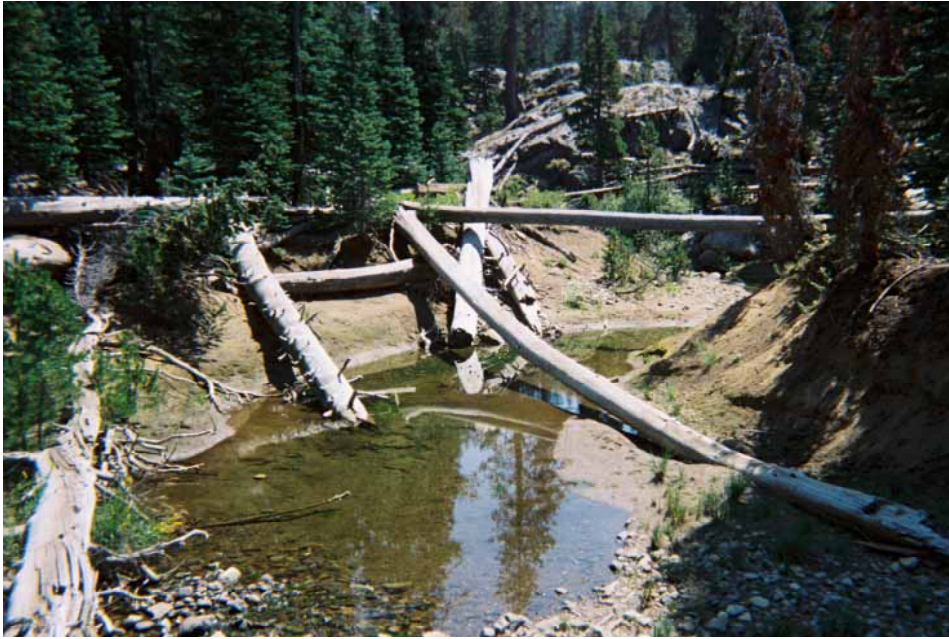
Figure 2: Caples Overflow channel (site #14), Upstream view, August 2002

Caples Lake Overflow, upstream of Caples Creek is a sensitive site that has an extreme bank erosion hazard and fair channel stability. The site displays indications of prior incision, lateral bank erosion, and local aggradation (Figure 2). The site is at a transition point between the steeper upstream channel types (A and B) and the low gradient meadow along the main stem Caples Creek. Based on topography, geology, valley type, it seems likely that a channel type change would naturally occur at this location. Evidence of 1997 flood damage includes excess fine sediment (from local bank erosion) and large woody debris (LWD). The modern channel is within an incised meander belt, but is not actively downcutting. The confluence with Caples Creek provides local base elevation control. Given the high bank instability and local sediment supply, it is likely that further channel adjustments will be through lateral migration. This could allow room for a more stable C channel to develop within the meander belt. However, the likelihood and timeframe for this recovery process under the regulated flow regime is uncertain (due to the small base flows and extreme, infrequent spills).

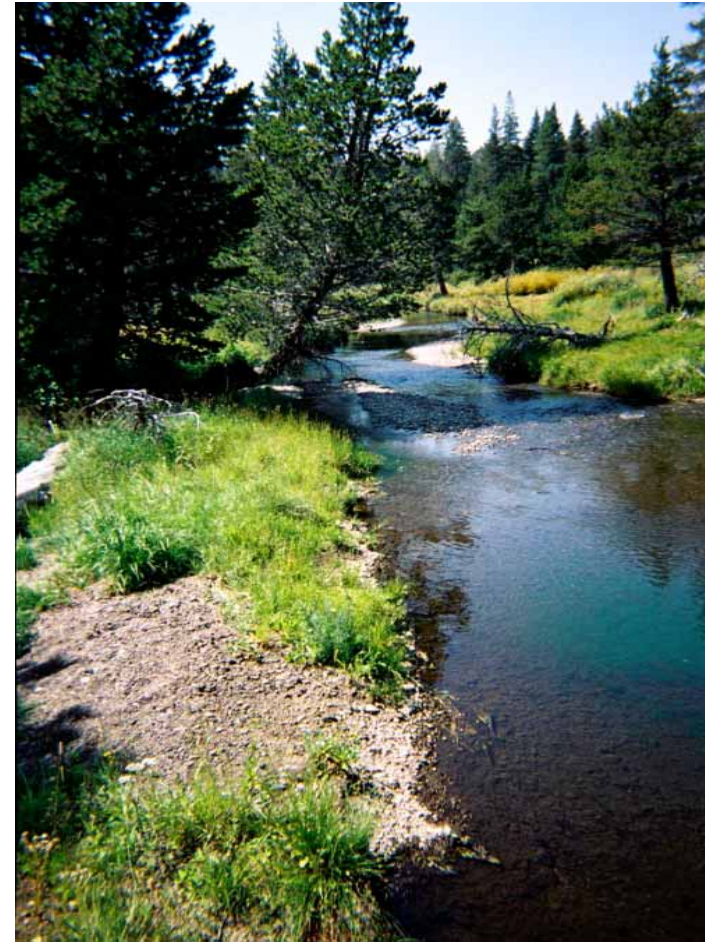
Figure 3: Caples Creek upstream of Kirkwood Creek (site #1), downstream view, August 2002

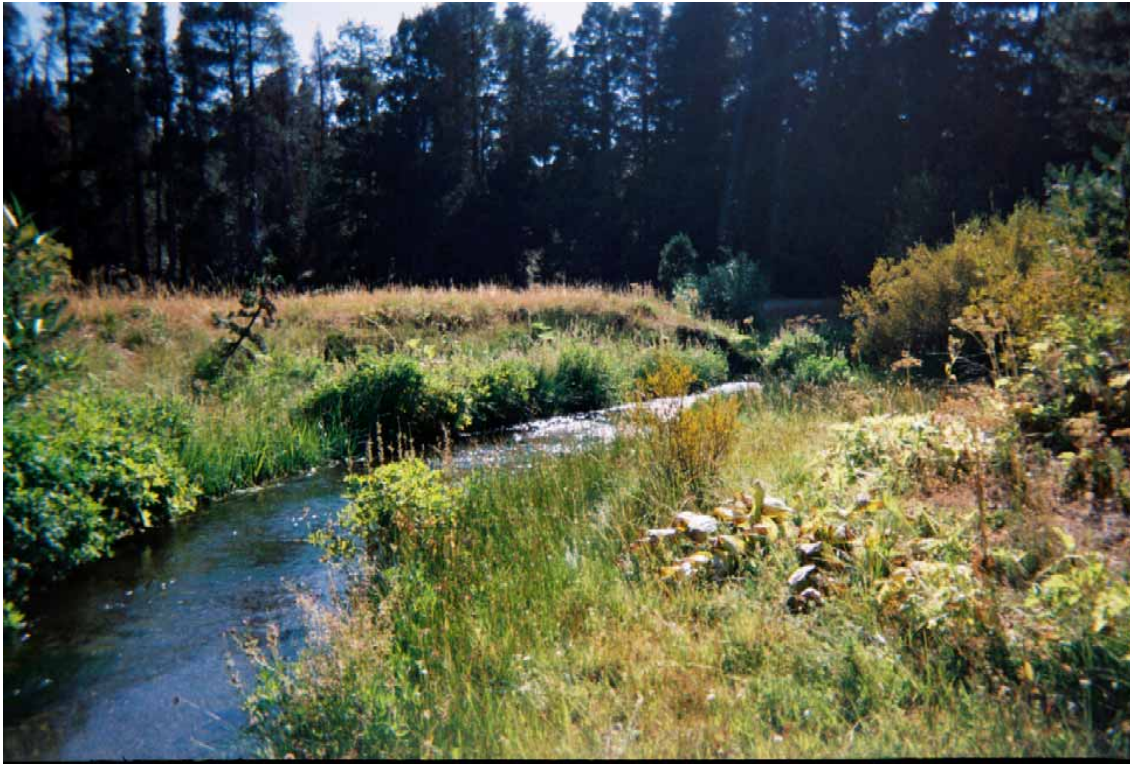
Oyster Creek, downstream of Highway 88 (site #19) is characterized as an F4 with incipient C4 channel development (Figure 8). The cross sections have a large range of entrenchment ratios, controlled by variations in the width of the incised meander belt. The sinuosity, slope, width/depth ratio are all suitable for C, F, or E channels, but the position within the incised channel creates entrenchment values more indicative of an F or C channel, consistent with bank erosion conditions.

Figure 8: Oyster Creek downstream of Highway 99 (site #19), upstream view, August 2002

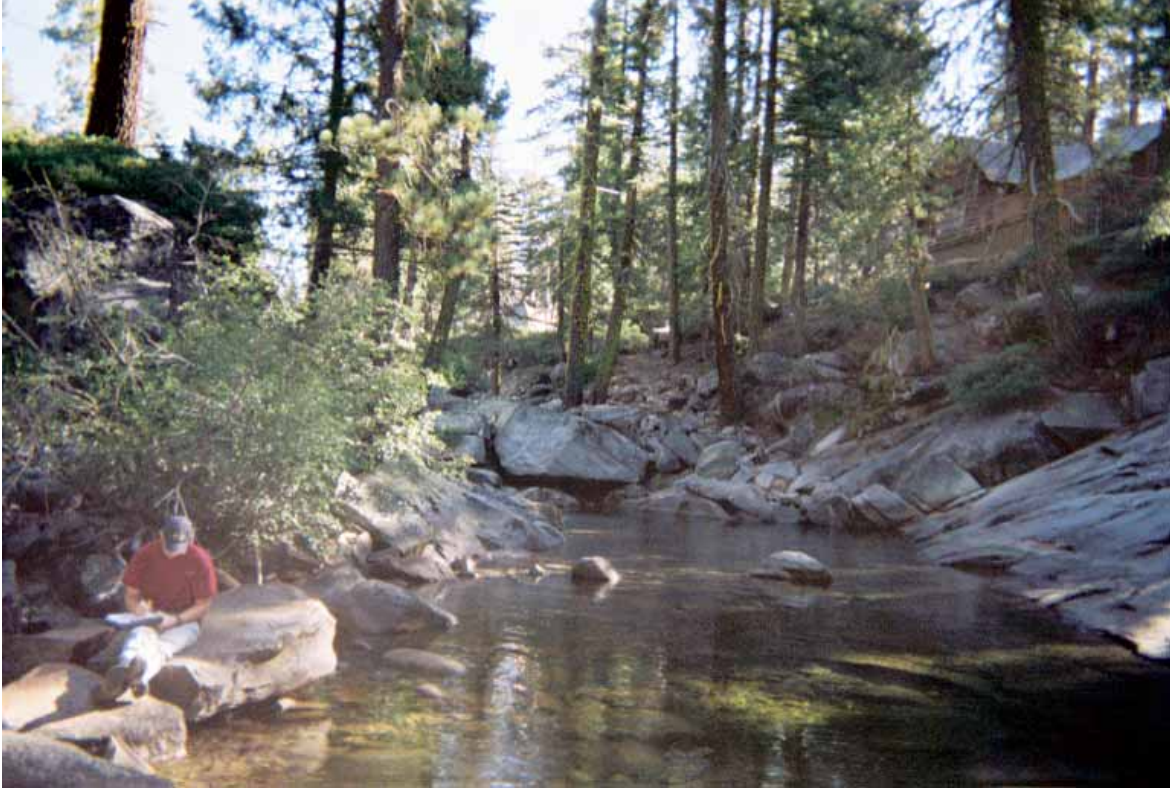
The South Fork, downstream of Strawberry Creek (site #5, at Sciots) is a B2 channel (Figure 16). Slope, sinuosity, and entrenchment ratio are typical of B channels, although the width/depth ratio is low. Some areas have bedrock substrate (B1), but the local reach is dominantly a B2 channel.

Figure 16: South Fork, downstream of Strawberry Creek (site #5), upstream view, September 2002

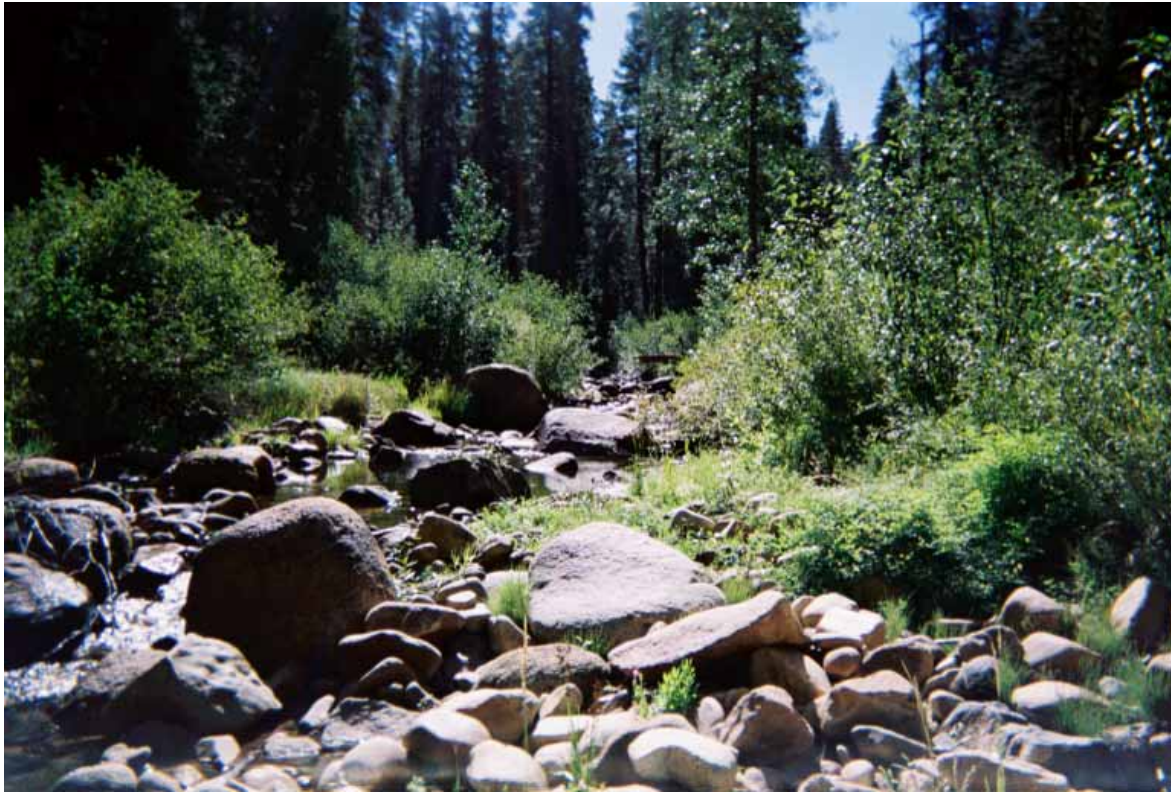
Strawberry Creek, upstream of Packsaddle Pass Road bridge (site #4) is a C3 channel (Figure 22). Slope, sinuosity, entrenchment ratio, and width/depth ratio are typical for C channels.

Figure 22: Strawberry Creek upstream of Packsaddle Pass Road (site #4), upstream view, September 2002

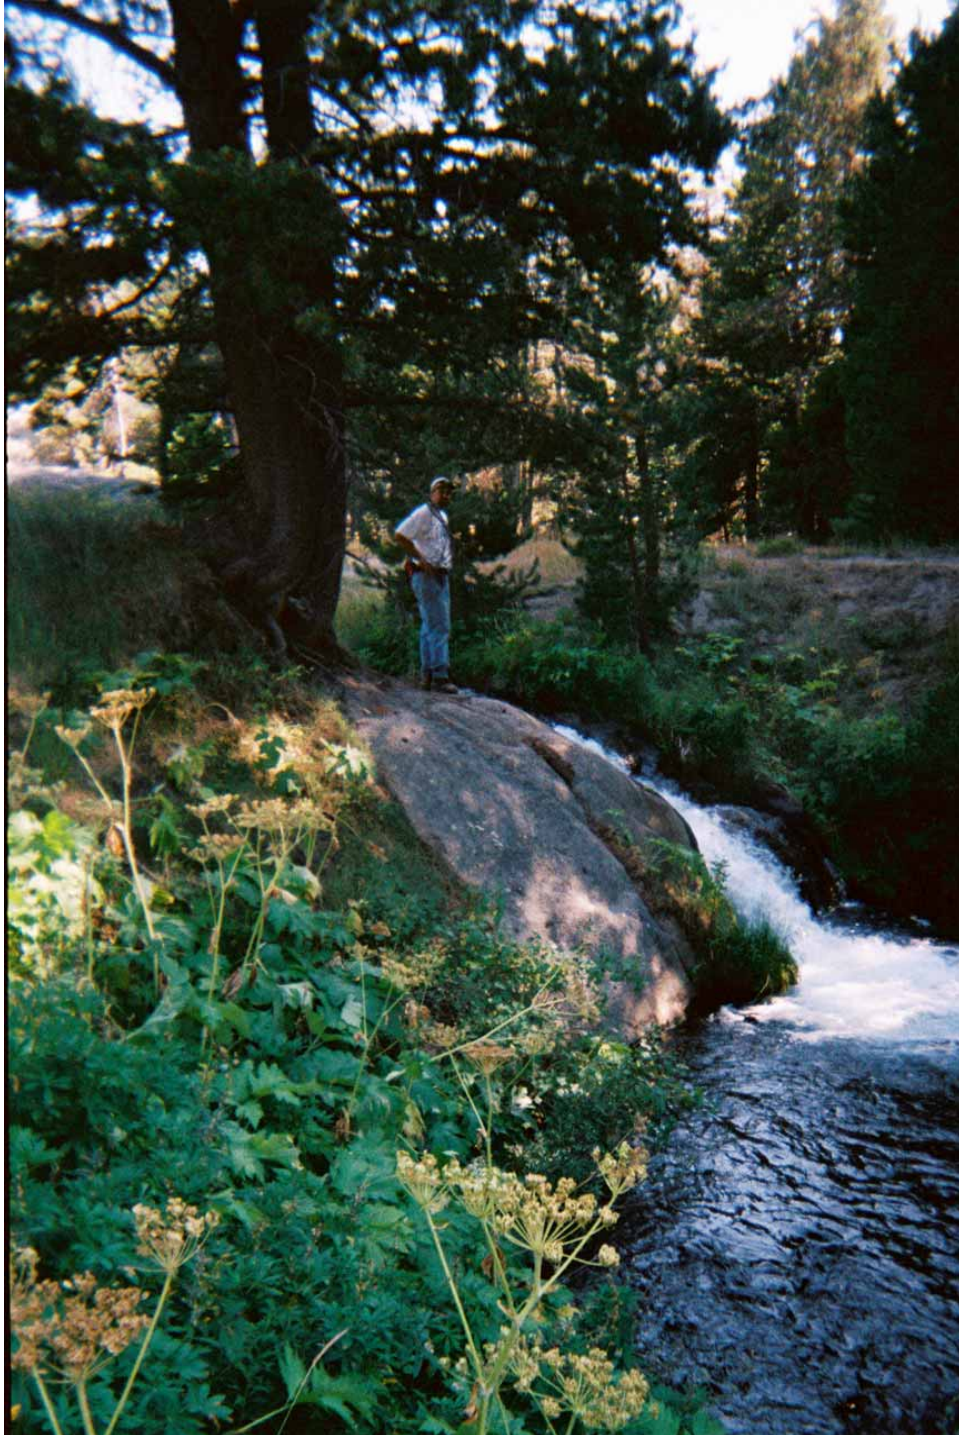
Figure 26: Oyster Creek Downstream of Highway 88 (site #19), upstream view at bedrock knickpoint, August 2002

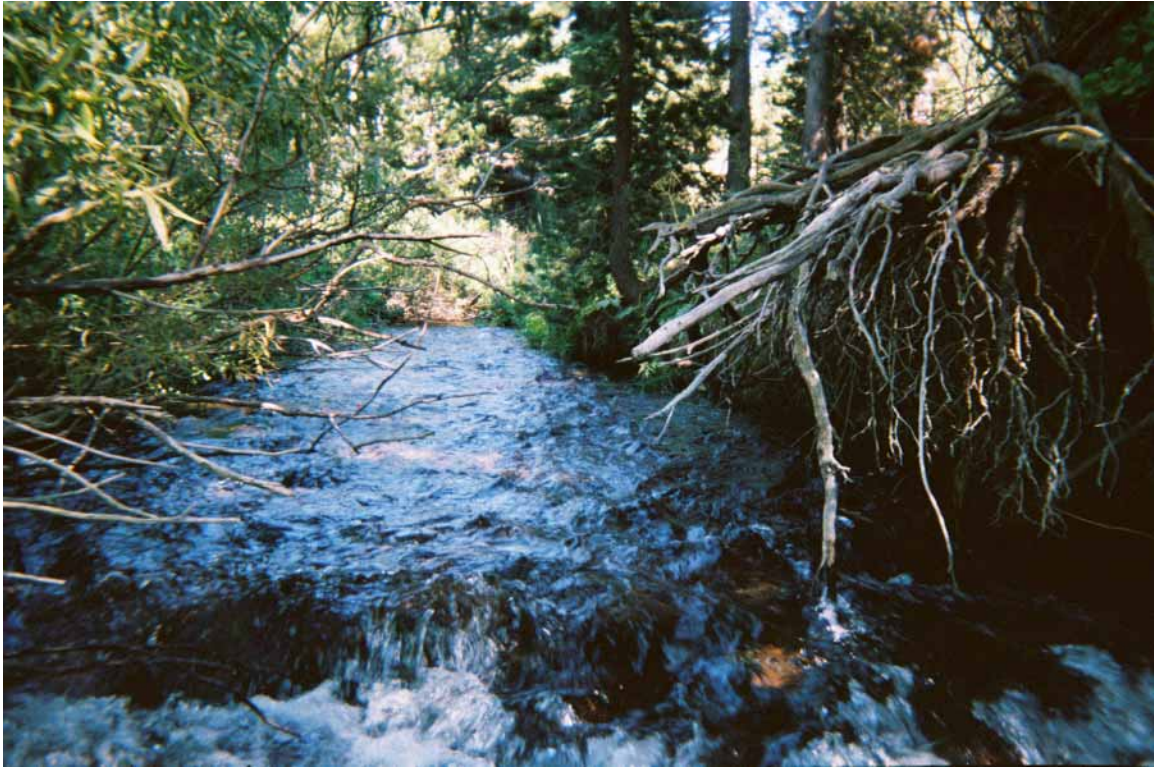
Figure 27: Oyster Creek downstream of Highway 88 (site #19) upstream view from RB to LB, August 2002

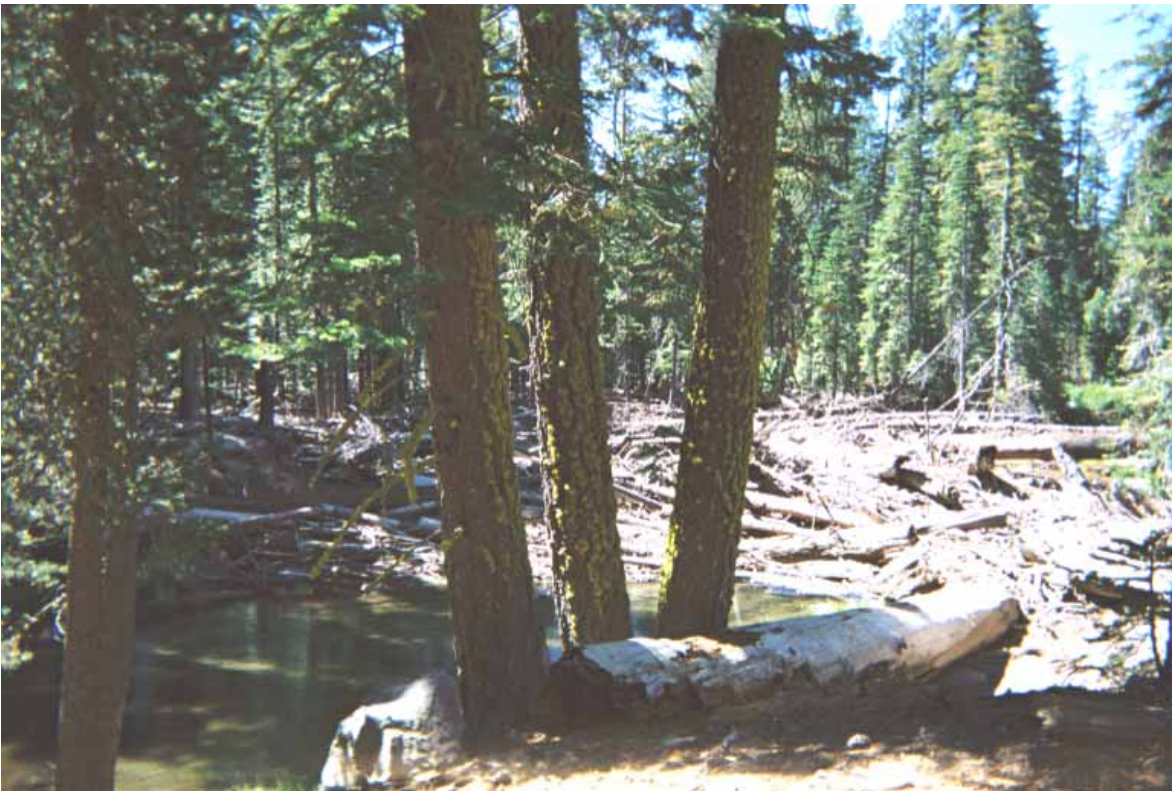
Figure 30: Silver Fork downstream of Forgotten Flat, downstream view of LWD jam, September 2002

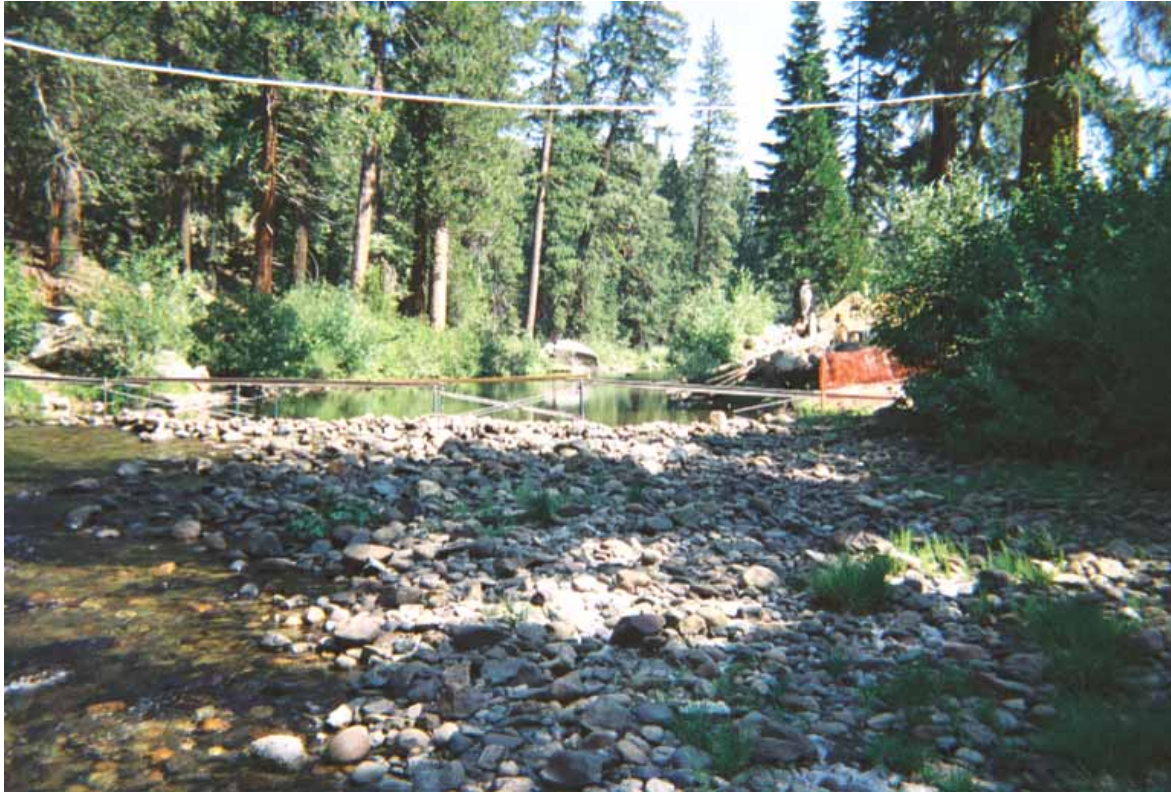
Figure 31: Silver Fork at China Flat (site #16), upstream view of bridge replacement construction, August 2002

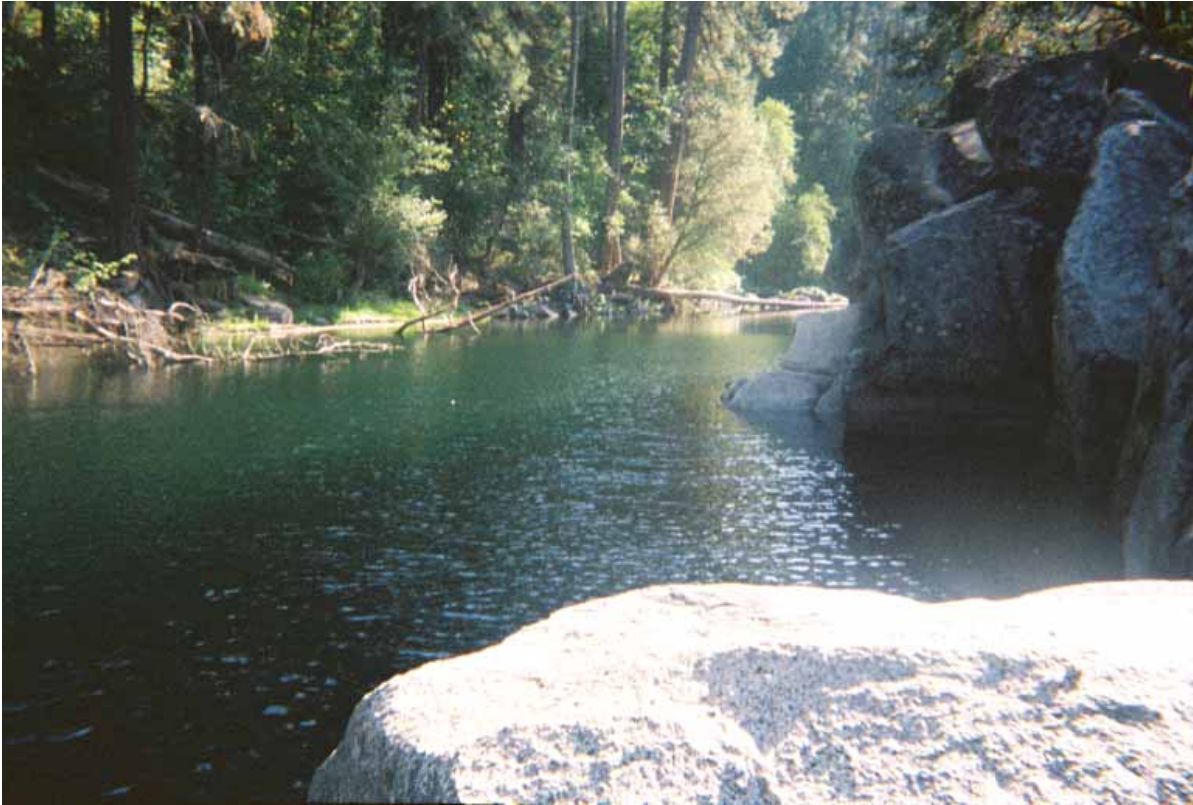
Figure 38: South Fork at Sand Flat (site 6), downstream view of bedrock confined pool, August 2002

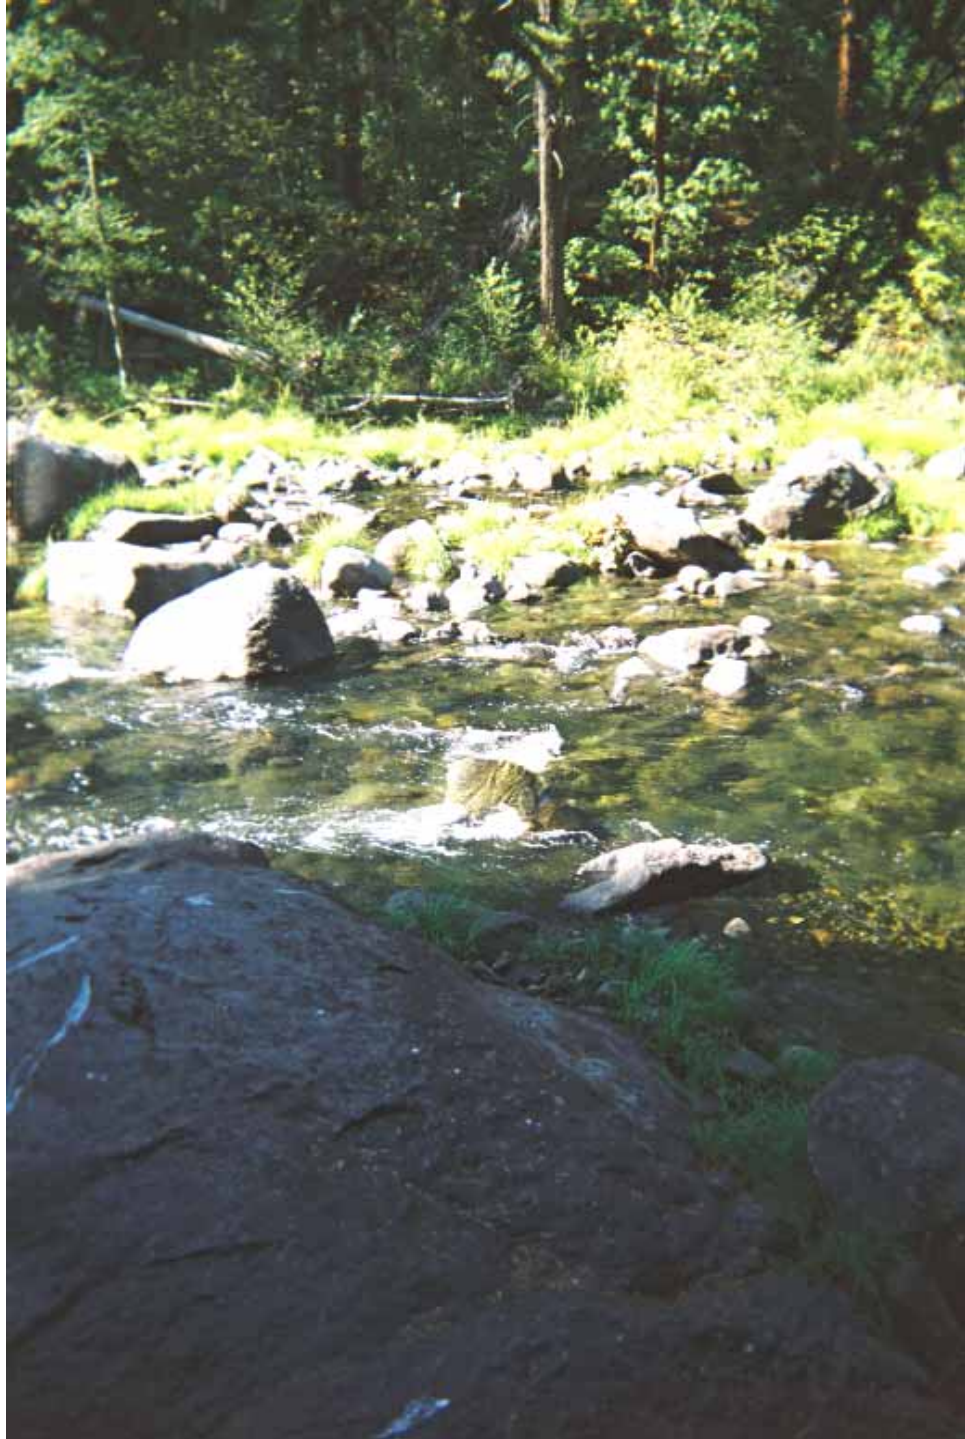
but includes sand deposits on side and mid-channel boulder bars that are vegetated with non-woody species (Figure 39). Based on valley gradient and width, high valley side

Figure 39: South Fork at Riverton Caltrans Station (site #11), cross section view from LB to RB, September 2002

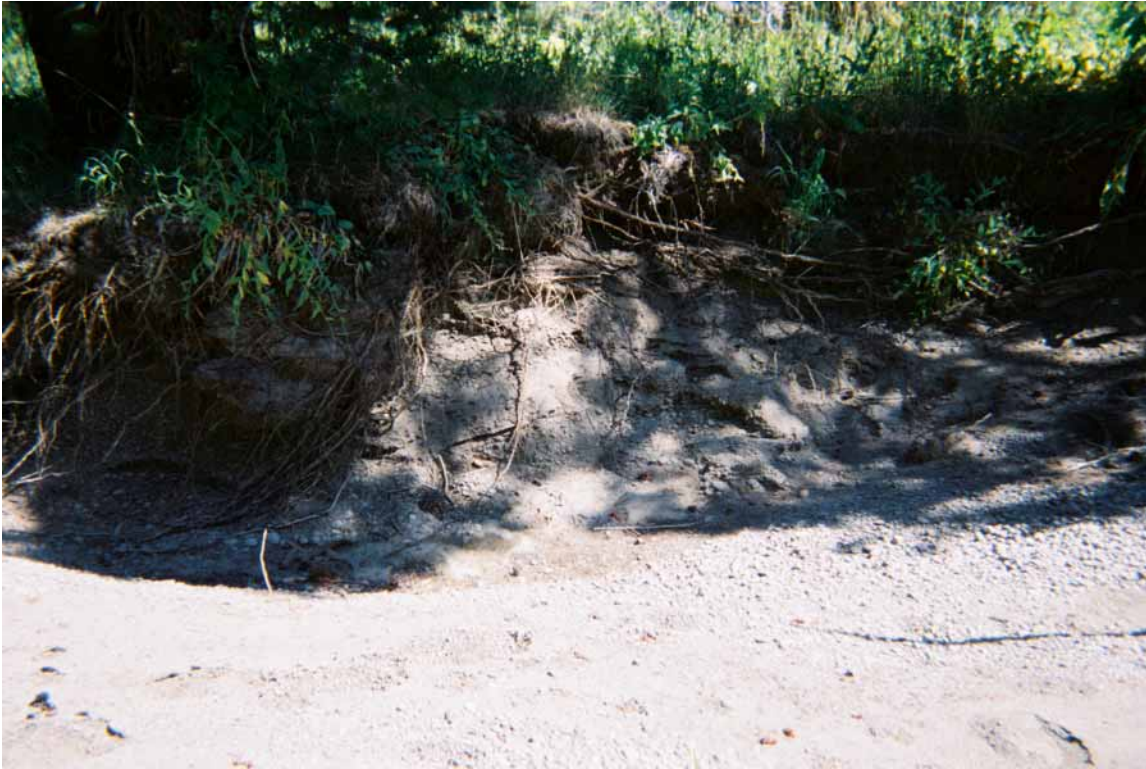
Figure 40: Lost Axe, unnamed tributary of Caples Creek (site #13), cross -section view of right bank, August 2002
