PROJECT 184: LANDSLIDE POTENTIAL ALONG THE EL DORADO CANAL

Prepared by: El Dorado Irrigation District
September 5, 2002

**EID LANDSLIDE MAPPING
EL DORADO CANAL
SITE DETAIL SHEET
(FLUMES 1 - 8&9)**

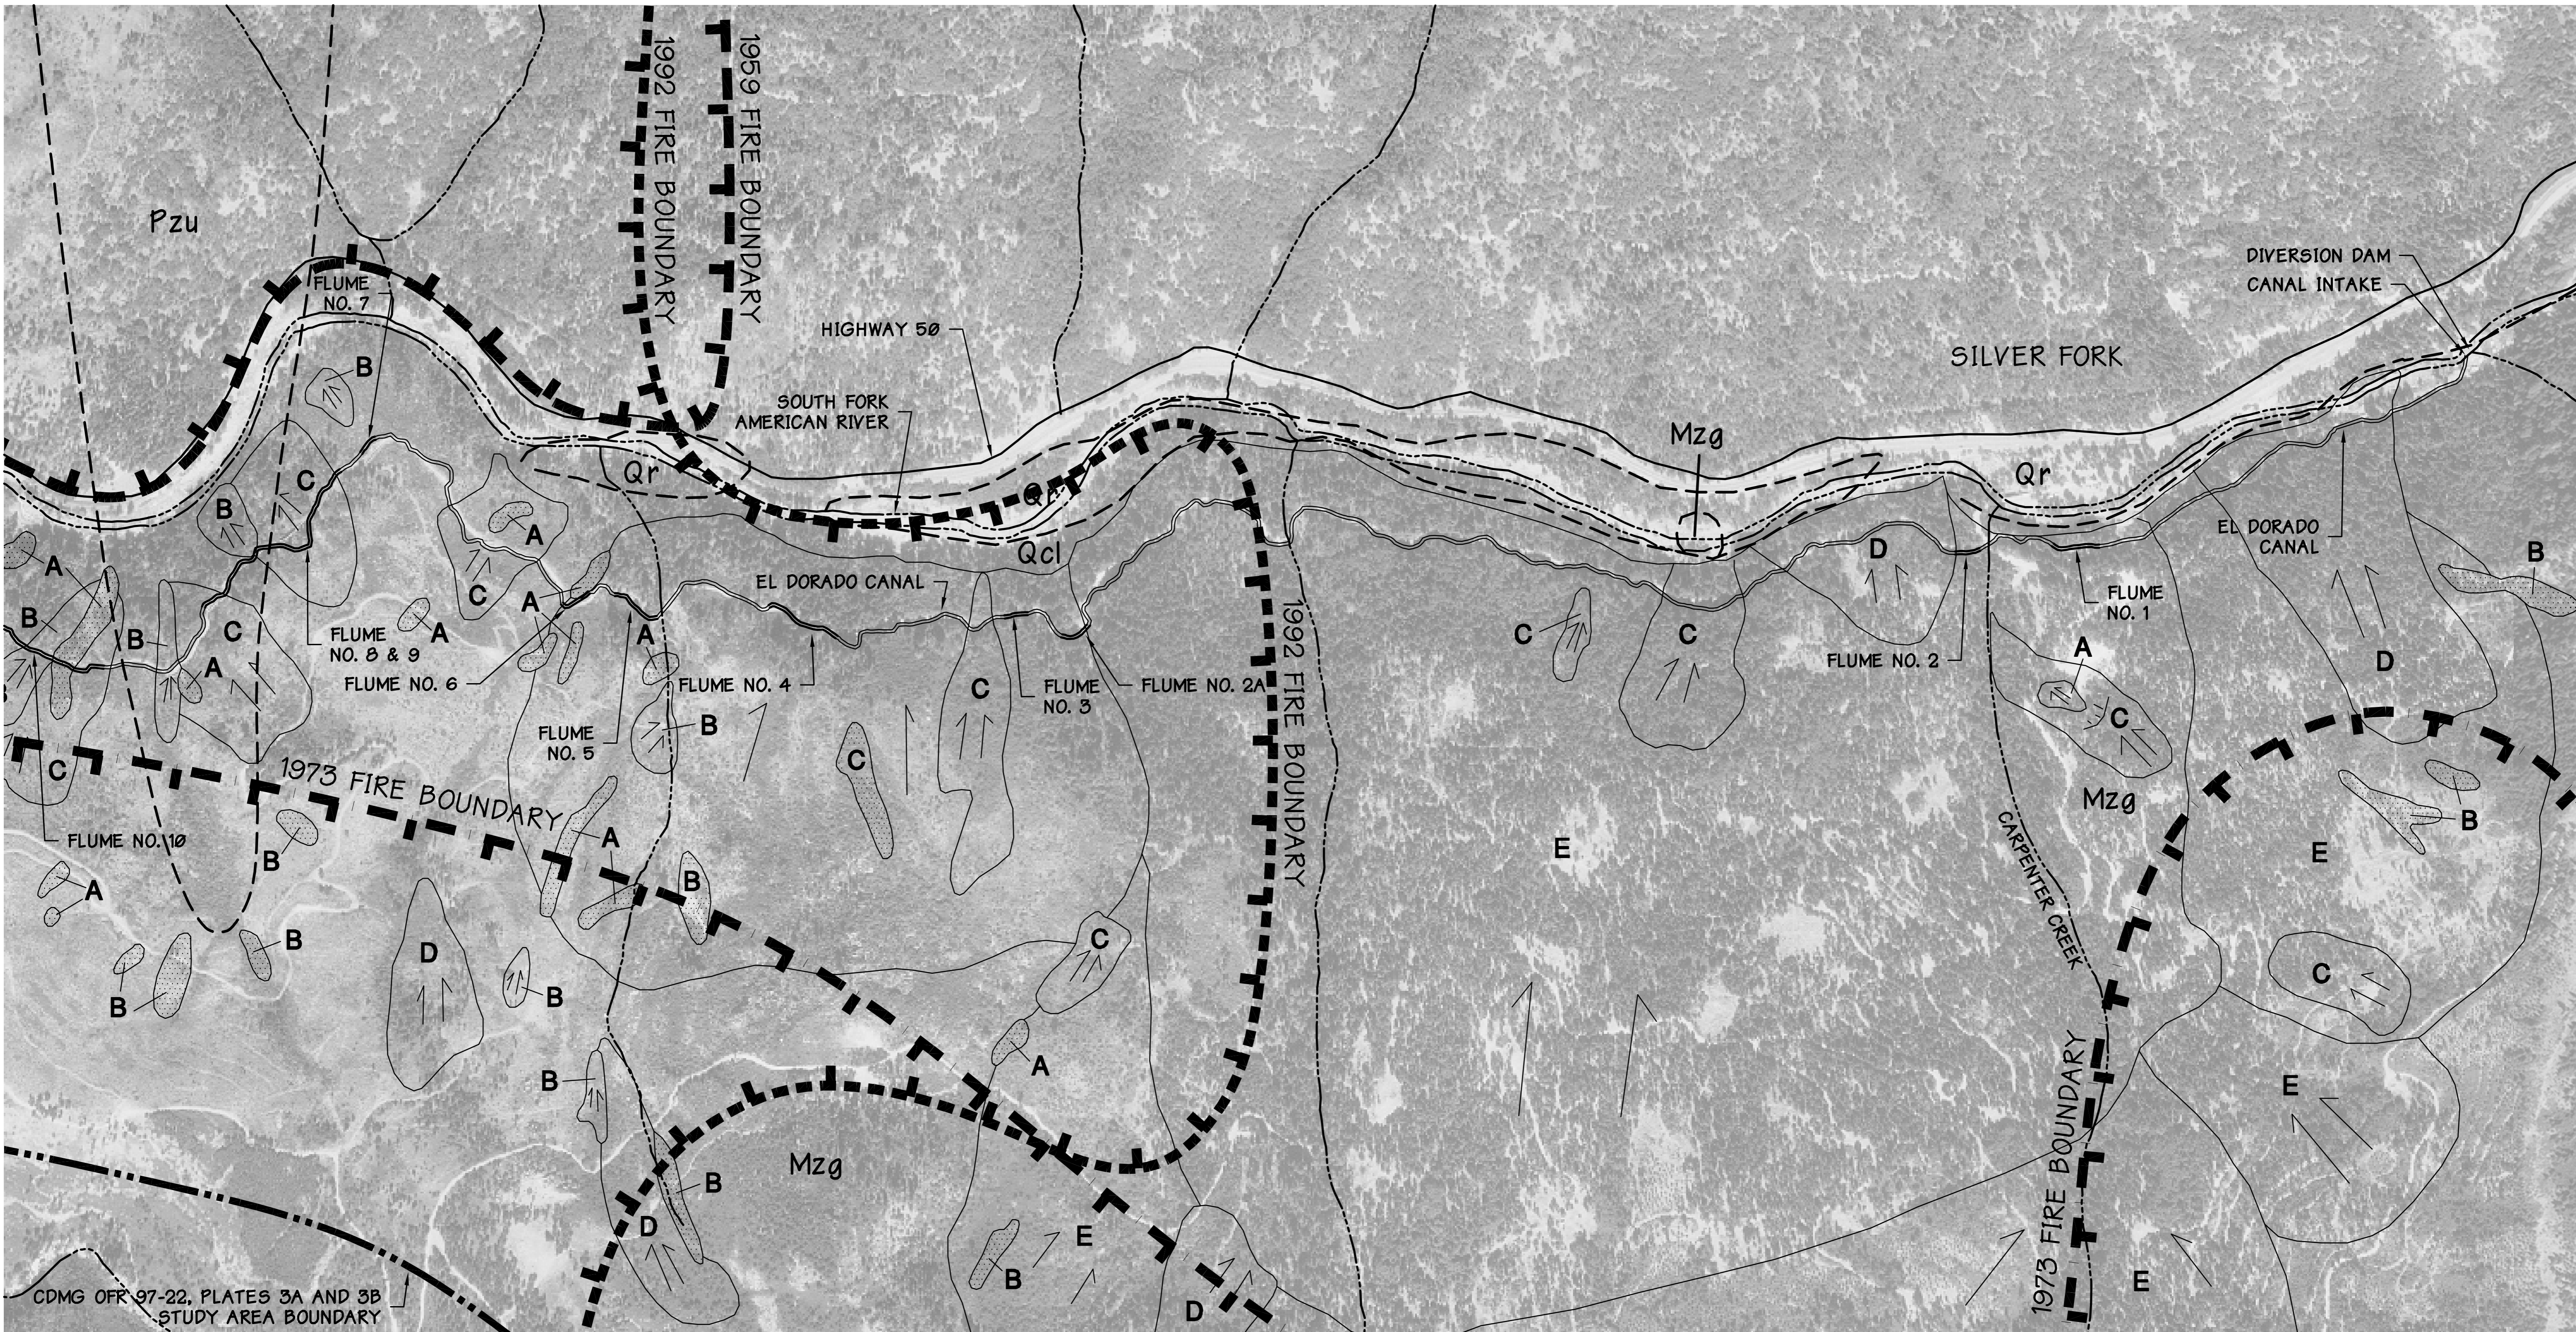
Figures 1 through 4 identify landslides along the canal with the corresponding classification.

Group A landslides may cause chronic problems unless remedial work is performed, such as installing erosion control measures. The acute failures that have already occurred may have removed the unstable materials, but it cannot be determined with the available data. Fifteen Group A landslides were identified that could potentially affect the canal (see Figures 1 through 4). It appears that the canal is located at the head of six of these landslides. Since the canal is at the head of the landslide, it may not have as significant of an impact as if it were in the middle or the toe of the landslide. However, an active landslide can quickly grow to include surrounding unstable soil. All of the identified Group A landslides near the canal are relatively small, and may only affect one or two sections of a flume.
