# 2011 Annual Noxious Weed Monitoring Report

## El Dorado Hydroelectric Project FERC Project 184

**January 2012**

Prepared by  
EN2 Resources, Inc.

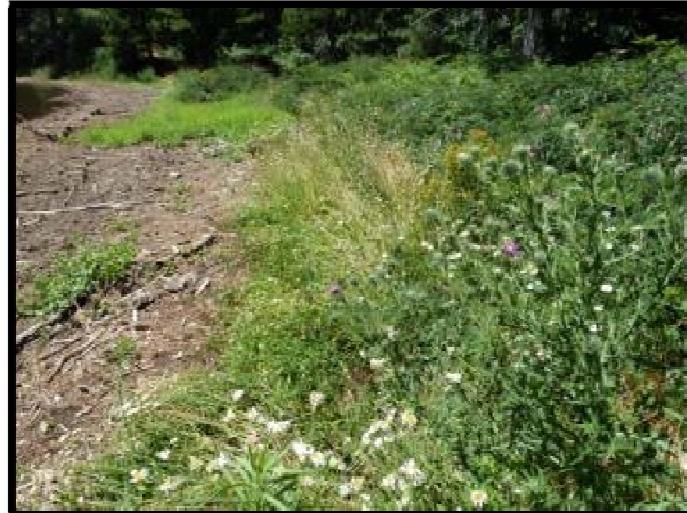
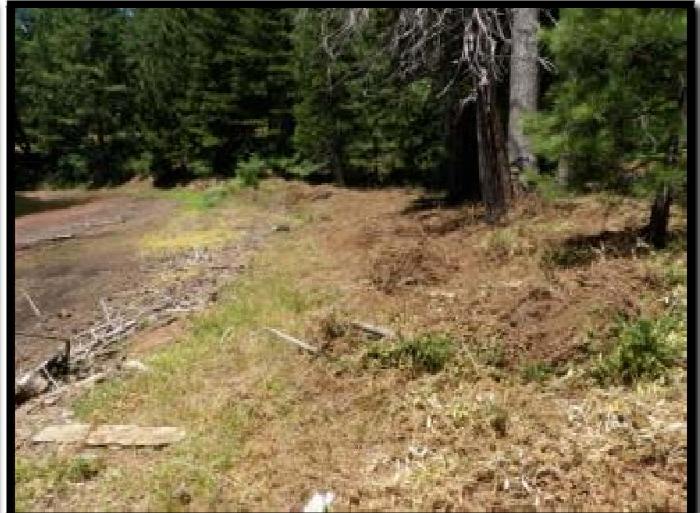
*Cover Photos: Effective treatment at Forebay Reservoir, occurrence L04-09 in 2010 (left) and 2011 (right).*

The linear infestations along the northeast shore of the reservoir, L04-09 and L05-09, are still present but treatments this year have reduced the density. However, a new line was added to the shoreline to reflect the spread of weeds along the shoreline. The primary weeds observed here in 2011 were Himalayan blackberry, Klamath weed and ox-eye daisy; however, wooly mullein, bull thistle and sweet pea are scattered throughout these areas as well. The blackberry is very dense in places along the shore and is mixed with native blackberry. We noted that much of the northern shoreline contained scattered ox-eye and it was visible across the reservoir along the south shore. Because of the proximity to the reservoir, these occurrences may best be controlled through physical means. Herbicides may be effective; however, there may be limited opportunity to apply herbicide because of the proximity to the lake.
