# RESULTS OF 2005 SURVEYS FOR FOOTHILL YELLOW-LEGGED FROG (*RANA BOYLII*) ON THE SOUTH FORK AMERICAN RIVER,

*El Dorado County, California for the  
El Dorado Hydroelectric Project (FERC No. 184)*

**Garcia and Associates**  
Natural and Cultural Resource Consultants

**JOB 1255/3**

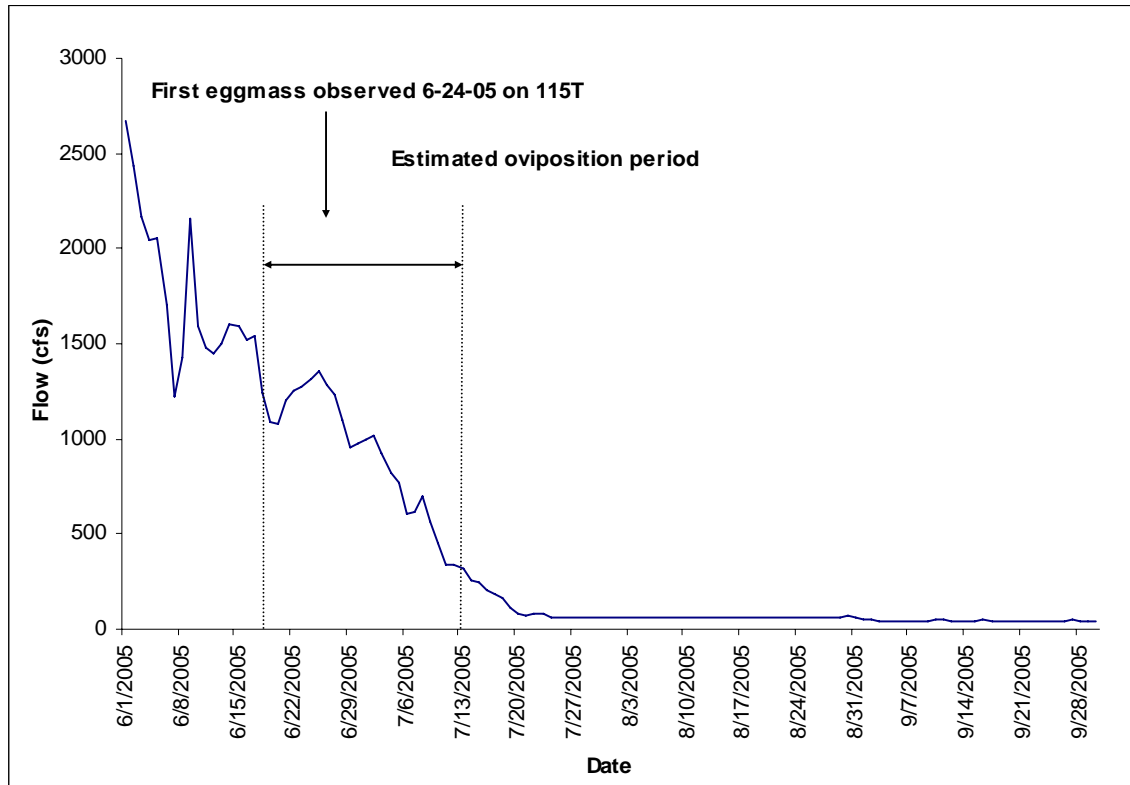
**Figure 3.2-11. Mean daily flow on the South Fork American River from June 12 to September 30, 2005 and estimated breeding period (measured at gaging station A-12 at Kyburz Diversion Dam).**

A total of 12 egg masses were located during surveys conducted between June 24 and July 13, 2005. None of these masses were examined to determine their stage of development using the Gosner (1960) table of anuran development which enables estimation of the oviposition date. However, based on the dates they were located and subsequent examination of tadpoles, it is estimated that these egg masses were deposited from mid-June to mid-July. During this time period, the daily mean flow in the SFAR was declining but still experienced short duration flow increases (Figure 3.2-11).

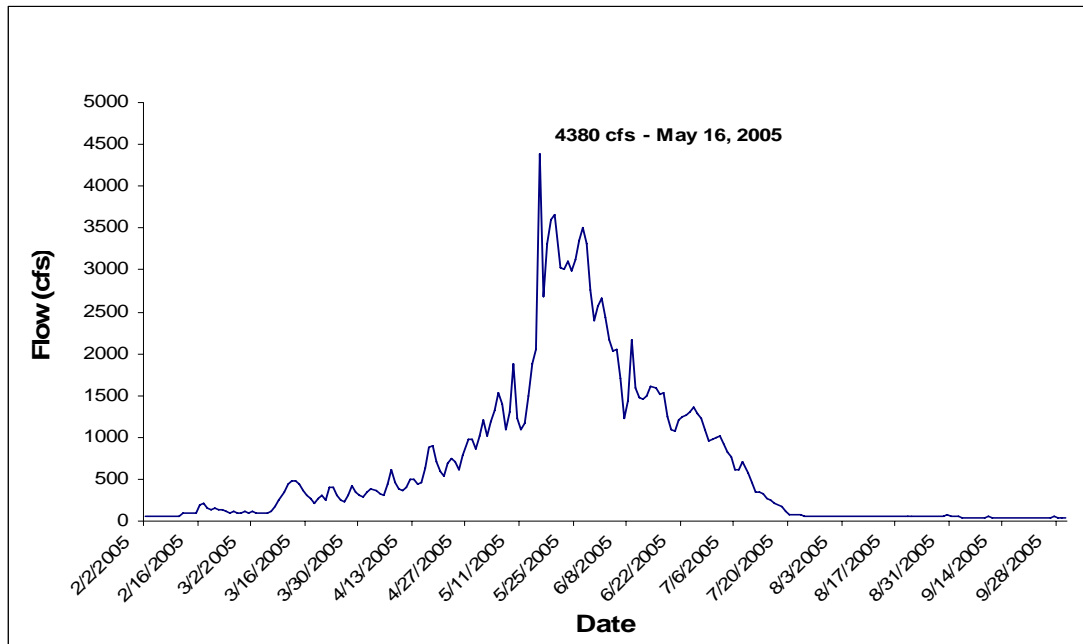
**Figure 4.1. Mean Daily Flow (cfs) on the South Fork American River from February 1 to September 30, 2005 (measured at gaging station A-12 at Kyburz Diversion Dam)**

The 2005 breeding season was approximately 1-2 months later in 2005 compared to 2004. In 2005, the first egg masses were observed during the June 24 surveys along Silver Creek (Site 115T) at the lower end of Project area and the last egg masses were observed on July 12 at Site 220R the highest elevation breeding site in the Project area. In 2004, all egg masses had hatched by early July and many had hatched during June (ECORP 2005). The variation in breeding dates between seasons is likely due to late rains and high flows present in 2005 from mid-March to mid-July (Figure 4.1). These conditions likely affected breeding and may have contributed to the lack of breeding evidence in 2005 at two sites where breeding was confirmed in 2004 (i.e., sites 105R and 110R, SFAR at and upstream of Akin Powerhouse, respectively). Some frogs may have delayed breeding while others may have oviposited during the period of high flows and either had their egg masses scoured (if water flows increased) or desiccated (if water

flows decreased). Scouring of egg masses was documented at several FYLF localities throughout California in 2005, including the South Fork Eel River (Kupferberg, unpublished data) and the North Fork Feather River (GANDA, unpublished data).

As a result of the late breeding season in 2005, tadpole development and metamorphosis were also delayed. Tadpoles were first observed in 2005 during the July 10 survey, whereas, in 2004 tadpoles were observed on June 14. Similarly, metamorphosis was not observed in 2005 until the late September survey, whereas, in 2004, tadpoles metamorphosed in late August.

The most significant decrease in mean daily flow along the SFAR was on July 15, 2005, when flow levels as measured at gaging station A-12 (SFAR below Kyburz Diversion Dam) dropped from 240 cfs to 79 cfs. Prior to this date, daily mean flows were greater than 100 cfs since March 4, 2005 (Figure 4.1). Egg masses were found at two sites along the upper reach (sites 213R and 220R; SFAR at Ogilby Creek and Maple Grove, respectively) prior to this date; however, no tadpoles or evidence of juvenile recruitment was found during subsequent surveys. One possible explanation for the lack of observations at these sites during subsequent surveys is that the egg masses were desiccated prior to hatching when water levels dropped. In contrast to the SFAR, breeding along Silver Creek (Site 115T) was relatively successful in 2005. We speculate

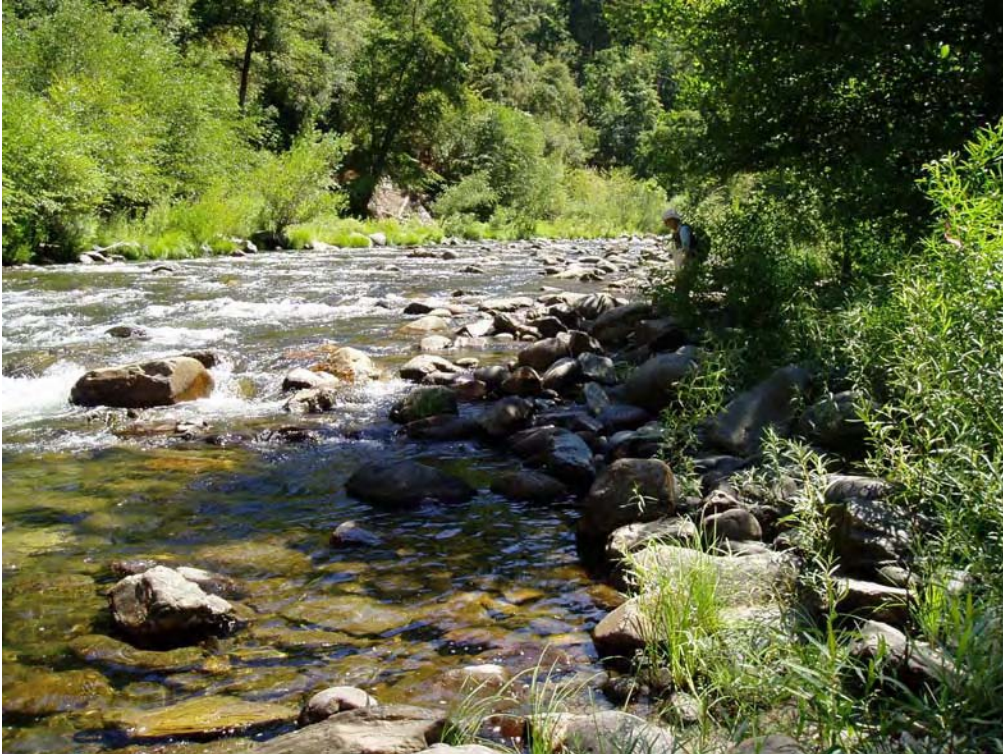
Site 105R-a – SFAR at Akin Powerhouse- bottom of site looking upstream, August 23, 2005

- Subsite 105a is located downstream of Akin Powerhouse. The site length is 96 m and consists of a left-bank low gradient lateral bar. Aquatic substrate consisted primarily of boulder (40%) and cobble (30%), with some gravel (20%) and sand (10%). The substrate was moderately embedded. Water velocity was very low throughout the shallow 10 – 15 cm edgewater habitat present along the length of the subsite. The habitat width extended out from the shore to an average of 2 m. Exposed cobble and boulder in edgewater areas provided habitat complexity and basking sites for FYLF. Flocculent material and interstitial spaces in the substrate provided abundant aquatic cover. Submerged vegetation, mostly algae, was prevalent (70%) throughout the subsite. Vegetation cover along the river margin was approximately 40 percent and was composed of willow and sedge. Emergent vegetation, overhanging vegetation, and riparian canopy were sparse; each provided less than 10 percent cover.

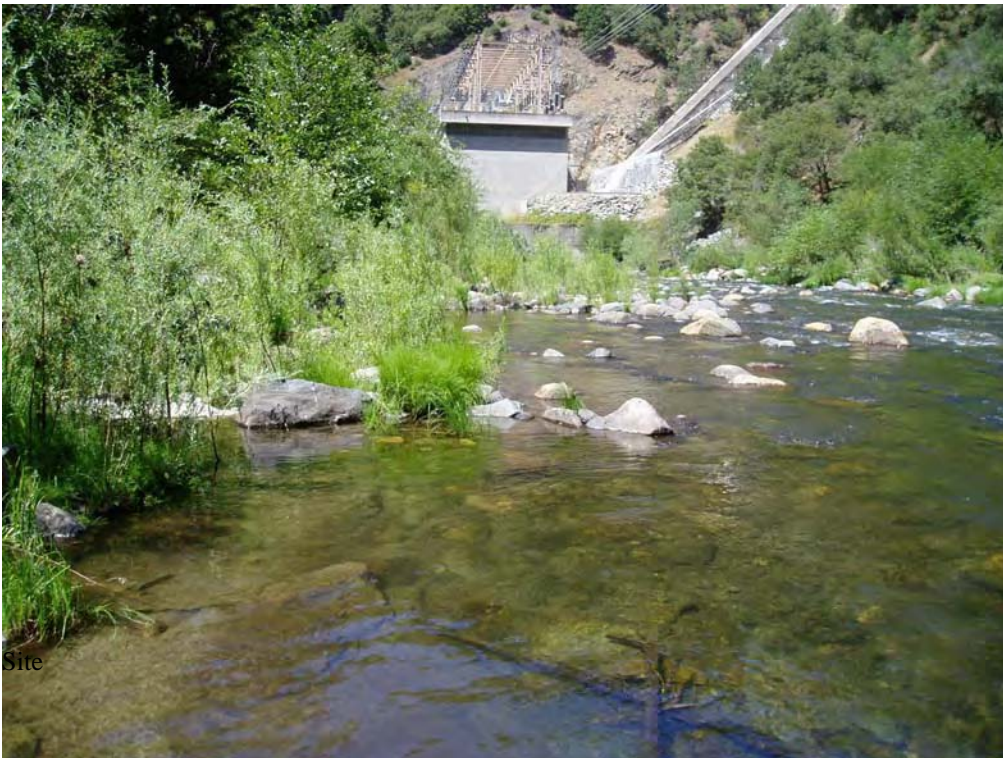
105R-a – SFAR at Akin Powerhouse- top of site looking downstream 105R, August 23, 2005

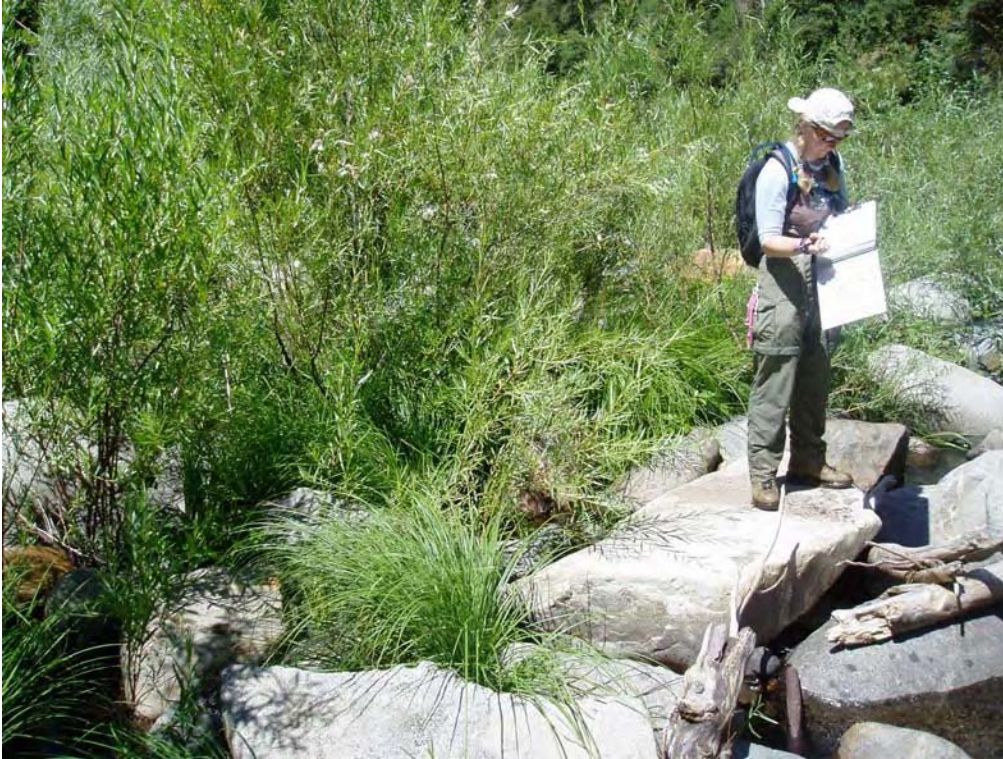
Site 105R-b – SFAR at Akin Powerhouse- top of site looking downstream, August 23, 2005

- Subsite 105b is a left bank lateral bar that is 39 m in length. This subsite is located immediately downstream of Akin Powerhouse. The site includes a side pool off of the main channel which becomes isolated from the main channel during base flow conditions present in the late summer. Aquatic substrate was cobble (50%), boulder (30%) and gravel (10%), sand (5%) and silt (5%). Within the side pool, aquatic substrate was composed primarily of small cobble (40%), gravel (30%), and boulder (20%). Edgewater areas were generally restricted to within approximately 0.5 m of shore, due to deep water and relatively high water velocities. Margin and emergent vegetation, as well as overhanging vegetation and canopy cover were all less than or equal to 10 percent. The general lack of vegetative cover provided ample basking sites for FYLF. Gaps in the substrate, algae, and detritus provided a moderate amount (50%) of aquatic cover.

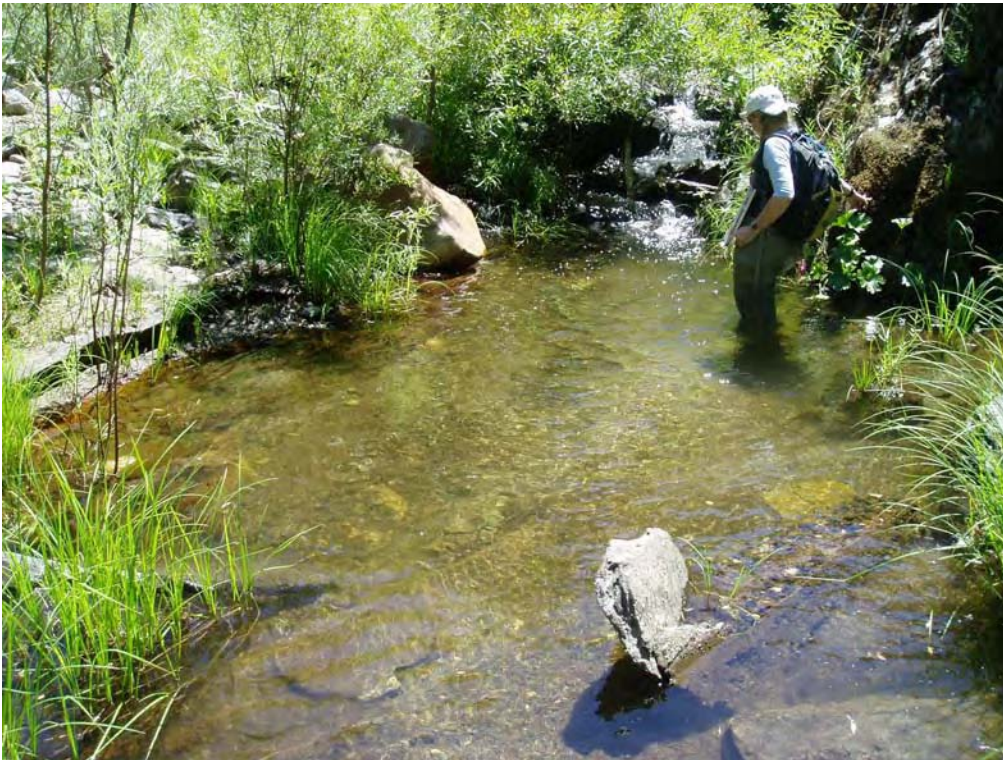
Site 105R-b – SFAR at Akin Powerhouse- side pool, August 23, 2005

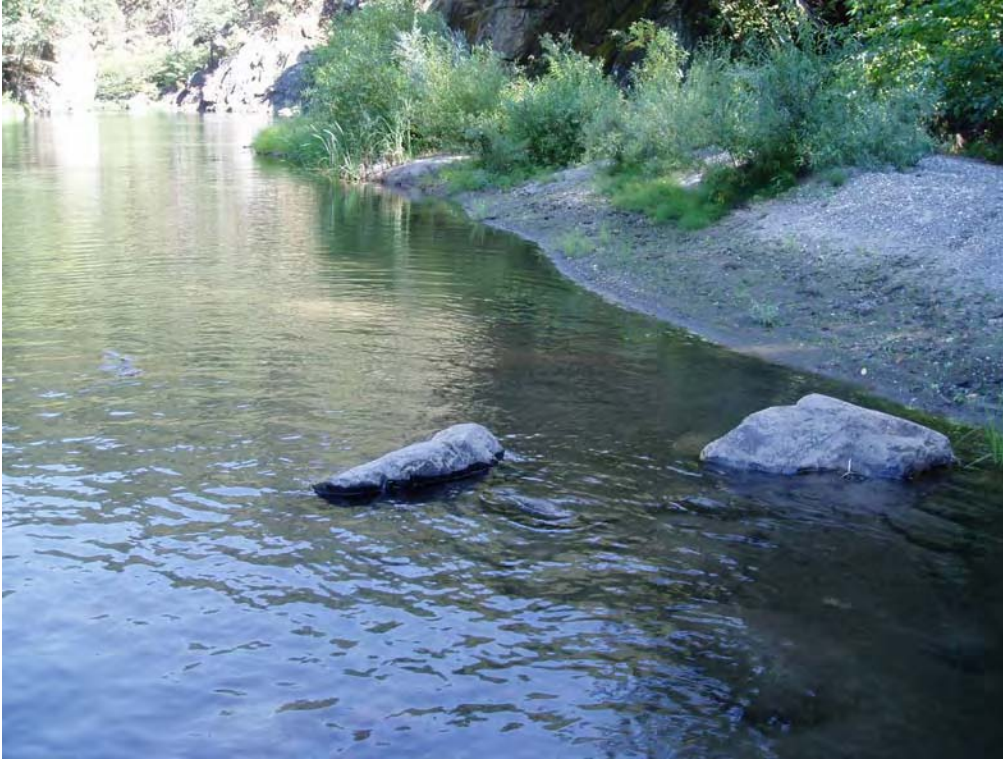
Site 105R-c – SFAR at Akin Powerhouse- bottom of site looking upstream, August 23, 2005

- Subsite 105c occurs at the pool tail-out upstream of Akin Powerhouse, and consists of a left bank sandbar 56 m in length. The aquatic substrate was primarily sand (60%), with relatively minor amounts of cobble (20%), boulder (10%), and gravel (10%). The prevalence of sand resulted in a high degree of substrate embeddedness. The edgewater portion of the site was approximately 20 m in length. A relatively large main channel pool occurs immediately adjacent to the sandbar, which restricts edgewater habitat to a width of about 2 m. Beyond 2 m from shore, water depth continues to increase. The relatively high embeddedness of the aquatic substrate and limited aquatic vegetation resulted in a low availability of aquatic cover. Few basking sites occur along the sandbar; however, exposed cobble and boulders were present at the base of the pool, just downstream of the sandbar.

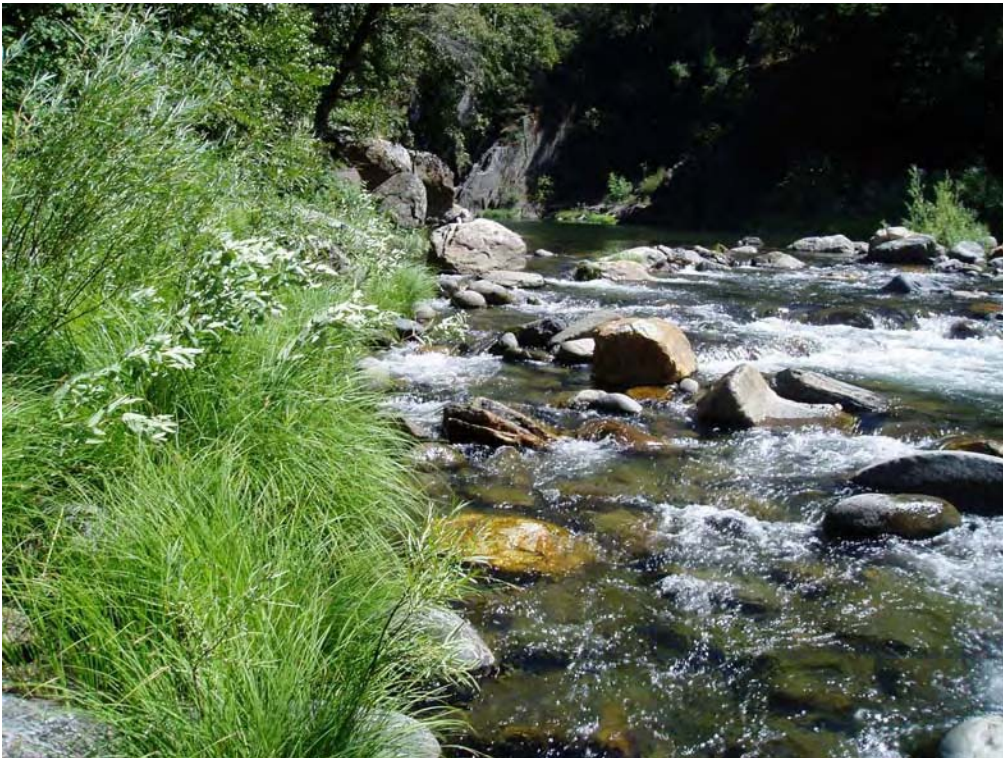
Site 105R-d – SFAR at Akin Powerhouse- bottom of site looking upstream, August 23, 2005

- Subsite 105d is located at the pool tail-out upstream of Akin Powerhouse. The site consists of a 30 m long, right bank boulder/sedge margin. The aquatic substrate was composed primarily of boulder (50%) and cobble (30%), with minor amounts of sand (10%) and gravel (10%). Shallow, low velocity edgewater areas generally extended less than 1 m from shore. Areas with low water velocities were generally restricted to backwaters formed by boulders. Outside of these small protected areas, water velocities increased substantially in association with the adjacent riffle. Sedge, blackberry, and young willows were abundant (70%) along the river margin. Only minimal amounts of emergent and submerged vegetation were present (10%). Interstitial spaces in the substrate provided a moderate amount of aquatic cover (30%). Exposed boulders provided adequate basking sites for FYLF.

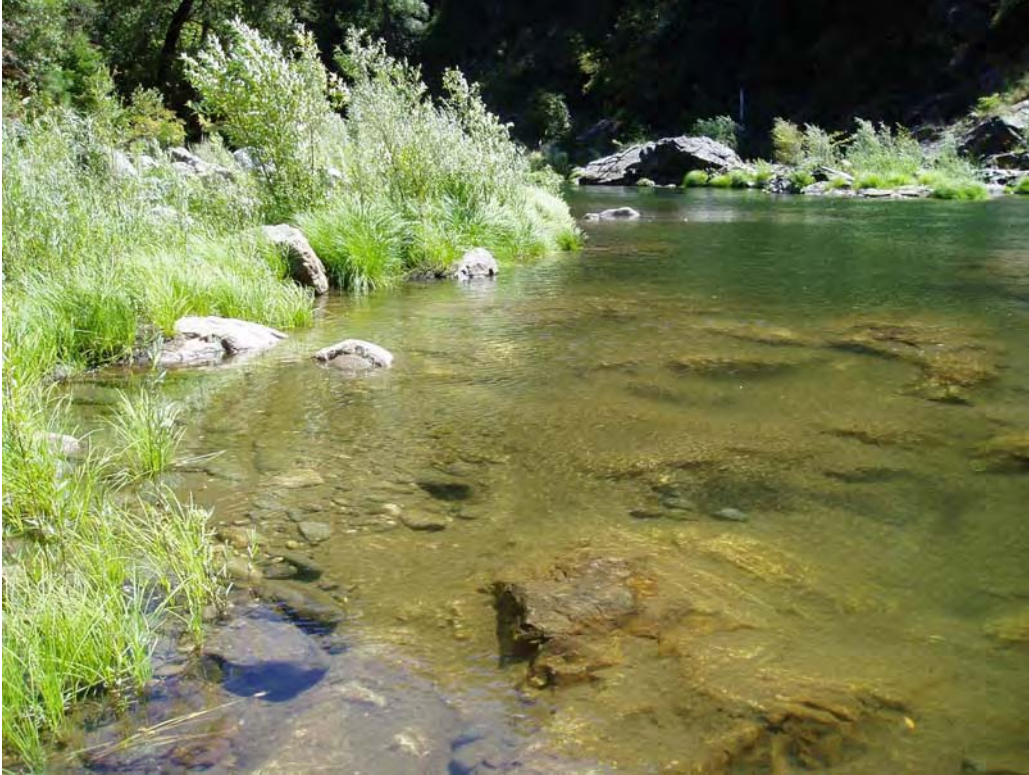
Site 110R-a – SFAR upstream of Akin Powerhouse-bottom of site looking upstream, August 30, 2005

- Subsite 110a is 35 m in length and consists of a right bank low gradient boulder/sedge margin, situated near the upstream edge of a cobble/boulder point bar. The subsite also included a small bedrock island located about 10 m from the right bank. The aquatic substrate was predominantly bedrock (30%), sand (30%) and silt (20%), with a small amount of cobble (10%) and boulder (10%). Due to the presence of high amounts of sand and silt, aquatic substrates were highly embedded. Shallow 30 cm, low velocity edgewater areas occur throughout the subsite. Sedges and young willows occurred along approximately 80 percent of the river margin. Emergent vegetation was essentially absent from the subsite. Interstitial spaces in the substrate, flocculent material, silt, and algae provided moderate aquatic cover.

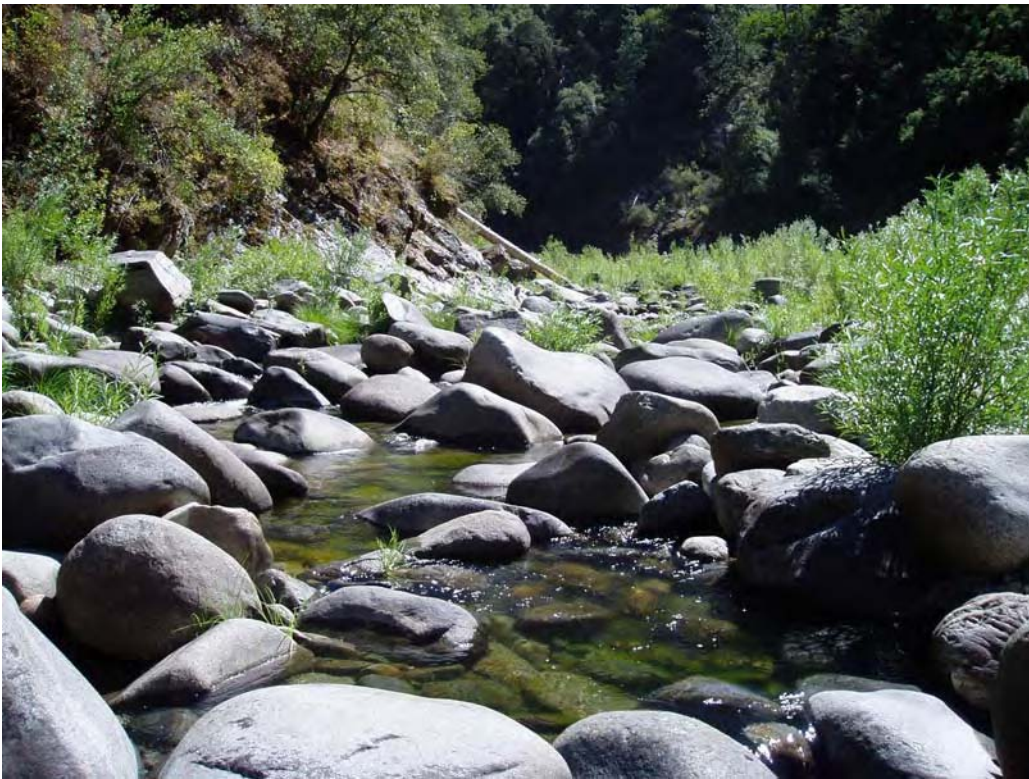
Site 110R-b – SFAR upstream of Akin Powerhouse-bottom of site looking upstream, August 30, 2005

- Subsite 110b is 80 m long and consists of a right bank low gradient side channel. The aquatic substrate was moderately embedded and consisted of a mixture of boulder (40%), cobble (20%), sand (20%), silt (10%), gravel (<10%), and bedrock (<10%). Margin vegetation, sedges, and willows occurred along approximately 30 percent of the side channel. Submerged vegetation, primarily green filamentous algae, occurred within approximately 50 percent of the subsite. Interstitial spaces in the substrate, algae, and flocculent material provided abundant (~80%) aquatic cover. Exposed boulders and cobbles, within and adjacent to the side channel, provided abundant basking sites.

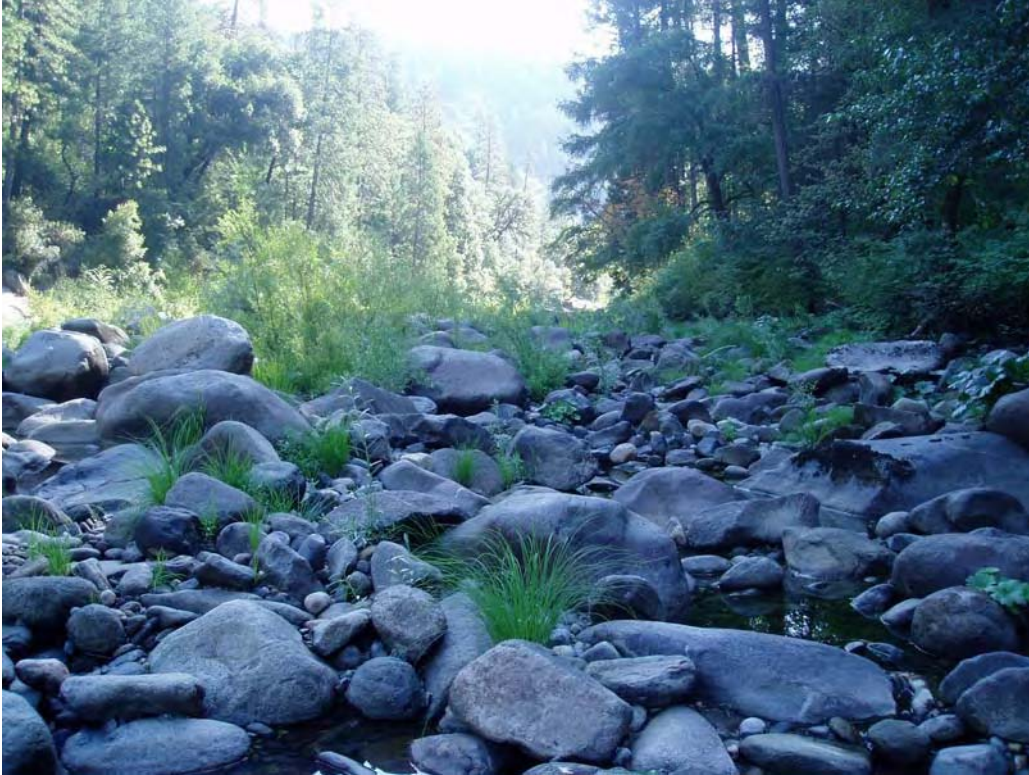
Site 120R-a – SFAR upstream of Silver Creek-bottom of site looking upstream, September 27, 2005

- Subsite 120a is 82 m long and consists of a left bank side channel and boulder/sedge margin situated on a boulder/cobble lateral bar. The aquatic substrate consisted of a mixture of boulder (40%), cobble (30%) and sand (20%), with some silt (<10%) and gravel (<10%). Sedges, grass, and forbs occurred along about 20 percent of the channel margin. Submerged vegetation (algae) was observed within 30 to 40 percent of the subsite. Algae, interstitial cracks, and silt provided moderate (40%) aquatic cover. A variety of basking sites, primarily exposed cobbles and boulders, were present throughout the subsite. Overhanging vegetation (<10%) and riparian canopy (20%) provided little shade during mid-day; however, due to the north-facing aspect of the canyon in this area, the subsite was shady in the late summer for a significant portion of the day. At base flow in 2005, flows through this side channel were extremely low, creating a series of isolated side pools.

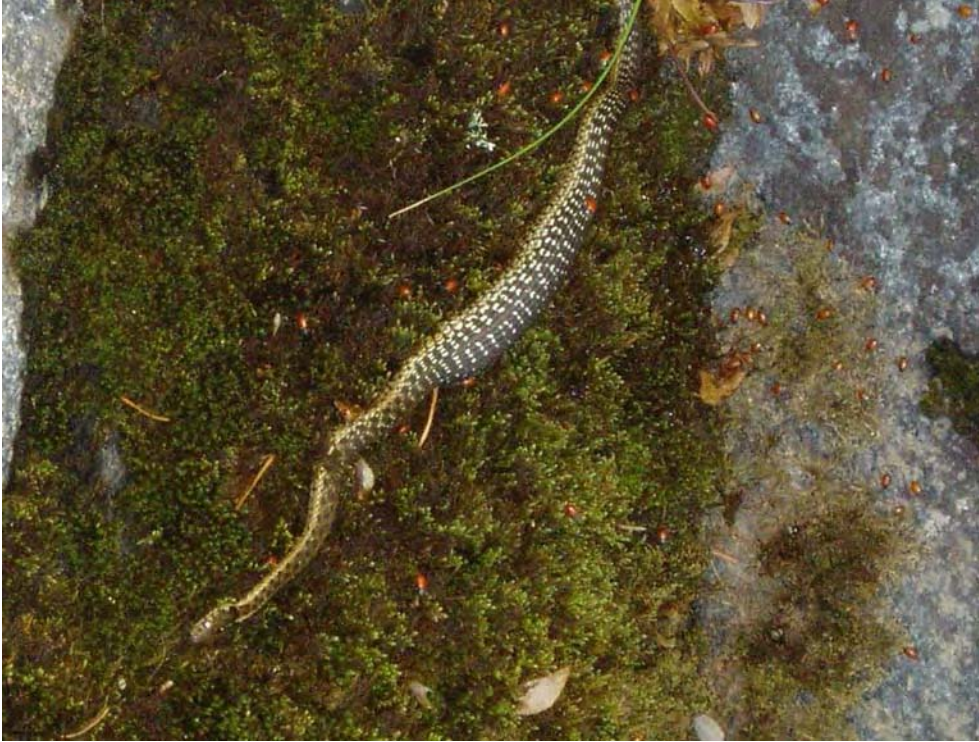
*Thamnophis couchii* observed along LB of Silver Cr., 38 m below gaging station. Note large lump mid body. This snake was subsequently palped and found with an adult female FYLF below. 9/27/05

During the late September surveys conducted on Silver Creek (115T), an adult Sierra garter snake (*Thamnophis couchii*) was captured and palped to determine its stomach contents. The snake was observed with a recently captured adult female FYLF (26 grams, 62 mm SVL). Stomach analysis of the predated female frog revealed several ladybeetle (Coleoptera) exoskeletons and one juvenile FYLF (~1 gram, 22 mm SVL).

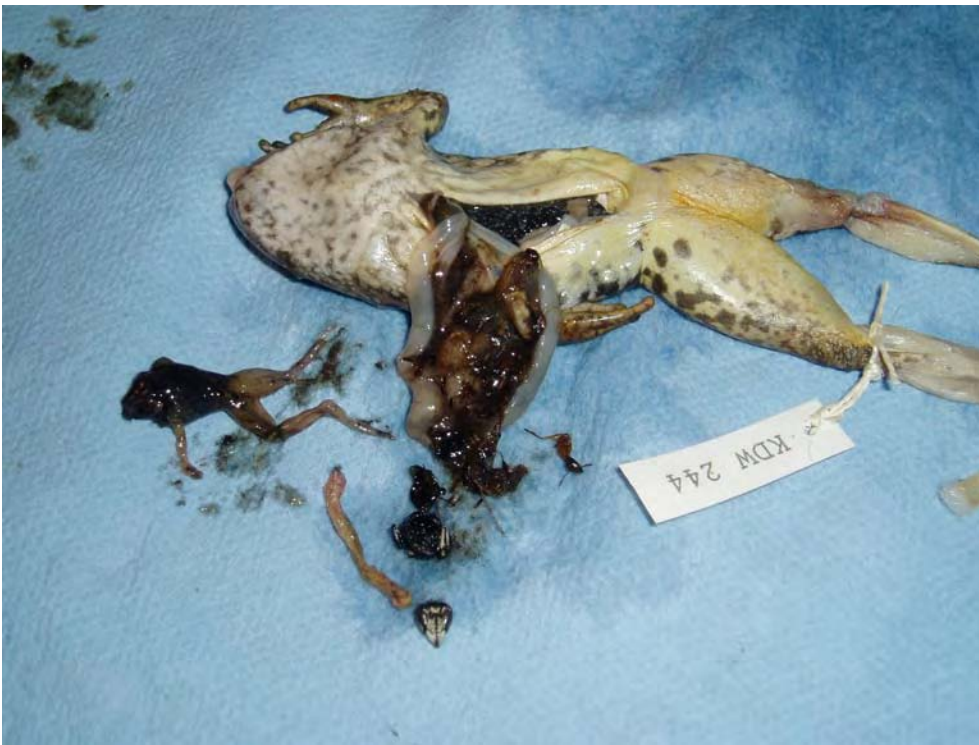
Adult female FYLF palped from *T. couchii* and stomach contents including one juvenile FYLF.
