# 2021 Surveys for Foothill Yellow-Legged Frog El Dorado Hydroelectric Project, FERC No. 184

**EL DORADO IRRIGATION DISTRICT  
2890 MOSQUITO ROAD  
PLACERVILLE, CALIFORNIA 95667**

**KLEINFELDER/GANDA  
2601 MISSION STREET, SUITE 600  
SAN FRANCISCO, CALIFORNIA 94110**

**January 2022**

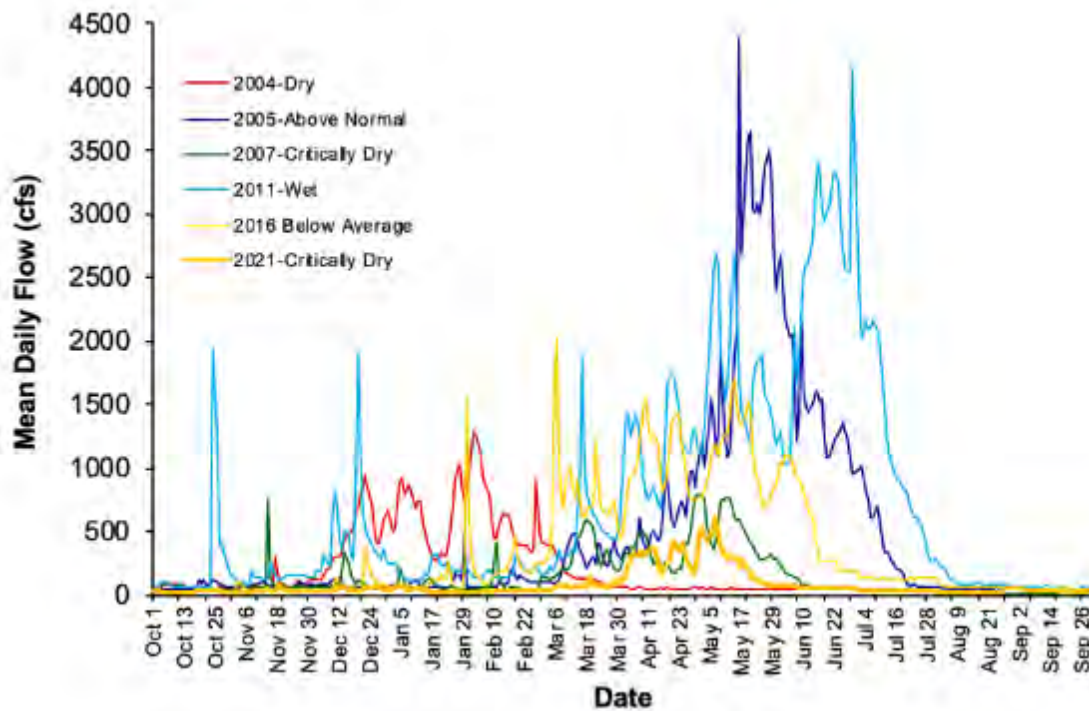
**Figure 4.1-1.** Mean daily flow (cfs) on the South Fork American River during FYLF survey years from 2004-2021 (measured at gaging station A-12 at Kyburz Diversion Dam).

In 2021, SFAR flows remained below 100 cfs throughout much of the critically dry water year, and peaked at 603 cfs (average daily flow) on May 6 (Figure 4.1-1). Based on the developmental stage of the two egg masses observed in 2021, the oviposition period occurred during May 25-26 when flows were approximately 89 cfs (Figure 4.1-2). In general, oviposition occurred earlier on the SFAR during dry (2004) and critically dry (2007 and 2021) water years, and later during above-normal (2005), wet (2011), and below normal (2016) water years (Figure 4.1-2). Although the oviposition period was estimated from only two egg masses, this oviposition period represents the shortest duration observed for all survey years between 2004-2021. Oviposition periods appeared to vary in duration across years, with the egg laying period lasting approximately 36 days in 2004, 26 days in 2005, 16 days in both 2007 and 2011, 3 days in 2016, and two days in 2021. In 2021, survey efforts were not completed on June 3 due to an injury requiring emergency response. The final survey round was canceled due to the Caldor Fire.

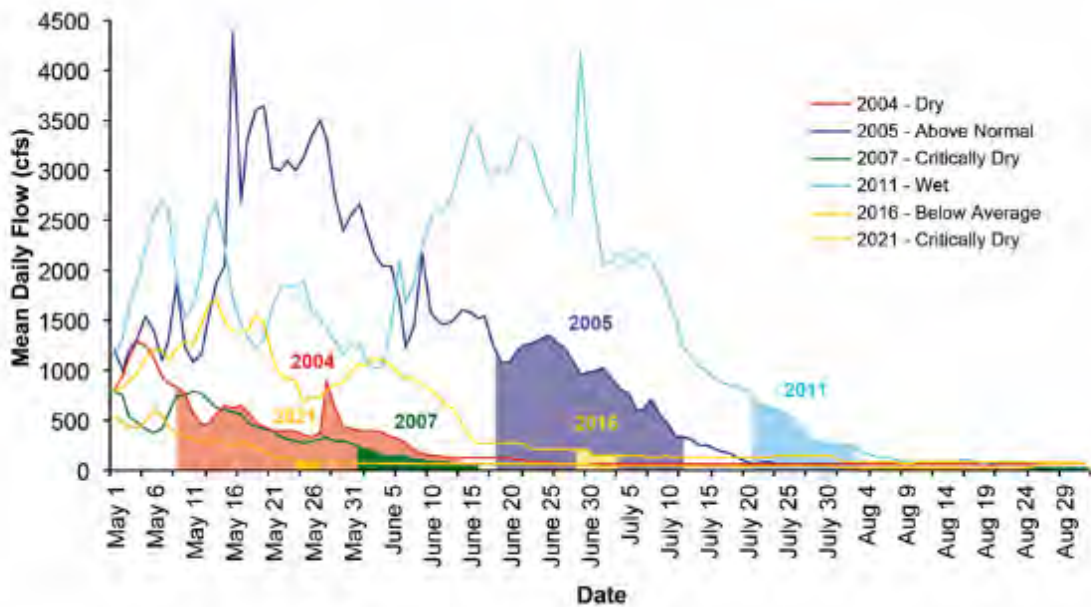
**Figure 4.1-2.** Mean daily flow (cfs) on the South Fork American River and estimated FYLF oviposition periods (represented by the shaded areas under the hydrographs) between 2004-2021.

Based on snow survey data from the California Department of Water Resources and the water year categories specified in the FERC license for Project No. 184, the SFAR experienced a critically dry water year in 2021 (CDWR 2021). During previous FYLF survey years, water year types were dry in 2004, above normal in 2005, critically dry in 2007, wet in 2011, and below normal in 2016 (Figure 4.1-1). During these years, FYLF surveys conducted on the SFAR allowed an estimation of oviposition periods by backdating the presence of egg masses based upon their developmental stage and typical inter-stage progression.

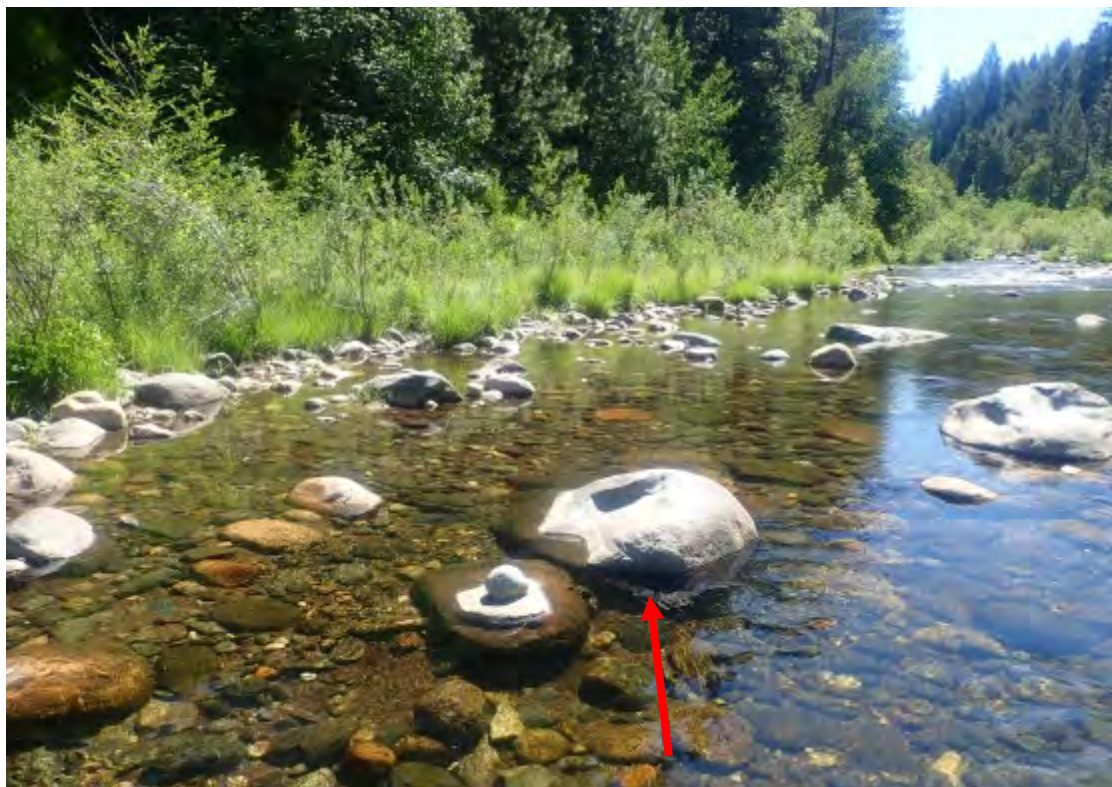
**Photo 23. Site 220b, oviposition site (indicated by red arrow) of egg masses “A” and “B”, June 25, 2021.**

Two egg masses were observed in 2021 located at Site 220b (Photos 23-25, Appendix A). They were found attached to the downstream side of the same boulder and recorded at Gosner stage 19. Subsequent surveys at this location yielded no additional egg masses or tadpoles. The egg masses were located 4.2 m from shore with a maximum water depth of 58 cm and 3 cm/second (cm/s) water flow. Water temperature at the oviposition site was 17.5°C. Based on the observed developmental stage and the date of observation, it is estimated that oviposition occurred eight days prior on, or about, May 25-26. It should be noted that this estimate is based on standardized rates of development. Predicting oviposition dates for late Gosner stages becomes more difficult because environmental factors can affect rates of development as embryos hatch and mature.

Two FYLF egg masses were observed at Site 220R during surveys in 2021 (Photos 23-25, Appendix A).
