Memorandum

Subject: Oyster Creek – 2022 Adaptive Management

Date: January 18, 2023

Oyster Creek
Stabilization Project

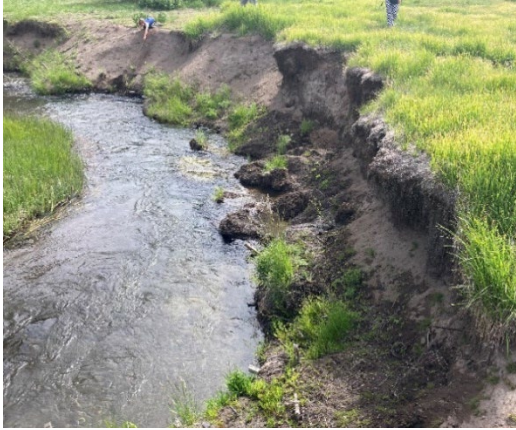
Photo No. 1A	Photo No. 1B
Date: 6/8/2022	Date: 10/18/2022
Description: Oyster Creek during Year-3 monitoring	Description: Oyster Creek following adaptive management.

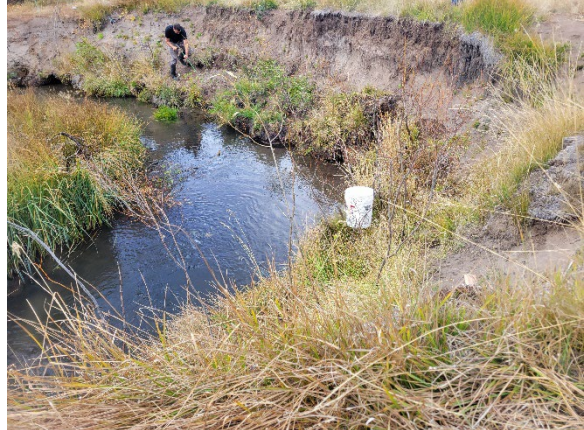
EID staff installed approximately 40 willow poles and 10 alder cuttings in the restoration area to increase the total number of surviving plantings. Planting concentrated on the mid- to lower slopes, where water availability was most suitable for willow growth and previous cuttings showed the highest rate of survival (see Photos 1B and 2B).

In addition, in areas where the bank was undercut, staff manually cut overhanging vegetation from the top of bank into sod blocks. The sod blocks measured 1-foot by 1-foot (minimum) and were positioned on the mid- and lower bank slopes and above the existing coir log where vegetation was absent. Two-

foot wooden stakes were used to pin the sod blocks into the bank. Soil was placed and compacted around the sod blocks. The intent of this action was to (1) control the loss of densely vegetated overhanging sections that may have otherwise naturally sheared off and dropped into the creek channel where they could become buried or wash away, (2) more effectively revegetate bank slopes otherwise void of vegetation, (3) reduce the potential for erosion (e.g., splash and sheet erosion), and (4) increase the potential for sediment accumulation behind the sod blocks thereby resulting in a more gradual bank slope. Approximately 25 linear feet of sod blocks were cut and repositioned along the bank.

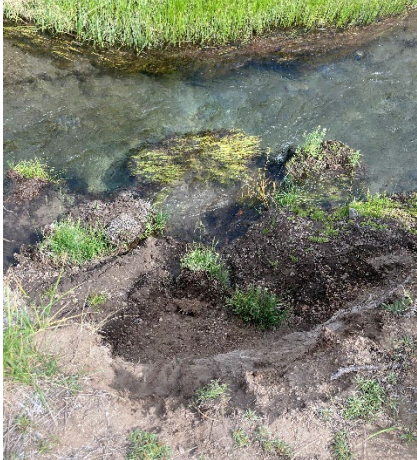
Photo No. 2A	Photo No. 2B
Date: 6/8/2022	Date: 10/18/2022
Description: Oyster Creek during Year-3 monitoring	Description: Oyster Creek following adaptive management.
