MARCH 2012

# Geomorphic Monitoring of Representative Channel Areas for El Dorado Hydroelectric Project No. 184

Stillwater Sciences  
279 Cousteau Place, Suite 400  
Davis, CA 95618

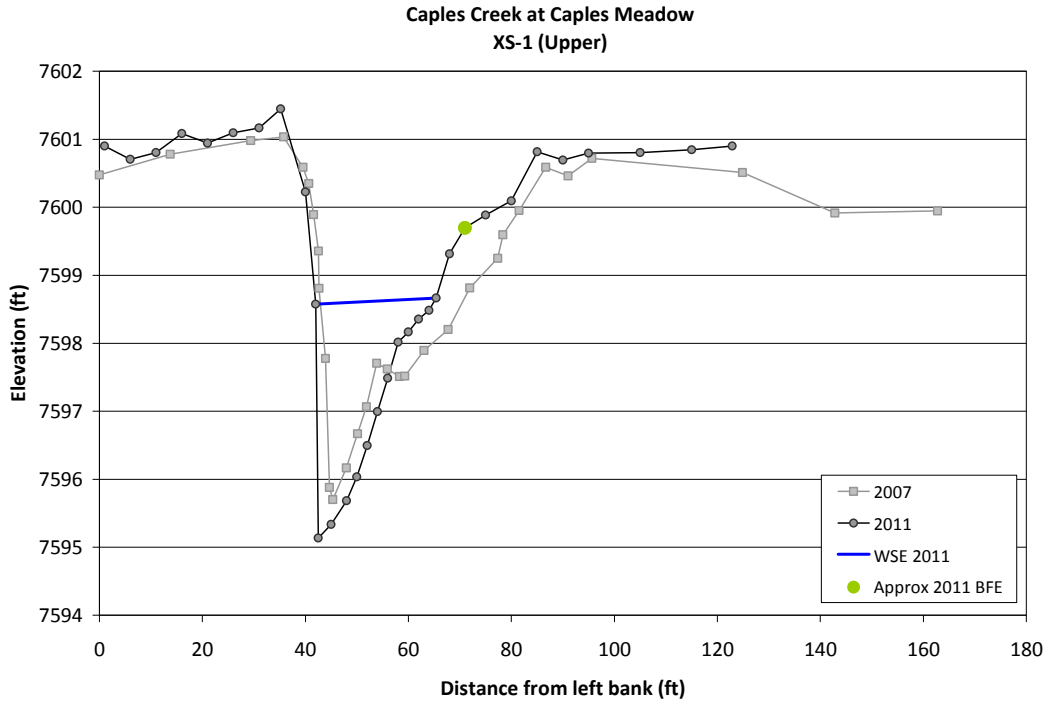
Figure 3-3. Caples Creek at Caples Meadow XS-1 survey data. Elevation is shown relative to the datum used for the 2007 survey (see Cardno Entrix 2011). Legend abbreviations: WSE = Water Surface Elevation; BFE = Bankfull Elevation.

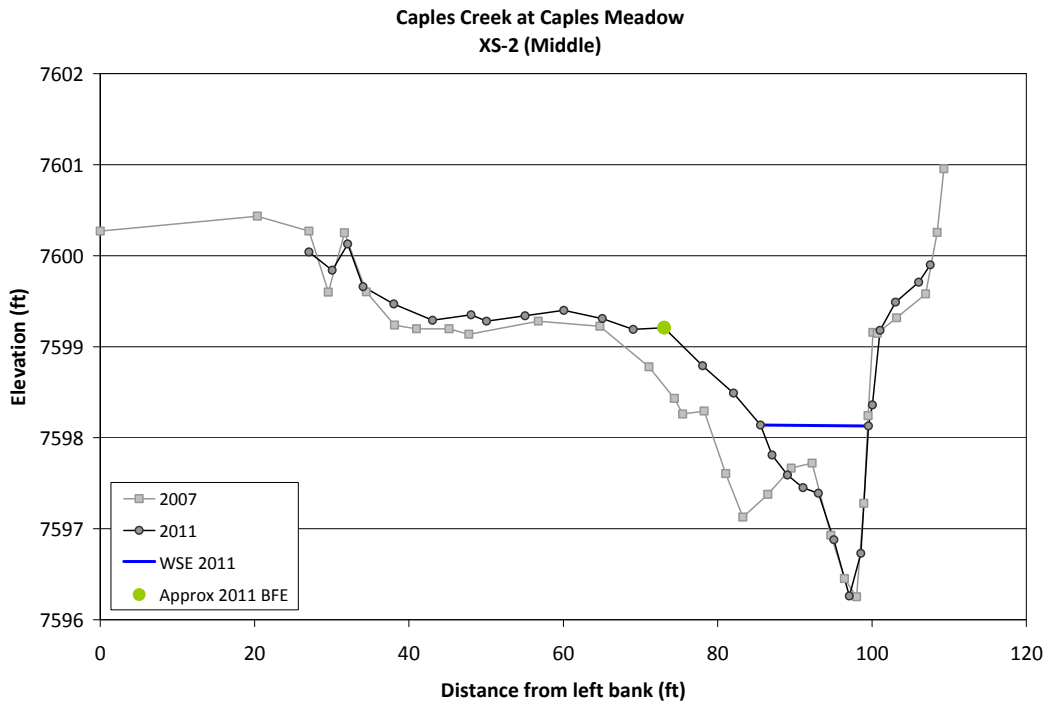
Figure 3-4. Caples Creek at Caples Meadow XS-2 survey data. Elevation is shown relative to the datum used for the 2007 survey (see Cardno Entrix 2011). Legend abbreviations: WSE = Water Surface Elevation; BFE = Bankfull Elevation.

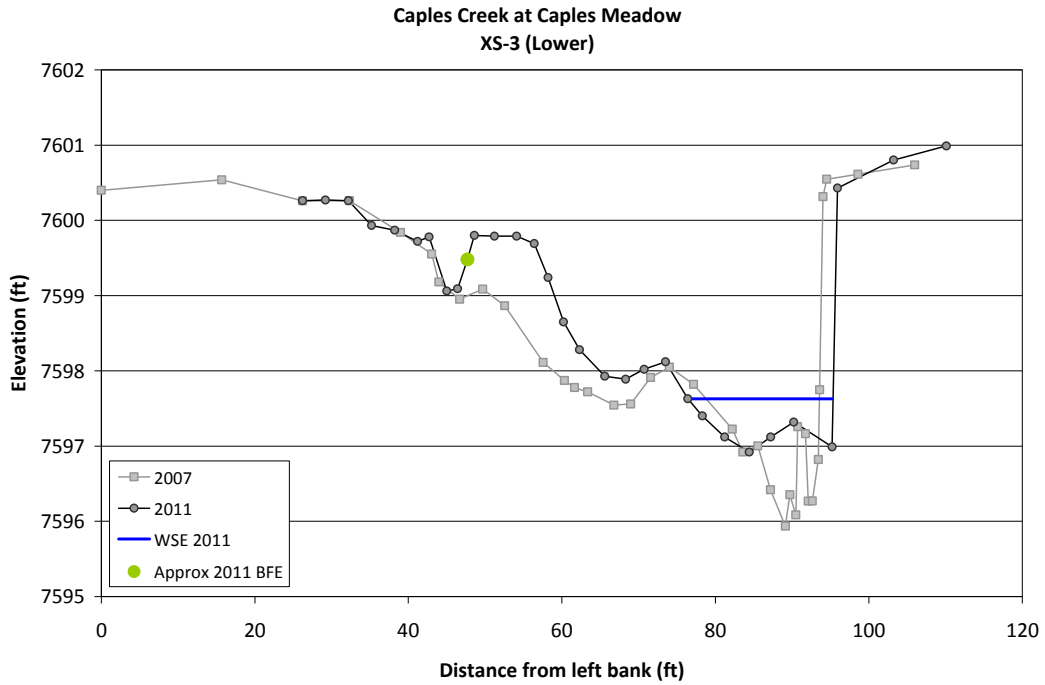
Figure 3-5. Caples Creek at Caples Meadow XS-3 survey data. Elevation is shown relative to the datum used for the 2007 survey (see Cardno Entrix 2011). Legend abbreviations: WSE = Water Surface Elevation; BFE = Bankfull Elevation.

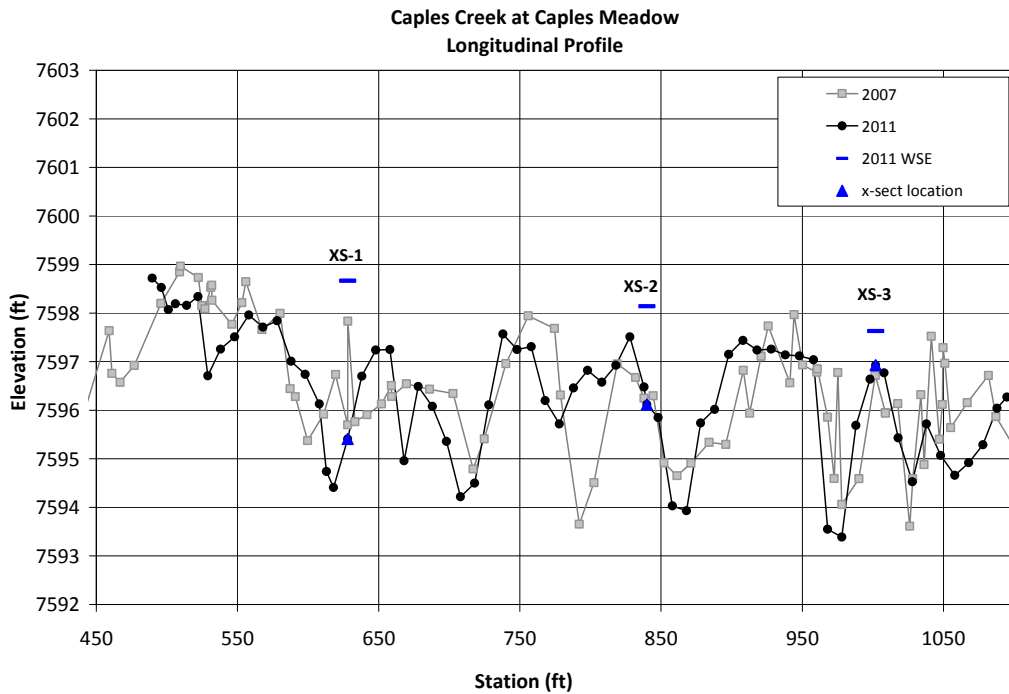
Figure 3-6. Caples Creek at Caples Meadow longitudinal profile. Elevation is shown relative to the datum used for the 2007 survey (see Cardno Entrix 2011). Legend abbreviations: WSE = Water Surface Elevation.

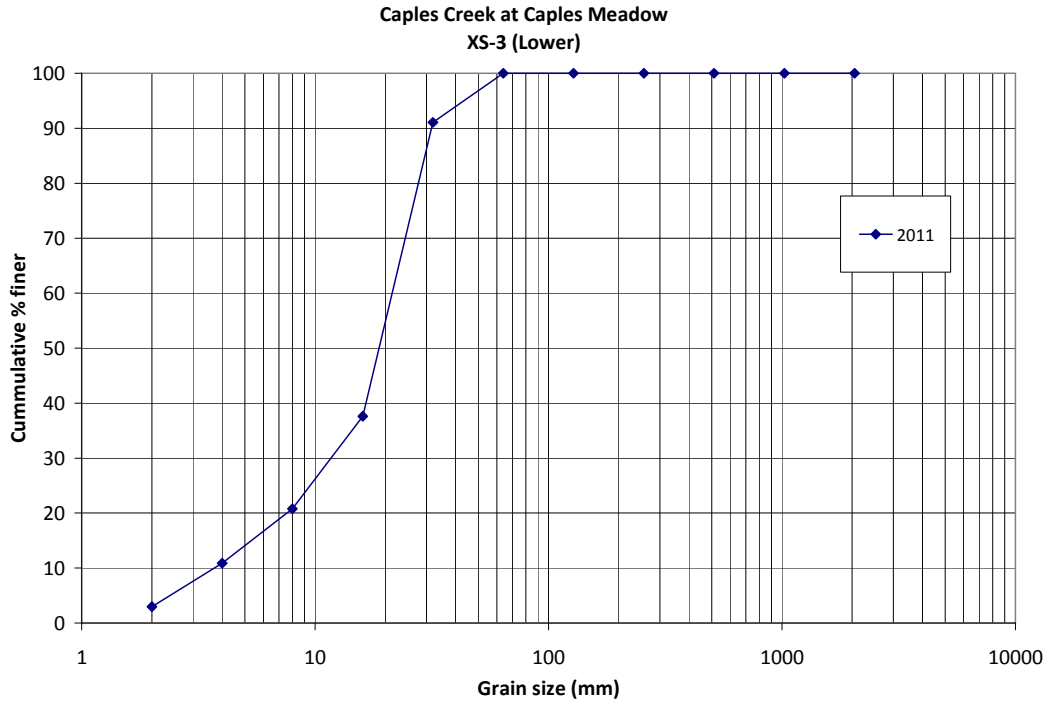
Figure 3-9. Caples Creek at Caples Meadow XS-3 bed particle size distribution.

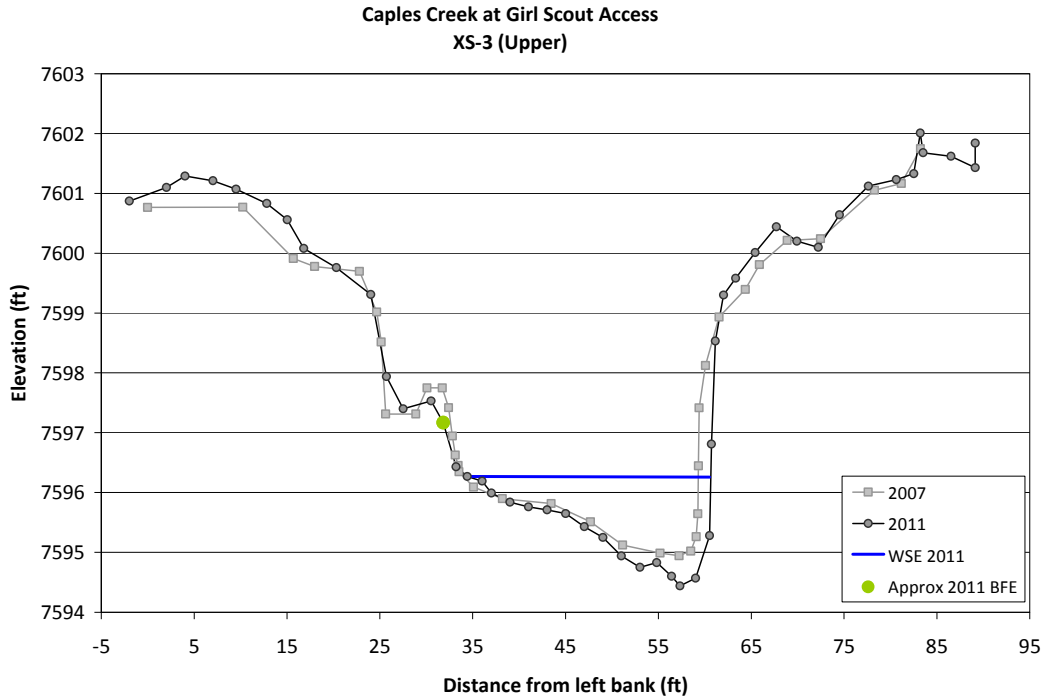
Figure 3-11. Caples Creek at Girl Scout Access XS-3 survey data. Elevation is shown relative to the datum used for the 2007 survey (see Cardno Entrix 2011). Legend abbreviations: WSE = Water Surface Elevation; BFE = Bankfull Elevation.

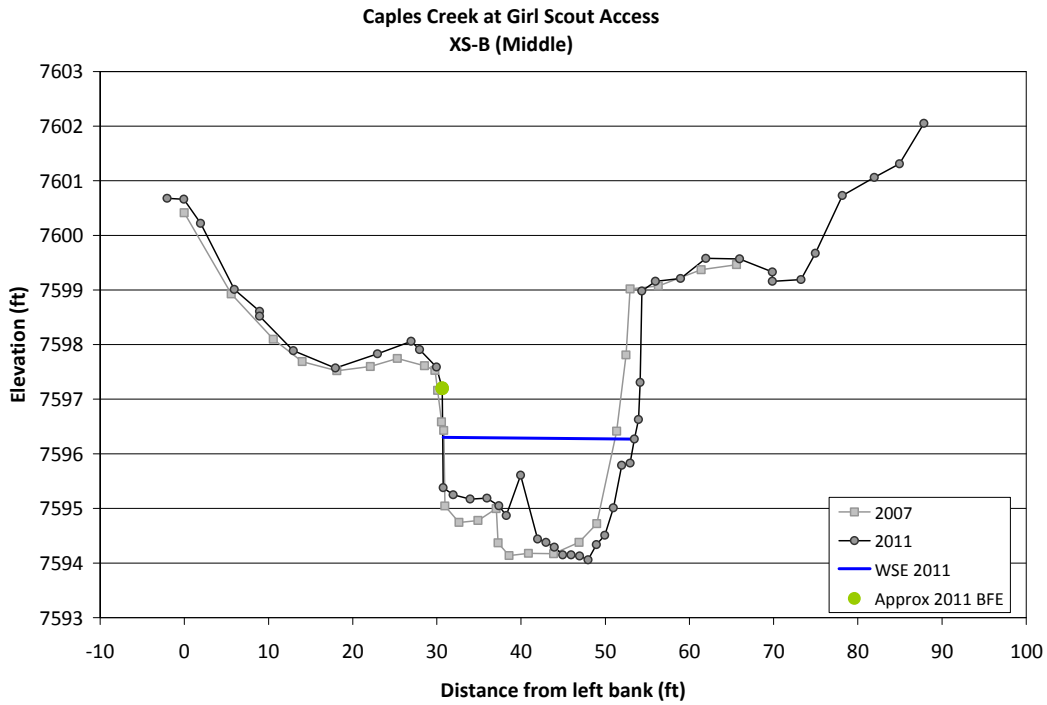
Figure 3-12. Caples Creek at Girl Scout Access XS-B survey data. Elevation is shown relative to a datum established for the 2007 survey. Legend abbreviations: WSE = Water Surface Elevation; BFE = Bankfull Elevation.

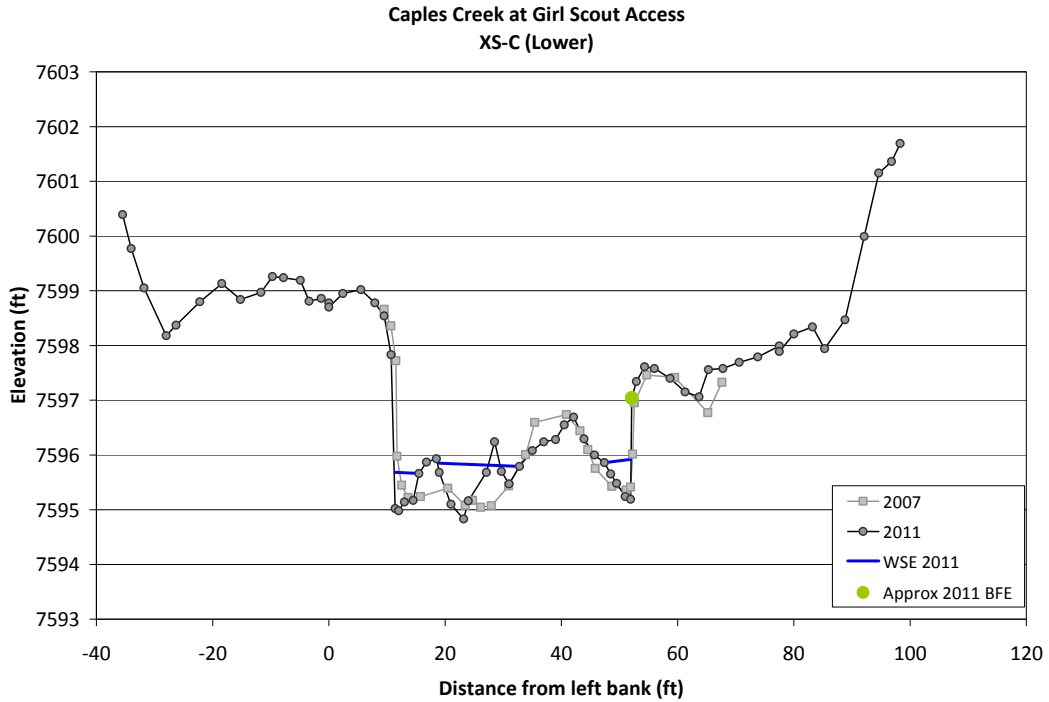
Figure 3-13. Caples Creek at Girl Scout Access XS-C survey data. Elevation is shown relative to a datum established for the 2007 survey. Legend abbreviations: WSE = Water Surface Elevation; BFE = Bankfull Elevation.

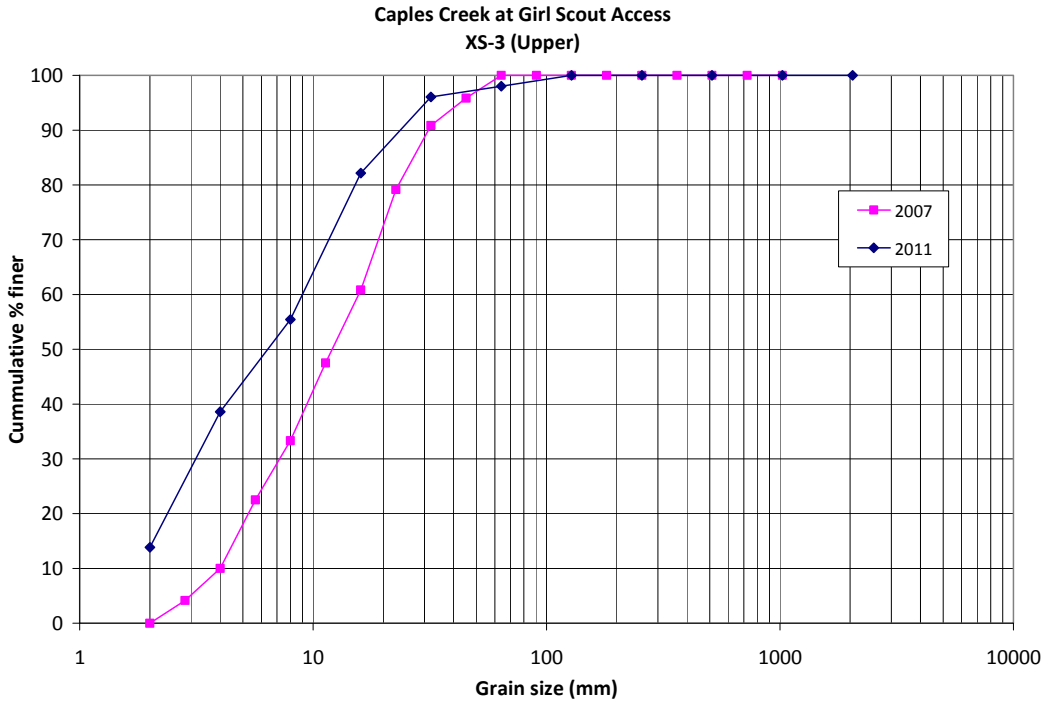
Figure 3-15. Caples Creek at Girl Scout Access XS-3 bed particle size distribution.

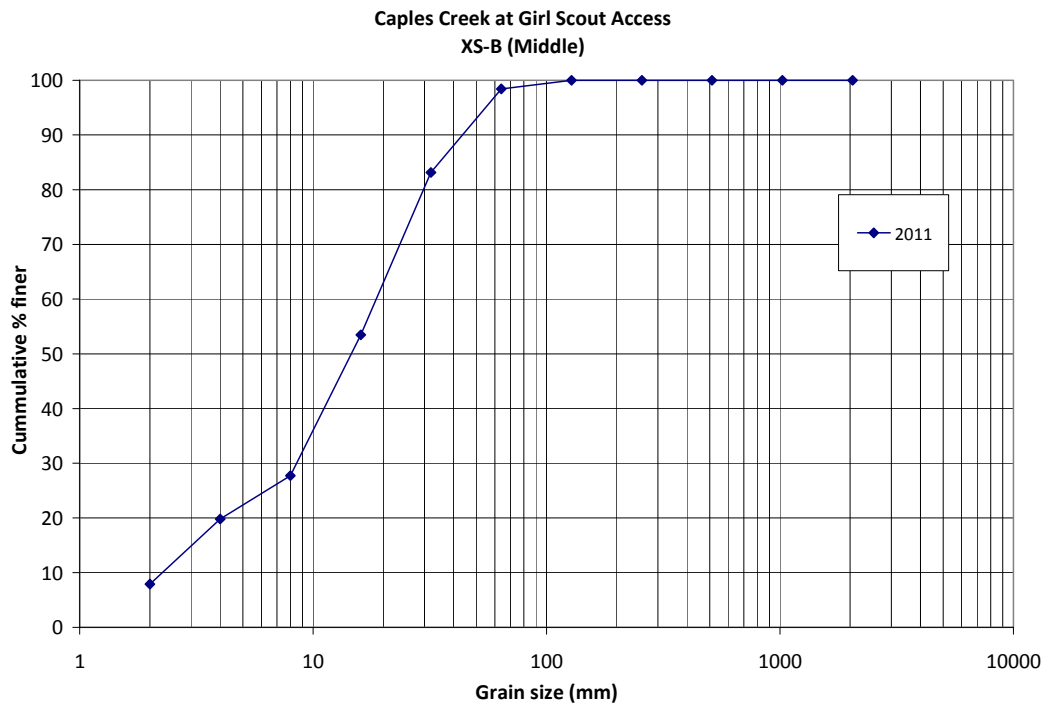
Figure 3-16. Caples Creek at Girl Scout Access XS-B bed particle size distribution.

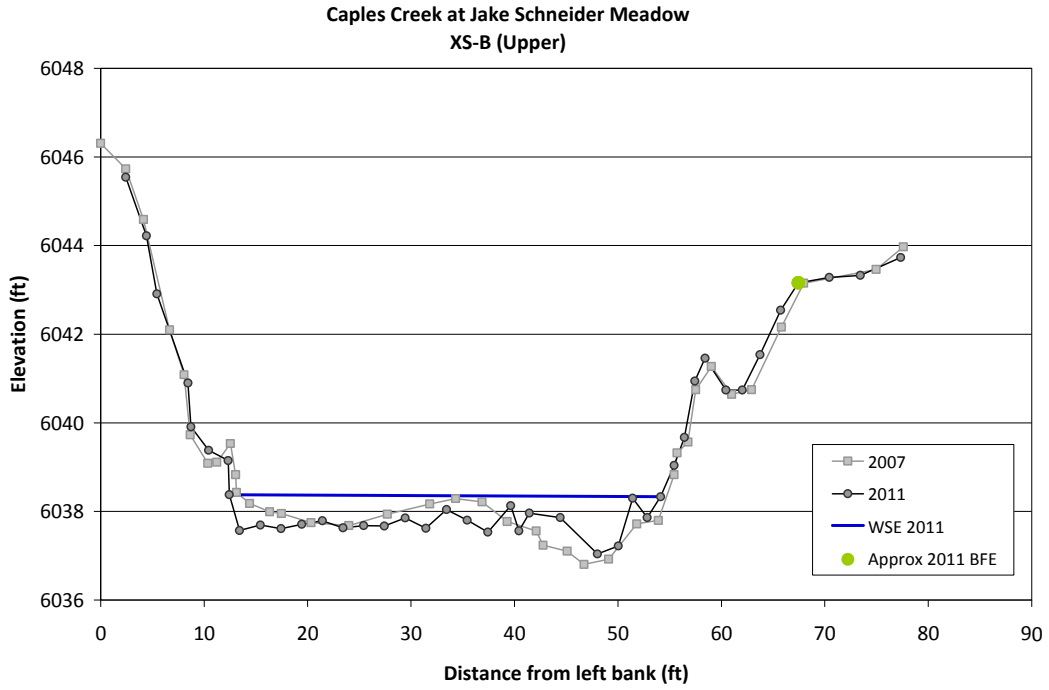
Figure 3-19. Caples Creek at Jake Schneider Meadow XS-B survey data. Elevation is shown relative to the datum used for the 2007 survey (see Cardno Entrix 2011). Legend abbreviations: WSE = Water Surface Elevation; BFE = Bankfull Elevation.

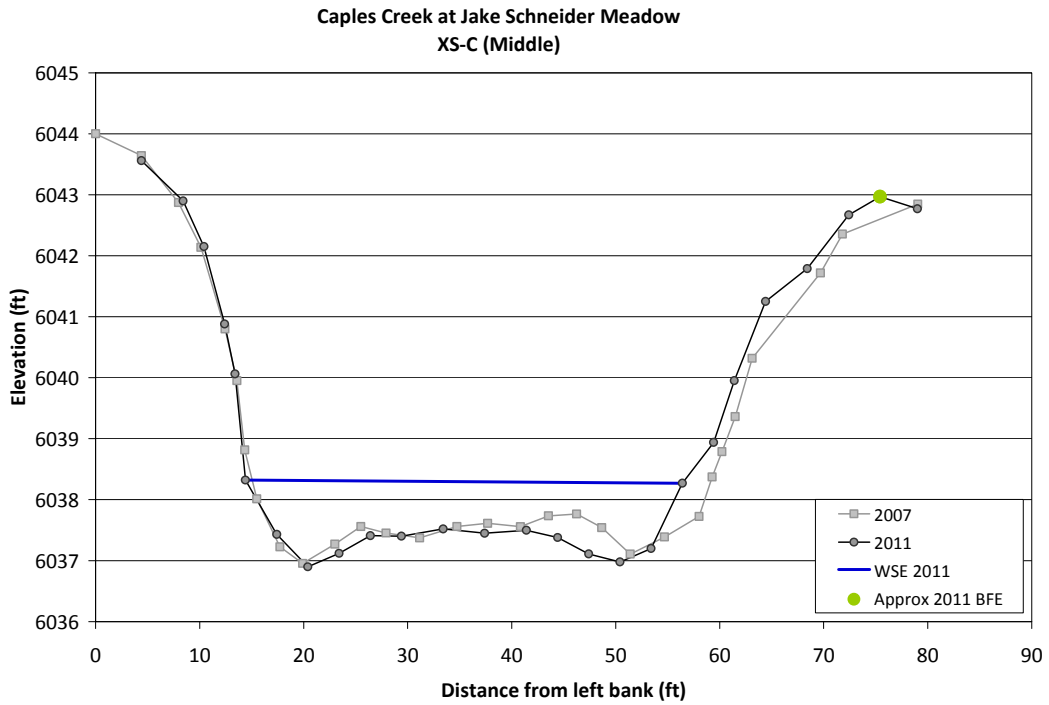
Figure 3-20. Caples Creek at Jake Schneider Meadow XS-C survey data. Elevation is shown relative to the datum used for the 2007 survey (see Cardno Entrix 2011). Legend abbreviations: WSE = Water Surface Elevation; BFE = Bankfull Elevation.

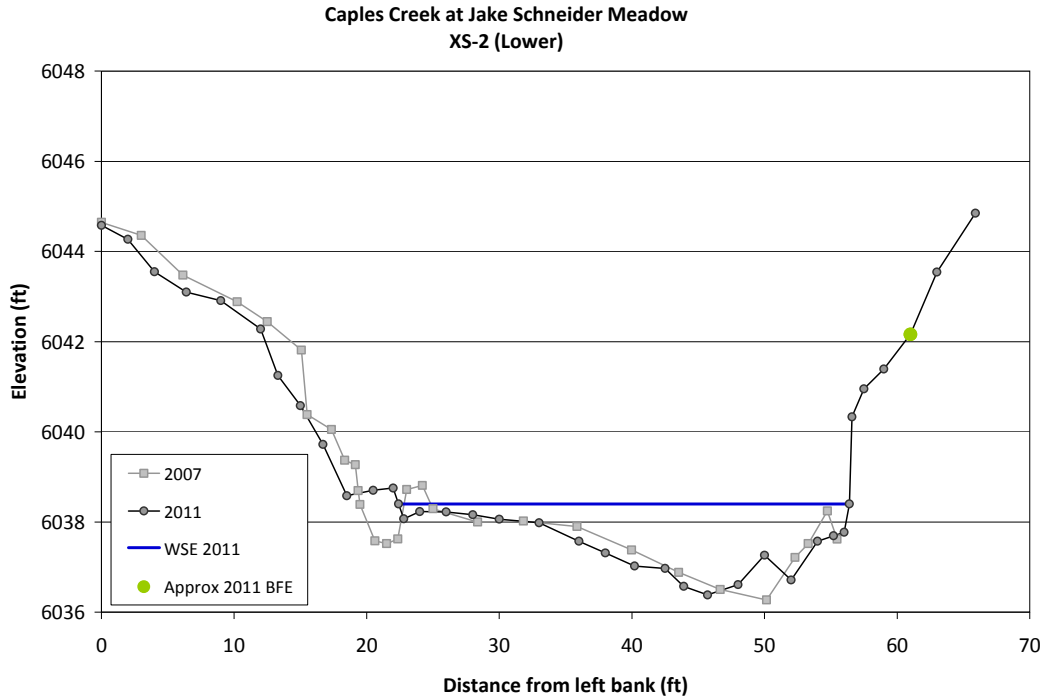
Figure 3-21. Caples Creek at Jake Schneider Meadow XS-2 survey data. Elevation is shown relative to the datum used for the 2007 survey (see Cardno Entrix 2011). Legend abbreviations: WSE = Water Surface Elevation; BFE = Bankfull Elevation.

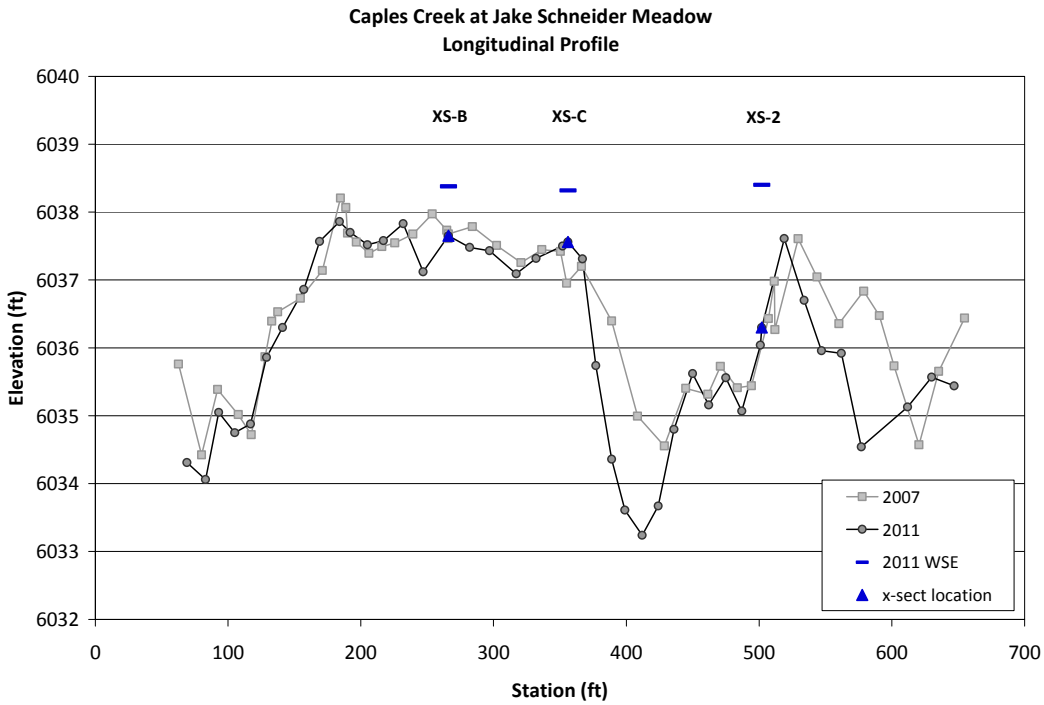
Figure 3-22. Caples Creek at Jake Schneider Meadow longitudinal profile data. Elevation is shown relative to the datum used for the 2007 survey (see Cardno Entrix 2011). Legend abbreviations: WSE = Water Surface Elevation.

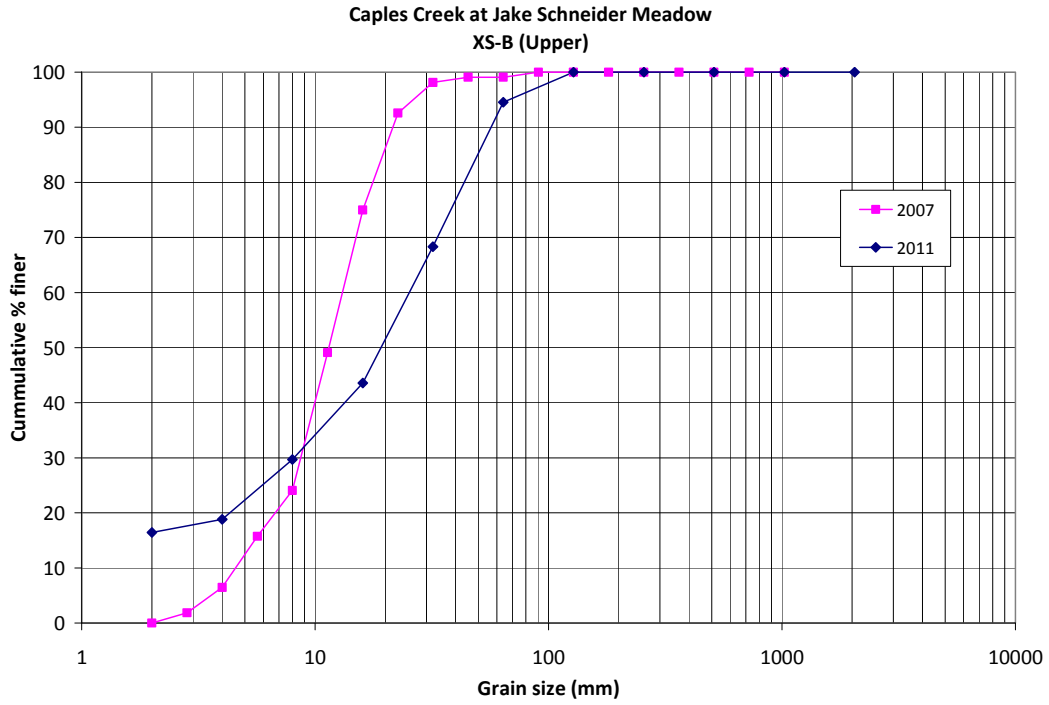
Figure 3-23. Caples Creek at Jake Schneider Meadow XS-B bed particle size distribution.

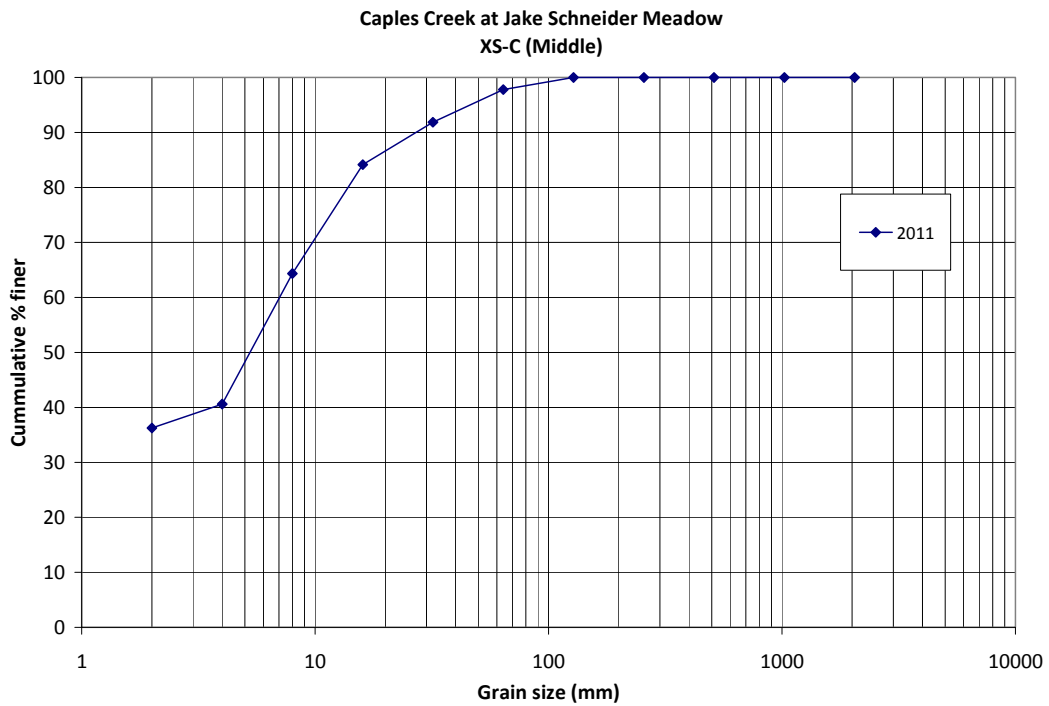
Figure 3-24. Caples Creek at Jake Schneider Meadow XS-C bed particle size distribution.

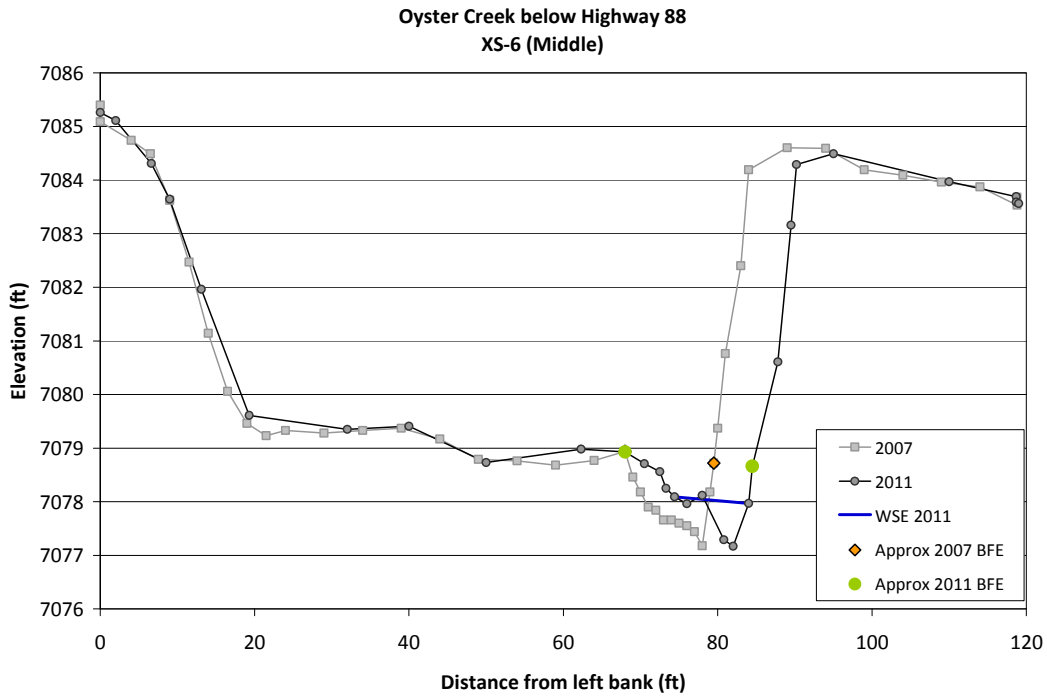
Figure 3-28. Oyster Creek below Highway 88 XS-6 survey data. Elevation is shown relative to the datum used for the 2007 survey (see Cardno Entrix 2011). Legend abbreviations: WSE = Water Surface Elevation; BFE = Bankfull Elevation.

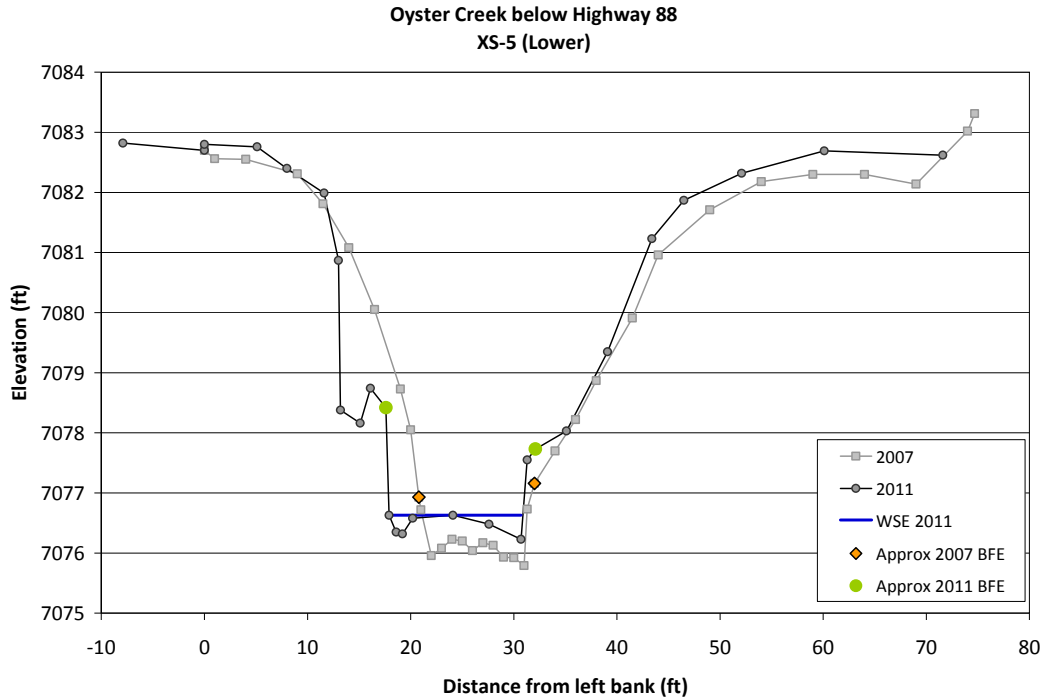
Figure 3-29. Oyster Creek below Highway 88 XS-5 survey data. Elevation is shown relative to the datum used for the 2007 survey (see Cardno Entrix 2011). Legend abbreviations: WSE = Water Surface Elevation; BFE = Bankfull Elevation.

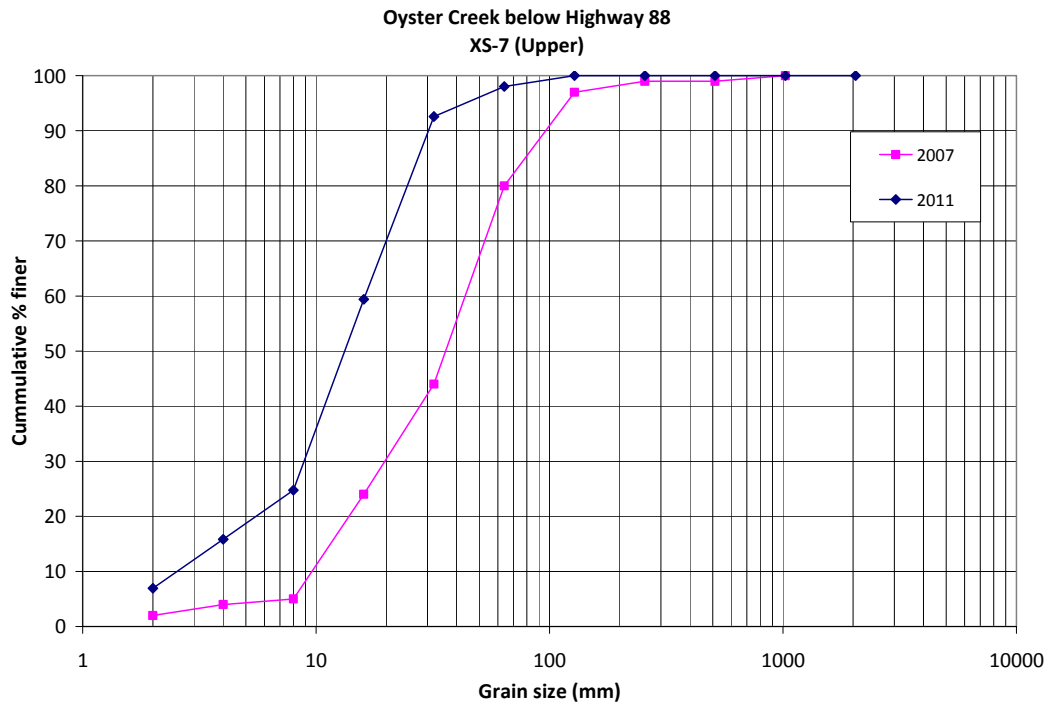
Figure 3-30. Oyster Creek below Highway 88 XS-7 bed particle size distribution.

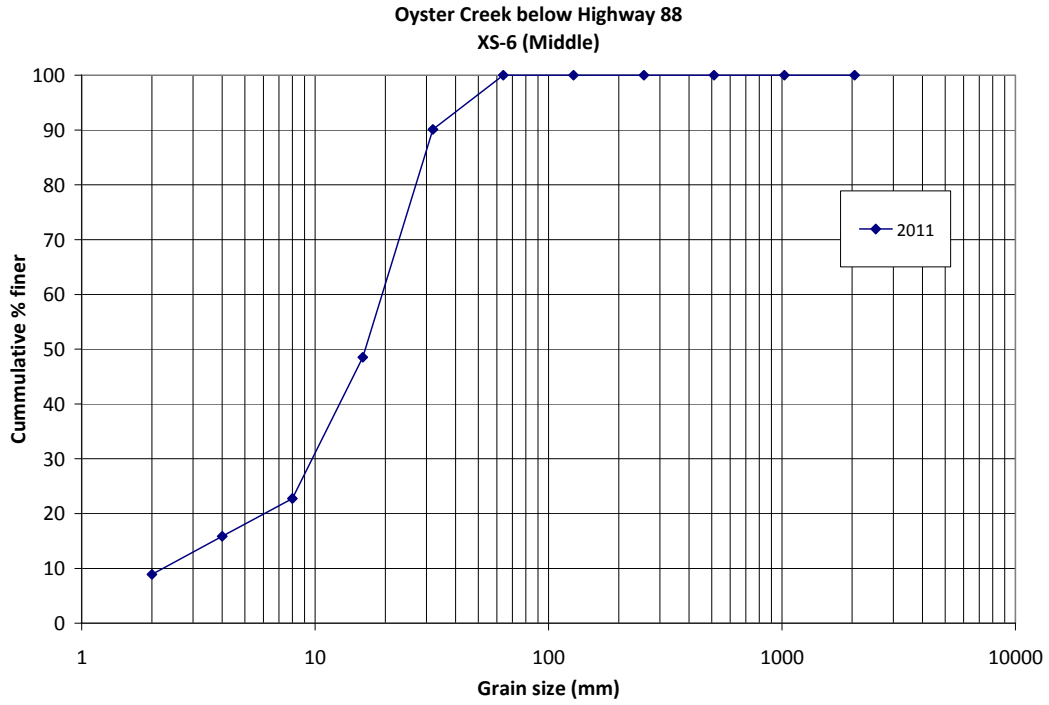
Figure 3-31. Oyster Creek below Highway 88 XS-6 bed particle size distribution.

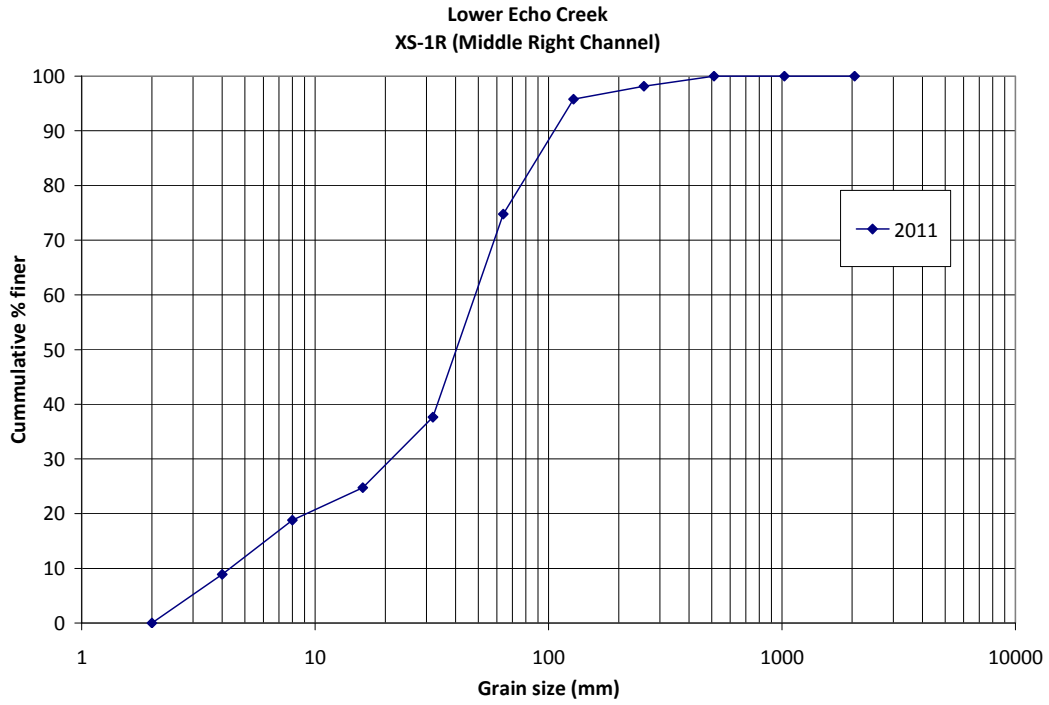
Figure 3-39. Lower Echo Creek XS-1R bed particle size distribution.

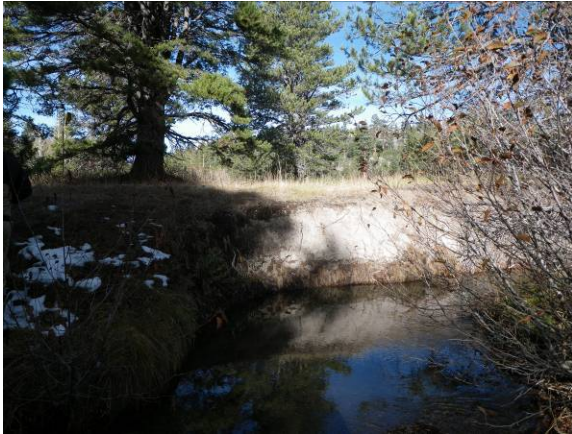
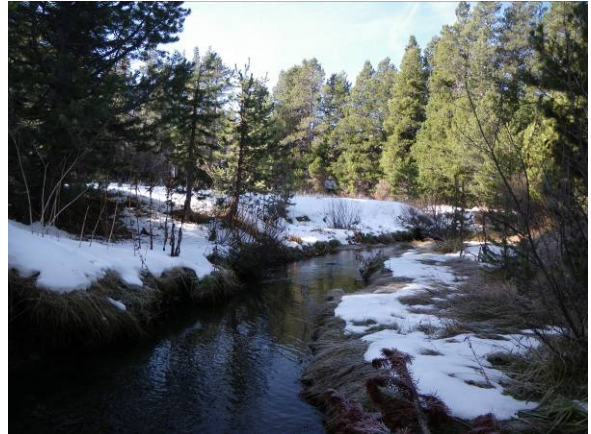
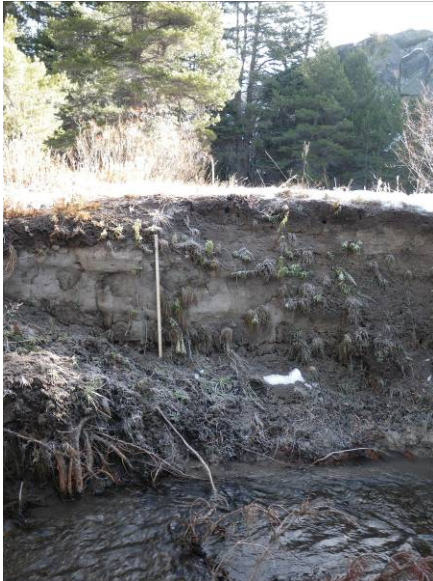
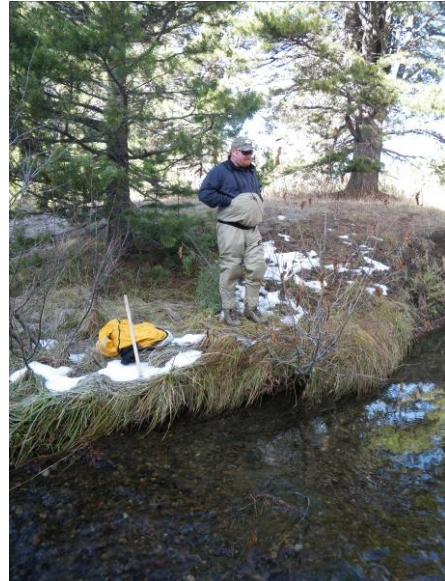
Figure A-1. Oyster Creek, XS- 1 (Lower): (a) looking upstream; (b) looking downstream; (c) looking at the left bank; (d) looking at the right bank; (e) looking at the bed.

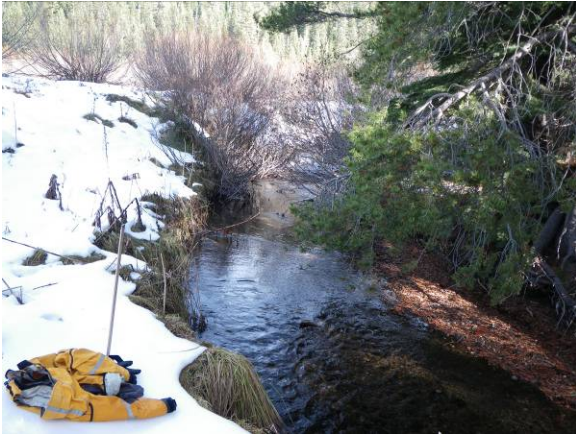
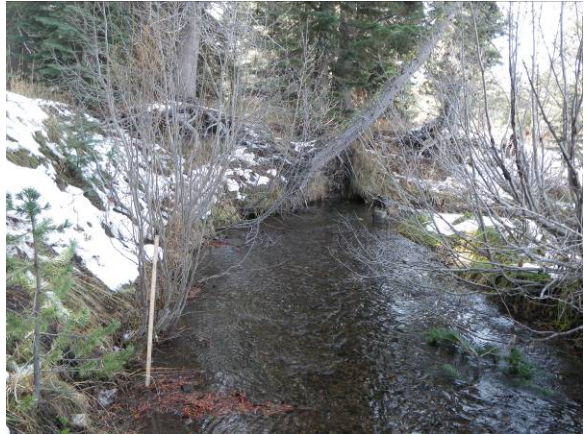
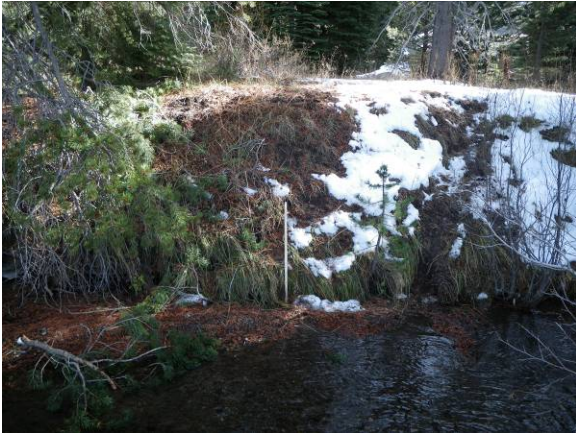
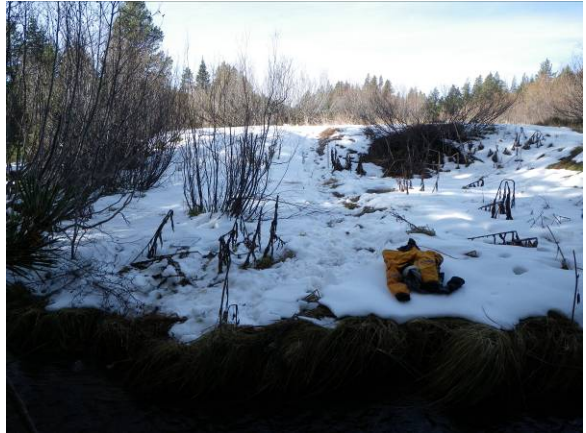
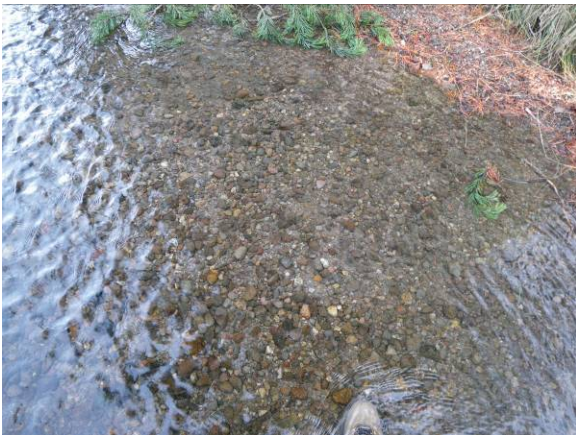
Figure A-3. Oyster Creek, XS-3 (Upper): (a) looking upstream; (b) looking downstream; (c) looking at the left bank; (d) looking at the right bank; and (e) looking at the bed.

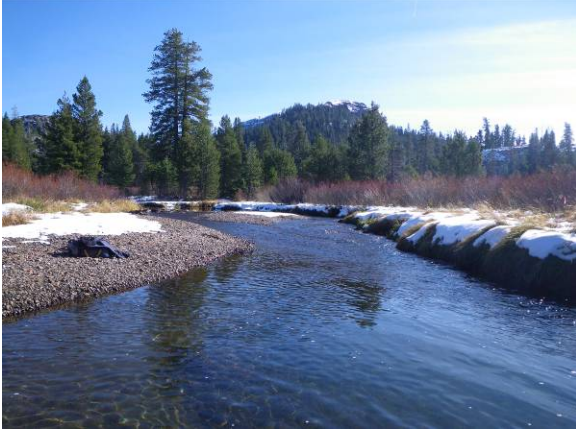
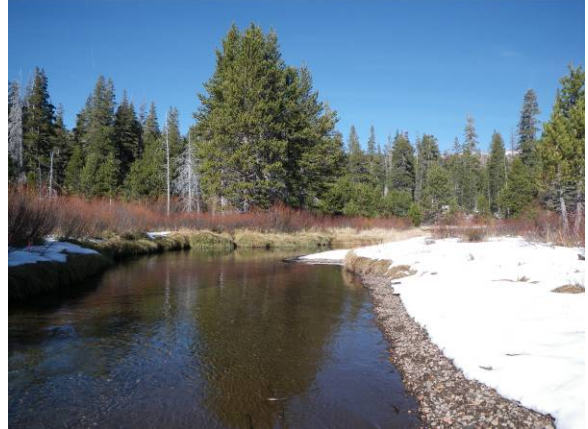
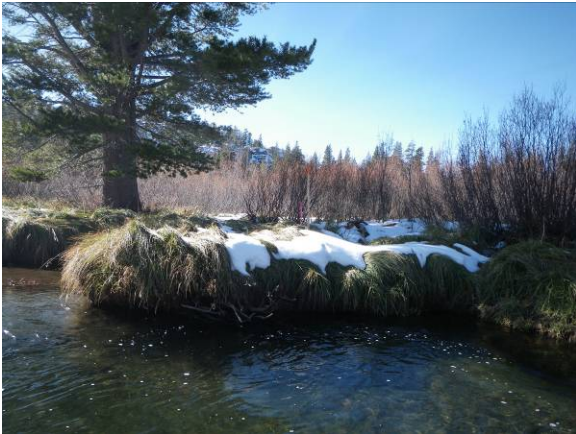
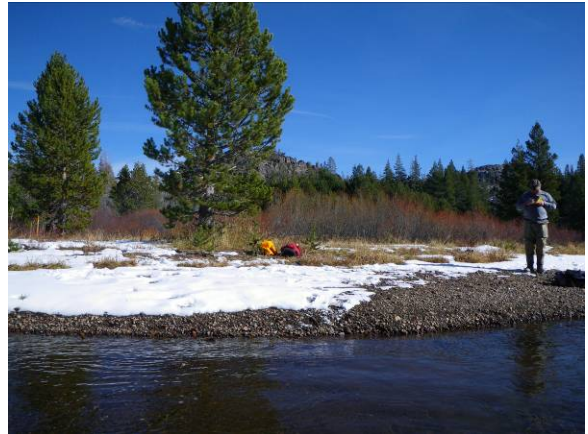
Figure A-4. Caples Creek at Caples Meadow, XS-1 (Upper): (a) looking upstream; (b) looking downstream; (c) looking at the left bank; (d) looking at the right bank; and (e) looking at the bed.

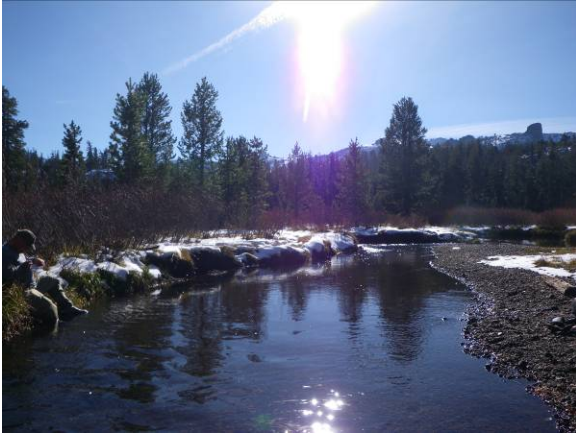
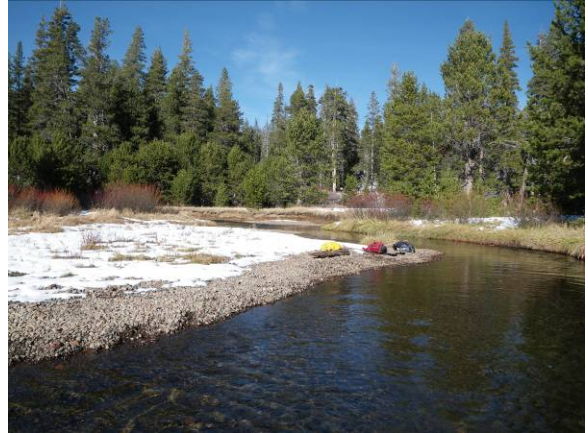
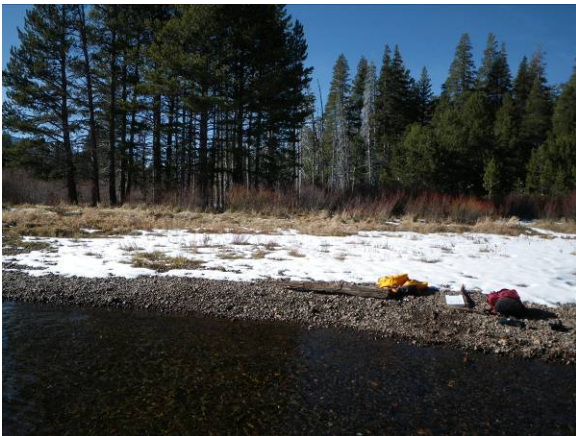
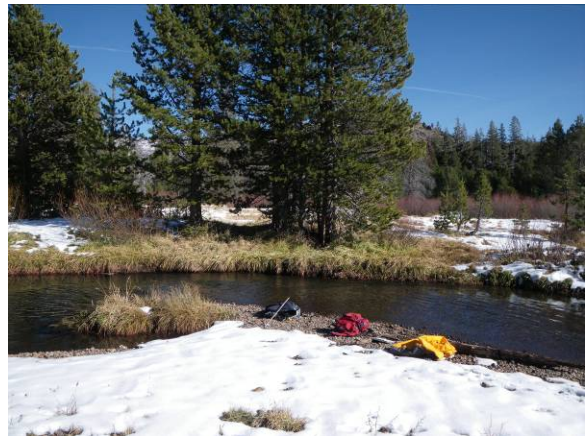
Figure A-5. Caples Creek at Caples Meadow, XS-2 (Mid): (a) looking upstream; (b) looking downstream; (c) looking at the left bank; (d) looking at the right bank; and (e) looking at the bed.

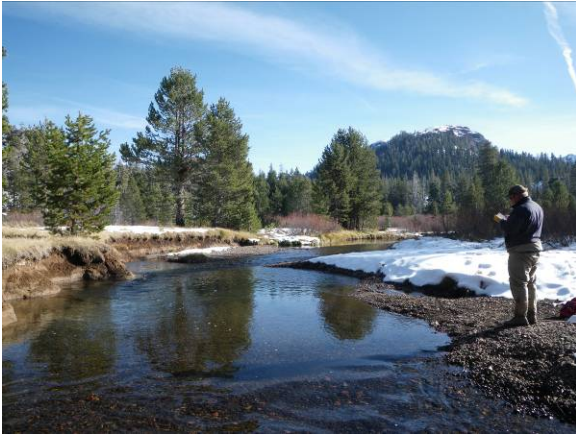
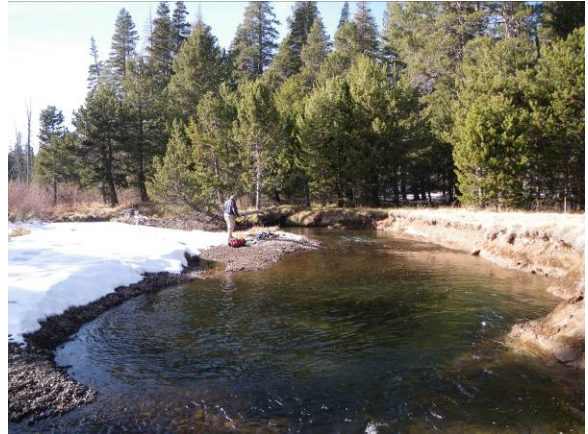
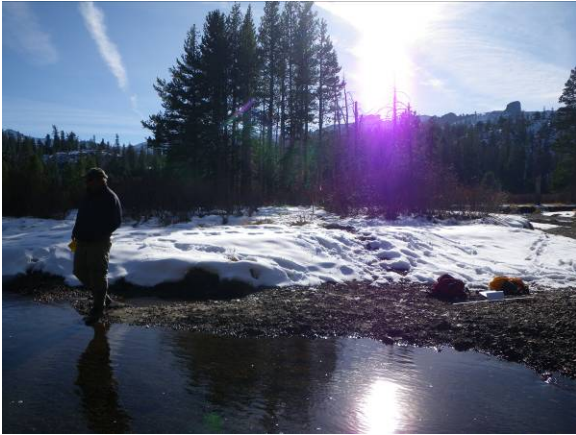
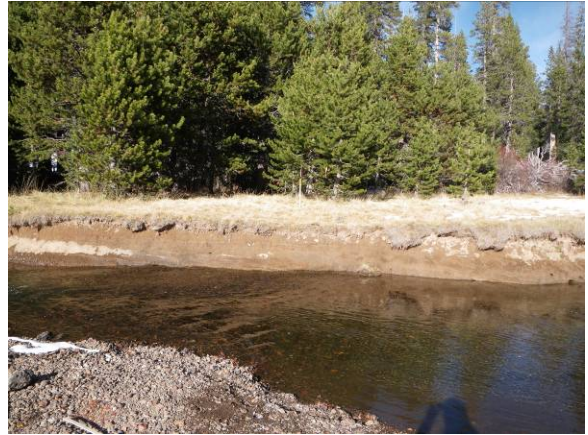
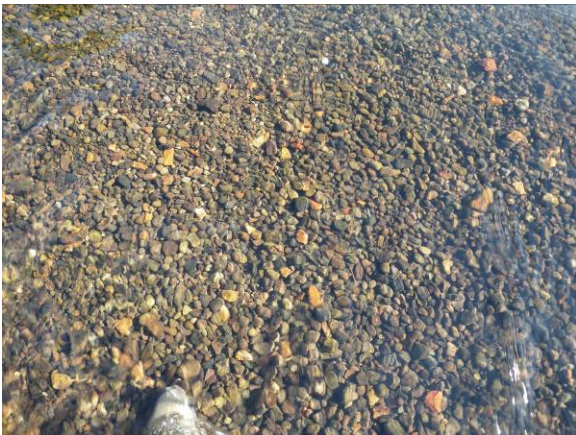
Figure A-6. Caples Creek at Caples Meadow, XS-3 (Lower): (a) looking upstream; (b) looking downstream; (c) looking at the left bank; (d) looking at the right bank; and (e) looking at the bed.
