MARCH 2012

# Geomorphic Monitoring of Representative Channel Areas for El Dorado Hydroelectric Project No. 184

Stillwater Sciences  
279 Cousteau Place, Suite 400  
Davis, CA 95618

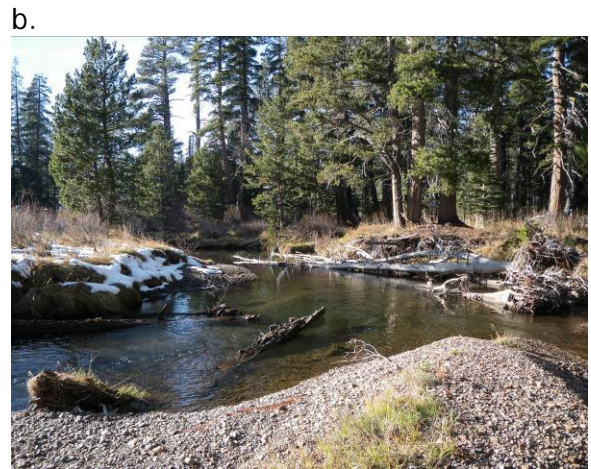
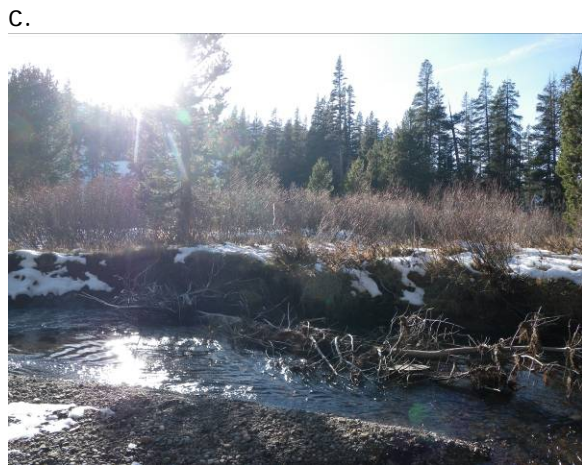
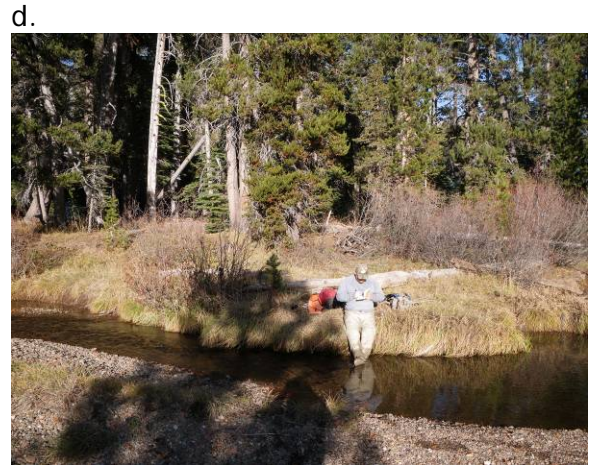
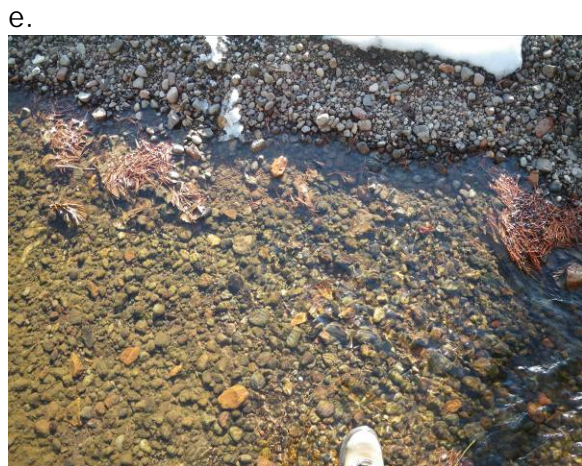
Figure A-7. Caples Creek at Girl Scout Access, XS-3 (Lower): (a) looking upstream; (b) looking downstream; (c) looking at the left bank; (d) looking at the right bank; and (e) looking at the bed.

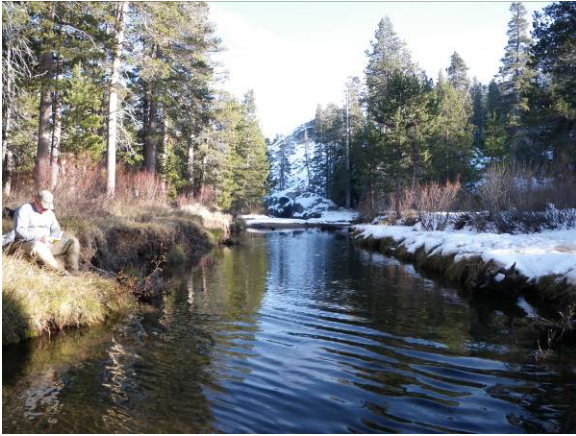
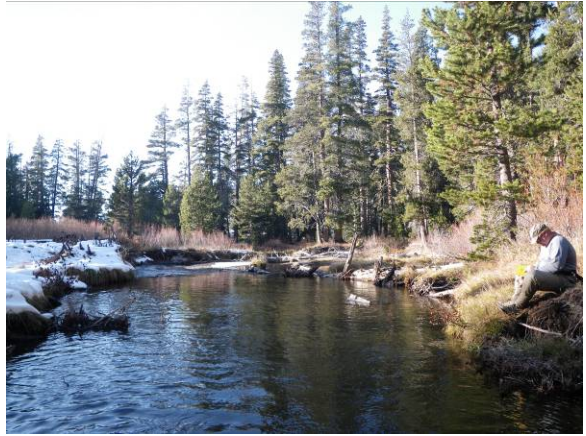
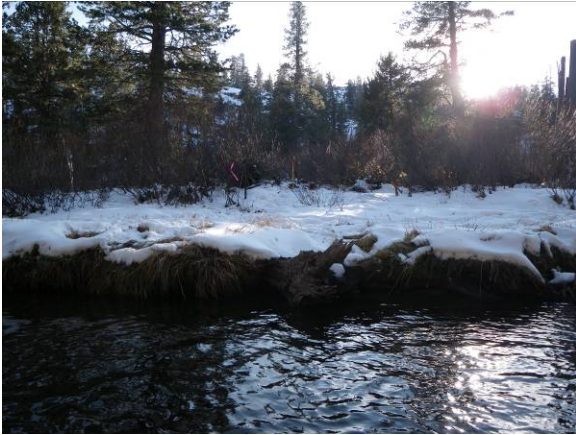
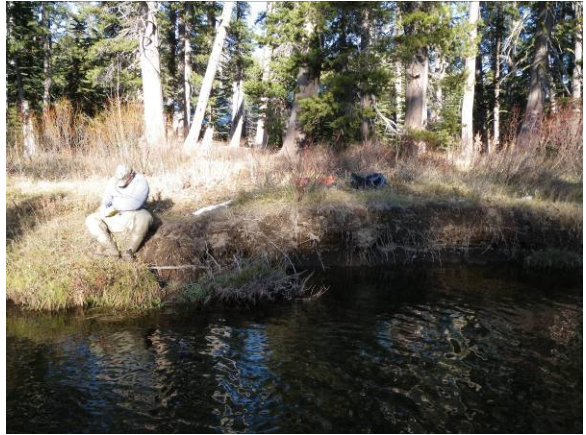
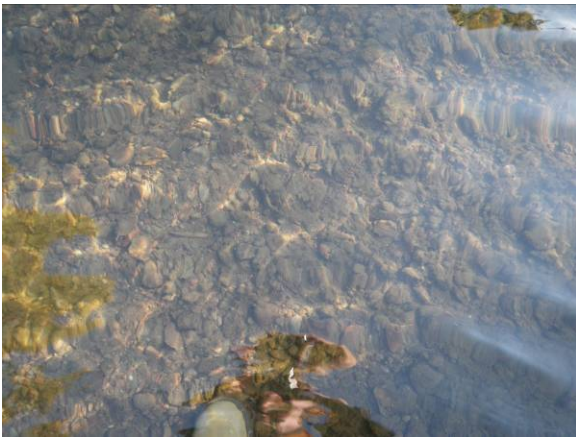
Figure A-8. Caples Creek at Girl Scout Access, XS-2 (Mid): (a) looking upstream; (b) looking downstream; (c) looking at the left bank; (d) looking at the right bank; and (e) looking at the bed.

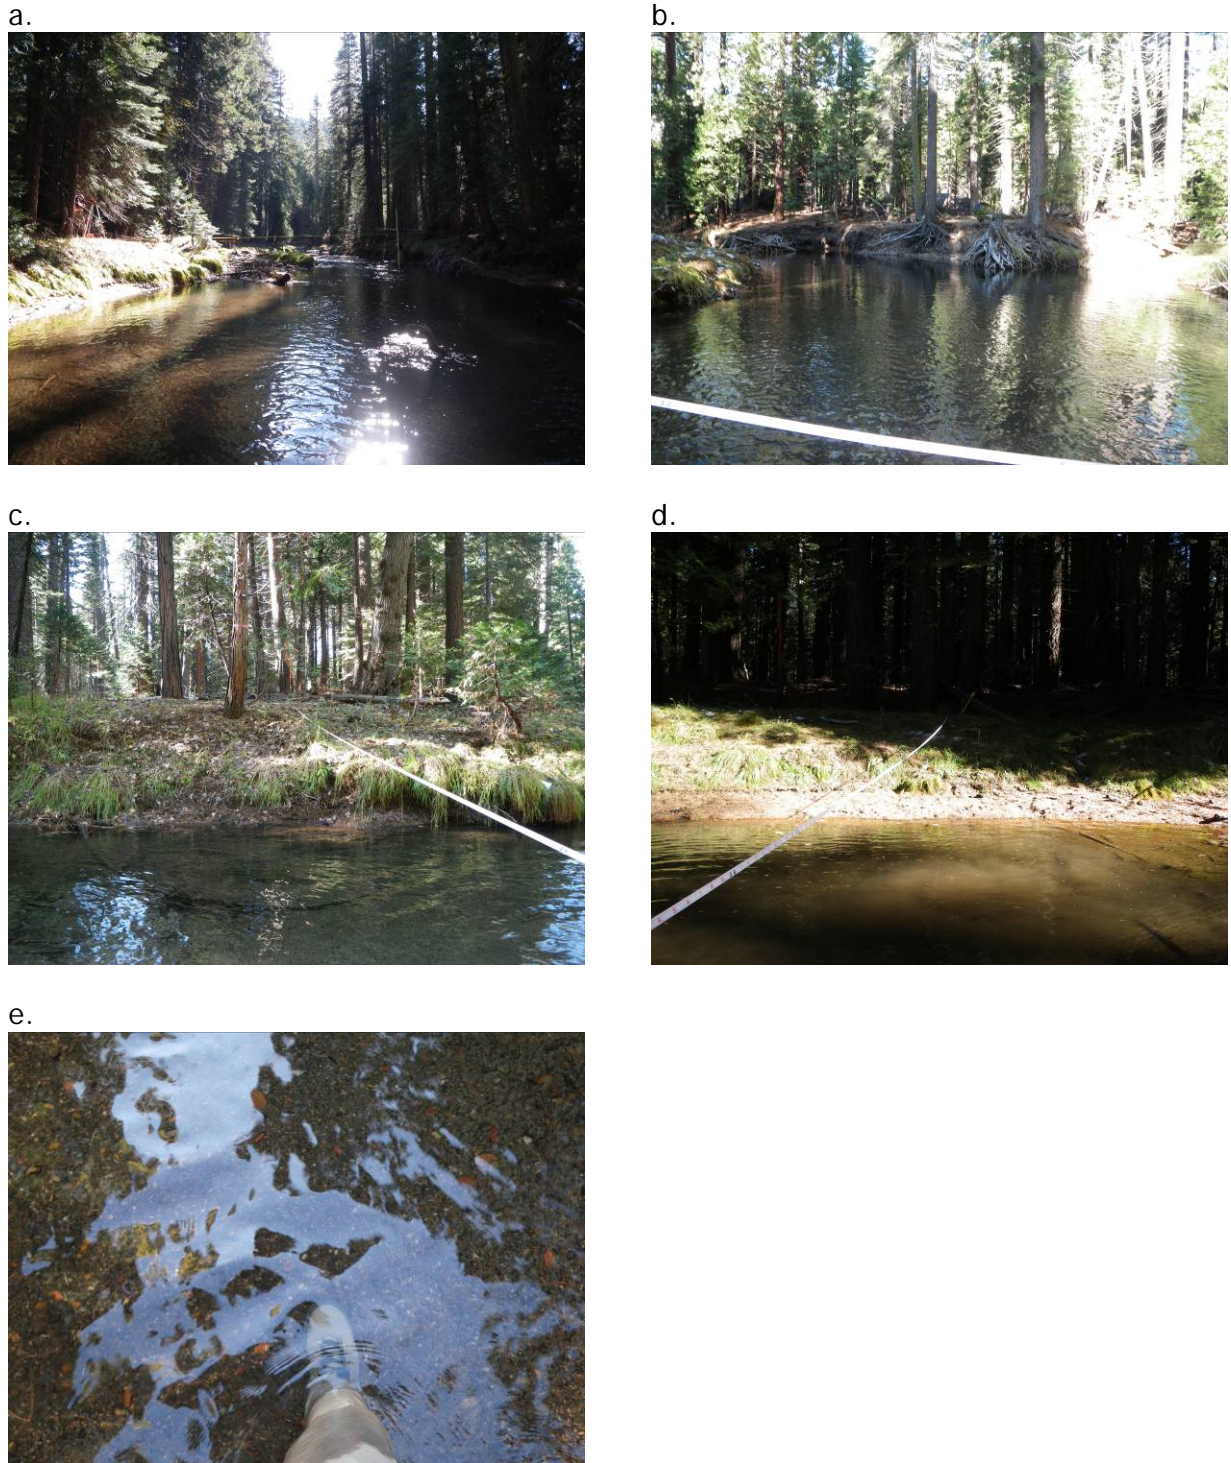
Figure A-11. Caples Creek at Jake Schneider Meadow, XS- C: (a) looking upstream; (b) looking downstream; (c) looking at the left bank; (d) looking at the right bank; and (e) looking at the bed.

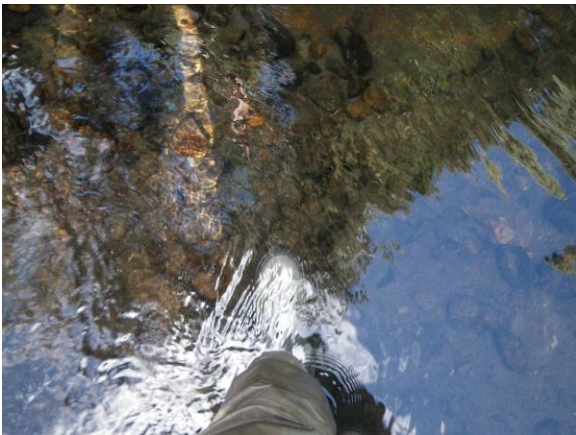
e.

Figure A-12. Caples Creek at Jake Schneider Meadow, XS-2: (a) looking upstream; (b) looking downstream; (c) looking at the left bank; (d) looking at the right bank; and (e) looking at the bed.

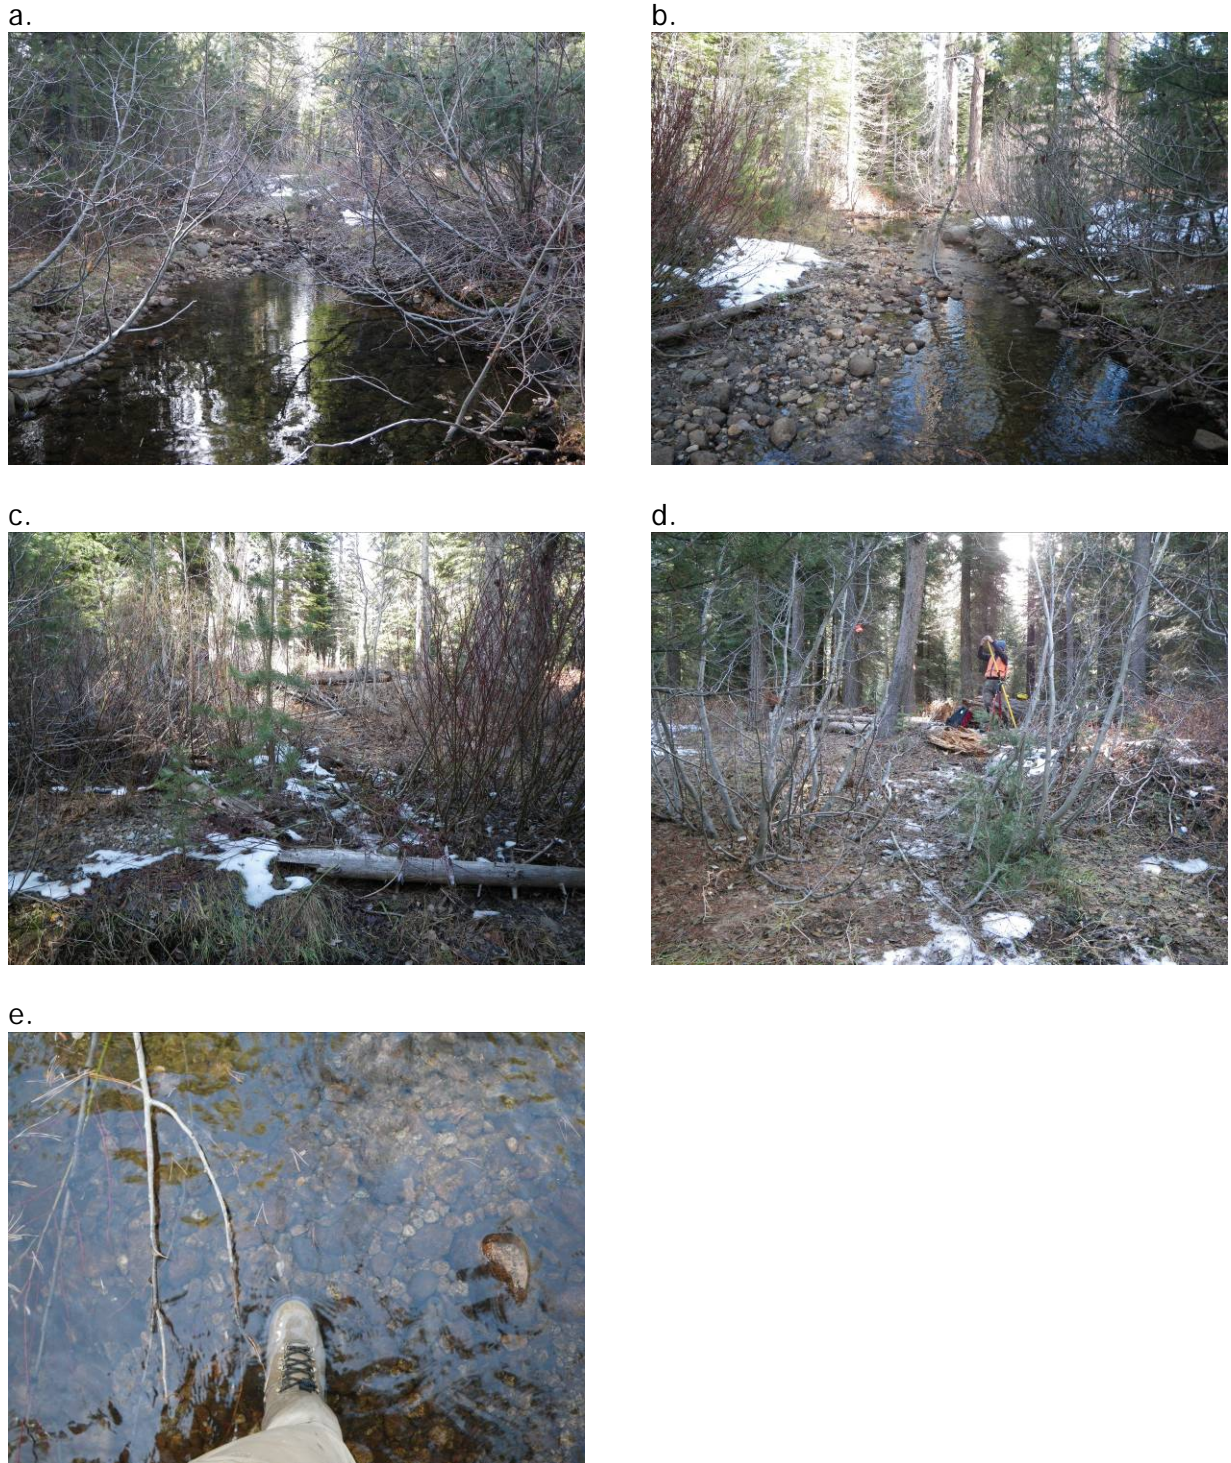
Figure A-13. Echo Creek, XS-1 at Left Channel: (a) looking upstream; (b) looking downstream; (c) looking at the left bank; (d) looking at the right bank; and (e) looking at the bed.

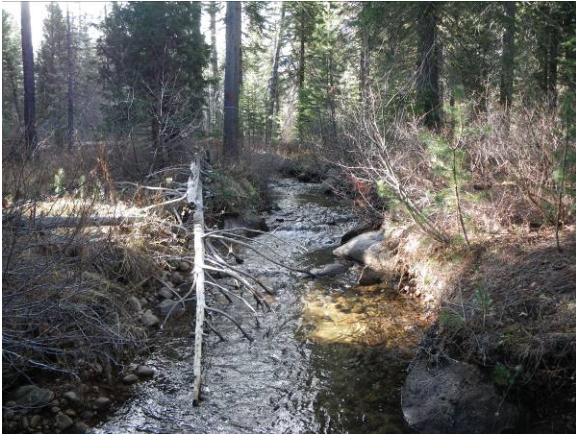
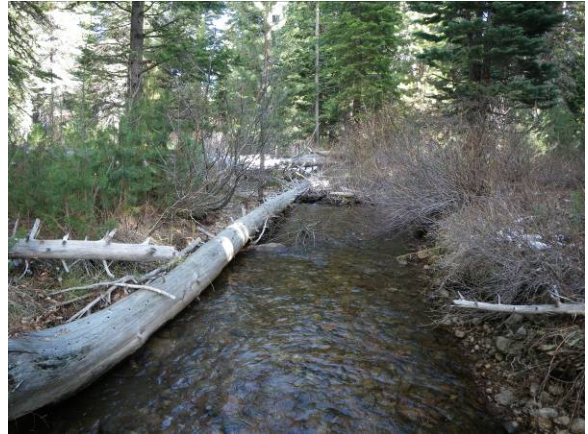
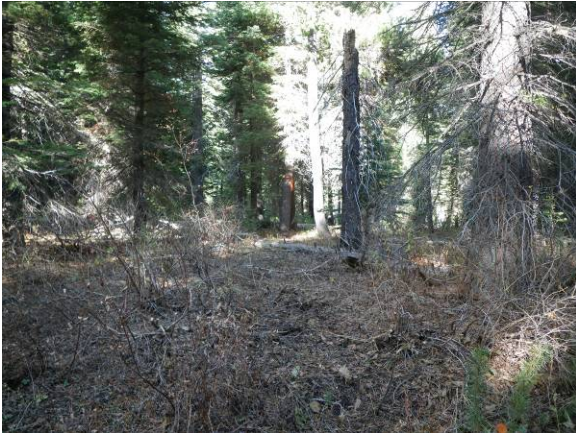
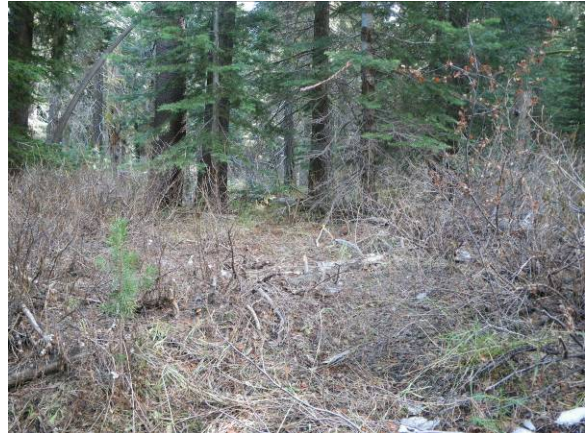
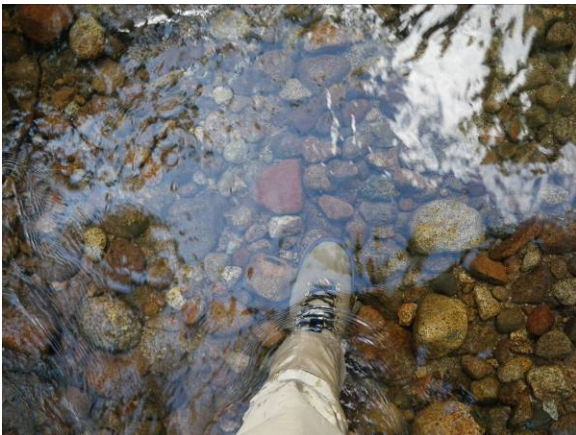
Figure A-14. Echo Creek, XS-1 at Right Channel: (a) looking upstream; (b) looking downstream; (c) looking at the left bank; (d) looking at the right bank; and (e) looking at the bed.

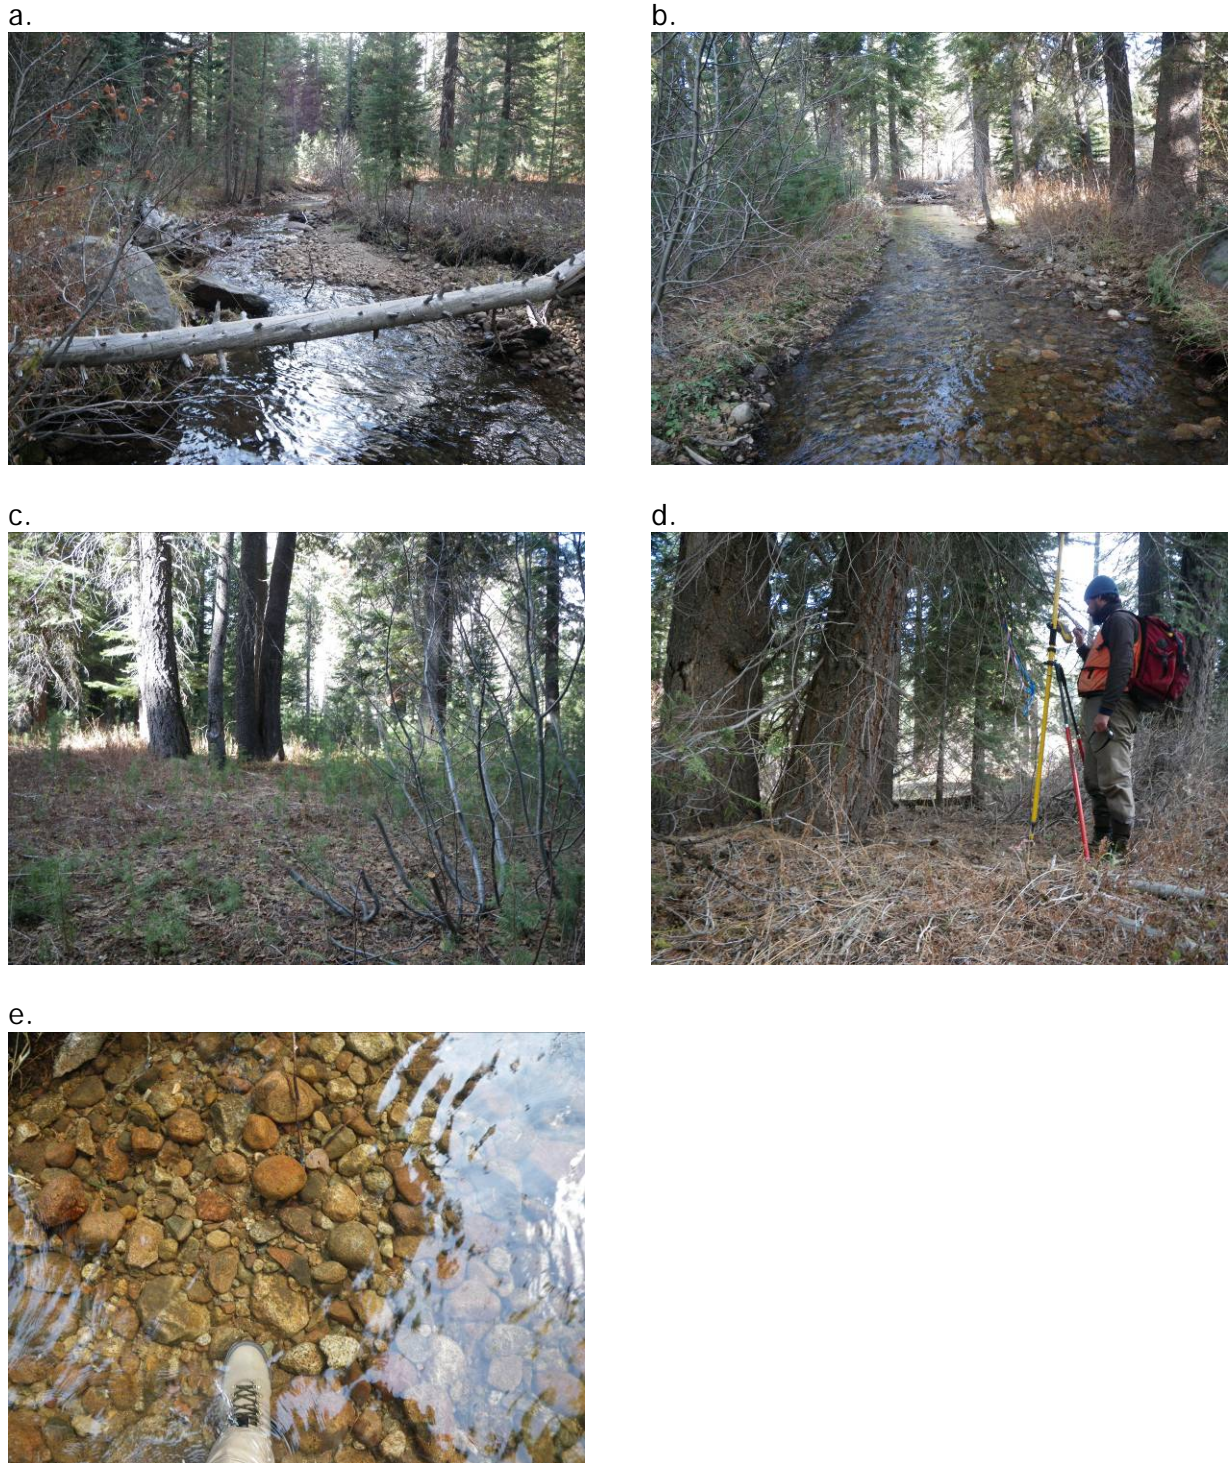
Figure A-15. Echo Creek, XS-2 at Right Channel: (a) looking upstream; (b) looking downstream; (c) looking at the left bank; (d) looking at the right bank; and (e) looking at the bed.

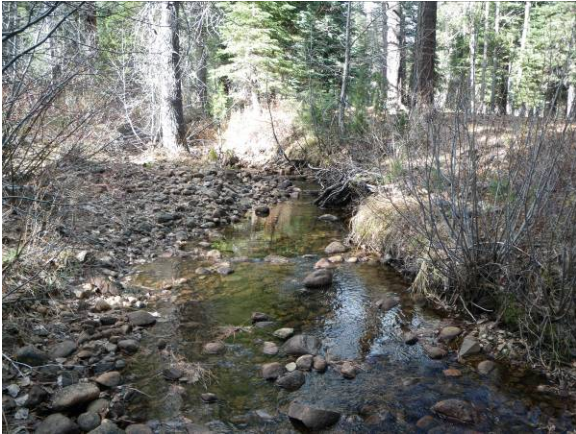
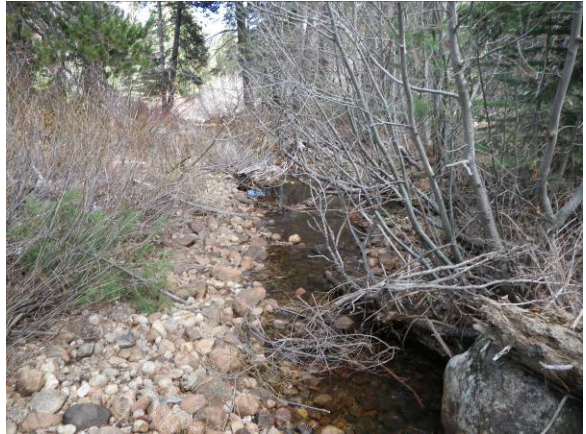
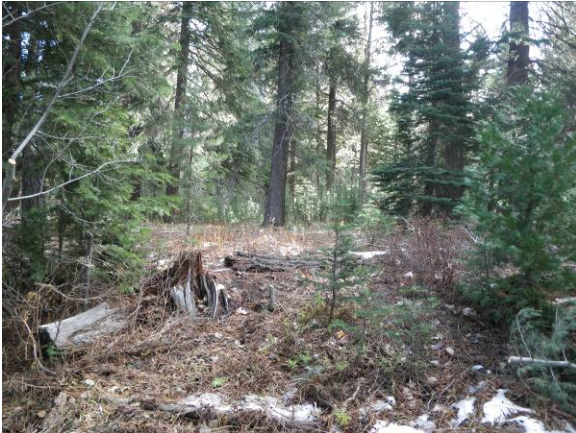
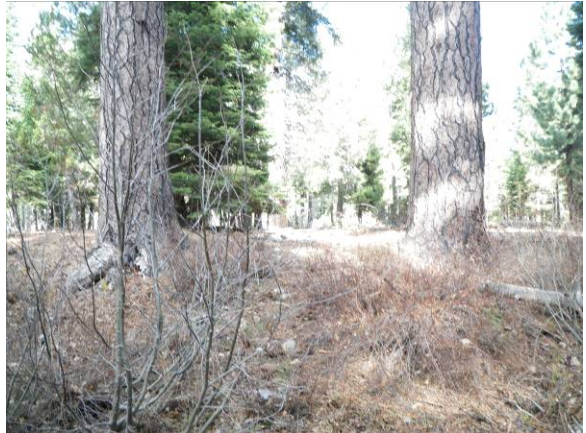
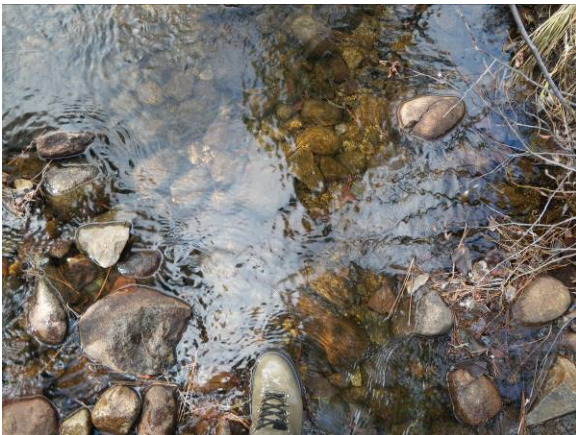
Figure A-16. Echo Creek, XS- 2 at Left Channel: (a) looking upstream; (b) looking downstream; (c) looking at the left bank; (d) looking at the right bank; and (e) looking at the bed.

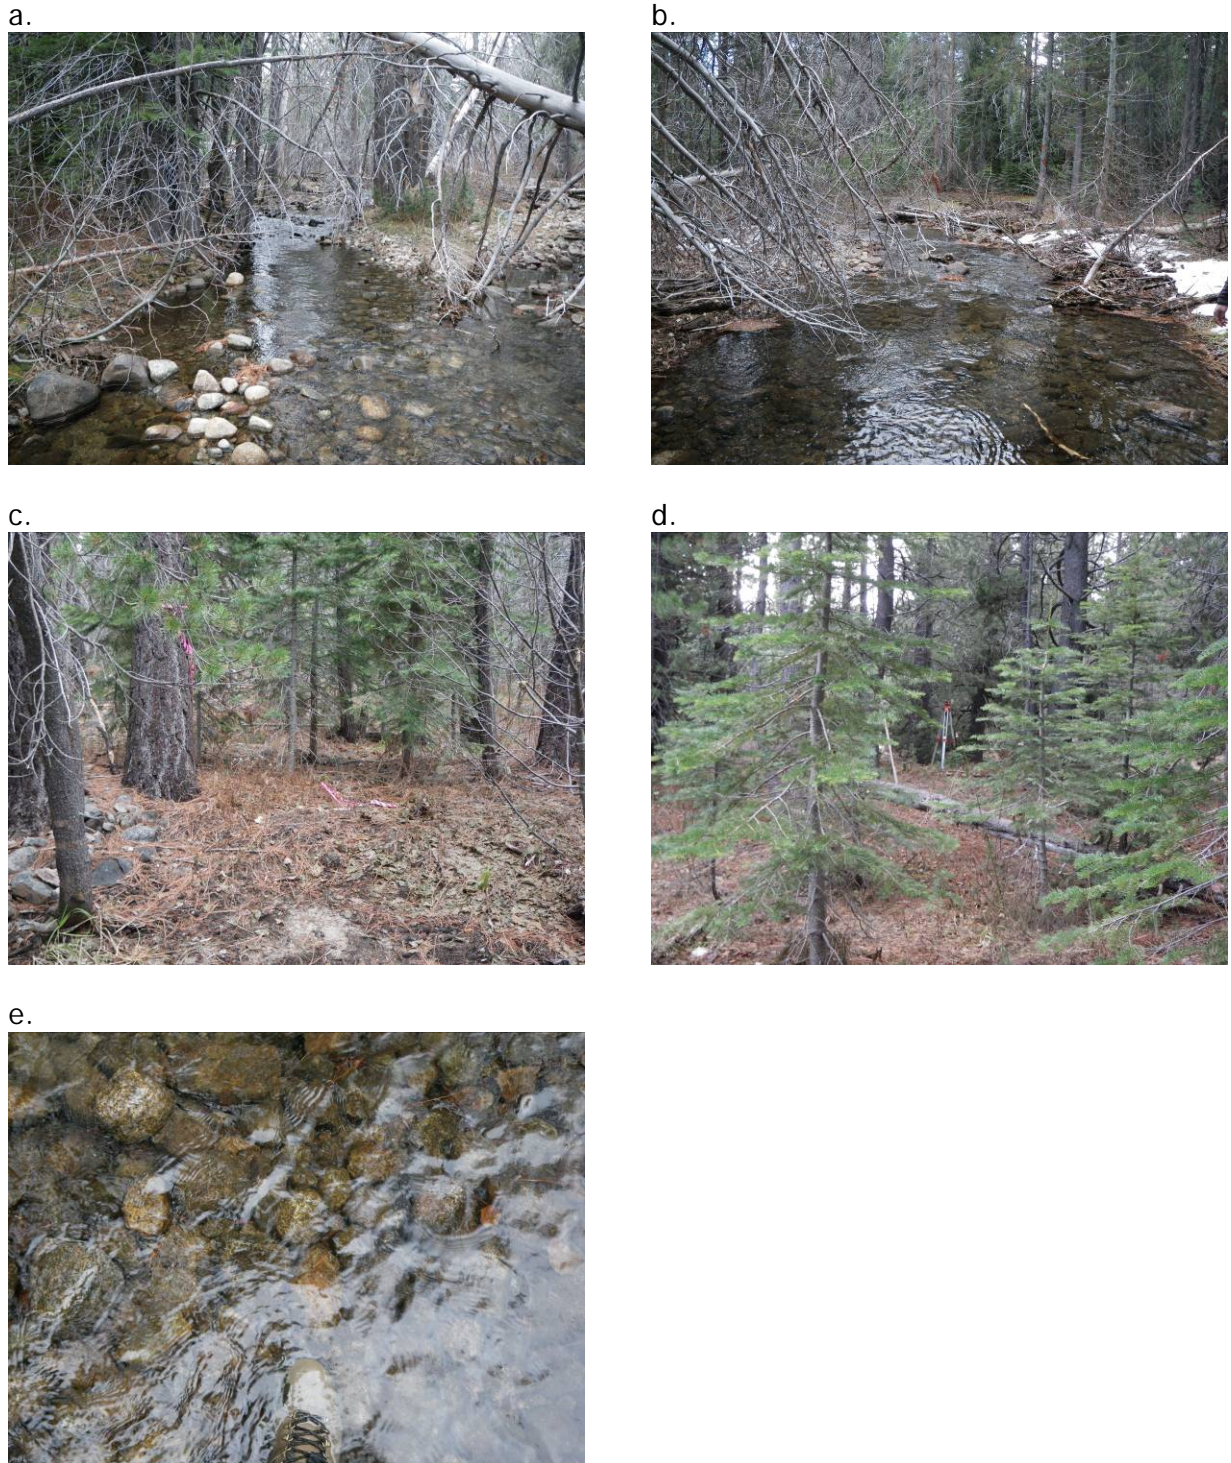
Figure A-17. Echo Creek, XS-0: (a) looking upstream; (b) looking downstream; (c) looking at the left bank; (d) looking at the right bank; and (e) looking at the bed.
