SEPTEMBER 2012

Geomorphic Monitoring of Representative Channel Areas

El Dorado Hydroelectric Project No. 184

Report Addendum

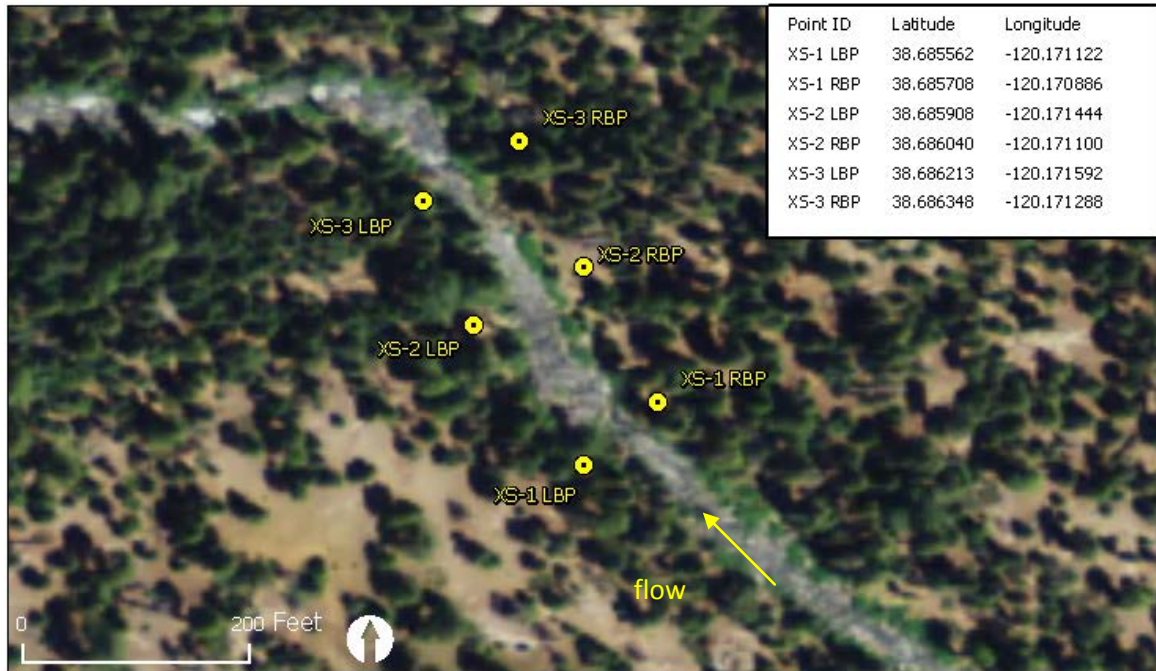
Figure 3-1. Site map of Forgotten Flat site showing cross-section endpoints and coordinates (in decimal degrees). LBP is left bank pin and RBP is right bank pin.

The Silver Fork American River at Forgotten Flat study site is an approximately 500 ft long reach located 3.5 miles downstream of Silver Lake (Figure 3-1). Approximately 70 percent of 22 mi² drainage area upstream of the study site is regulated by Silver Lake (Cardno Entrix 2002). The channel bed through Forgotten Flat has a coarse-grained boulder framework and a plane bed morphology with a moderately steep reach average gradient.

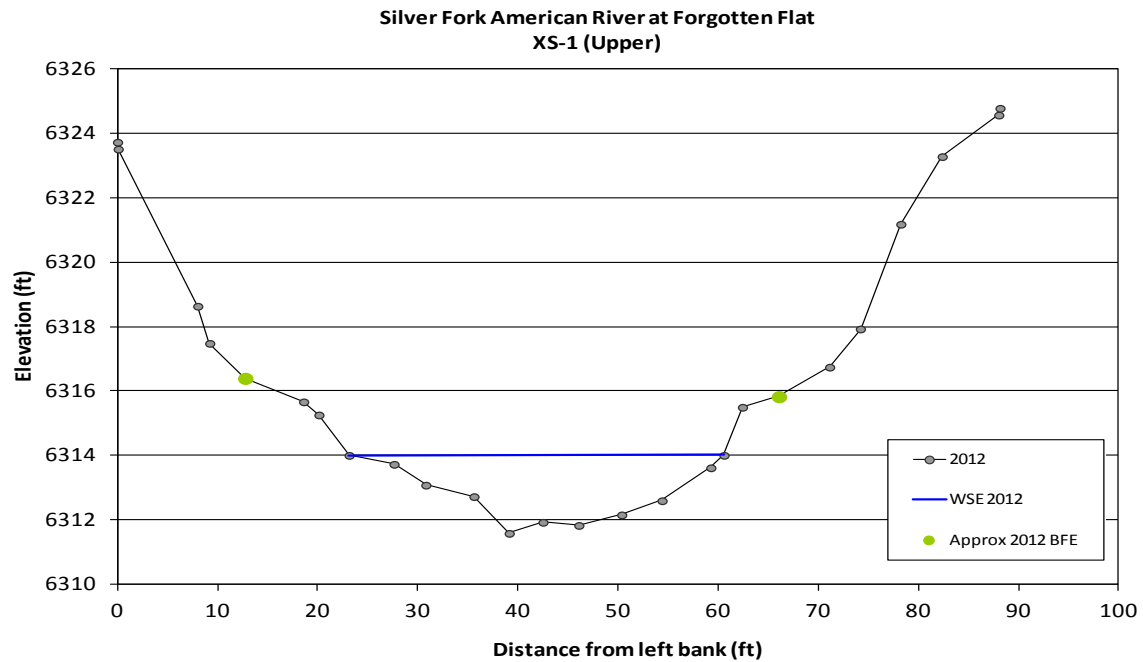
Figure 3-2. Silver Fork American River at Forgotten Flat XS-1 survey data. Elevation is an approximation of NAVD88 based on GPS survey. Legend abbreviations: WSE = water surface elevation; BFE = bankfull elevation.

The Silver Fork American River at Forgotten Flat study site cross-sections for 2012 are shown in Figures 3-2 through 3-4. The compilation of cross-section photos for this site is provided in Appendix A. An exhaustive search was conducted in the 2011 and 2012 field campaigns to relocate historical cross-sections in the field, but to no avail. Therefore, three new monitoring cross-sections were established and their locations documented. The channel appears to be stable at all three cross-section locations. Fine sediment deposits predominately occur as lee and obstruction deposits associated with large framework boulders.

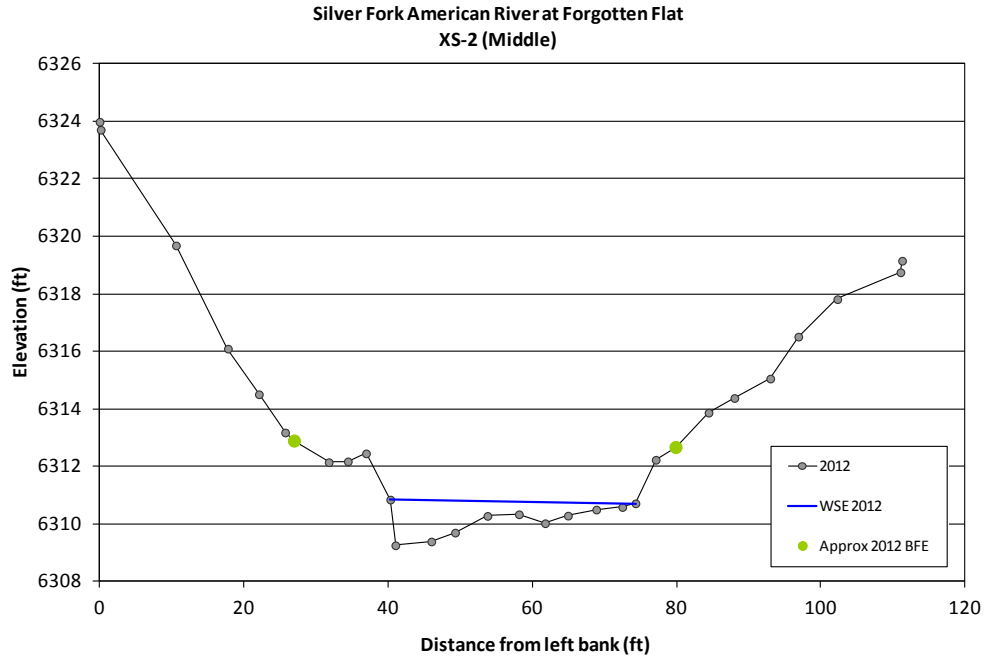
Figure 3-3. Silver Fork American River at Forgotten Flat XS-2 survey data. Elevation is an approximation of NAVD88 based on GPS survey. Legend abbreviations: WSE = water surface elevation; BFE = bankfull elevation.

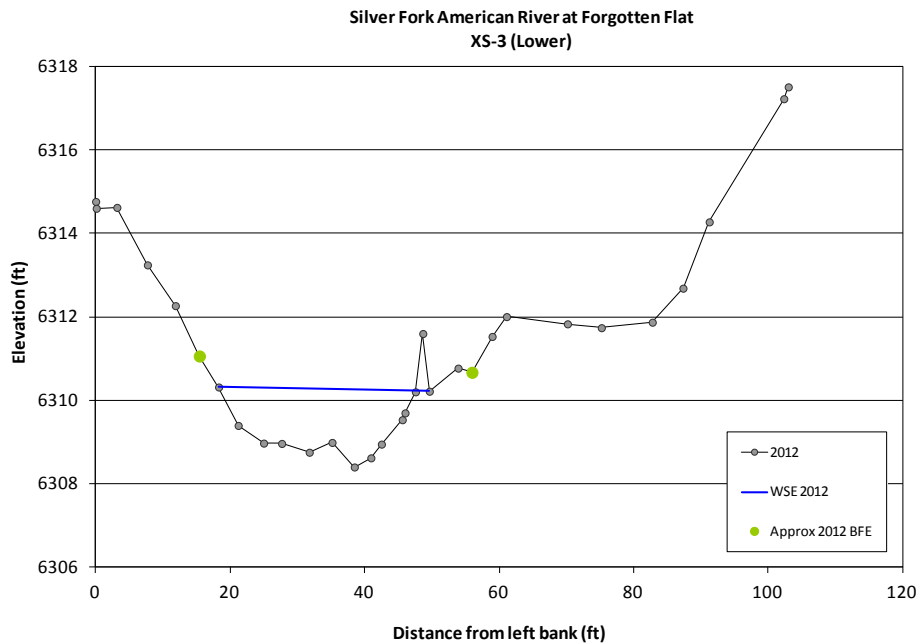
Figure 3-4. Silver Fork American River at Forgotten Flat XS-3 survey data. Elevation is an approximation of NAVD88 based on GPS survey. Legend abbreviations: WSE = water surface elevation; BFE = bankfull elevation.

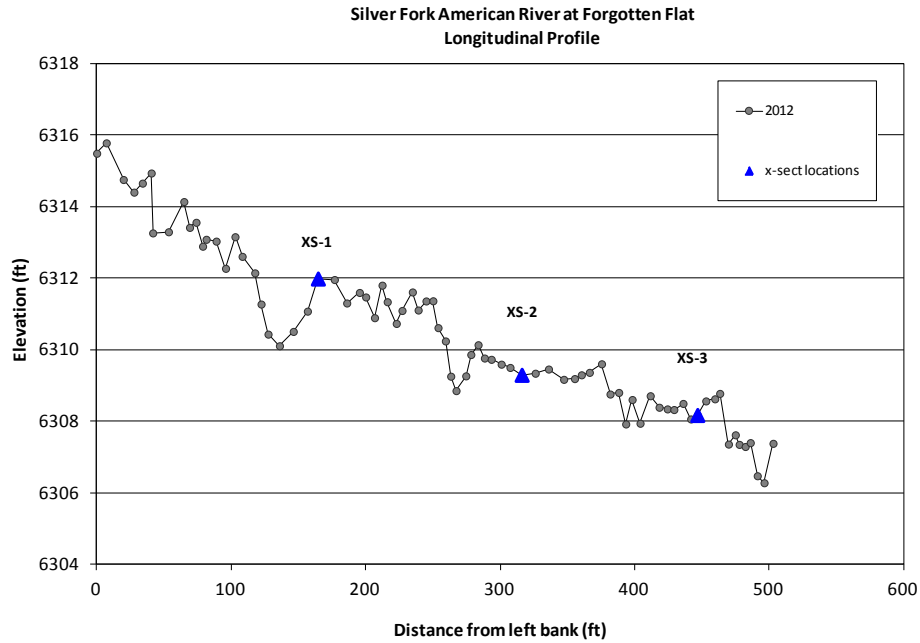
Figure 3-5. Silver Fork American River at Forgotten Flat longitudinal profile survey data. Elevation is an approximation of NAVD88 based on GPS survey. Legend abbreviations: WSE = water surface elevation; BFE = bankfull elevation.

The Silver Fork American River at Forgotten Flat longitudinal profile for 2012 is shown in Figure 3-5. The 2012 profile is approximately 10 bankfull widths in length (~500 ft) and extends approximately 165 ft upstream of XS-1 and approximately 55 ft downstream of XS-3, and has a reach-average slope of 0.0157. As historical longitudinal profile data for this site were not available, an assessment of longitudinal profile change was not conducted.

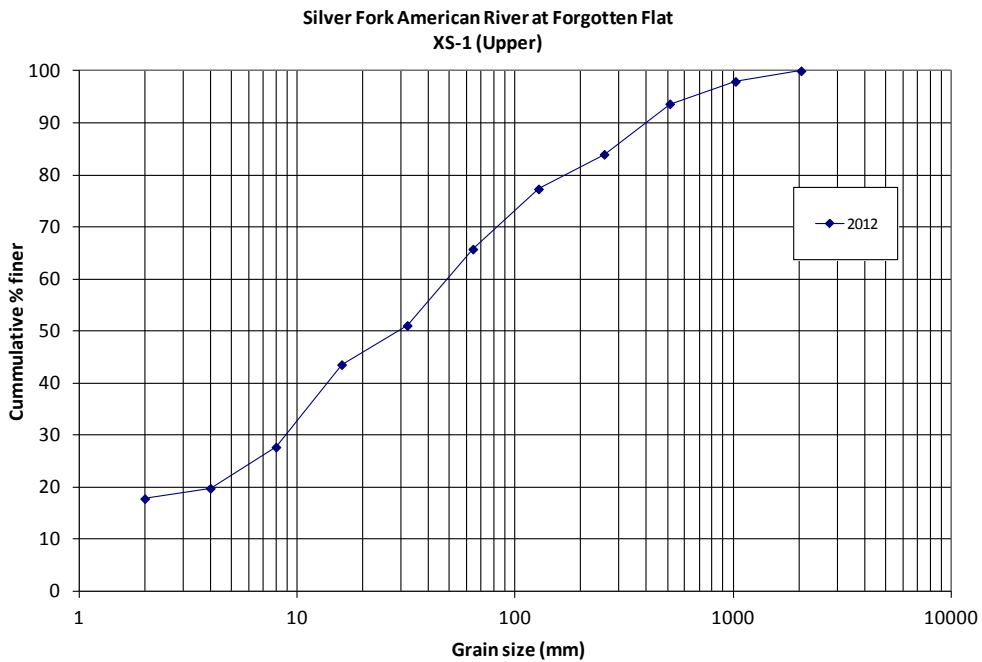
Figure 3-6. Silver Fork American River at Forgotten Flat XS-1 bed particle size distribution.

The Silver Fork American River at Forgotten Flat study site bed particle size distribution data for 2012 are shown in Figures 3-6 to 3-8 and representative sizes are shown in Table 3-1. The compilation of bed sediment photos for each cross-section surveyed at this site is provided in Appendix A. The 2012 data show that the bed particle size distribution is predominantly coarse gravel and larger (> 32 mm) with the median particle size at all cross-sections being coarse to very coarse gravel (between 25 and 52 mm). There are also large sand deposits along channel margins and filling interstitial void spaces between large coarse grains. The bed sediment lithology is predominantly granitic and meta-volcanic.

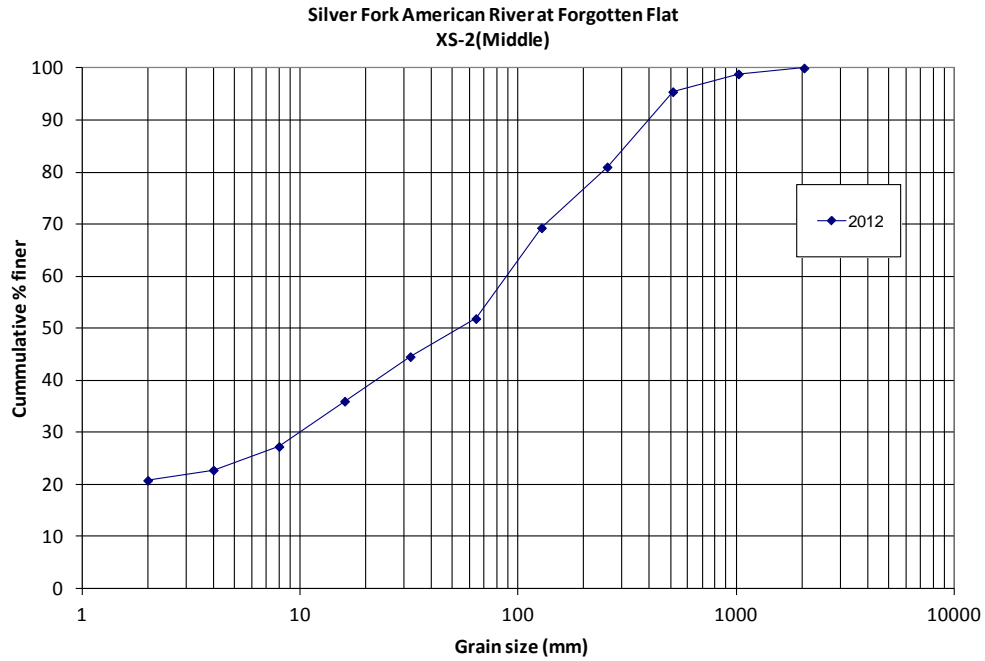
Figure 3-7. Silver Fork American River at Forgotten Flat XS-2 bed particle size distribution.

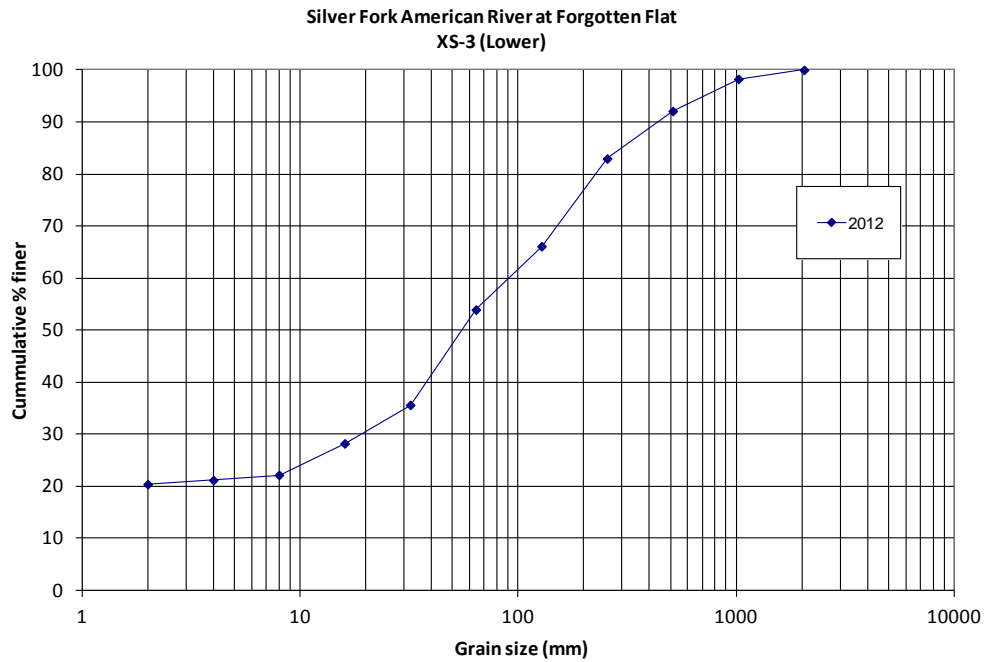
Figure 3-8. Silver Fork American River at Forgotten Flat XS-3 bed particle size distribution.

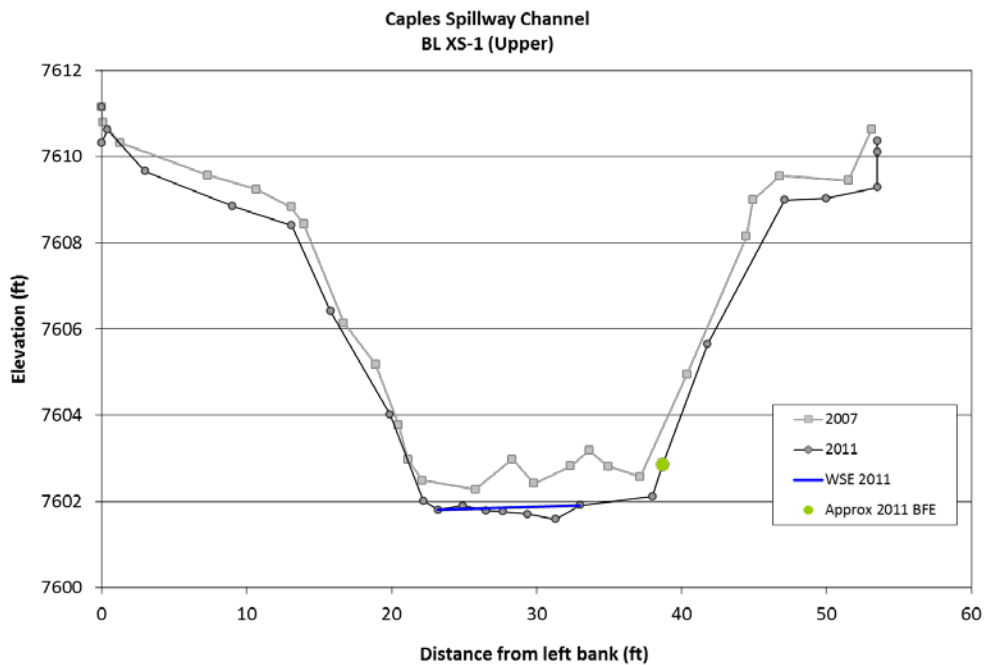
Figure 3-10. Caples Spillway Channel BL XS-1 survey data. Elevation is shown relative to the datum used for the 2007 survey (see Cardno Entrix 2011). Legend abbreviations: WSE = water surface elevation; BFE = bankfull elevation.

The Caples Spillway Channel study site cross-sections for 2007 and 2011 are shown in Figures 3-10 to 3-12 and change metrics are summarized in Table 3-3. The compilation of cross-section photos for this site is provided in Appendix A. At this site, three cross-sections surveyed in 2007 were re-occupied. The channel bed at the upper cross-section (BL XS-1) shows moderate channel incision (i.e., negative net percent change in channel area) over the past 5 years, and a moderate amount of absolute percent change. This indicates that the entire bed essentially incised in a uniform fashion across the width of the cross-section, which is also evident from the cross-section comparison plot (Figure 3-10). The middle cross-section (BL XS-2) shows very little change between 2007 and 2011 (i.e., the net percent change and absolute percent change are around 5%). The lower cross-section (BL XS-3) left bank pin was previously installed in the base of a tree that had fallen over between 2007 and 2011, which introduces some uncertainty when comparing the 2007 and 2011 survey data. However, comparison of 2007 and 2011 data for BL XS-3 show a moderate negative net percent change and moderate absolute percent change. Comparison of the 2007 and 2011 cross-section plots at BL XS-3 shows minor bank retreat on the left bank and slight incision and bank retreat from the thalweg and across the entire right bank.

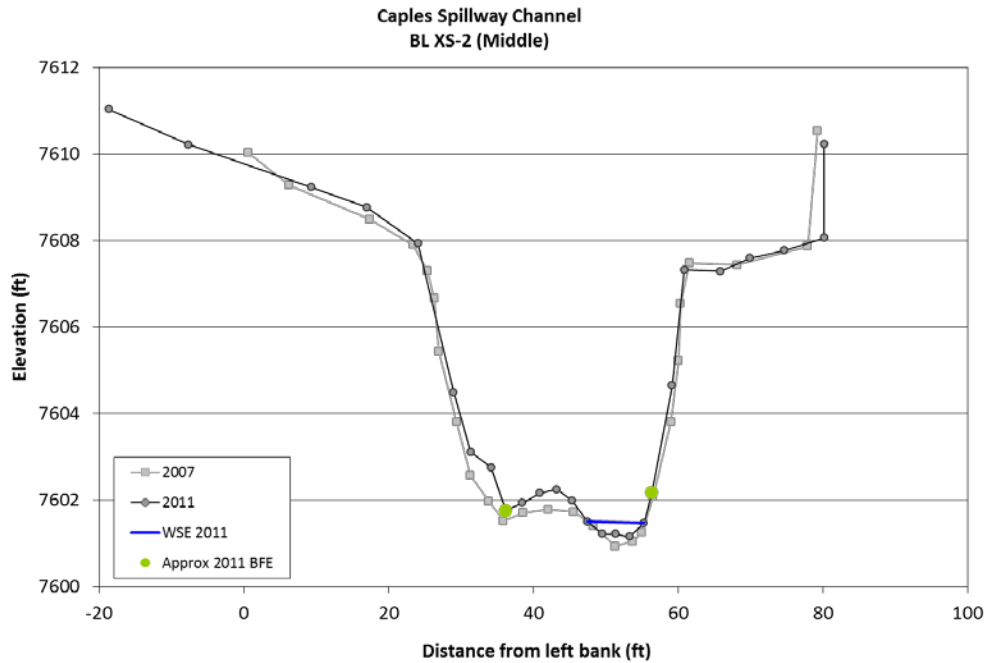
Figure 3-11. Caples Spillway Channel BL XS-2 survey data. Elevation is shown relative to the datum used for the 2007 survey (see Cardno Entrix 2011). Legend abbreviations: WSE = water surface elevation; BFE = bankfull elevation.

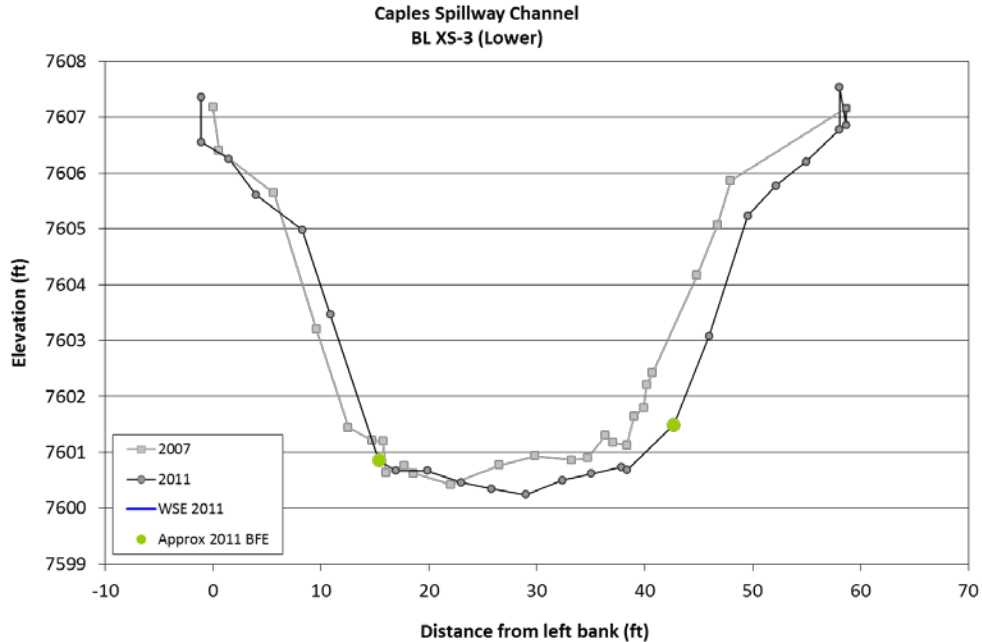
Figure 3-12. Caples Spillway Channel BL XS-3 survey data. Elevation is shown relative to the datum used for the 2007 survey (see Cardno Entrix 2011). Legend abbreviations: WSE = water surface elevation; BFE = bankfull elevation.

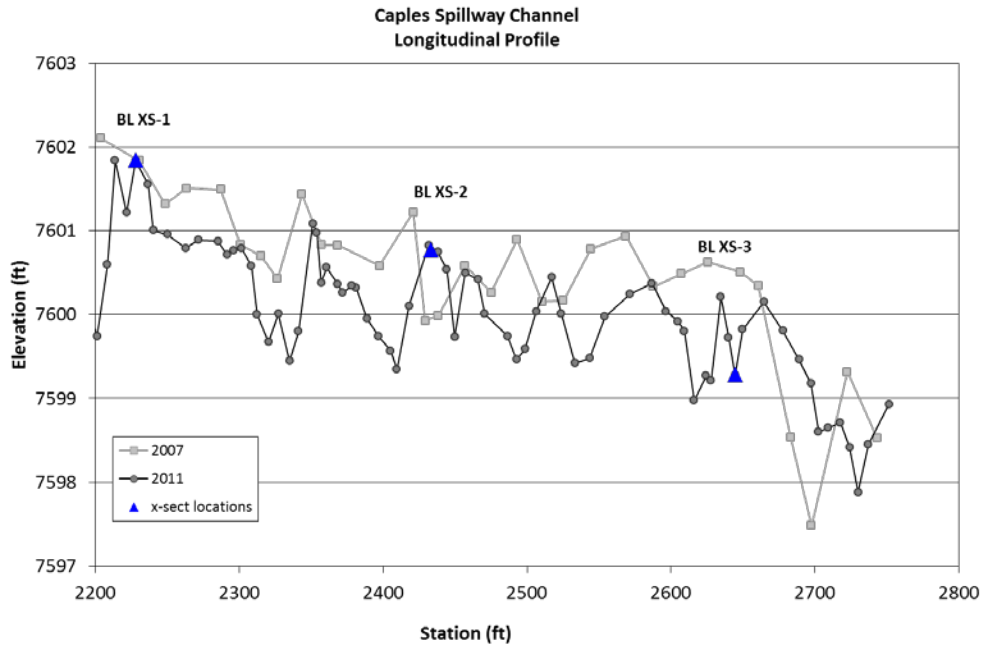
Figure 3-13. Caples Spillway Channel longitudinal profile data. Elevation is shown relative to a datum established for the 2007 survey. Legend abbreviations: WSE = water surface elevation.

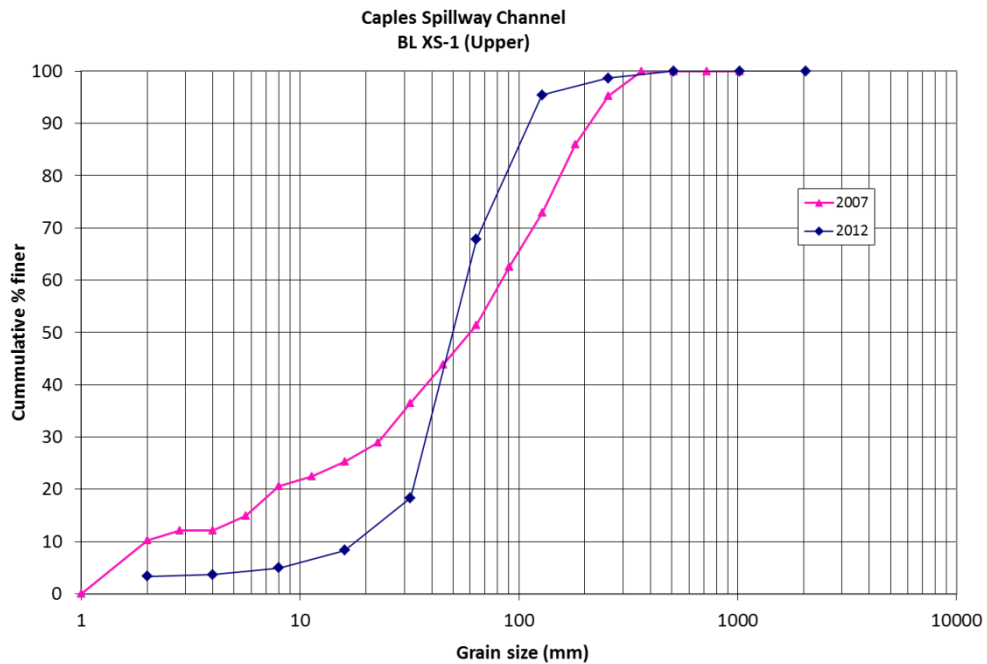
Figure 3-14. Caples Spillway Channel BL XS-1 bed particle size distribution.

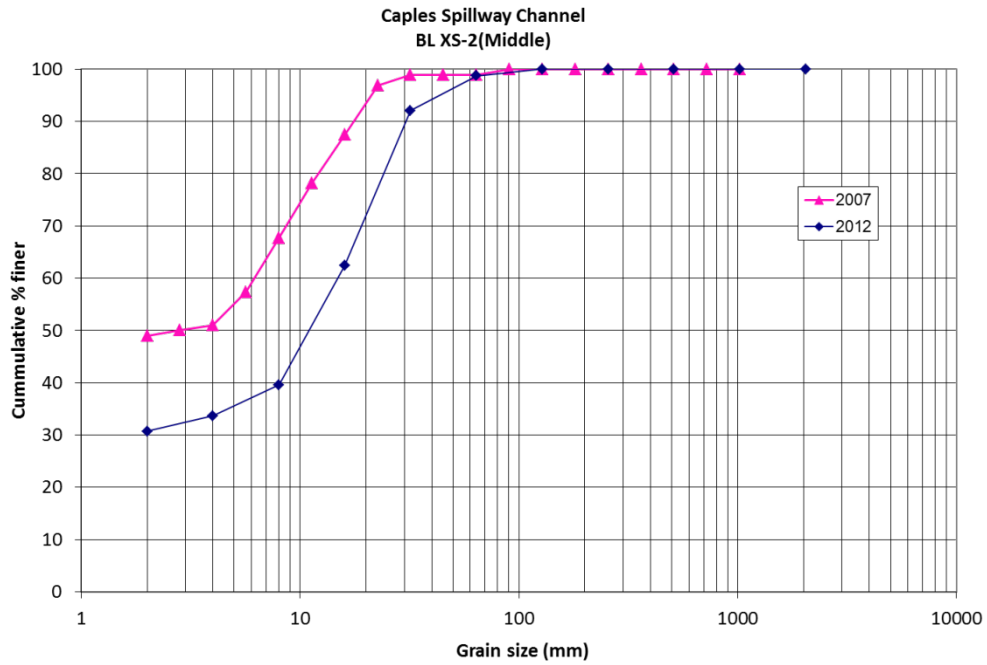
Figure 3-15. Caples Spillway Channel BL XS-2 bed particle size distribution.

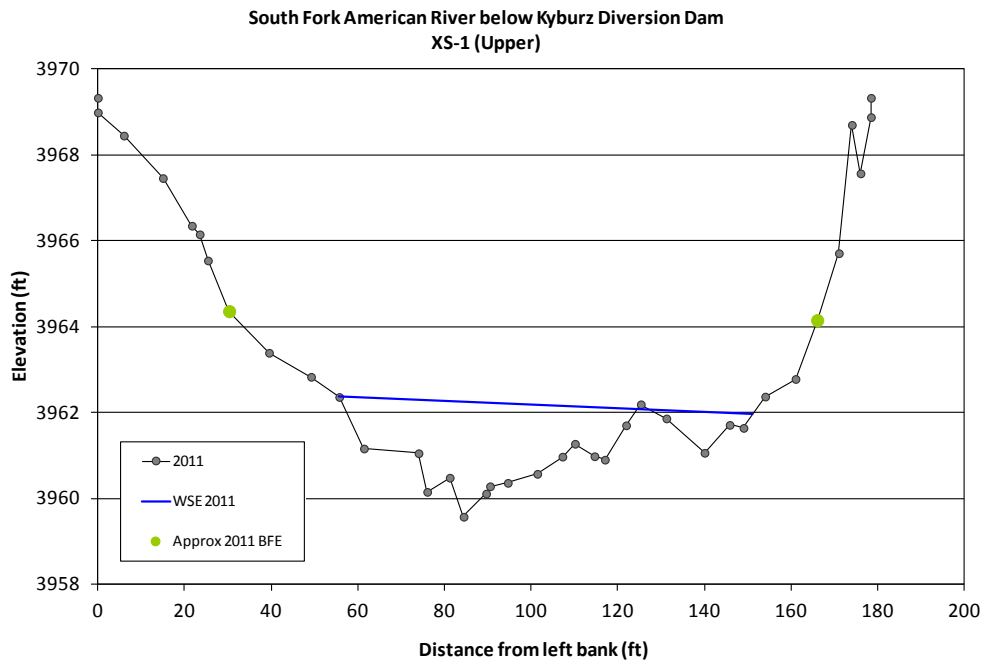
Figure 3-18. South Fork American River below Kyburz Diversion Dam XS-1 survey data. Elevation is an approximation of NAVD88 based on GPS survey. Legend abbreviations: WSE = water surface elevation; BFE = bankfull elevation.

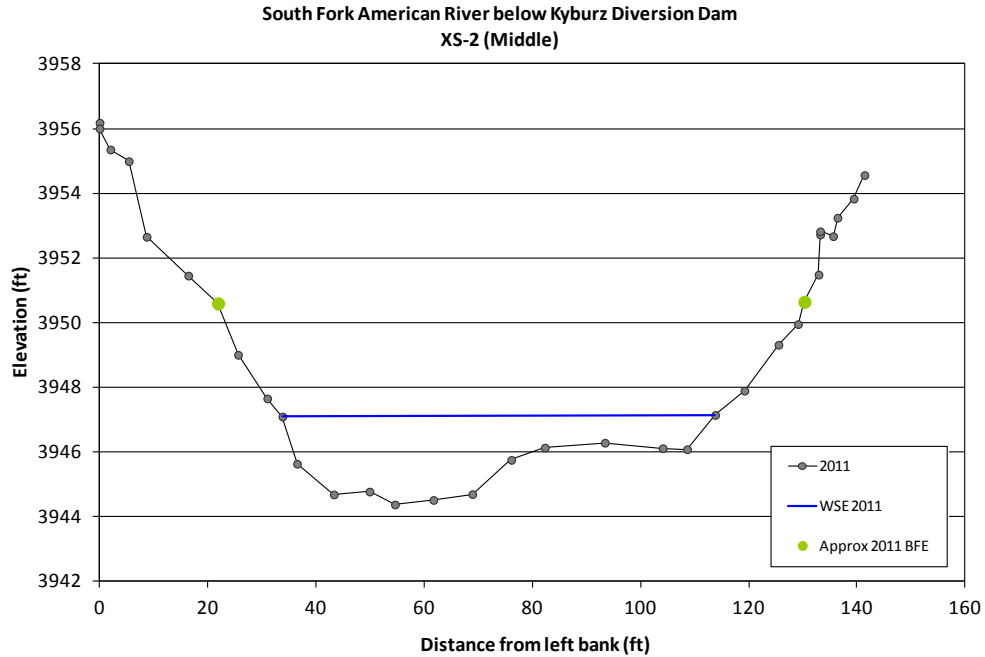
Figure 3-19. South Fork American River below Kyburz Diversion Dam XS-2 survey data. Elevation is an approximation of NAVD88 based on GPS survey. Legend abbreviations: WSE = water surface elevation; BFE = bankfull elevation.

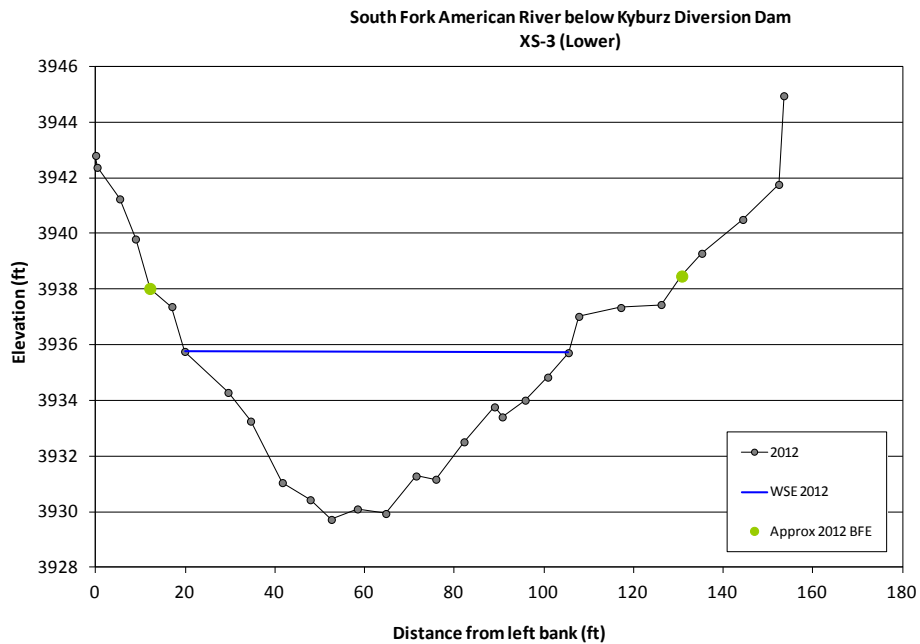
Figure 3-20. South Fork American River below Kyburz Diversion Dam XS-3 survey data. Elevation is an approximation of NAVD88 based on GPS survey. Legend abbreviations: WSE = water surface elevation; BFE = bankfull elevation.

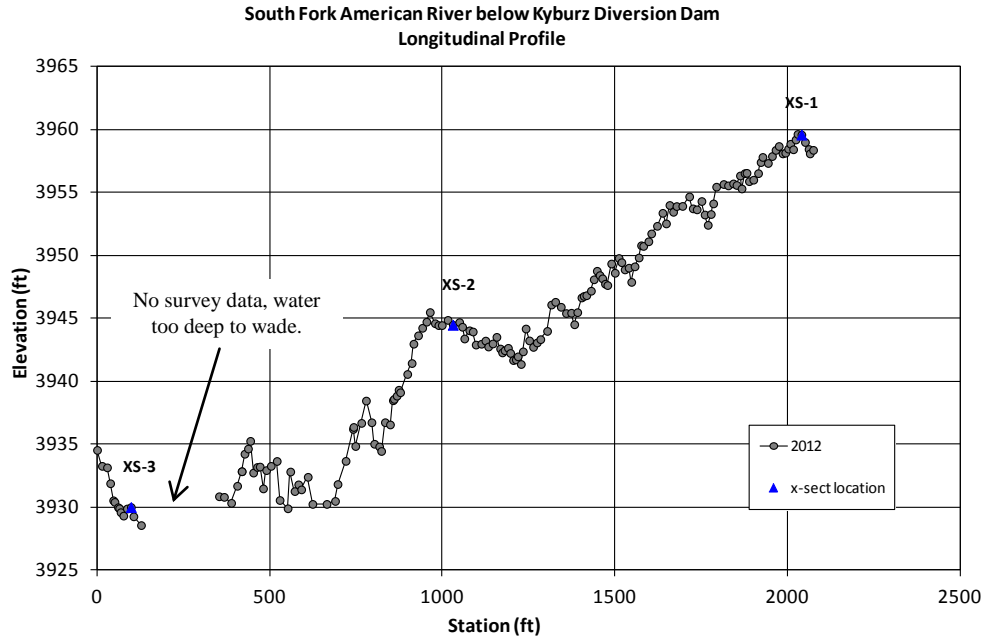
Figure 3-21. South Fork American River below Kyburz Diversion Dam longitudinal profile survey data. Elevation is an approximation of NAVD88 based on GPS survey.

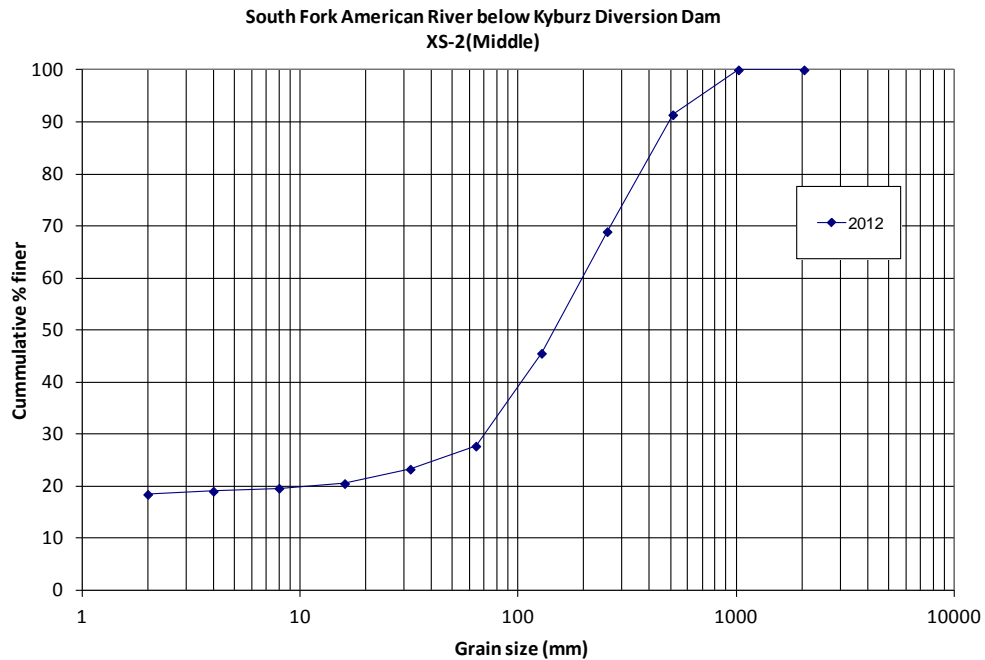
Figure 3-22. South Fork American River below Kyburz Diversion Dam XS-2 bed particle size distribution.

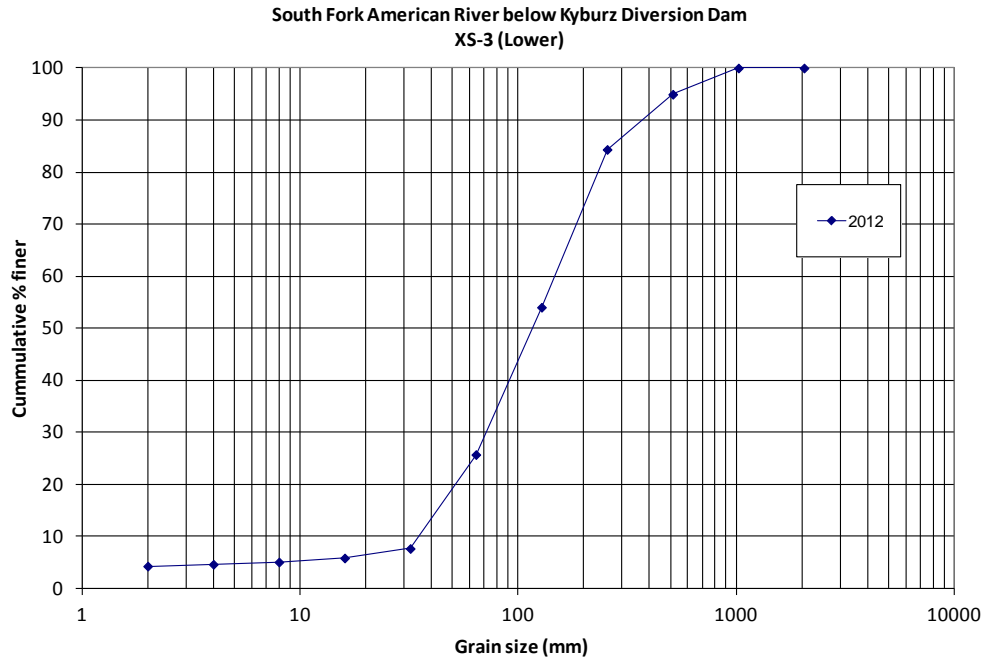
Figure 3-23. South Fork American River below Kyburz Diversion Dam XS-3 bed particle size distribution.

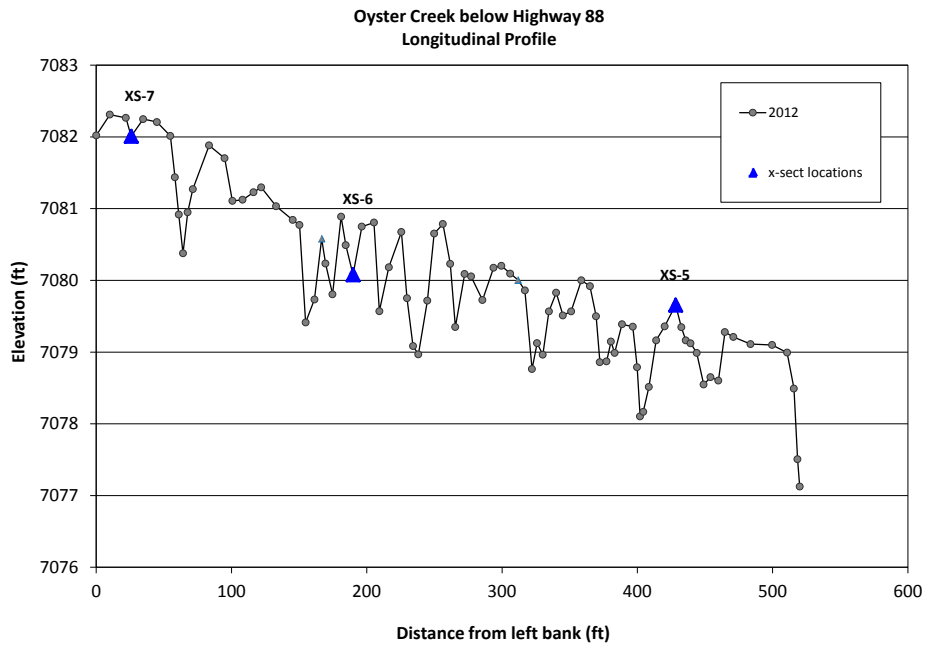
Figure 3-25. Oyster Creek below Highway 88 XS-5 longitudinal profile survey data. Elevation is shown relative to the datum used for the 2007 survey (see Blue Line Consulting 2009).

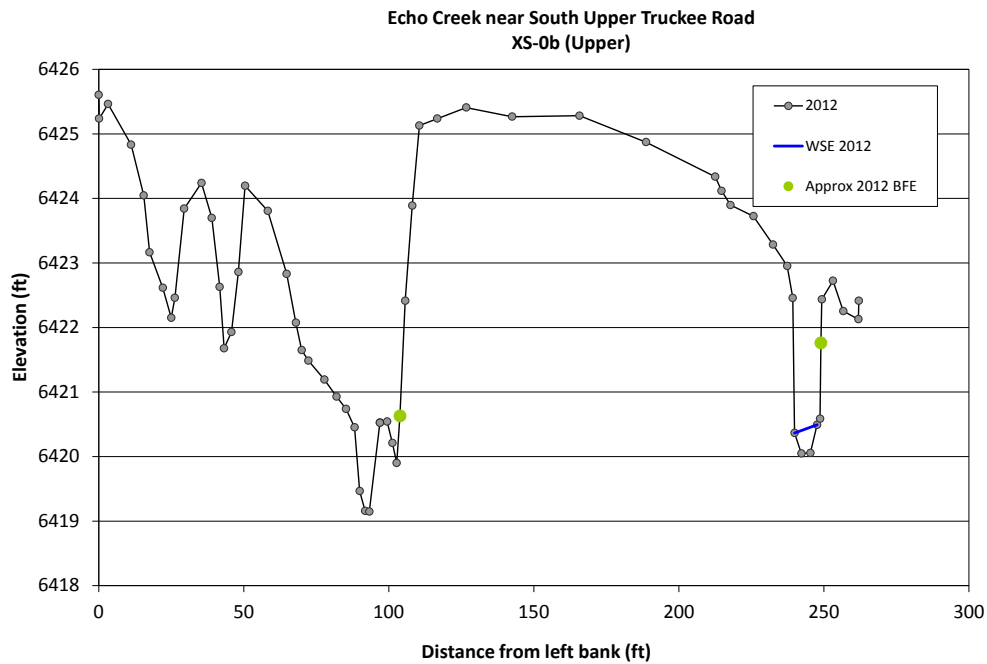
Figure 3-27. Lower Echo Creek XS-0b survey data. Elevation is an approximation of NAVD88 based on GPS survey. Legend abbreviations: WSE = water surface elevation; BFE = bankfull elevation.

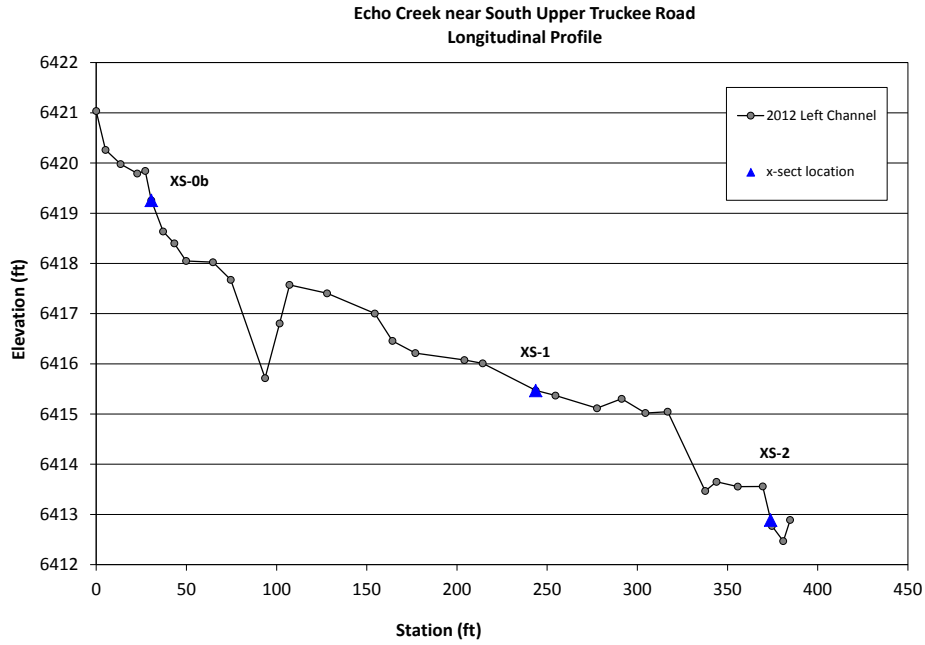
Figure 3-28. Lower Echo Creek left channel longitudinal profile survey data. Elevation is an approximation of NAVD88 based on GPS survey.

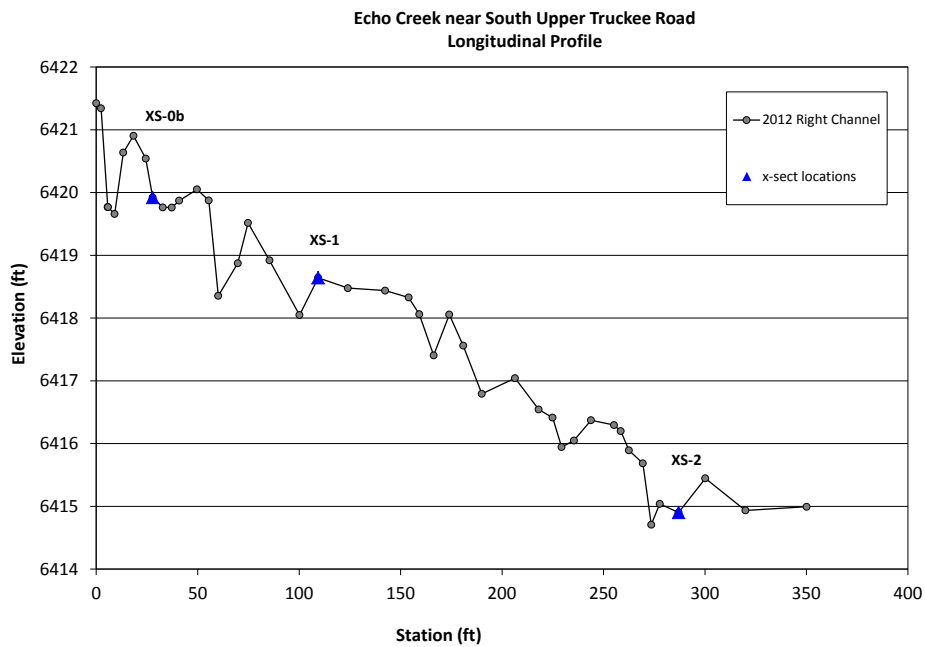
Figure 3-29. Lower Echo Creek right channel longitudinal profile survey data. Elevation is an approximation of NAVD88 based on GPS survey.

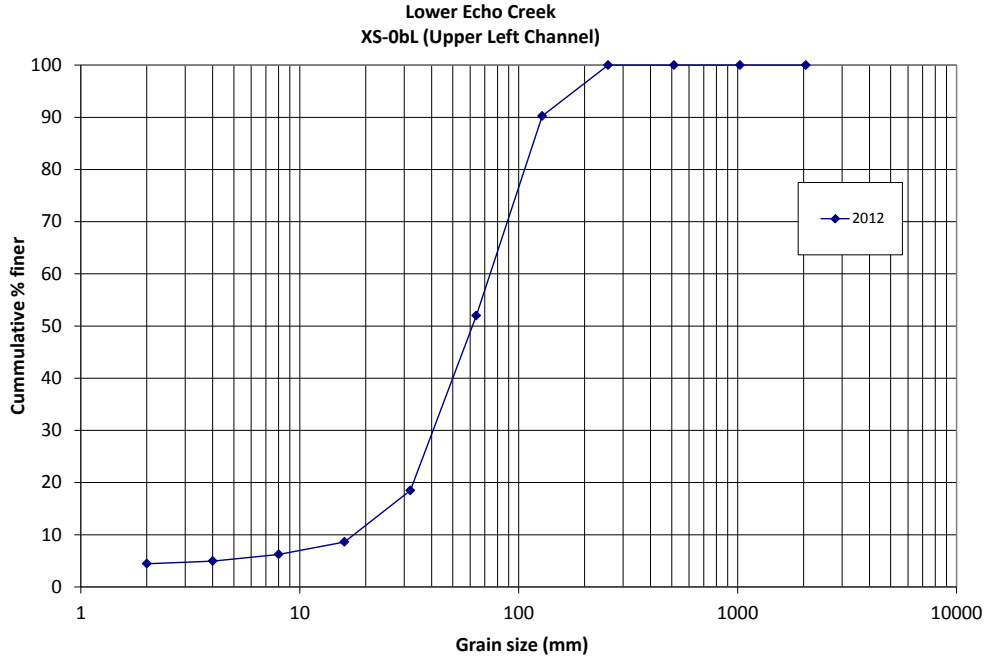
Figure 3-30. Lower Echo Creek XS-0b left channel bed particle size distribution.

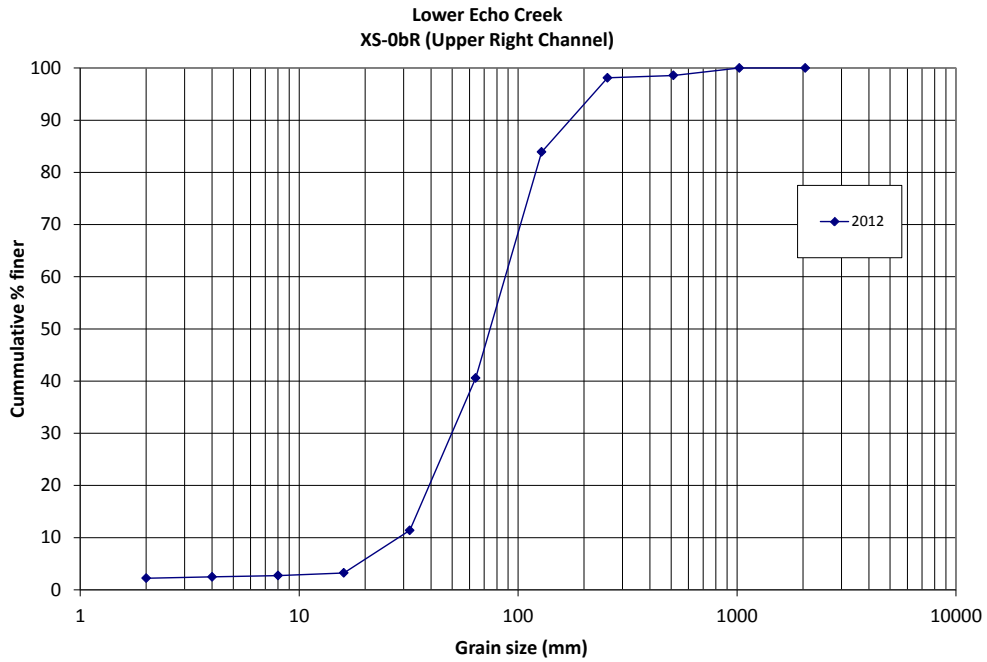
Figure 3-31. Lower Echo Creek XS-0b right channel bed particle size distribution.

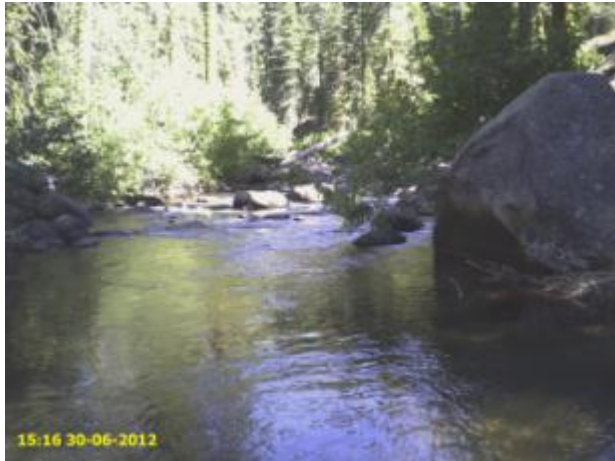
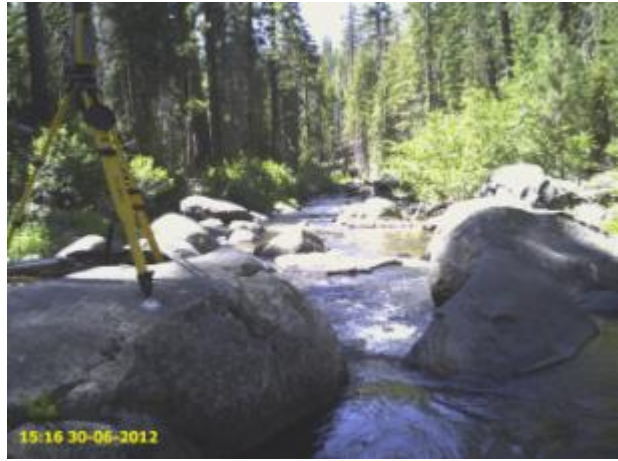
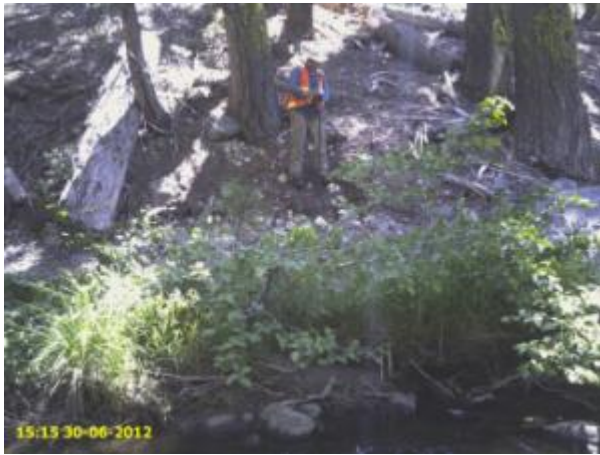
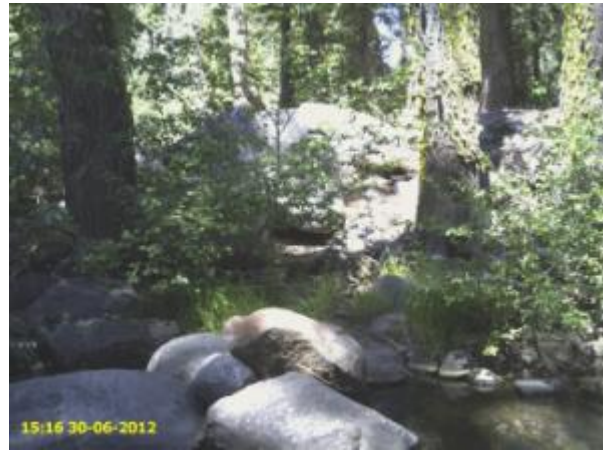
Figure A-1. Forgotten Flat, XS- 1 (Upper): (a) looking upstream; (b) looking downstream; (c) looking at the left bank; (d) looking at the right bank; (e) looking at the bed.

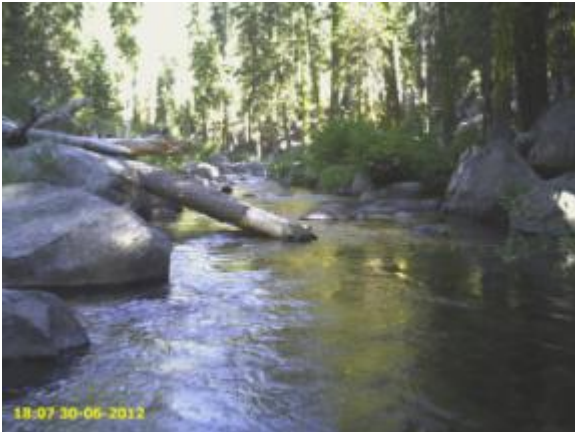
a.

Figure A-2. Forgotten Flat, XS-2 (Mid): (a) looking upstream; (b) looking downstream; (c) looking at the left bank; (d) looking at the right bank; and (e-f) looking at the bed.

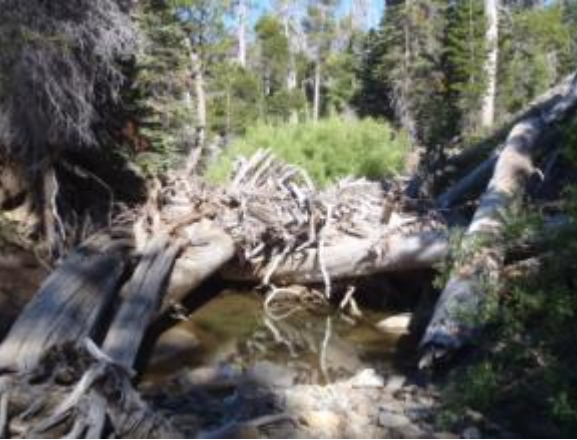
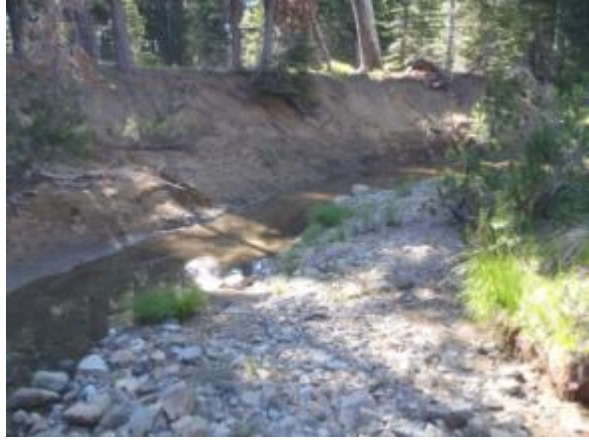
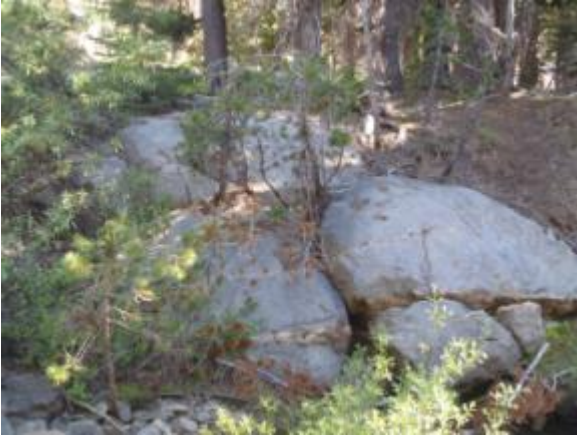
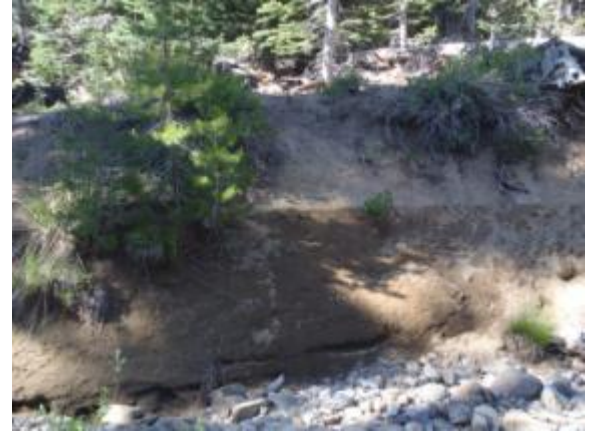
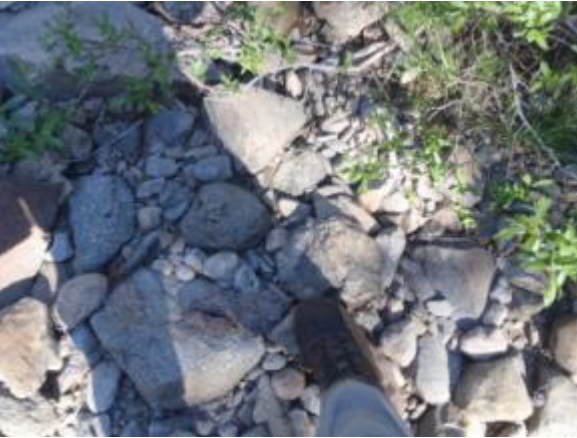
Figure A-4. Caples Spillway Channel, BI XS-1 (Upper): (a) looking upstream; (b) looking downstream; (c) looking at the left bank; (d) looking at the right bank; and (e) looking at the bed.

Based on the comparison of historical and current data, the Caples Spillway Channel study site appears to be moderately unstable with significant channel incision and eroding banks along most of the reach. The imbalance of sediment and flow that has resulted in the observed channel incision has also caused bed coarsening throughout most of the study site, suggesting that the rate
