SEPTEMBER 2012

Geomorphic Monitoring of Representative Channel Areas

El Dorado Hydroelectric Project No. 184

Report Addendum

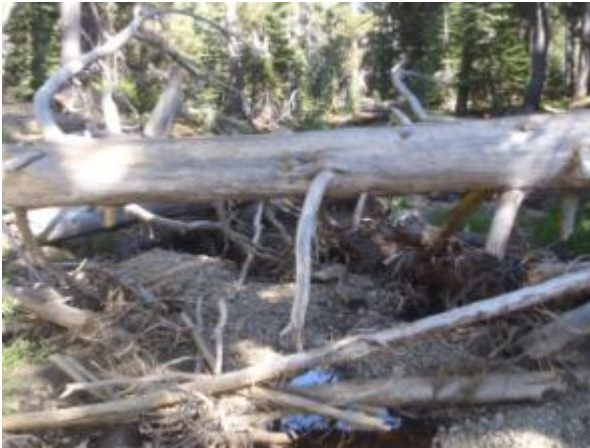
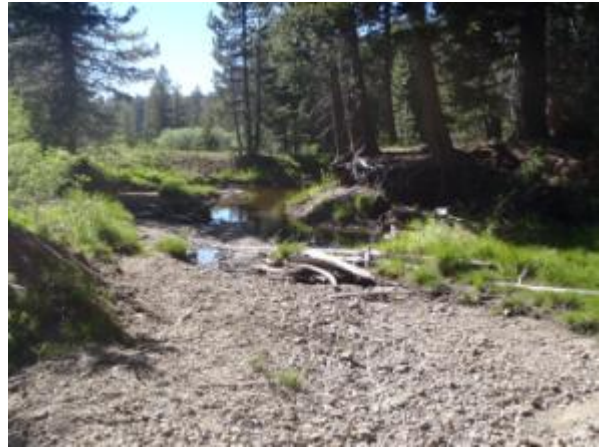
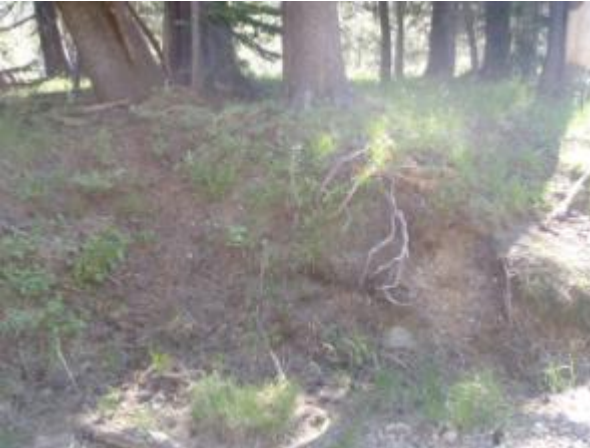
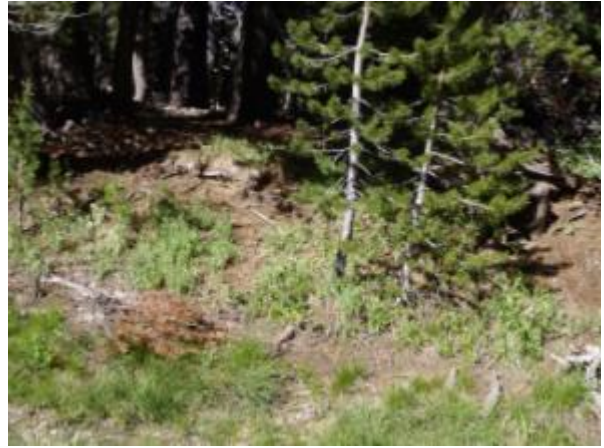
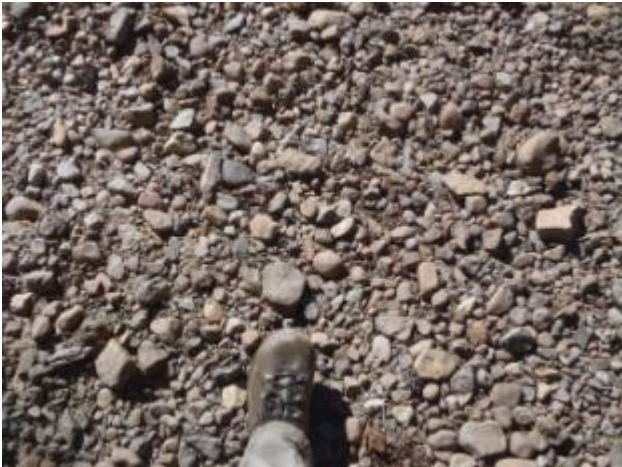
Figure A-6. Caples Spillway Channel, BI XS-3 (Lower): (a) looking upstream; (b) looking downstream; (c) looking at the left bank; (d) looking at the right bank; and (e) looking at the bed.

Based on the comparison of historical and current data, the Caples Spillway Channel study site appears to be moderately unstable with significant channel incision and eroding banks along most of the reach. The imbalance of sediment and flow that has resulted in the observed channel incision has also caused bed coarsening throughout most of the study site, suggesting that the rate

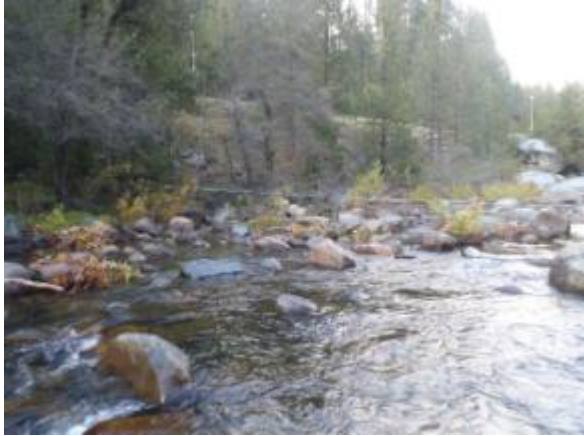
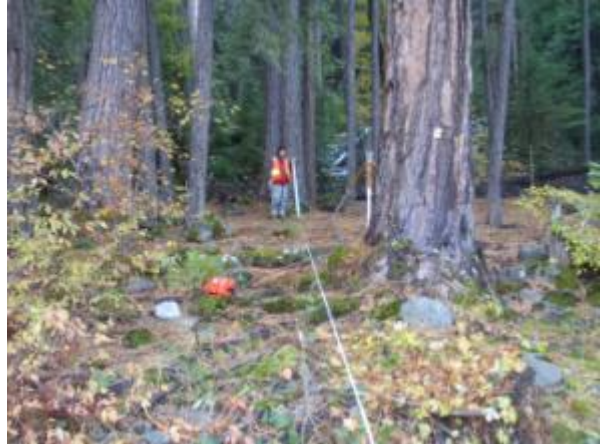
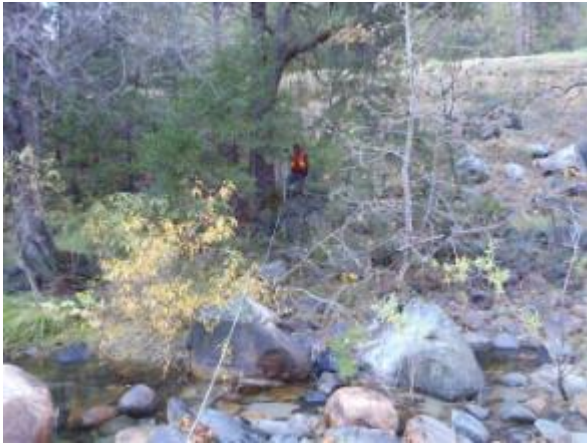
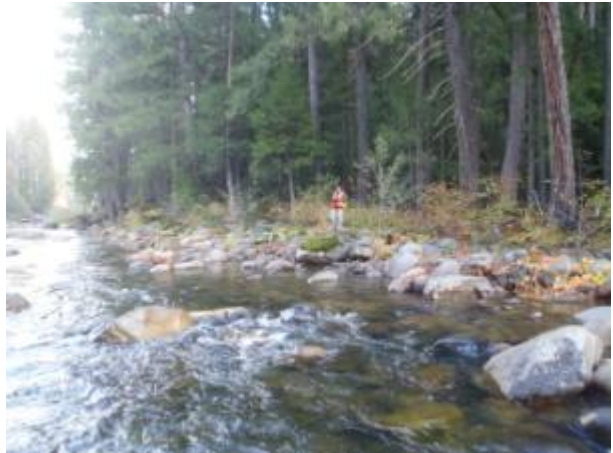
Figure A-7. Sand Flat, XS-1 (Upper): (a) looking upstream; (b) looking at the left bank; (c) looking at the right bank; and (d) looking at the bed.

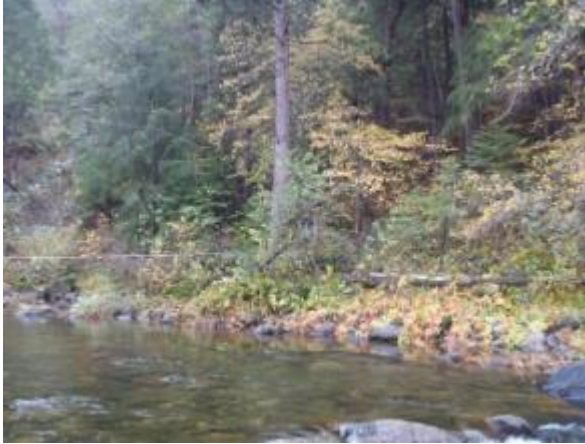
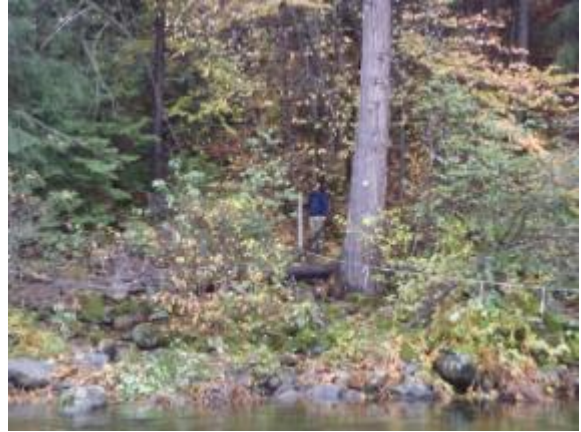
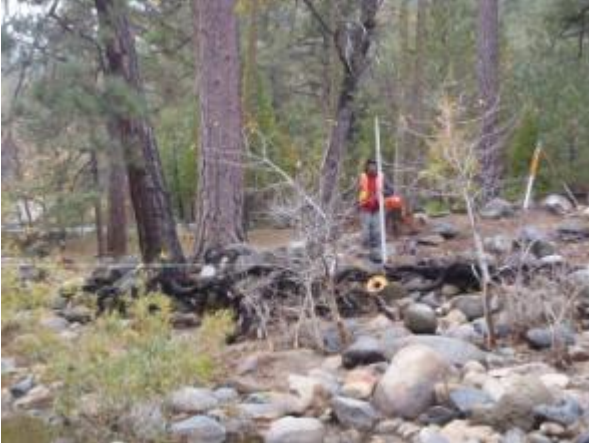
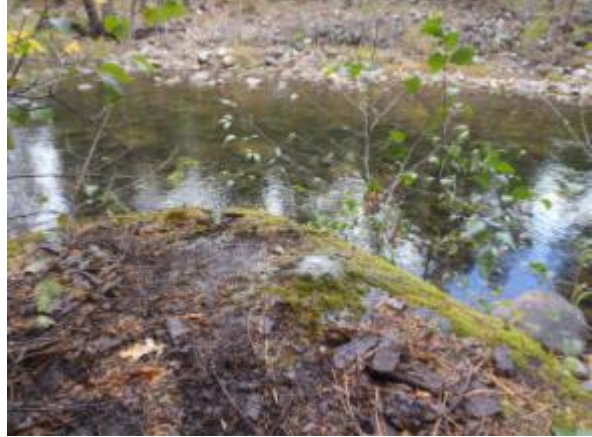
Figure A-8. Sand Flat, XS-2 (Mid): (a) looking upstream; (b) looking at the left bank; (c) looking at the right bank; and (d) looking at the bed.

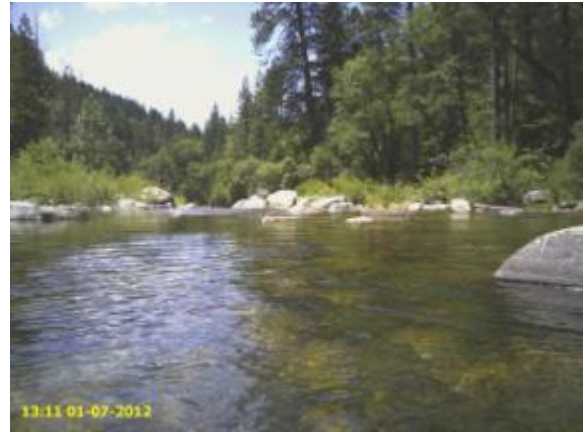
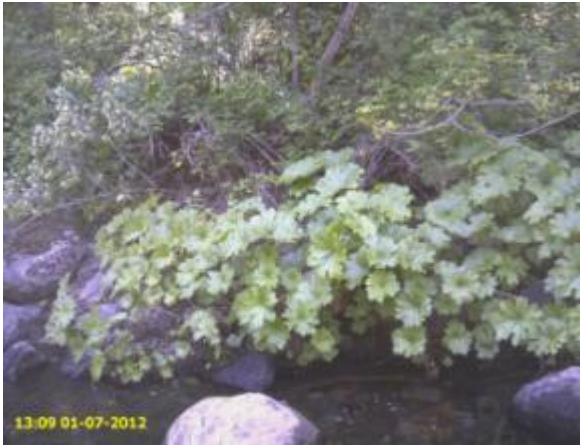
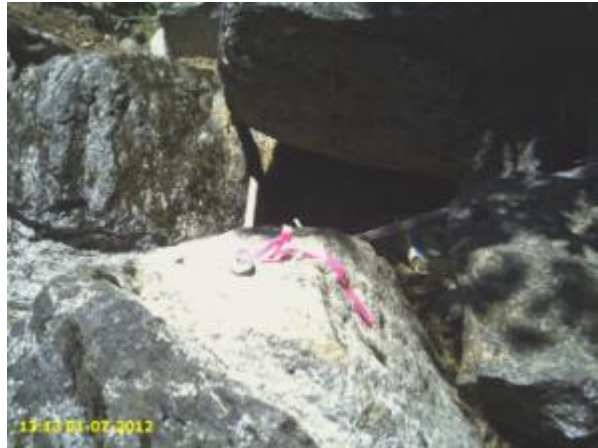
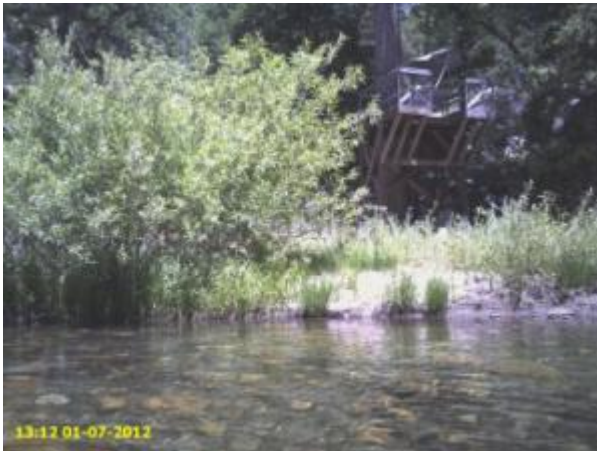
Figure A-9. Sand Flat, XS-3 (Lower): (a) looking upstream; (b) looking downstream; (c) looking at the left bank; (d) looking at the right bank; and (e) looking at the bed.

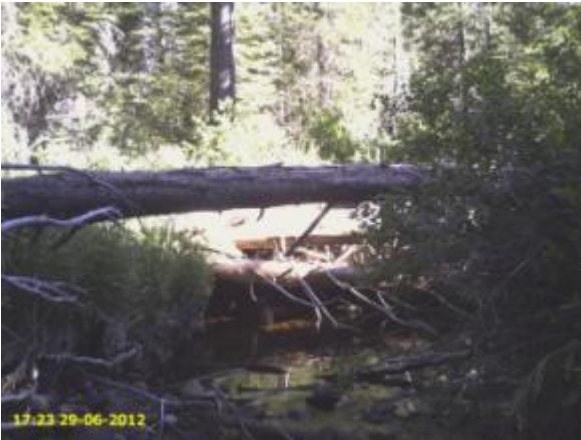
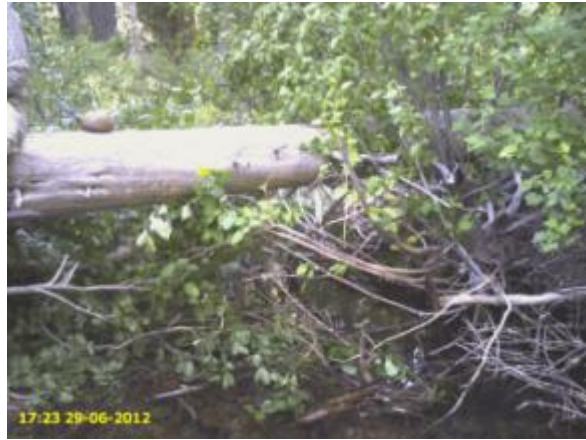
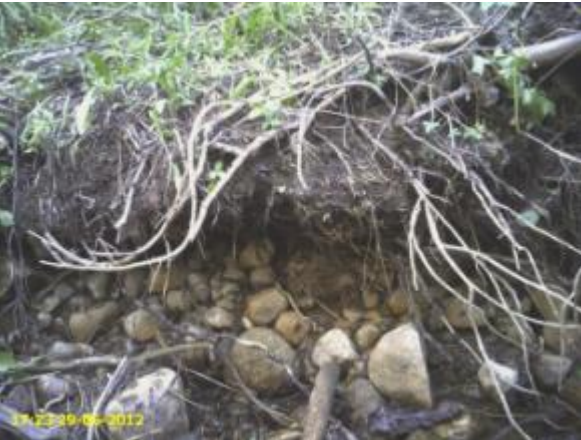
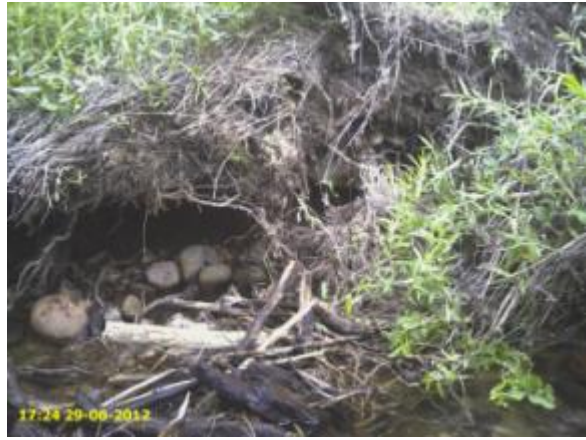
Figure A-11. Echo Creek, XS-0b at Right Channel: (a) looking upstream; (b) looking downstream; (c) looking at the left bank; (d) looking at the right bank
