Caples Spillway Channel Stabilization Plan

El Dorado Hydroelectric Project
(FERC No. 184)

March 2018

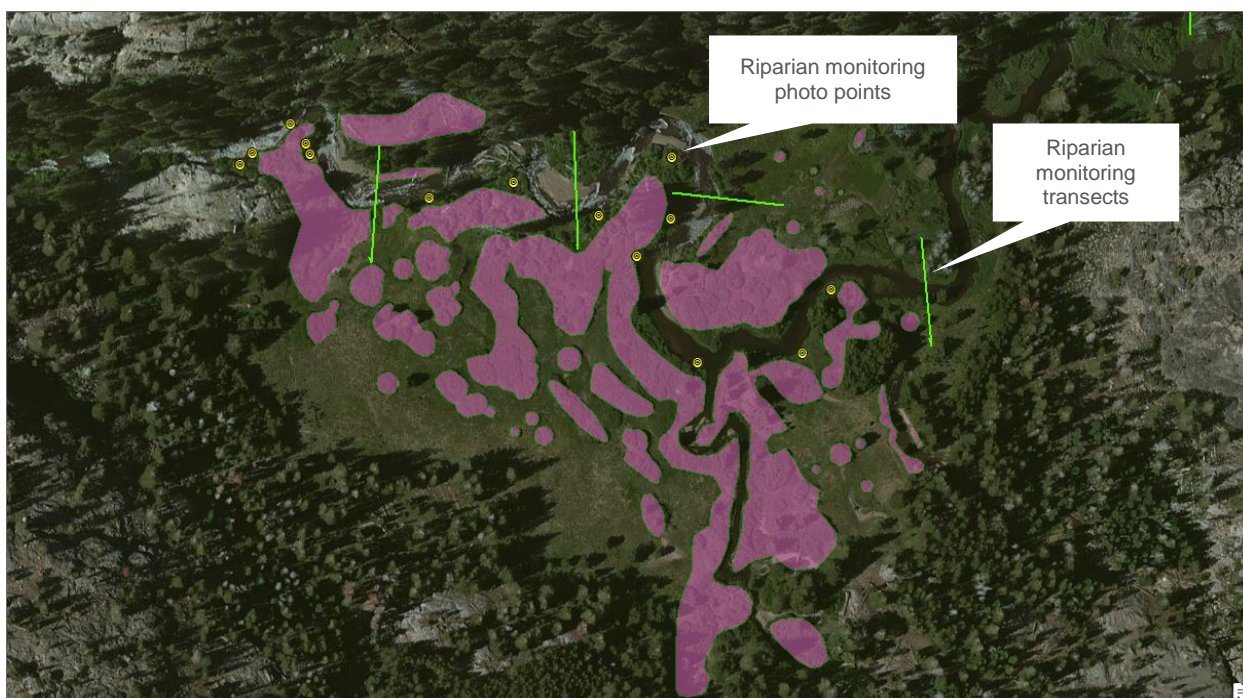
Figure 1. Potential willow harvest source areas (purple) in Caples Meadow and near Kirkwood Creek

Prior to harvesting willow materials, a qualified ecologist will identify suitable willows that could be used for source material for the pole plantings and the fascines. The ecologist will also flag the locations of each stabilization treatment within each erosion area. All willow cuttings are anticipated to be collected from along Caples Creek, including in the vicinity of Caples Meadow, or Kirkwood Creek, located downstream of the spillway channel. Willow cutting source materials may also be collected from other locations in close proximity to the project area.

There are long-term riparian vegetation monitoring sites located in the Caples Creek meadow area. These monitoring sites include photopoints along Caples Creek as part of the Project No. 184 Riparian Recruitment Monitoring Plan and transects across Caples Creek as part of the Project No. 184 Riparian Species Composition Monitoring Plan. Figure 1 depicts the location of the monitoring photopoints and transects as well as the approximate area where willow harvest would occur. Willow harvest will not occur in the immediate vicinity of the riparian monitoring photopoints and transects.

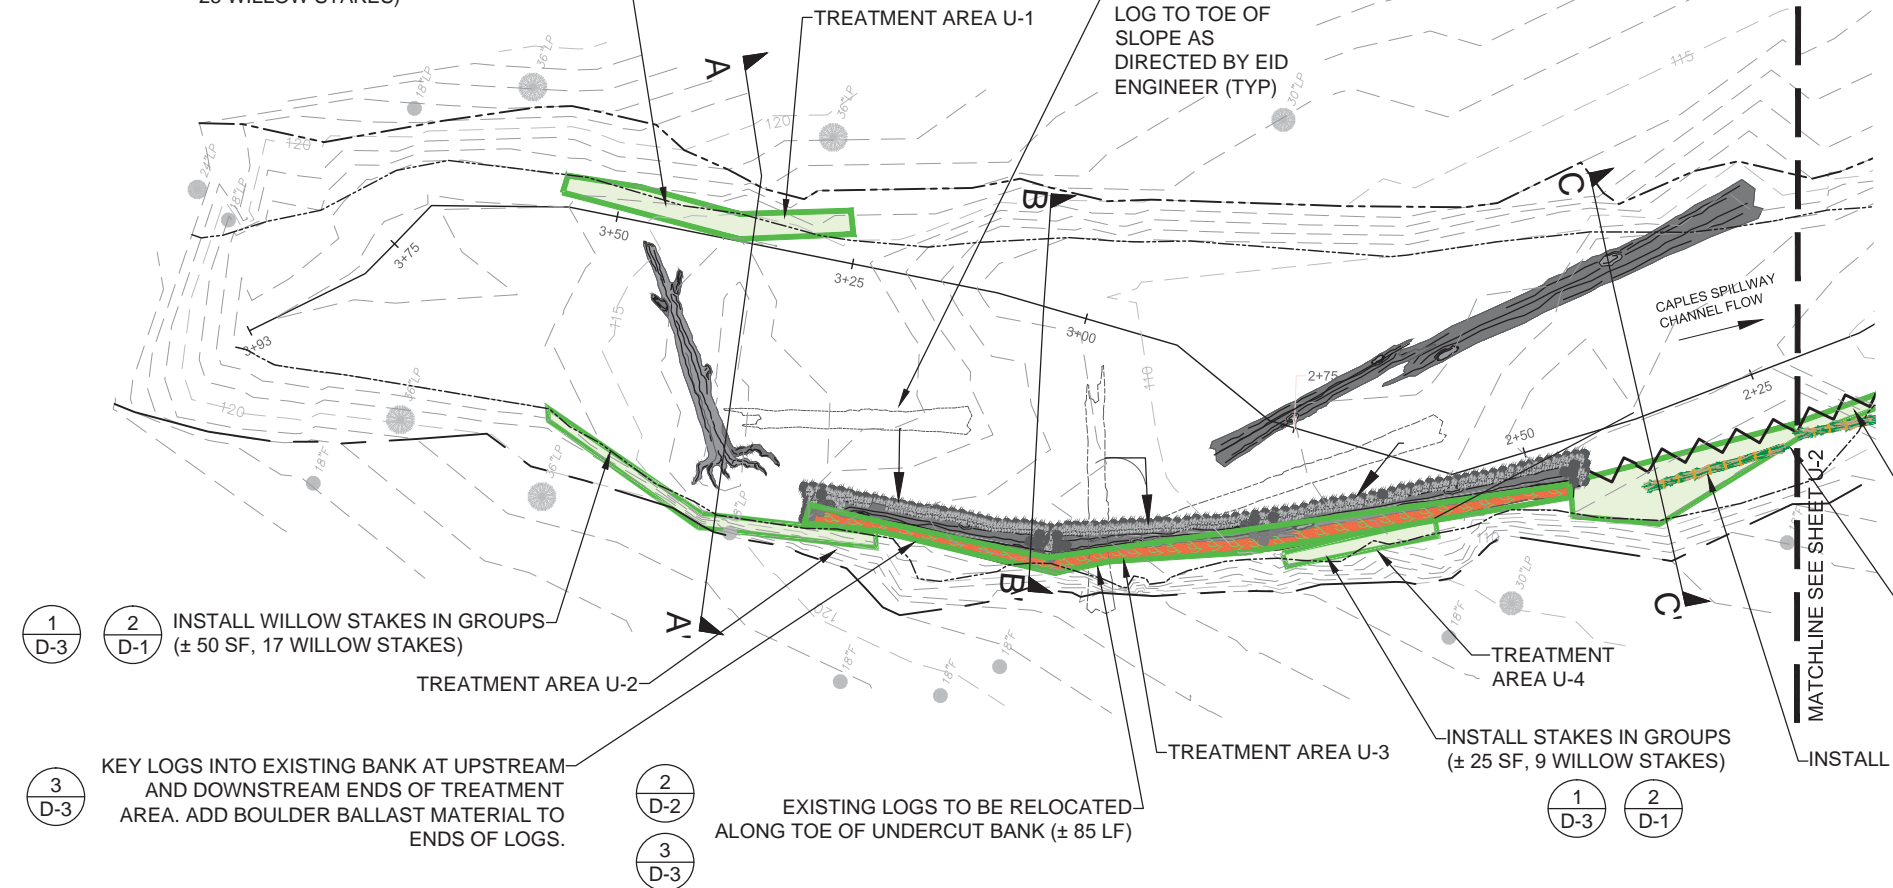
2
D-3 2
D-1
INSTALL WILLOW STAKES SPACED ALONG TOE OF SLOPE INTERMITTENTLY AMONGST EXISTING BOULDERS (± 75 SF, 25 WILLOW STAKES)

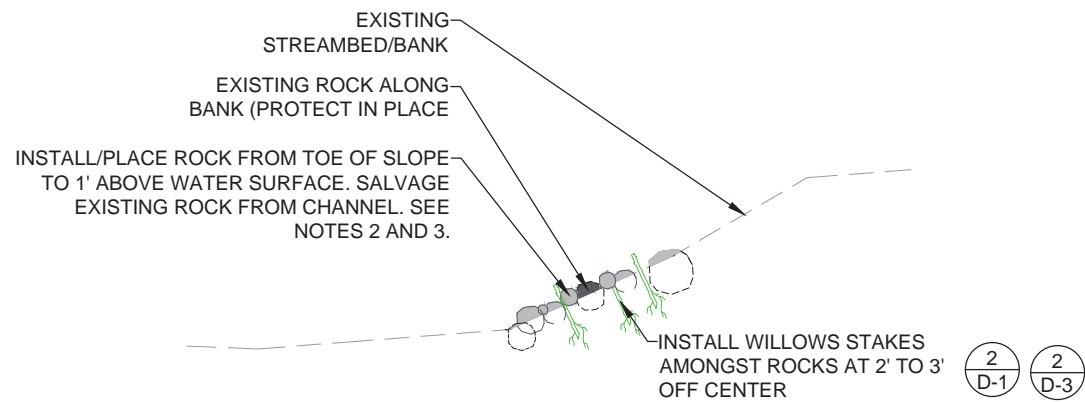
COMBINATION OF ROCK AND WILLOW STAKES

- NOTES:
- PROPOSED ROCK SHALL BE PLACED BETWEEN, IN, AROUND, ETC. TO CREATE CONTINUOUS ROCK SURFACE
 - ROCK SIZE SHALL BE A MINIMUM OF 8" DIAMETER AND 25 POUNDS.
 - ROCK SHALL BE ANGULAR IN NATURE
 - ROCK SHALL BE GENERALLY UNIFORM IN DIAMETER
 - ROCK SHALL BE 1/3 BURIED IN NATIVE STREAMBED/BANK

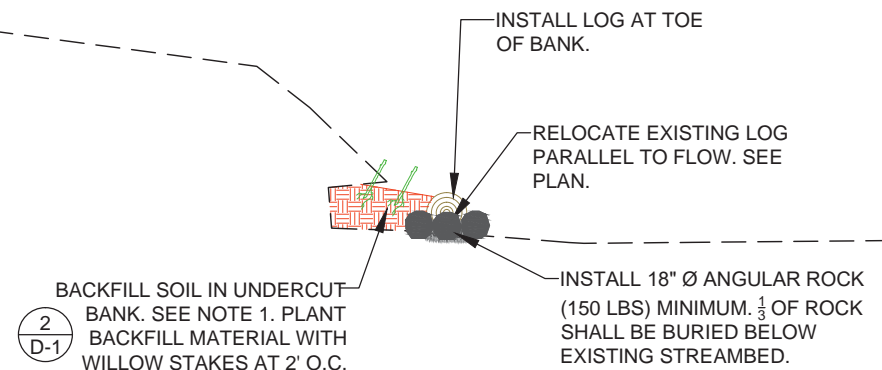
BACKFILL SOIL IN UNDERCUT BANK. SEE NOTE 1. PLANT BACKFILL MATERIAL WITH WILLOW STAKES AT 2' O.C. 2
D-1

INSTALL LOG AT TOE OF BANK.

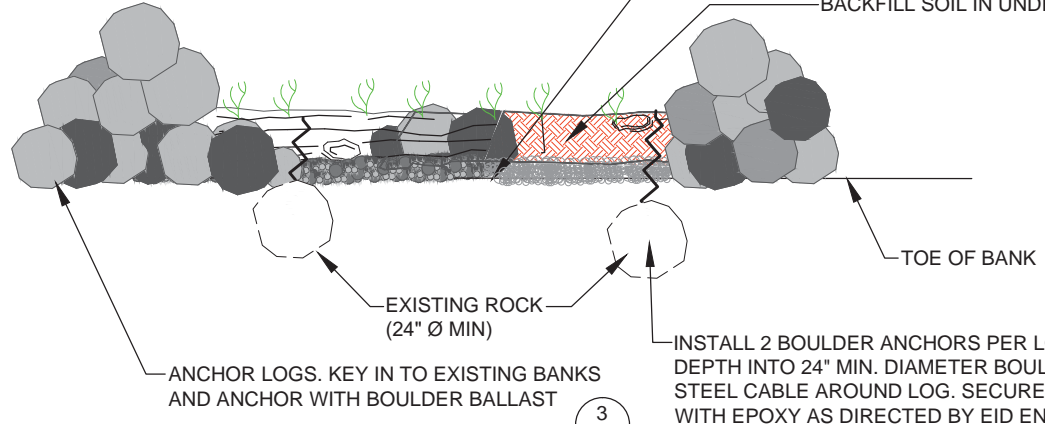
ANCHOR LOGS. KEY IN TO EXISTING BANKS AND ANCHOR WITH BOULDER BALLAST 3
D-3

INSTALL 2 BOULDER ANCHORS PER LOG. DRILL 6" DEPTH INTO 24" MIN. DIAMETER BOULDER, INSTALL STEEL CABLE AROUND LOG. SECURE CABLE IN HOLE WITH EPOXY AS DIRECTED BY EID ENGINEER.

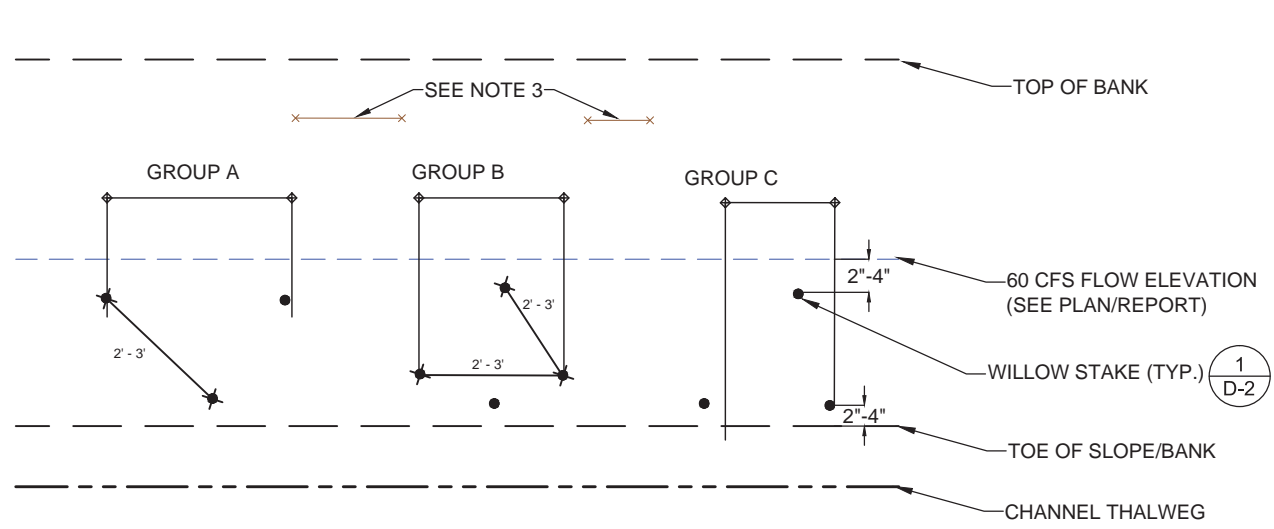
WILLOW STAKING IN GROUPS
NOT TO SCALE

- NOTE:
1. X = 2' O.C. ±
 2. WILLOW STAKING GROUPS (A,B,C) SHALL BE ALTERNATED LONGITUDINALLY DOWN CHANNEL.
 3. SPACING BETWEEN GROUPS SHALL BE 3' - 5' AS DIRECTED BY EID ENGINEER.

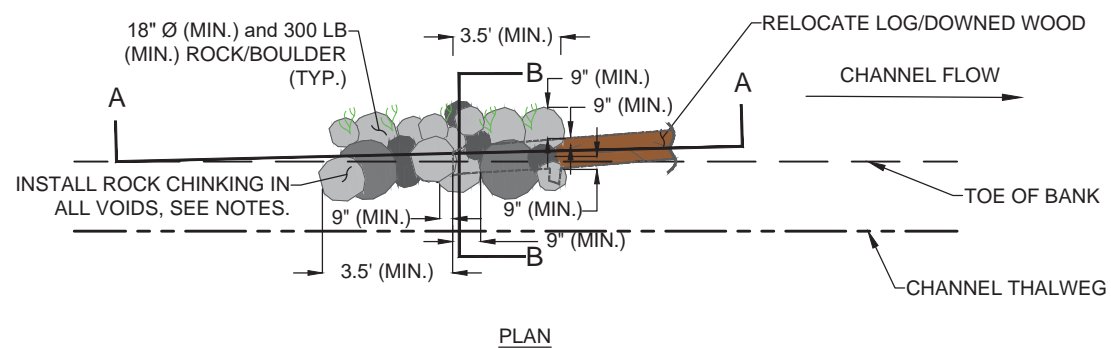
LOG BANK PROTECTION - END TREATMENT
NOT TO SCALE

- NOTE:
1. NATIVE MATERIAL FOR ALL BACKFILL SHALL BE NATIVE TO THE PROJECT SITE, CONTAIN ORGANIC MATERIAL, NOT BE ROCK, SAND, COBBLE AS TO PROMOTE VEGETATION GROWTH.

2. CHINKING ROCK SHALL BE INSTALLED IN ALL AREAS WHERE BOULDERS AND ROCK ARE TO BE PLACED TO REDUCE/ELIMINATE VOID SPACE IN AND AROUND THE BOULDERS AND ROCKS (EXISTING AND PROPOSED). THE INTENT IS TO PROVIDE A SOLID MATRIX OF ROCK TO REDUCE POTENTIAL FOR FAILURE OF THE ROCK, BOULDER AND/OR LOG STRUCTURES ASSOCIATED WITH THE PROJECT.

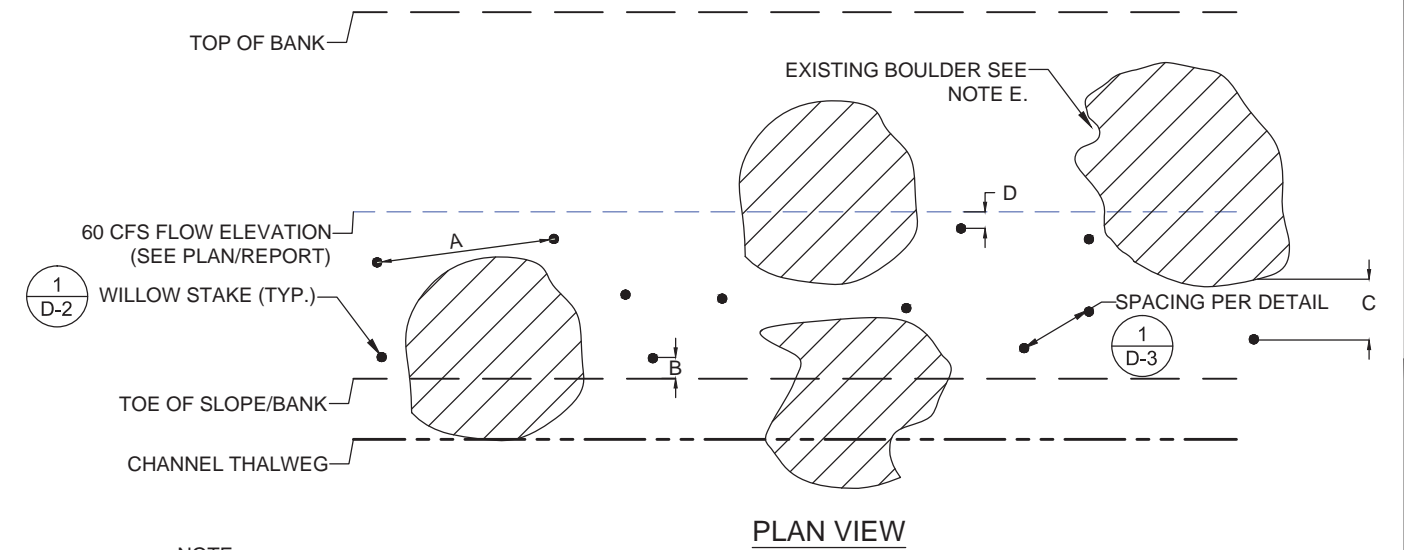
WILLOW STAKING IN AMONGST BOULDERS
NOT TO SCALE

- NOTE:
- A. SPACING OF WILLOW STAKES SHALL BE 2-3' O.C.
 - B. WILLOWS SHALL BE SET NO CLOSER THAN 2" TO TOE OF SLOPE/BANK
 - C. WILLOW STAKES SHALL BE SET NO CLOSER THAN 6" TO EXISTING ROCK/BOULDERS
 - D. WILLOW STAKES SHALL BE SET NO CLOSER THAN 2" FROM 60 CFS FLOW ELEVATION AS DIRECTED BY EID ENGINEER
 - E. BOULDER MAY REPRESENT VEGETATION, ROCK, ETC. - OBJECT PREVENTING WILLOW STAKE INSTALLATION.

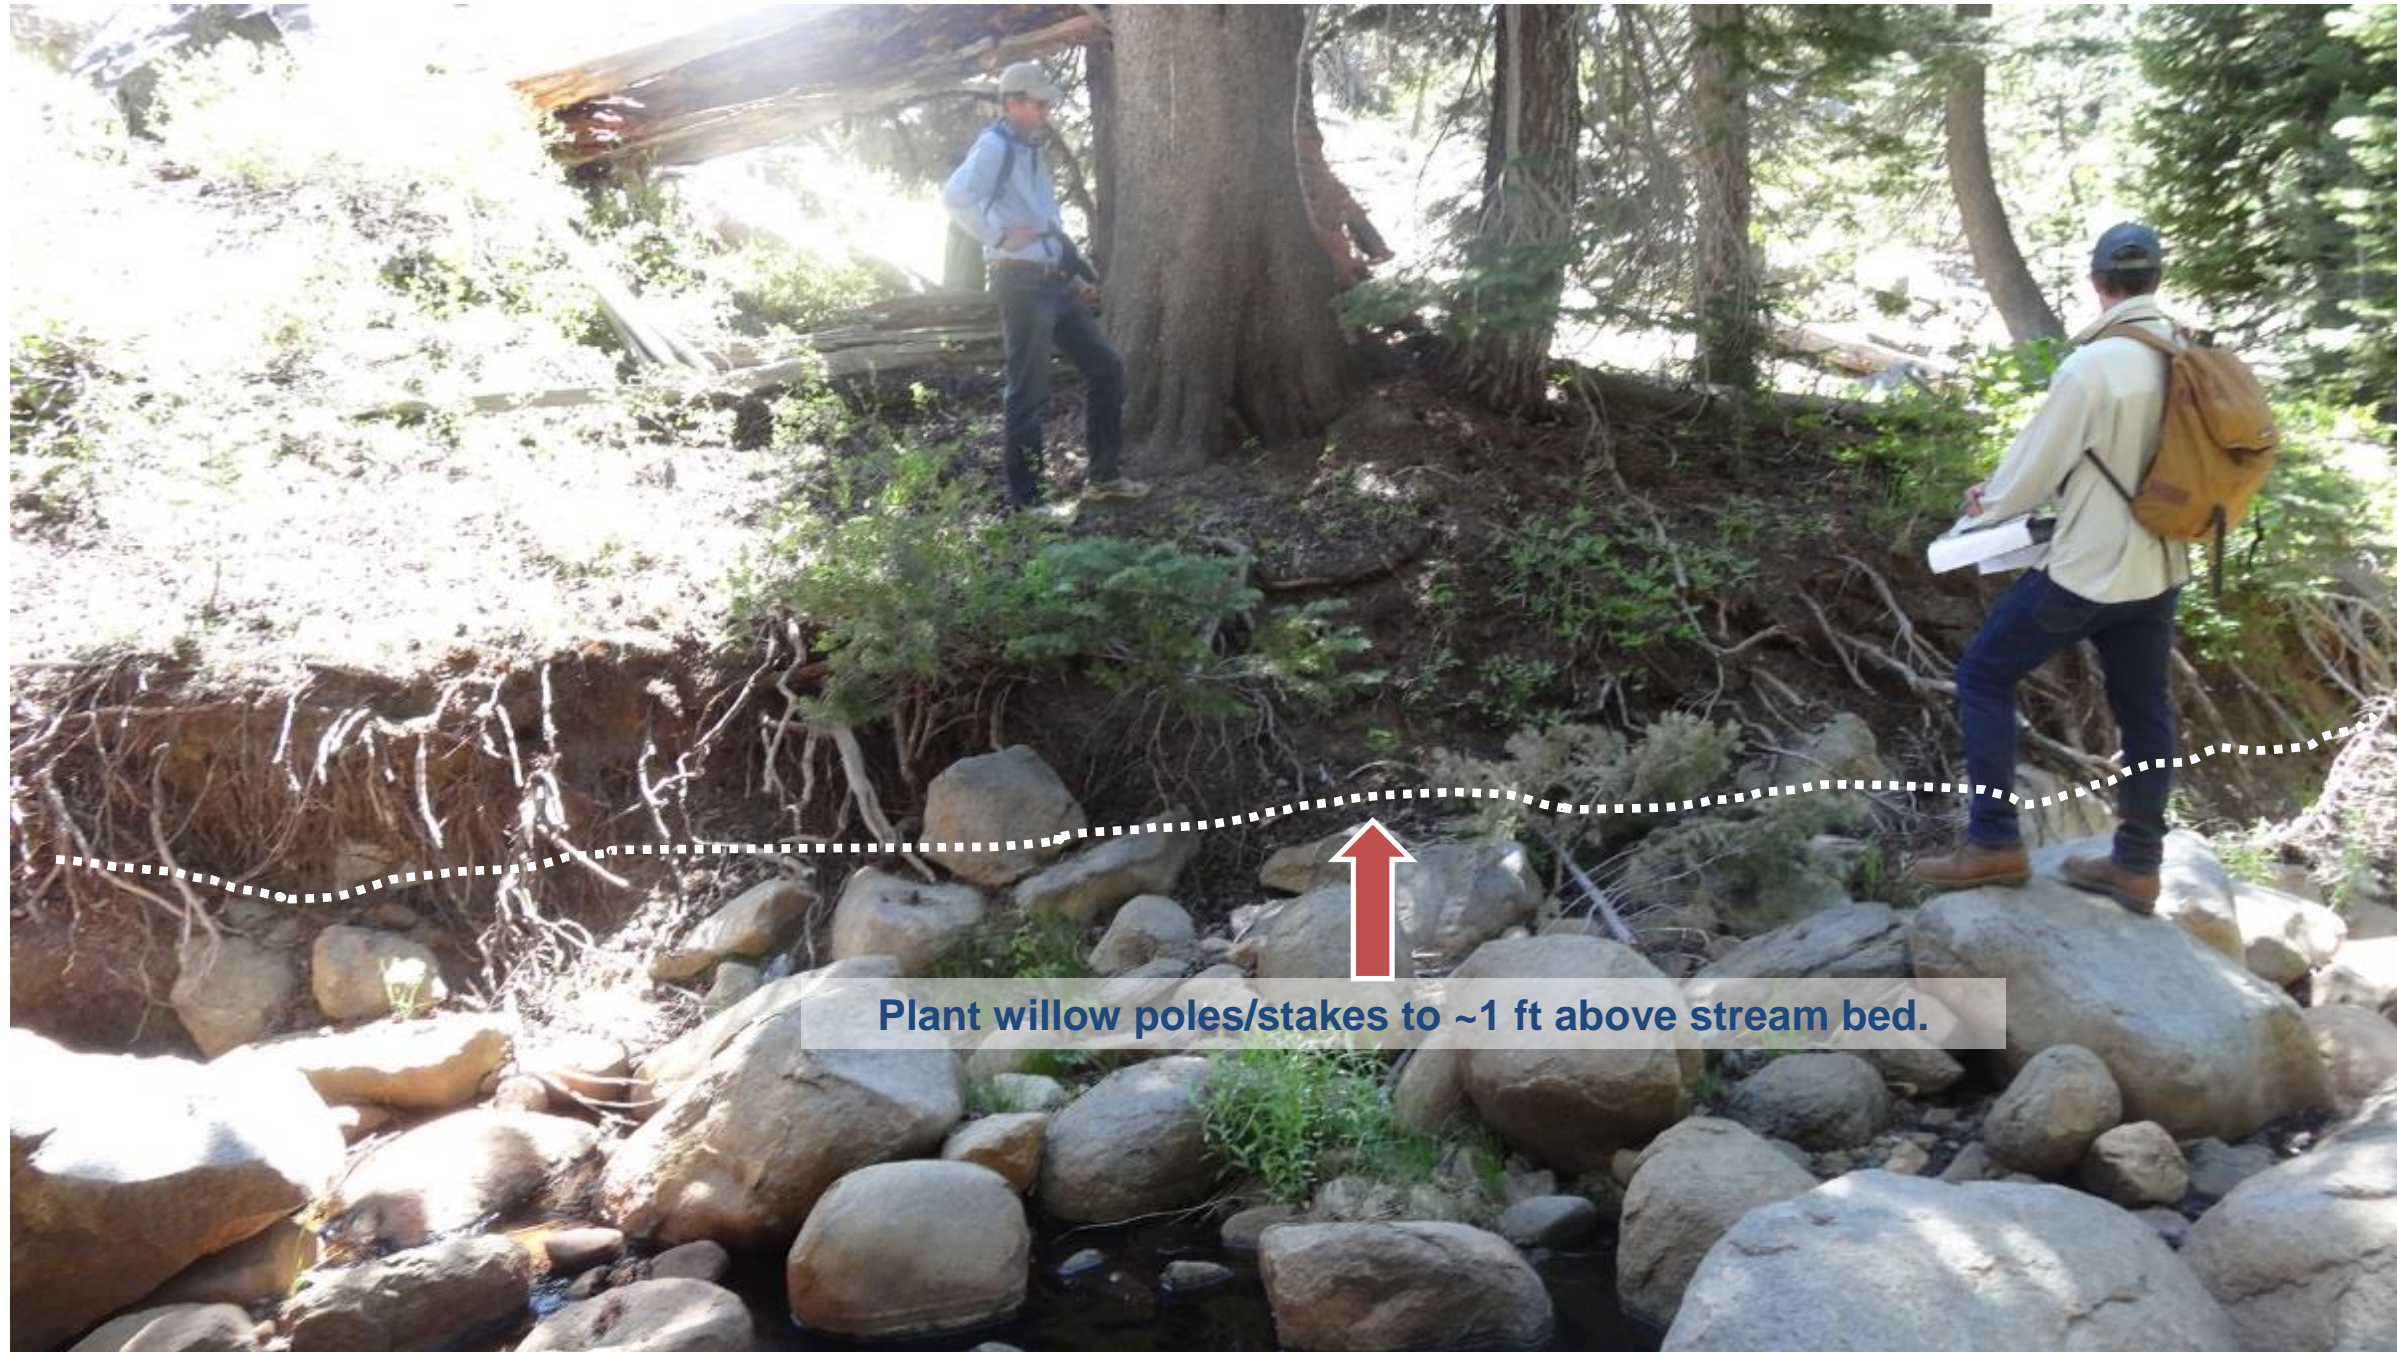
Figure 1 Upper Site – Treatment Area U-1: LB 3+55 to 3+25

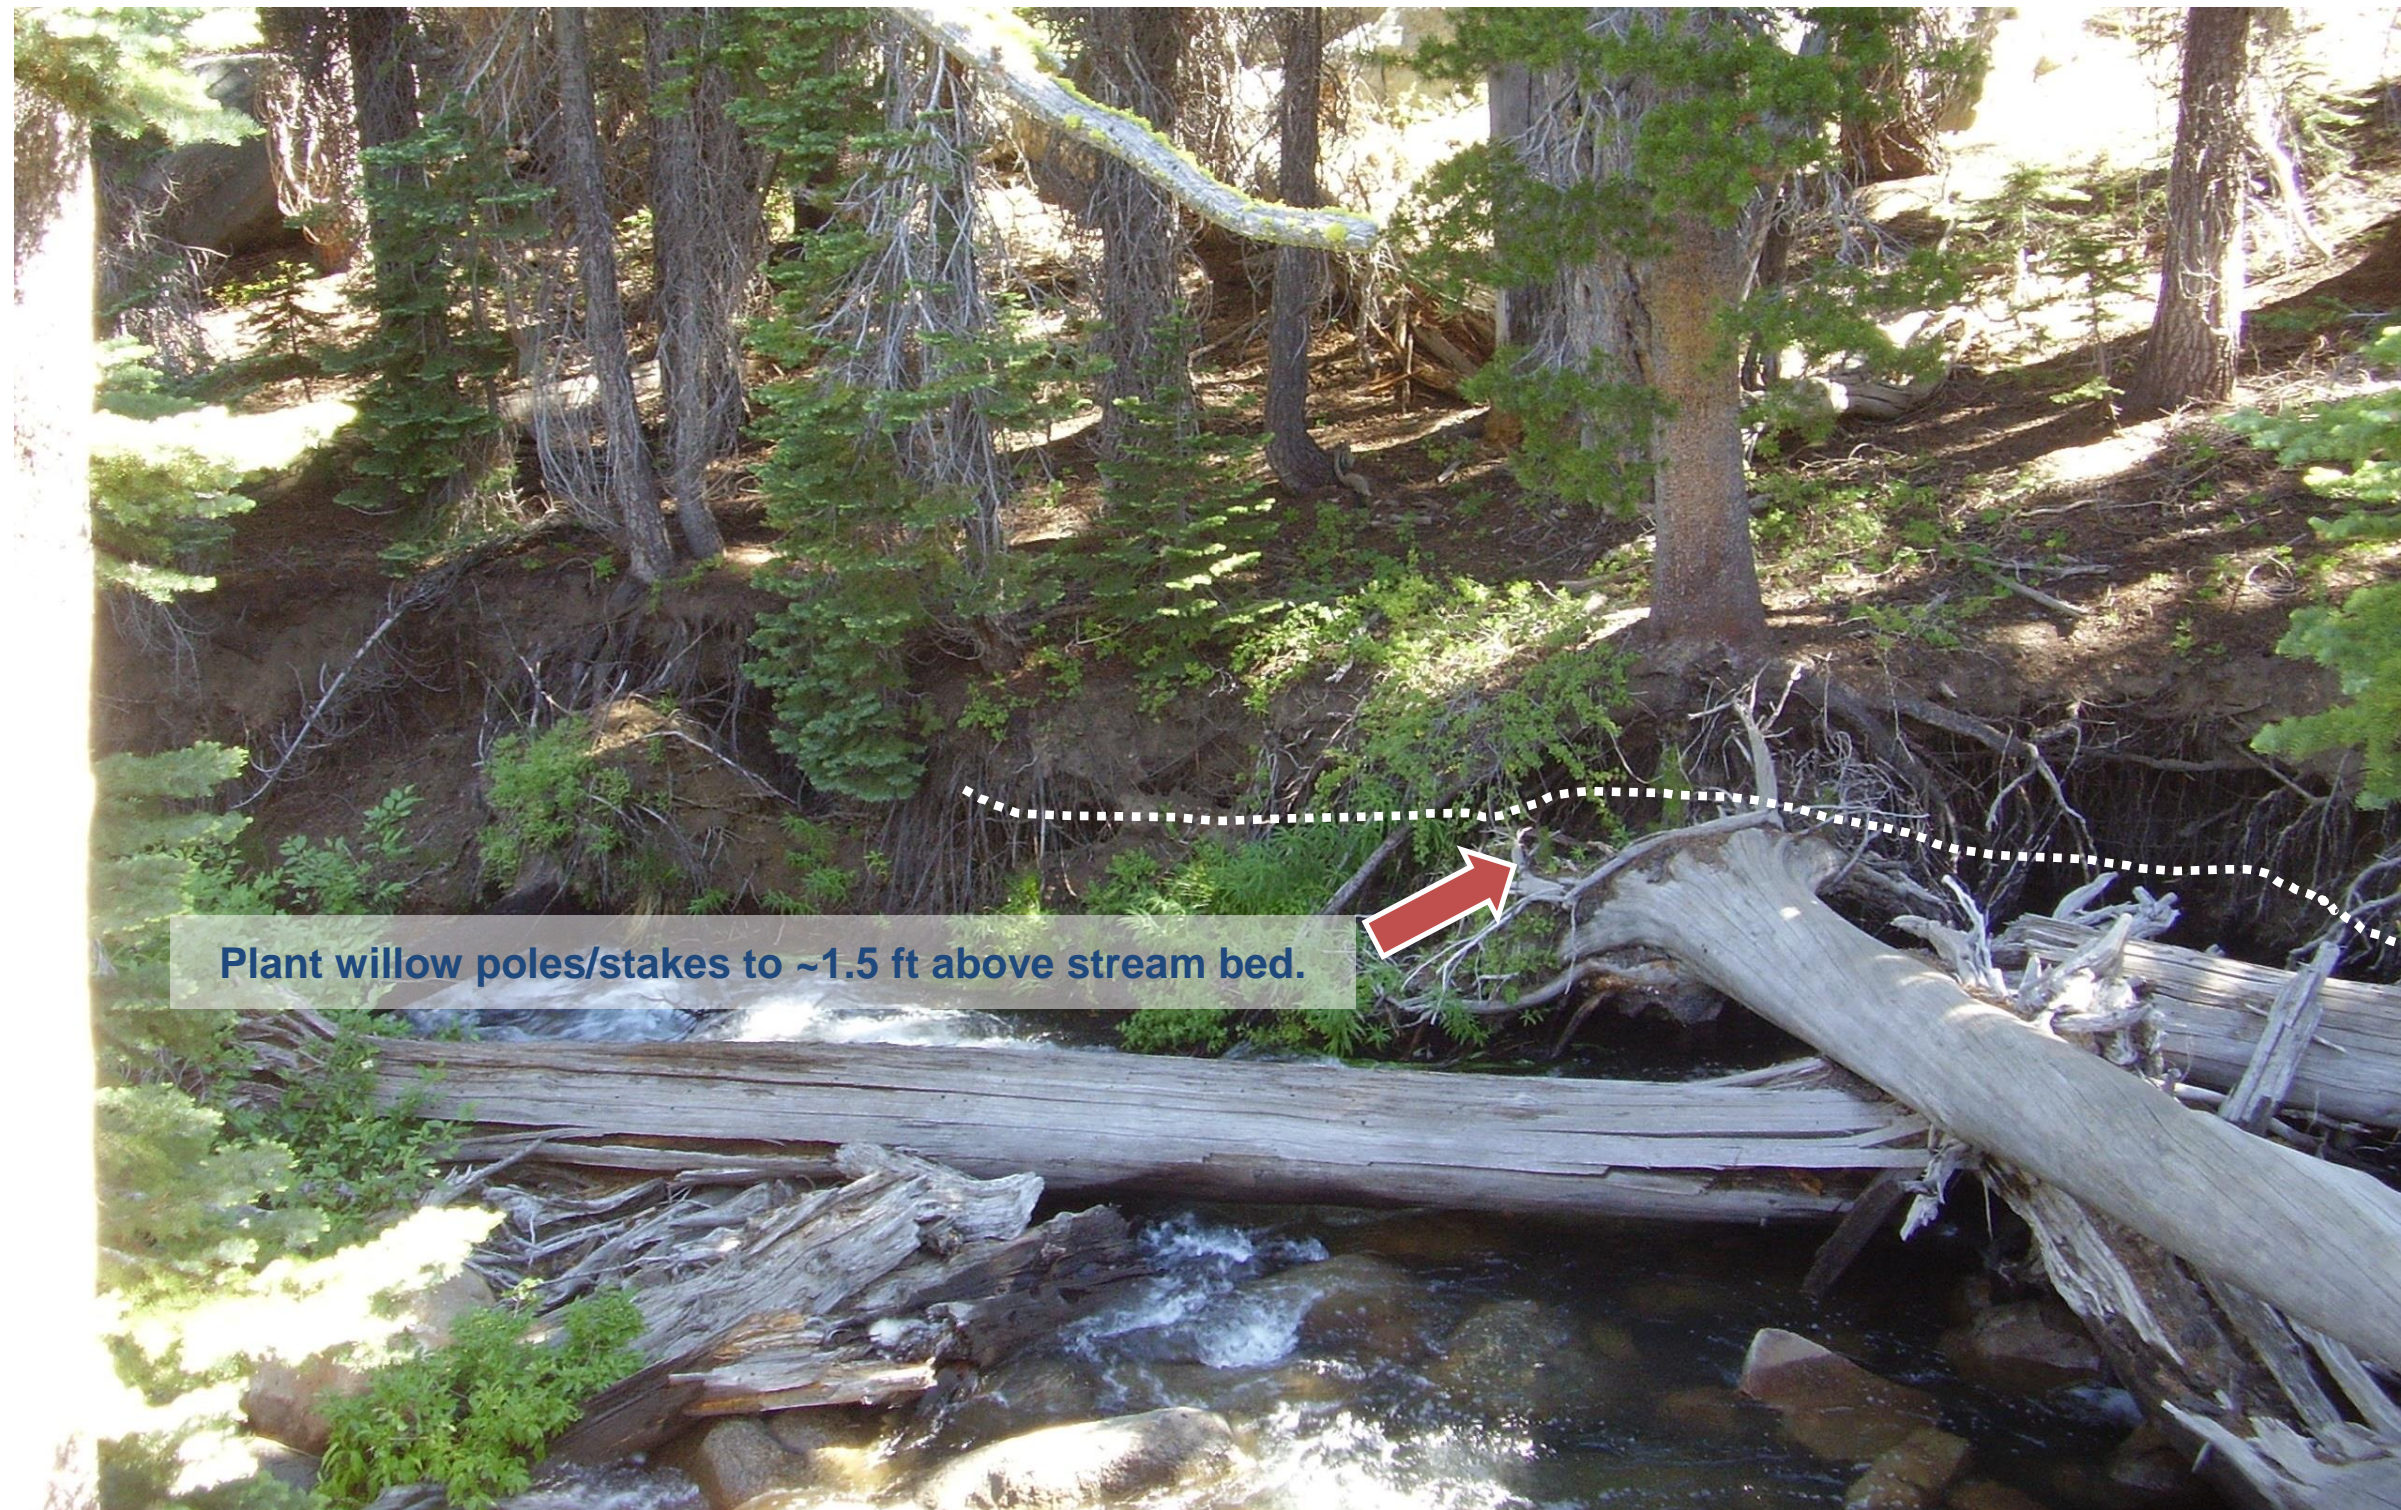
Figure 2 Upper Site – Treatment Area U-2: RB 3+57 to 3+17

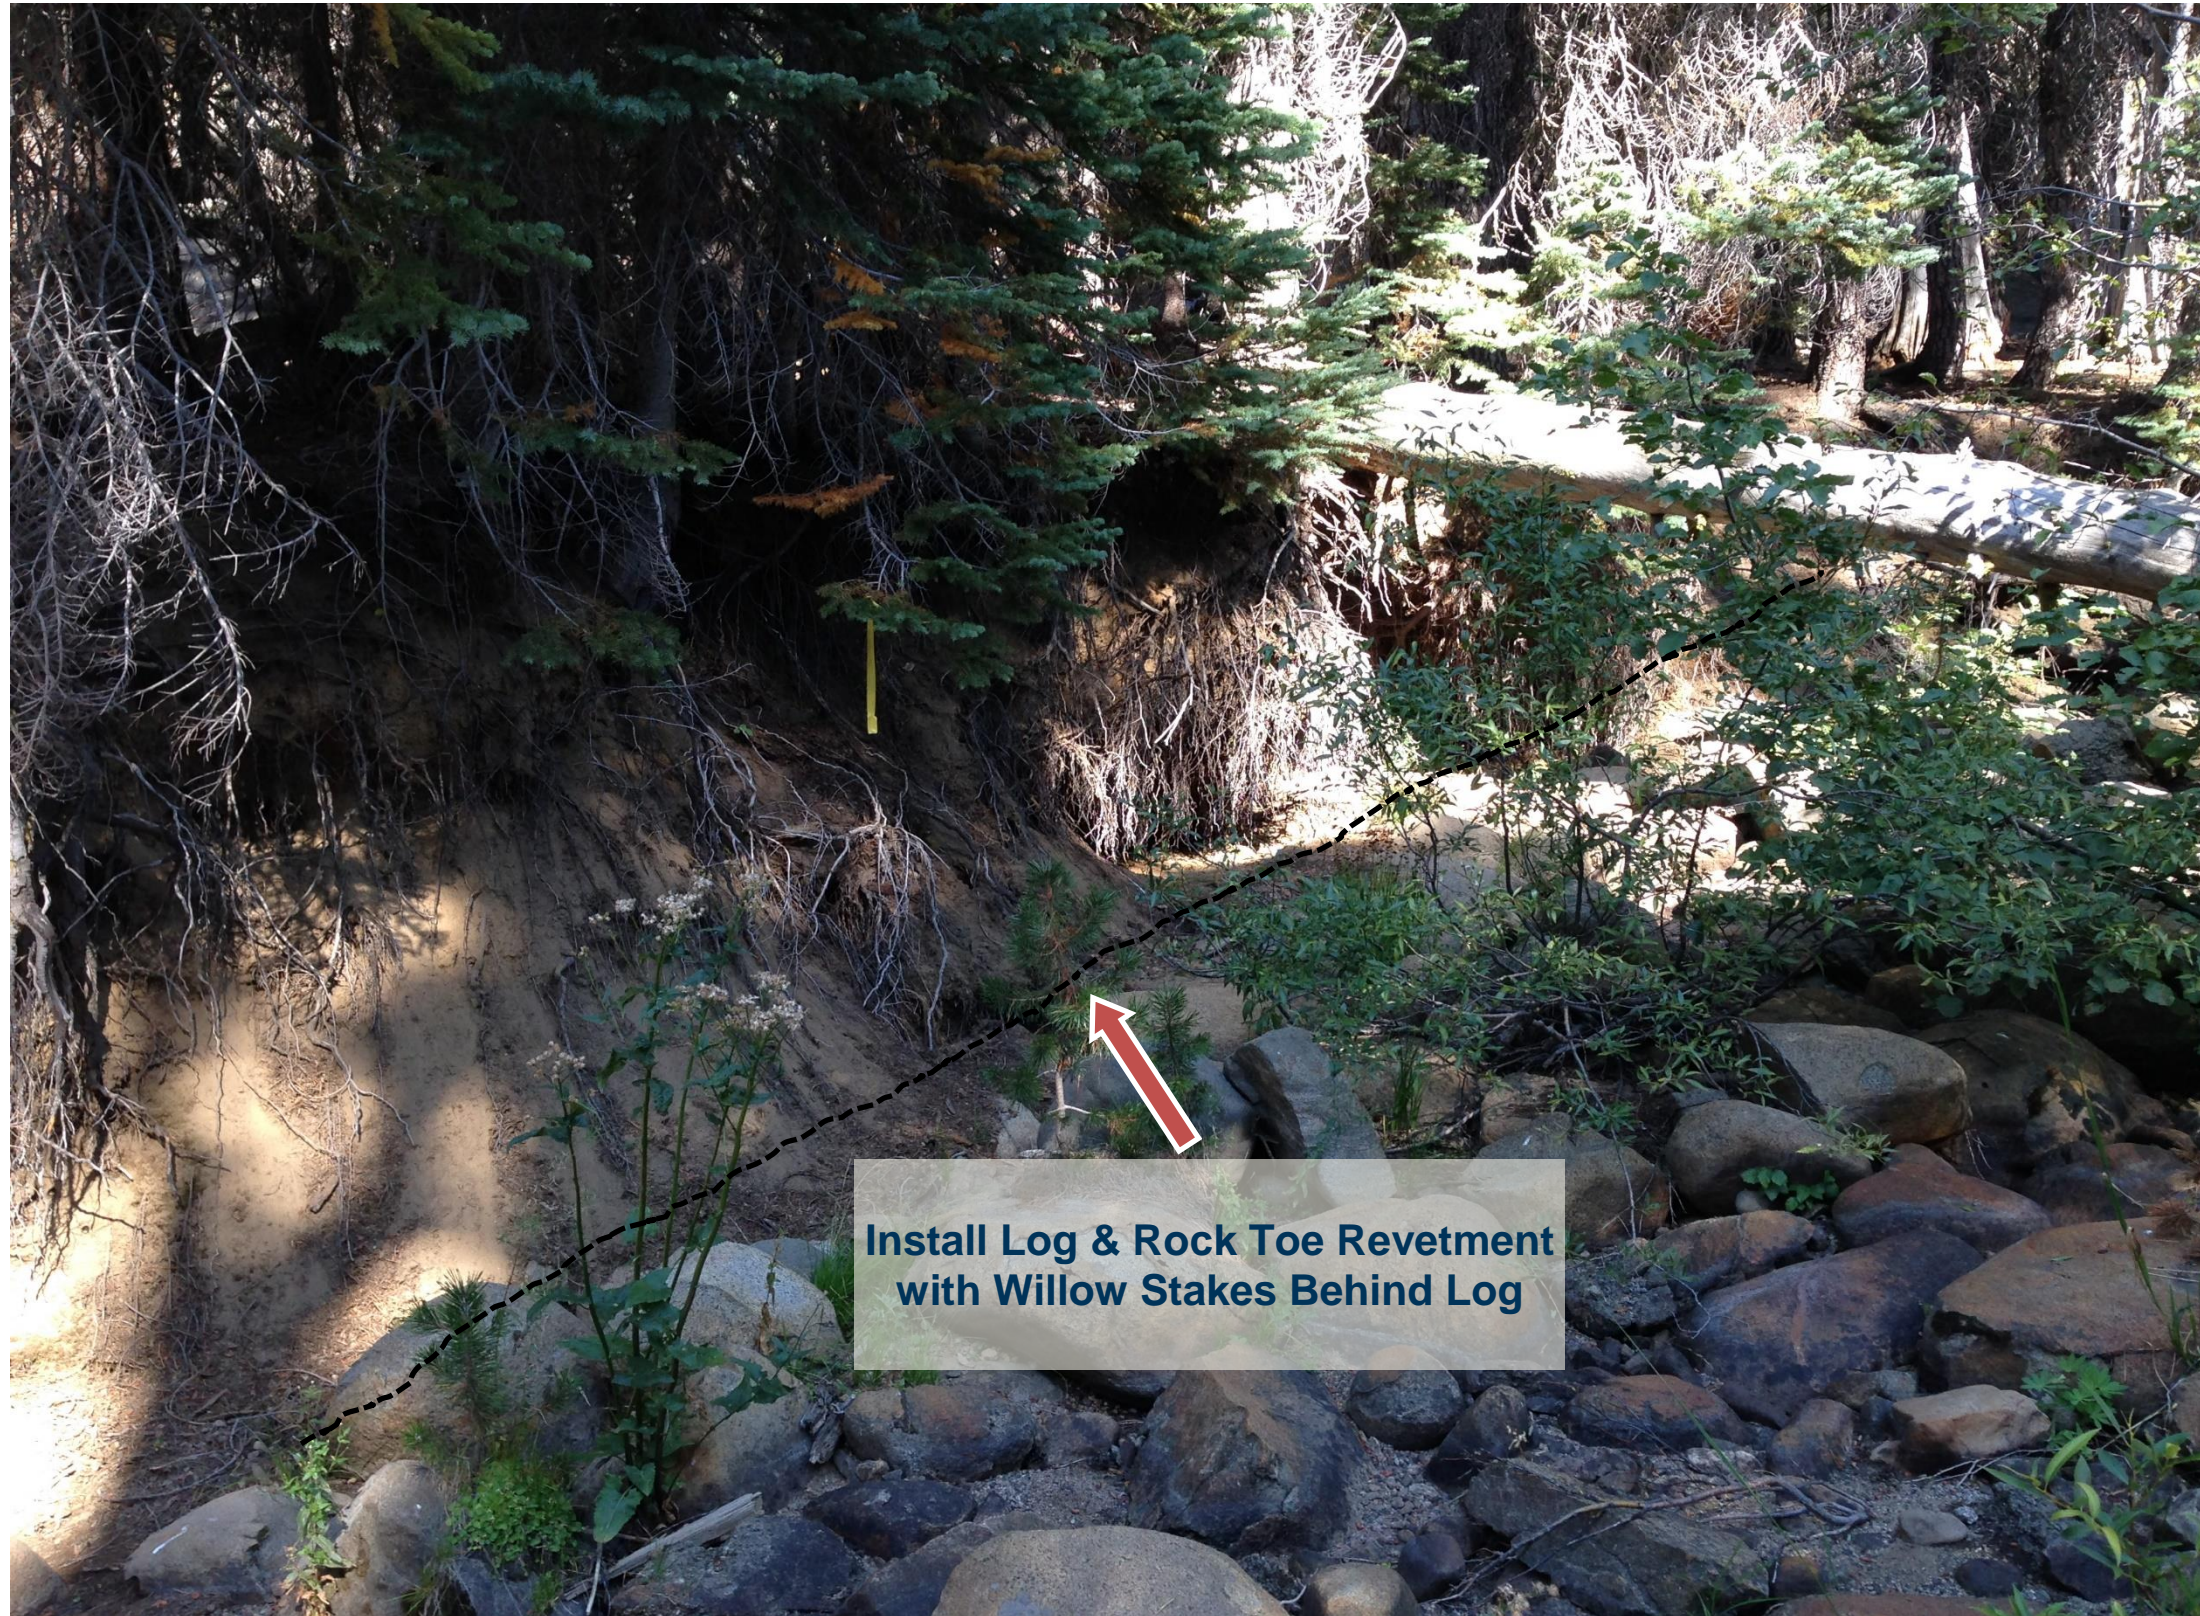
Figure 3 Upper Site - Treatment Area U-3: 2+45 to 3+30

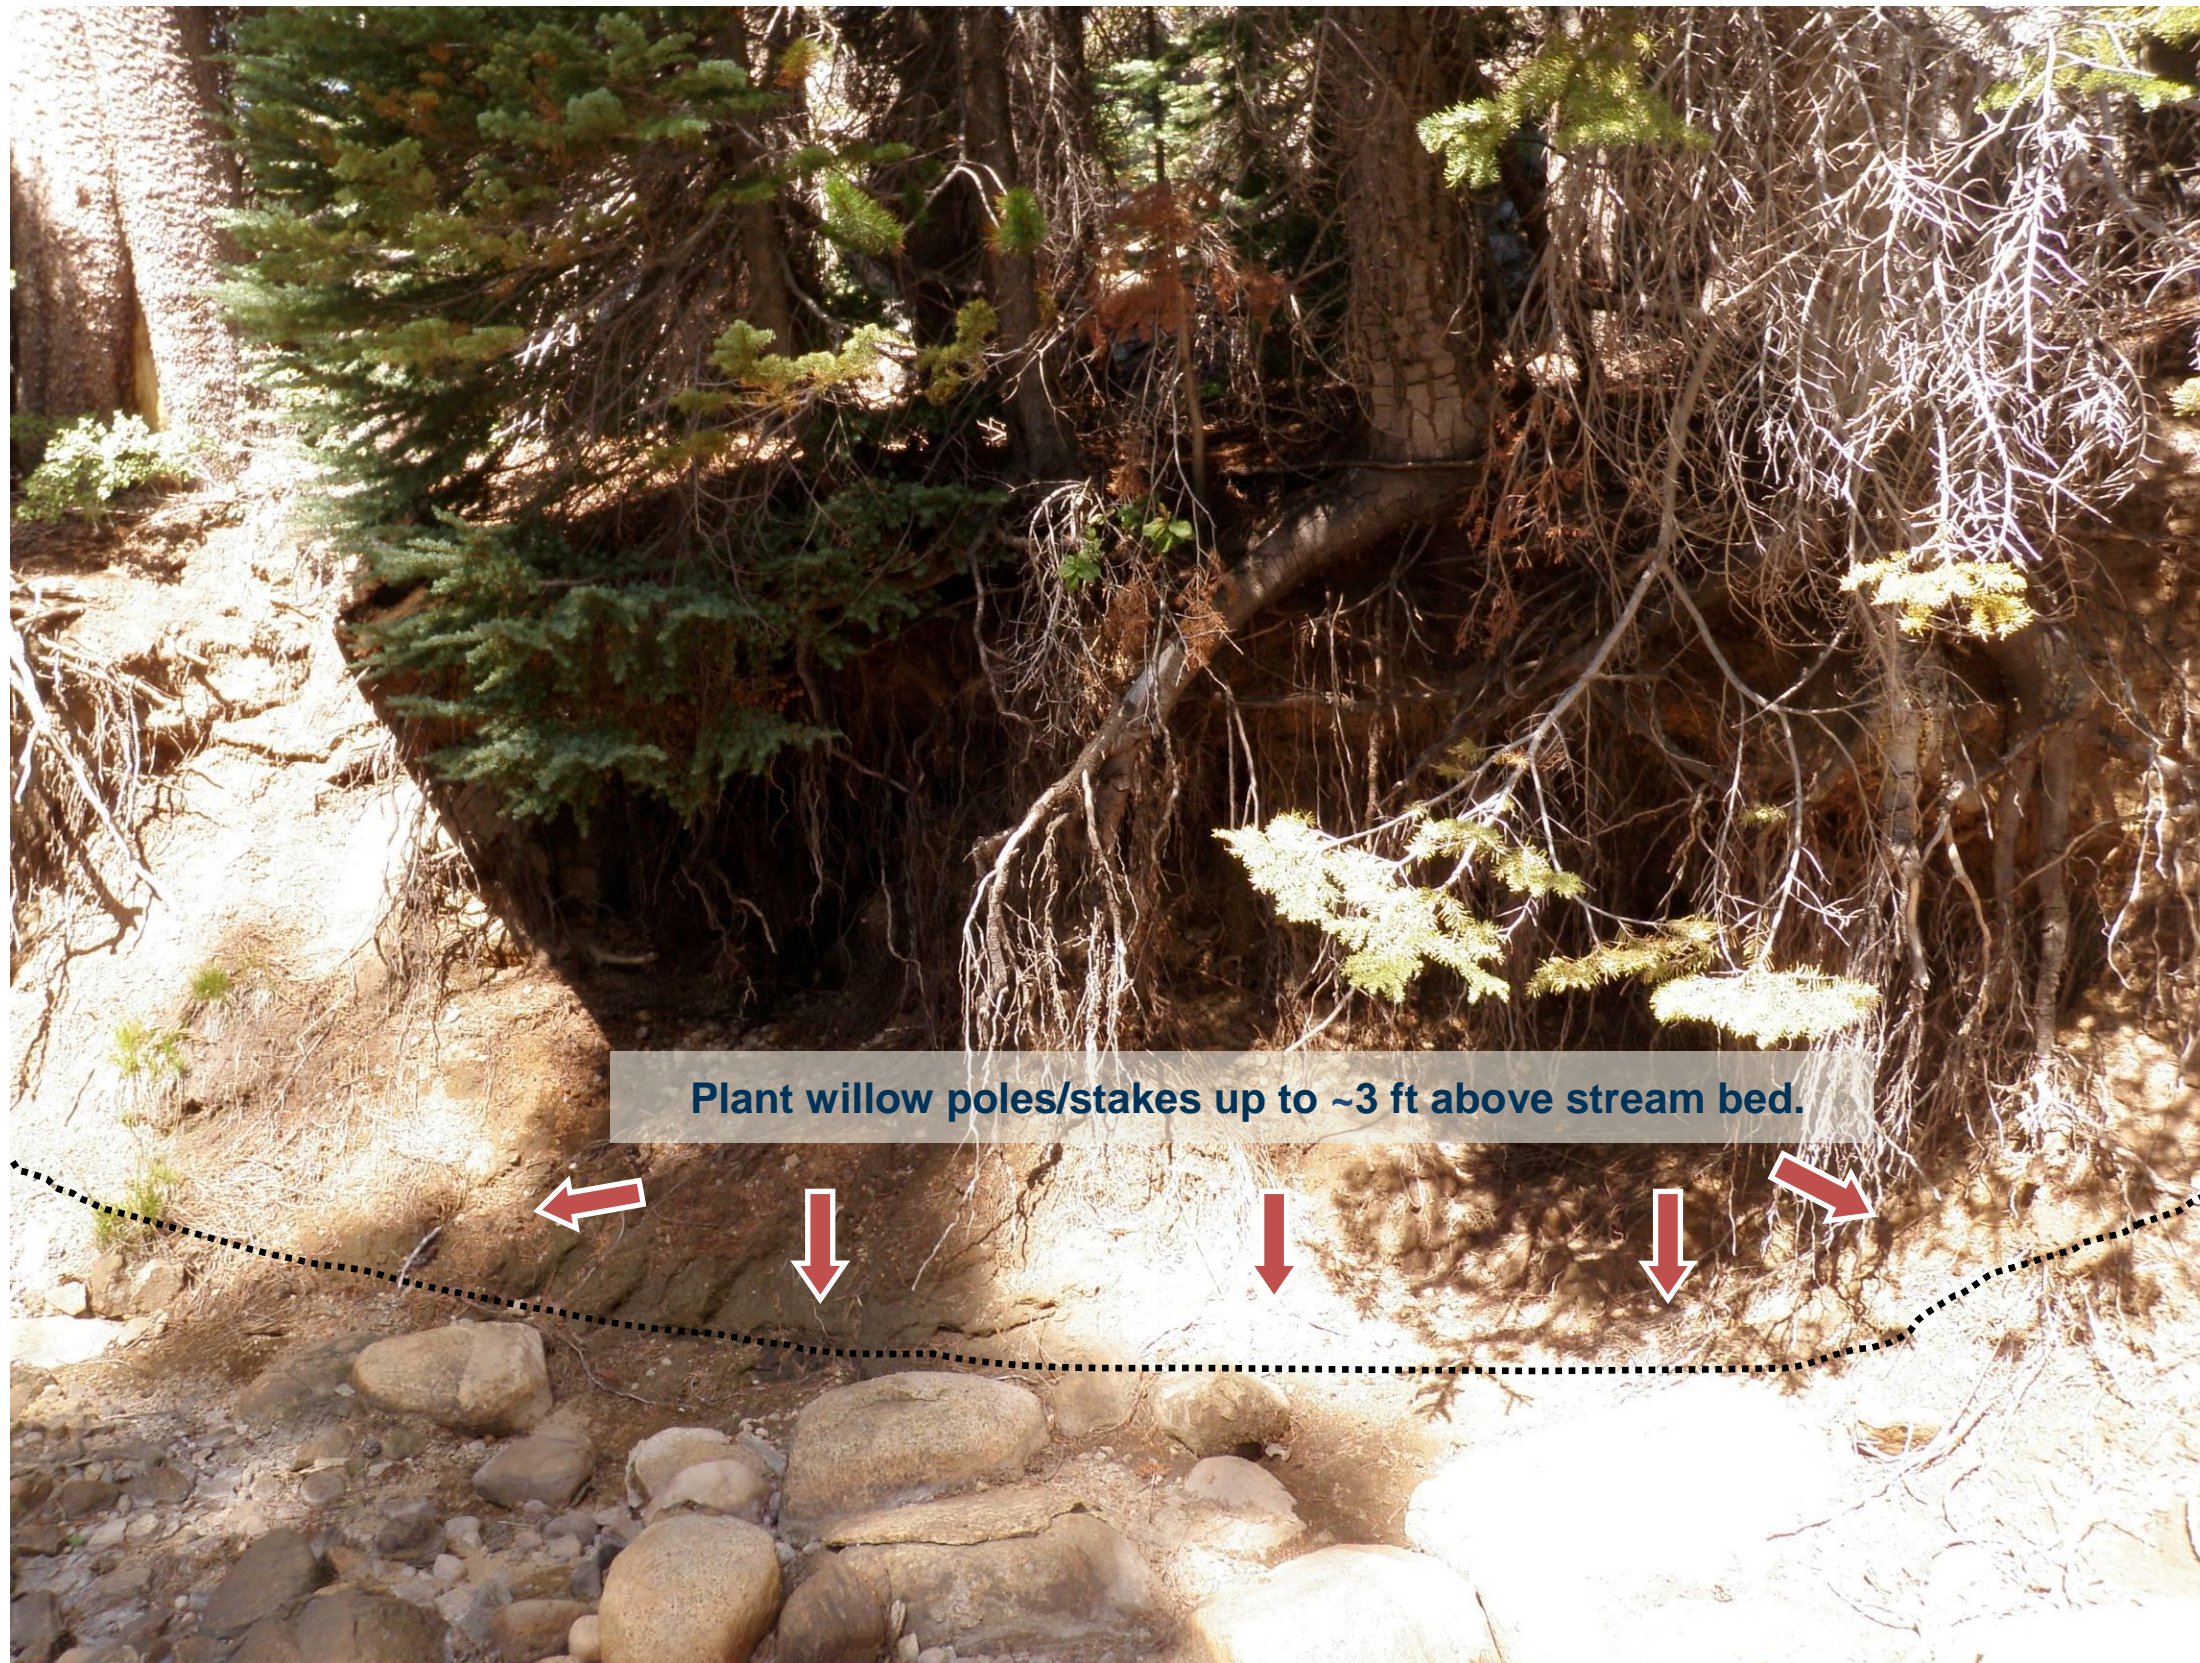
Figure 4 Upper Site - Treatment Area U-4: 2+72 to 2+58
