Caples Spillway Channel Stabilization Plan

El Dorado Hydroelectric Project
(FERC No. 184)

March 2018

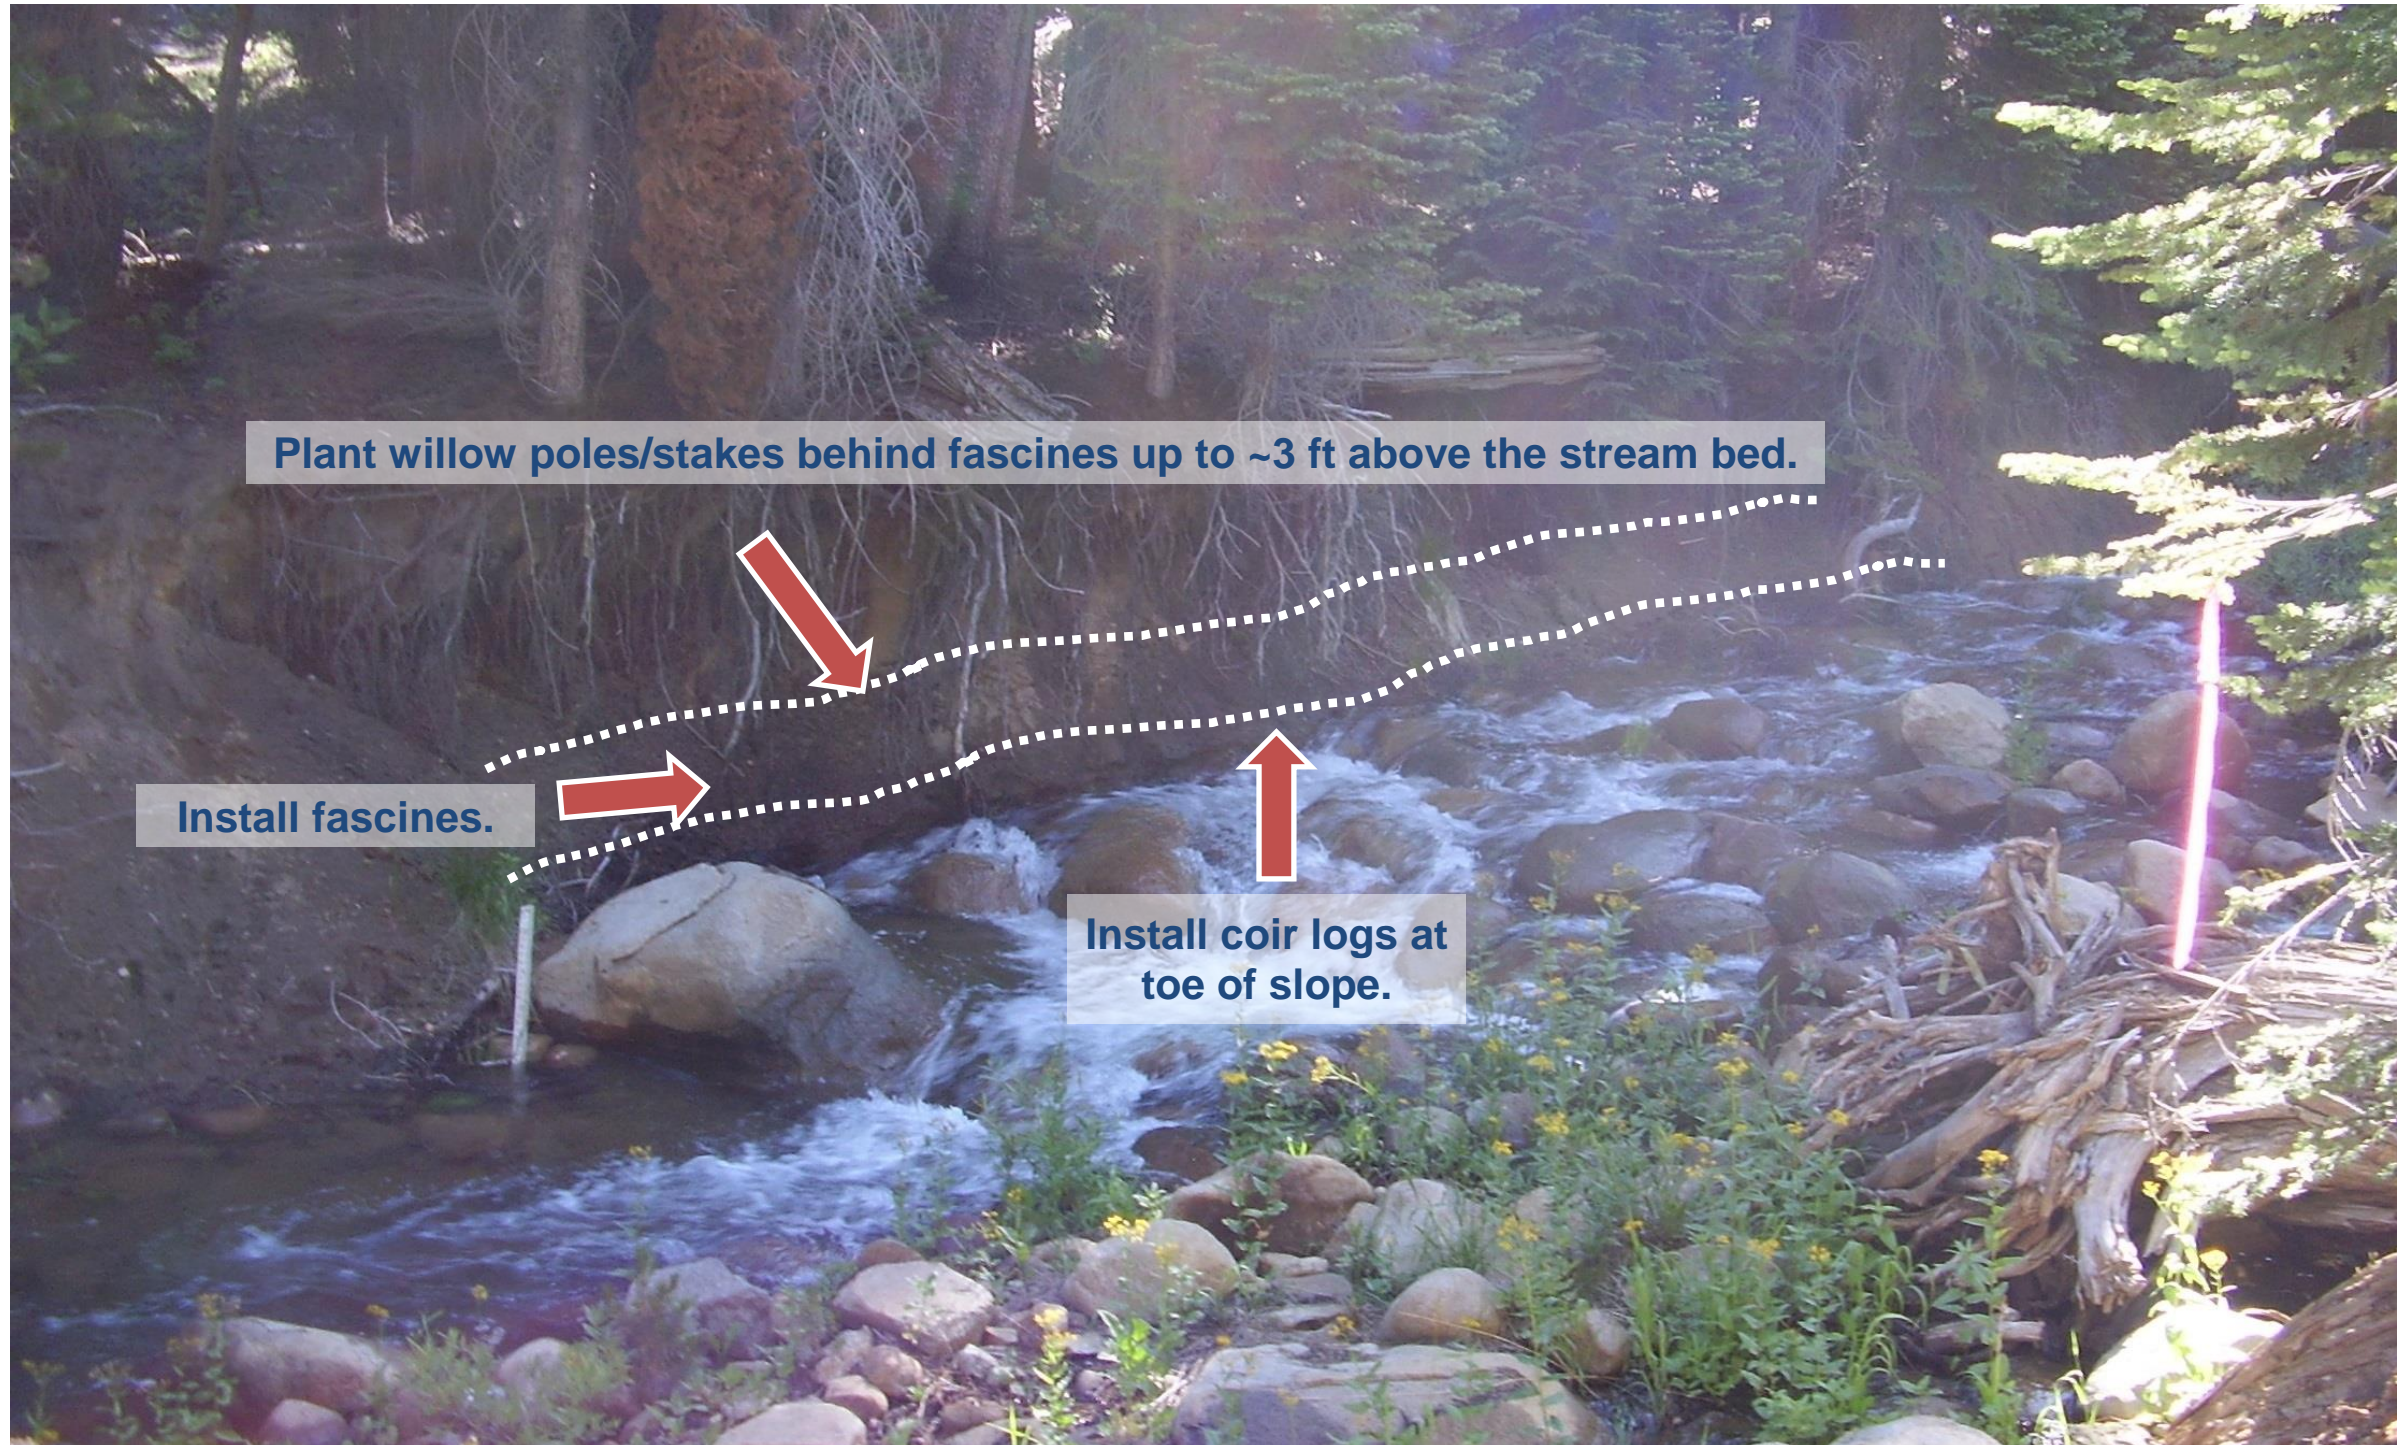
Figure 5 Upper Site – Treatment Area U-5: RB 2+46 to 1+39

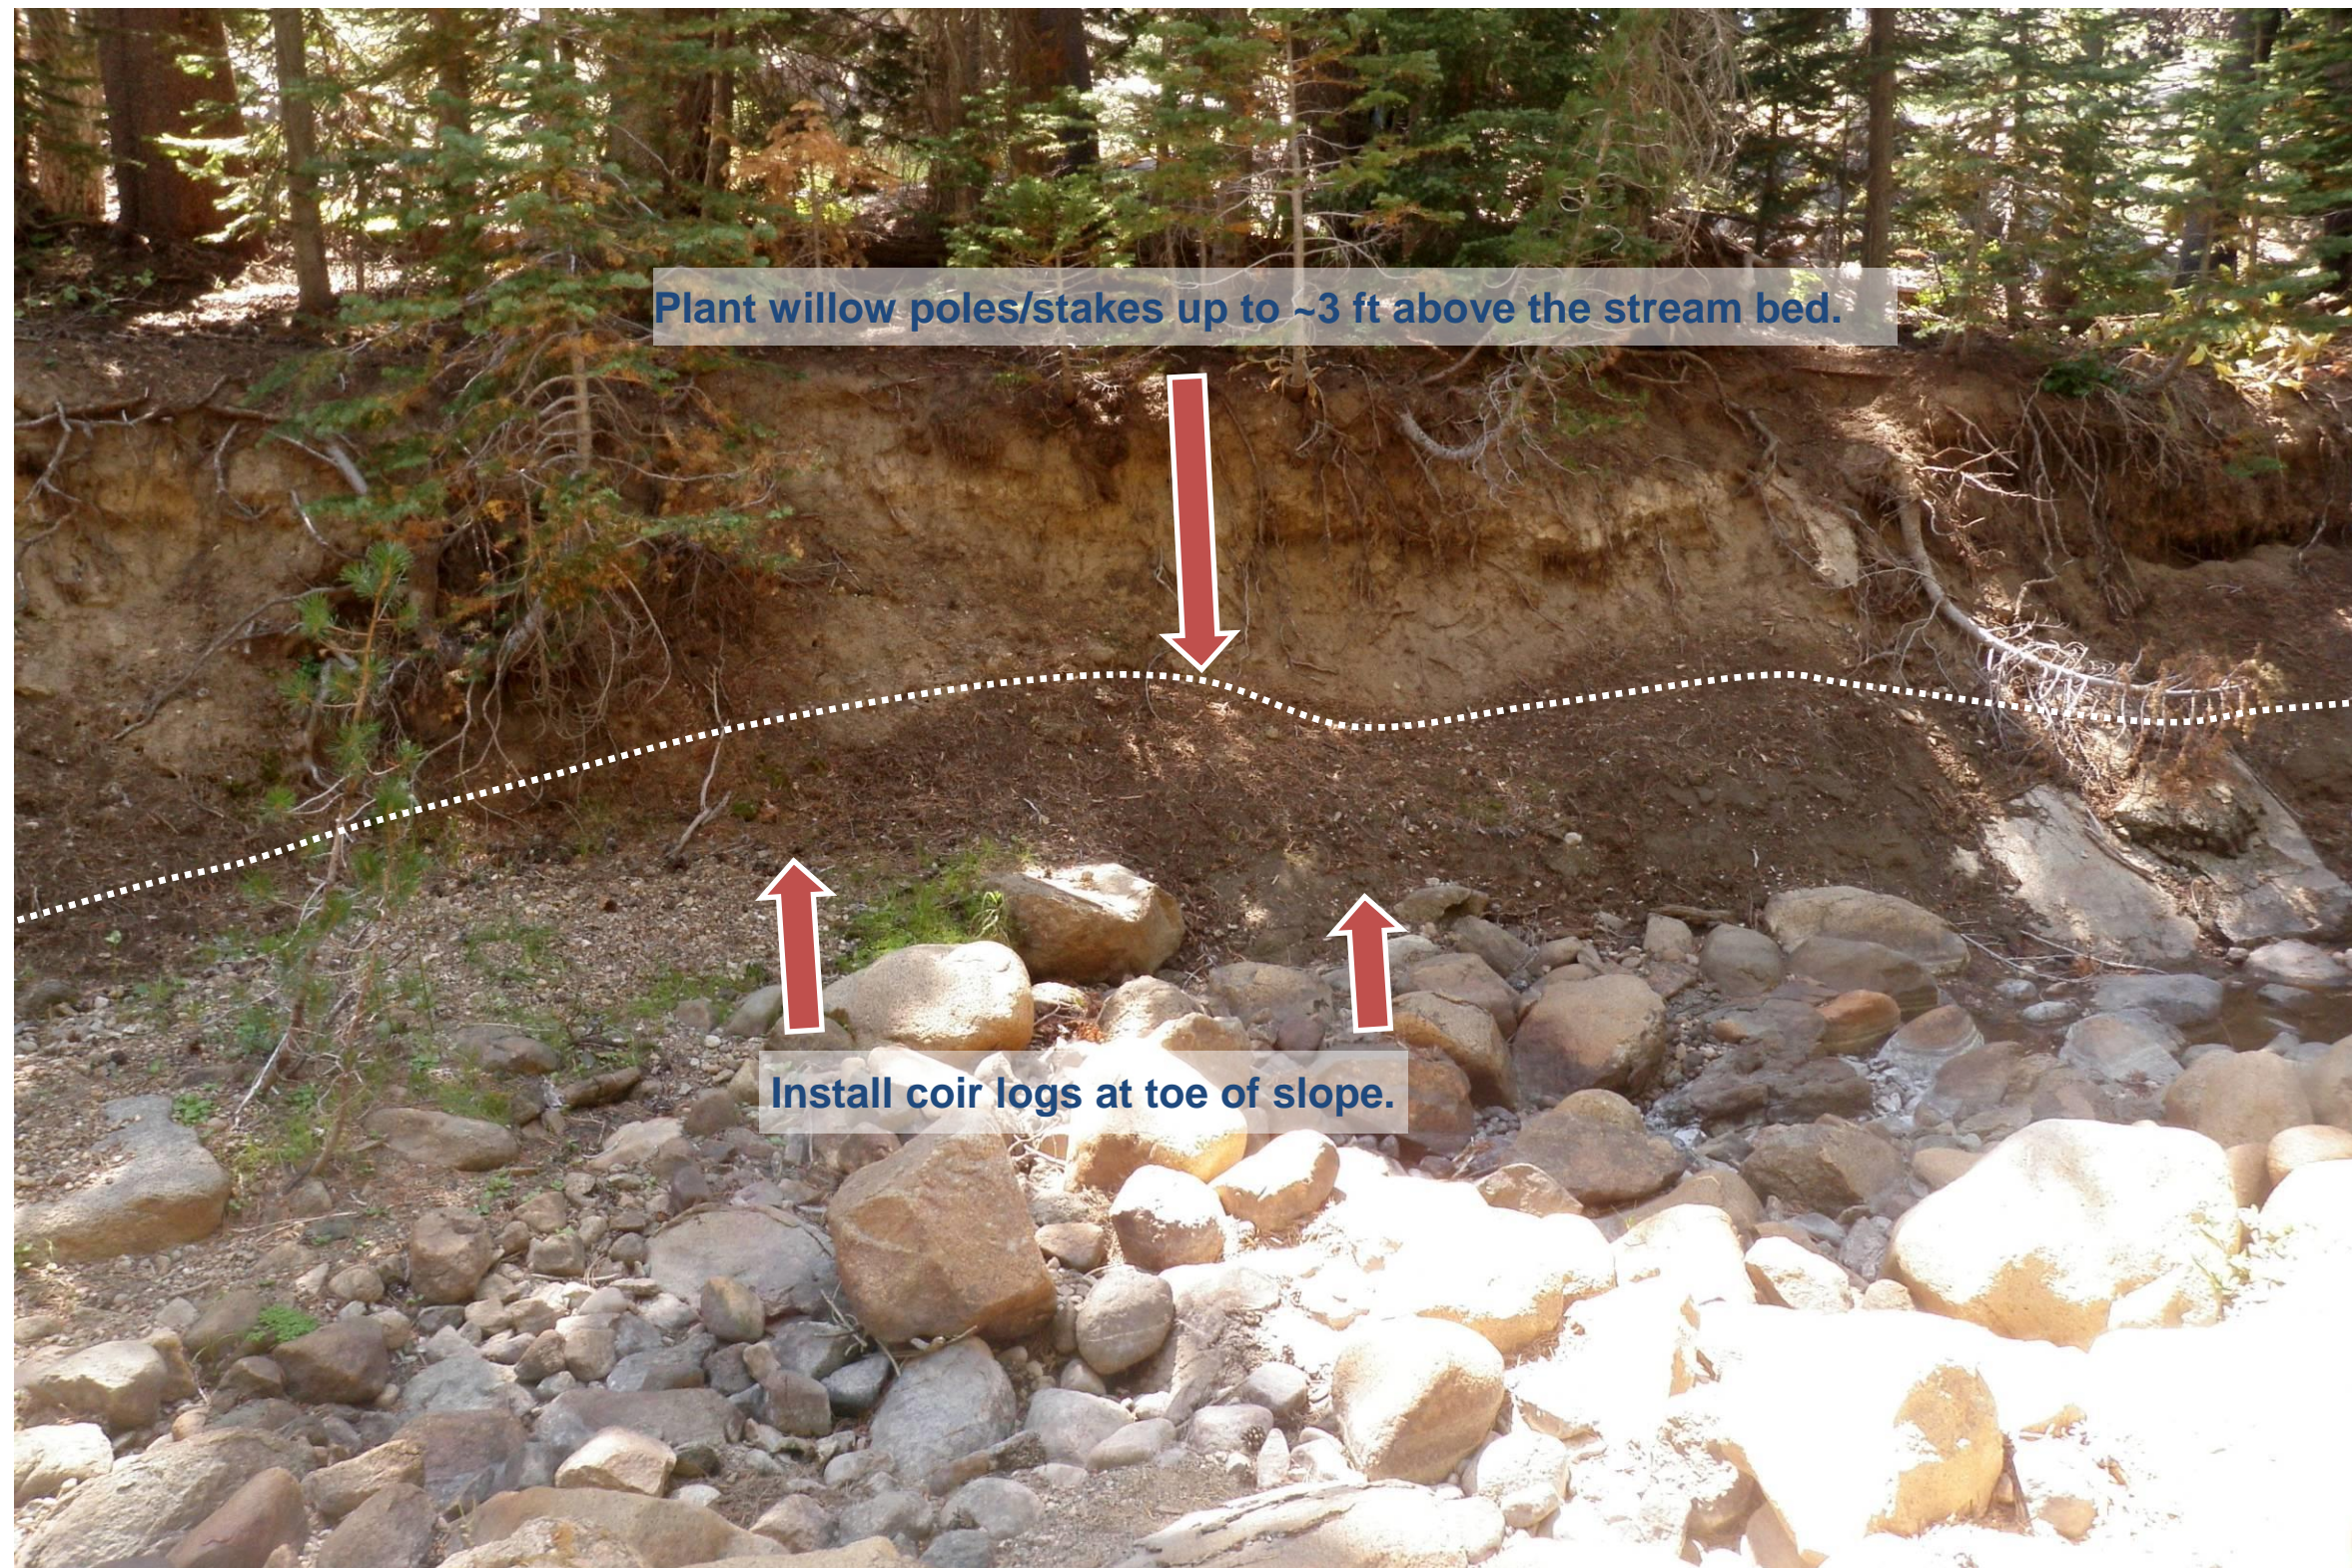
Figure 6a Upper Site – Treatment Area U-6: LB 1+87 to 1+25 (Photo 1 of 2)

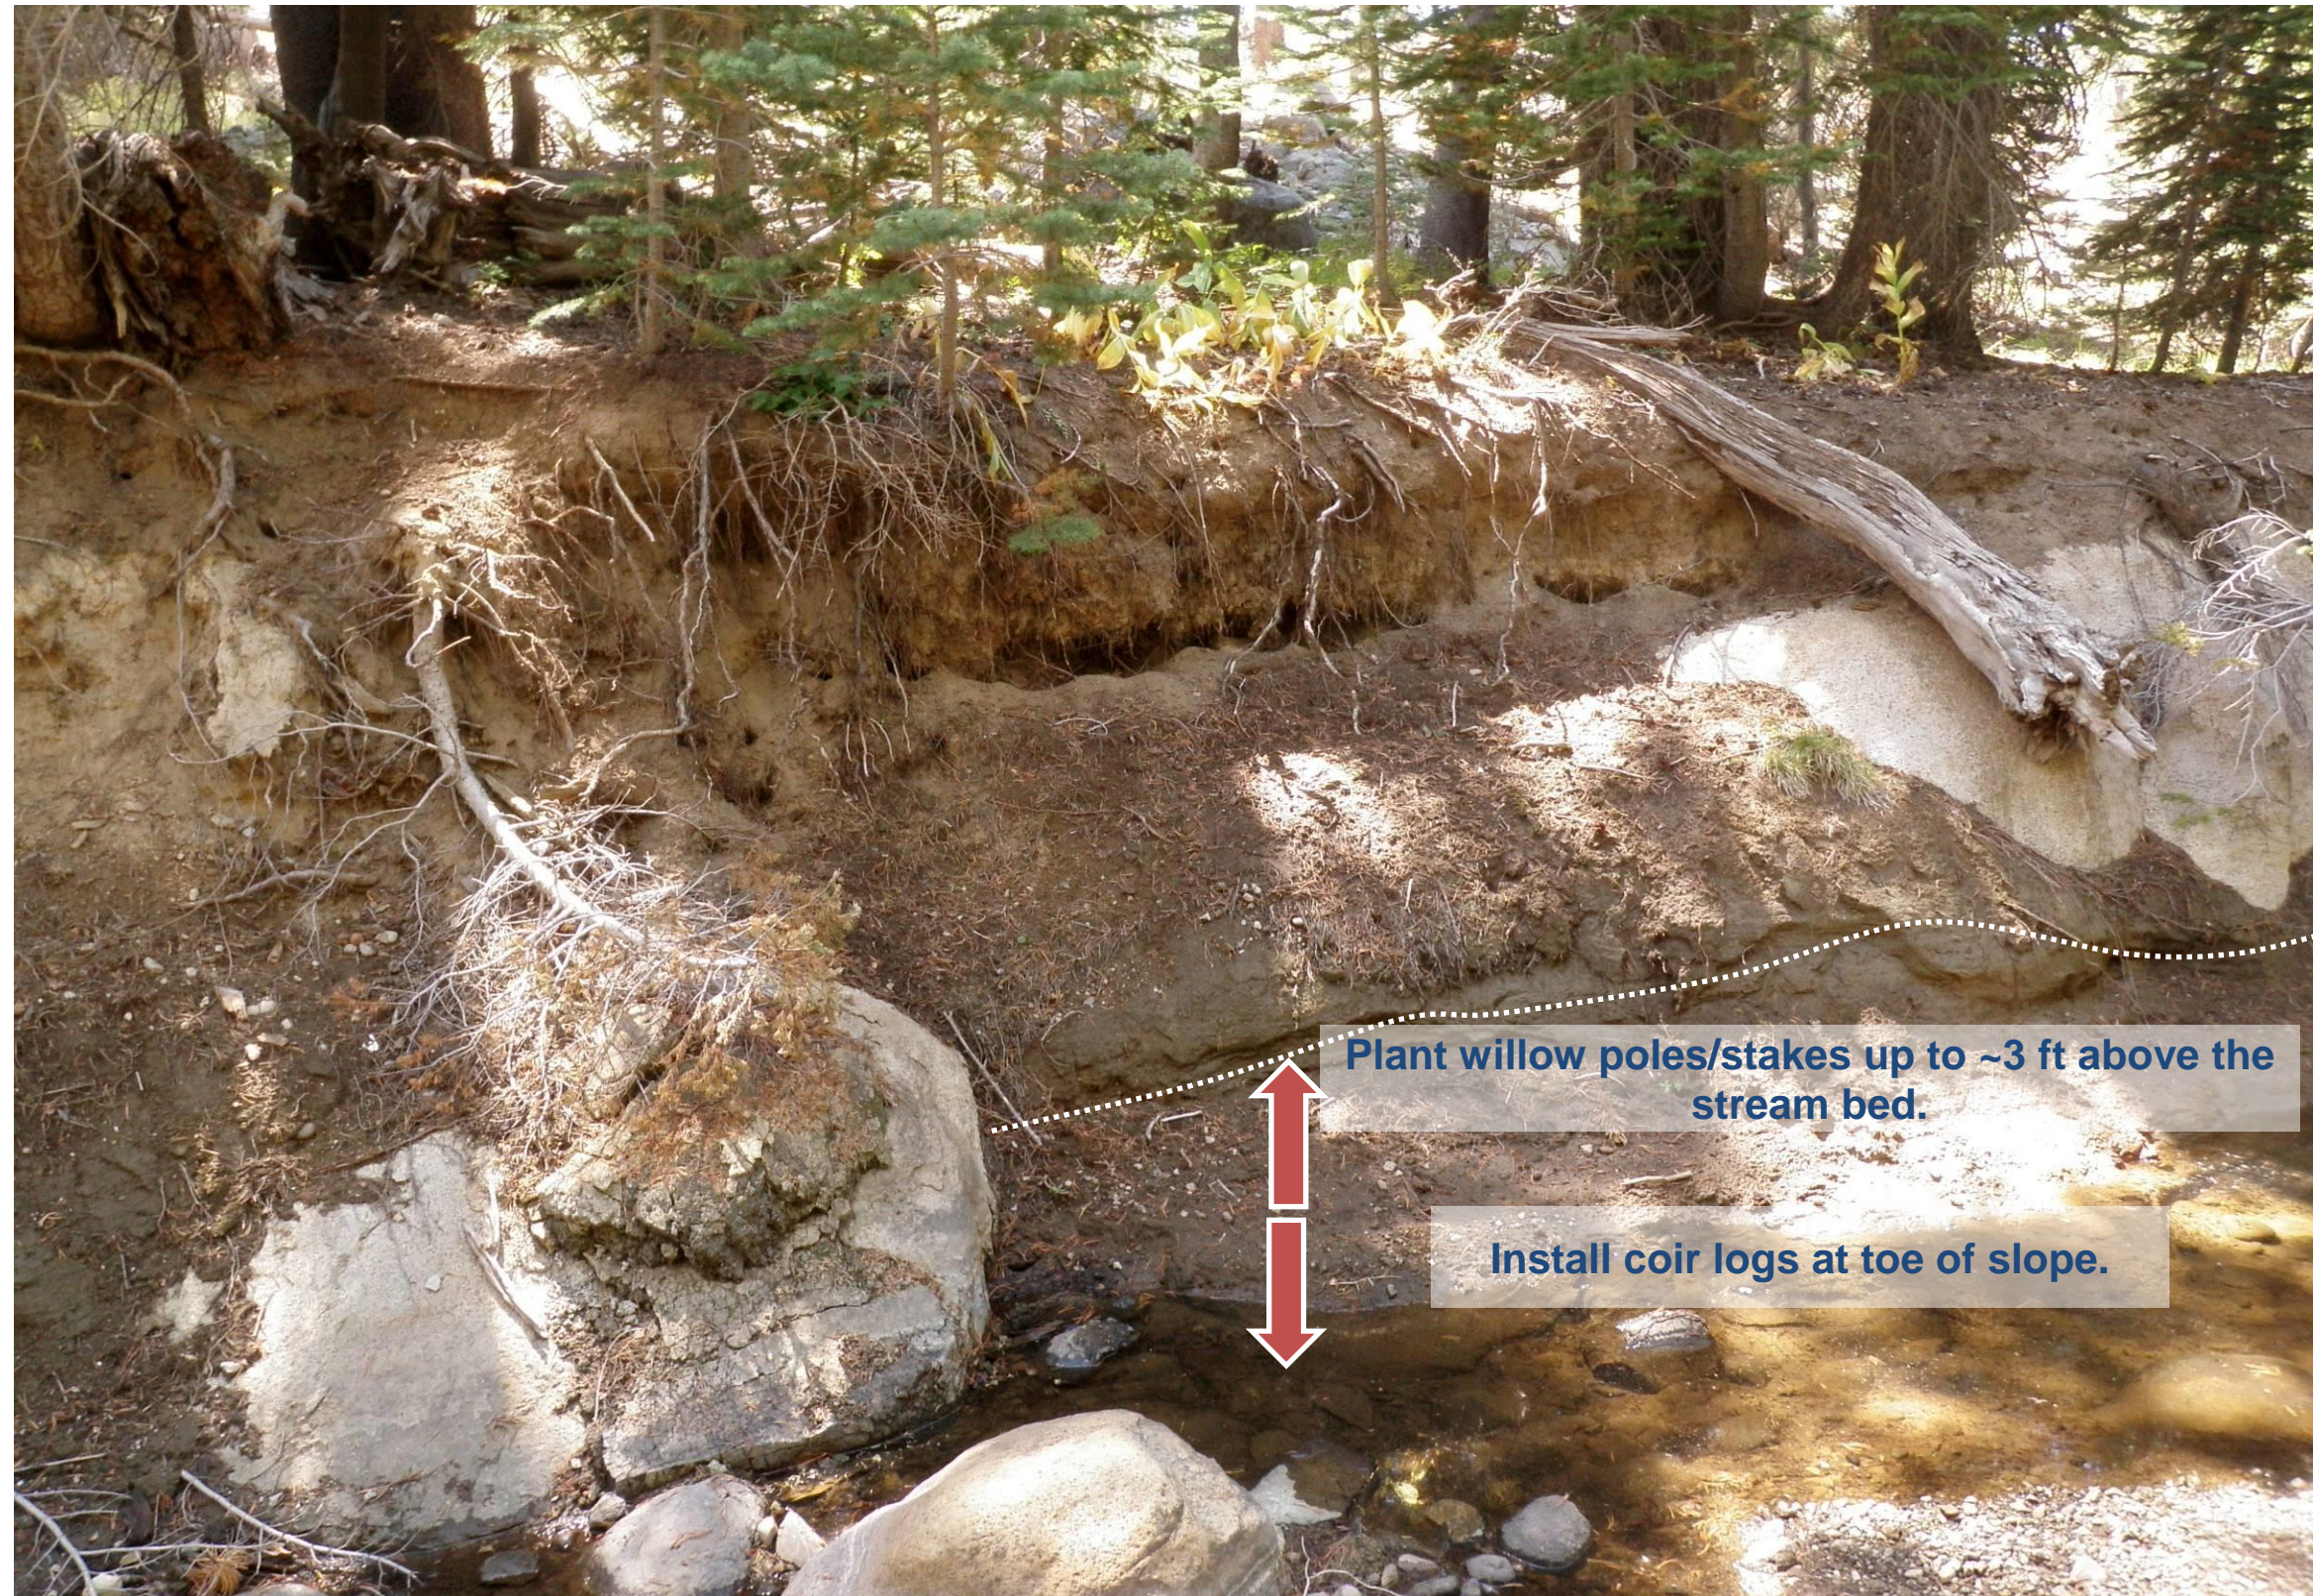
Figure 6b Upper Site – Treatment Area U-6: LB 2+46-1+39 (Photo 2 of 2)

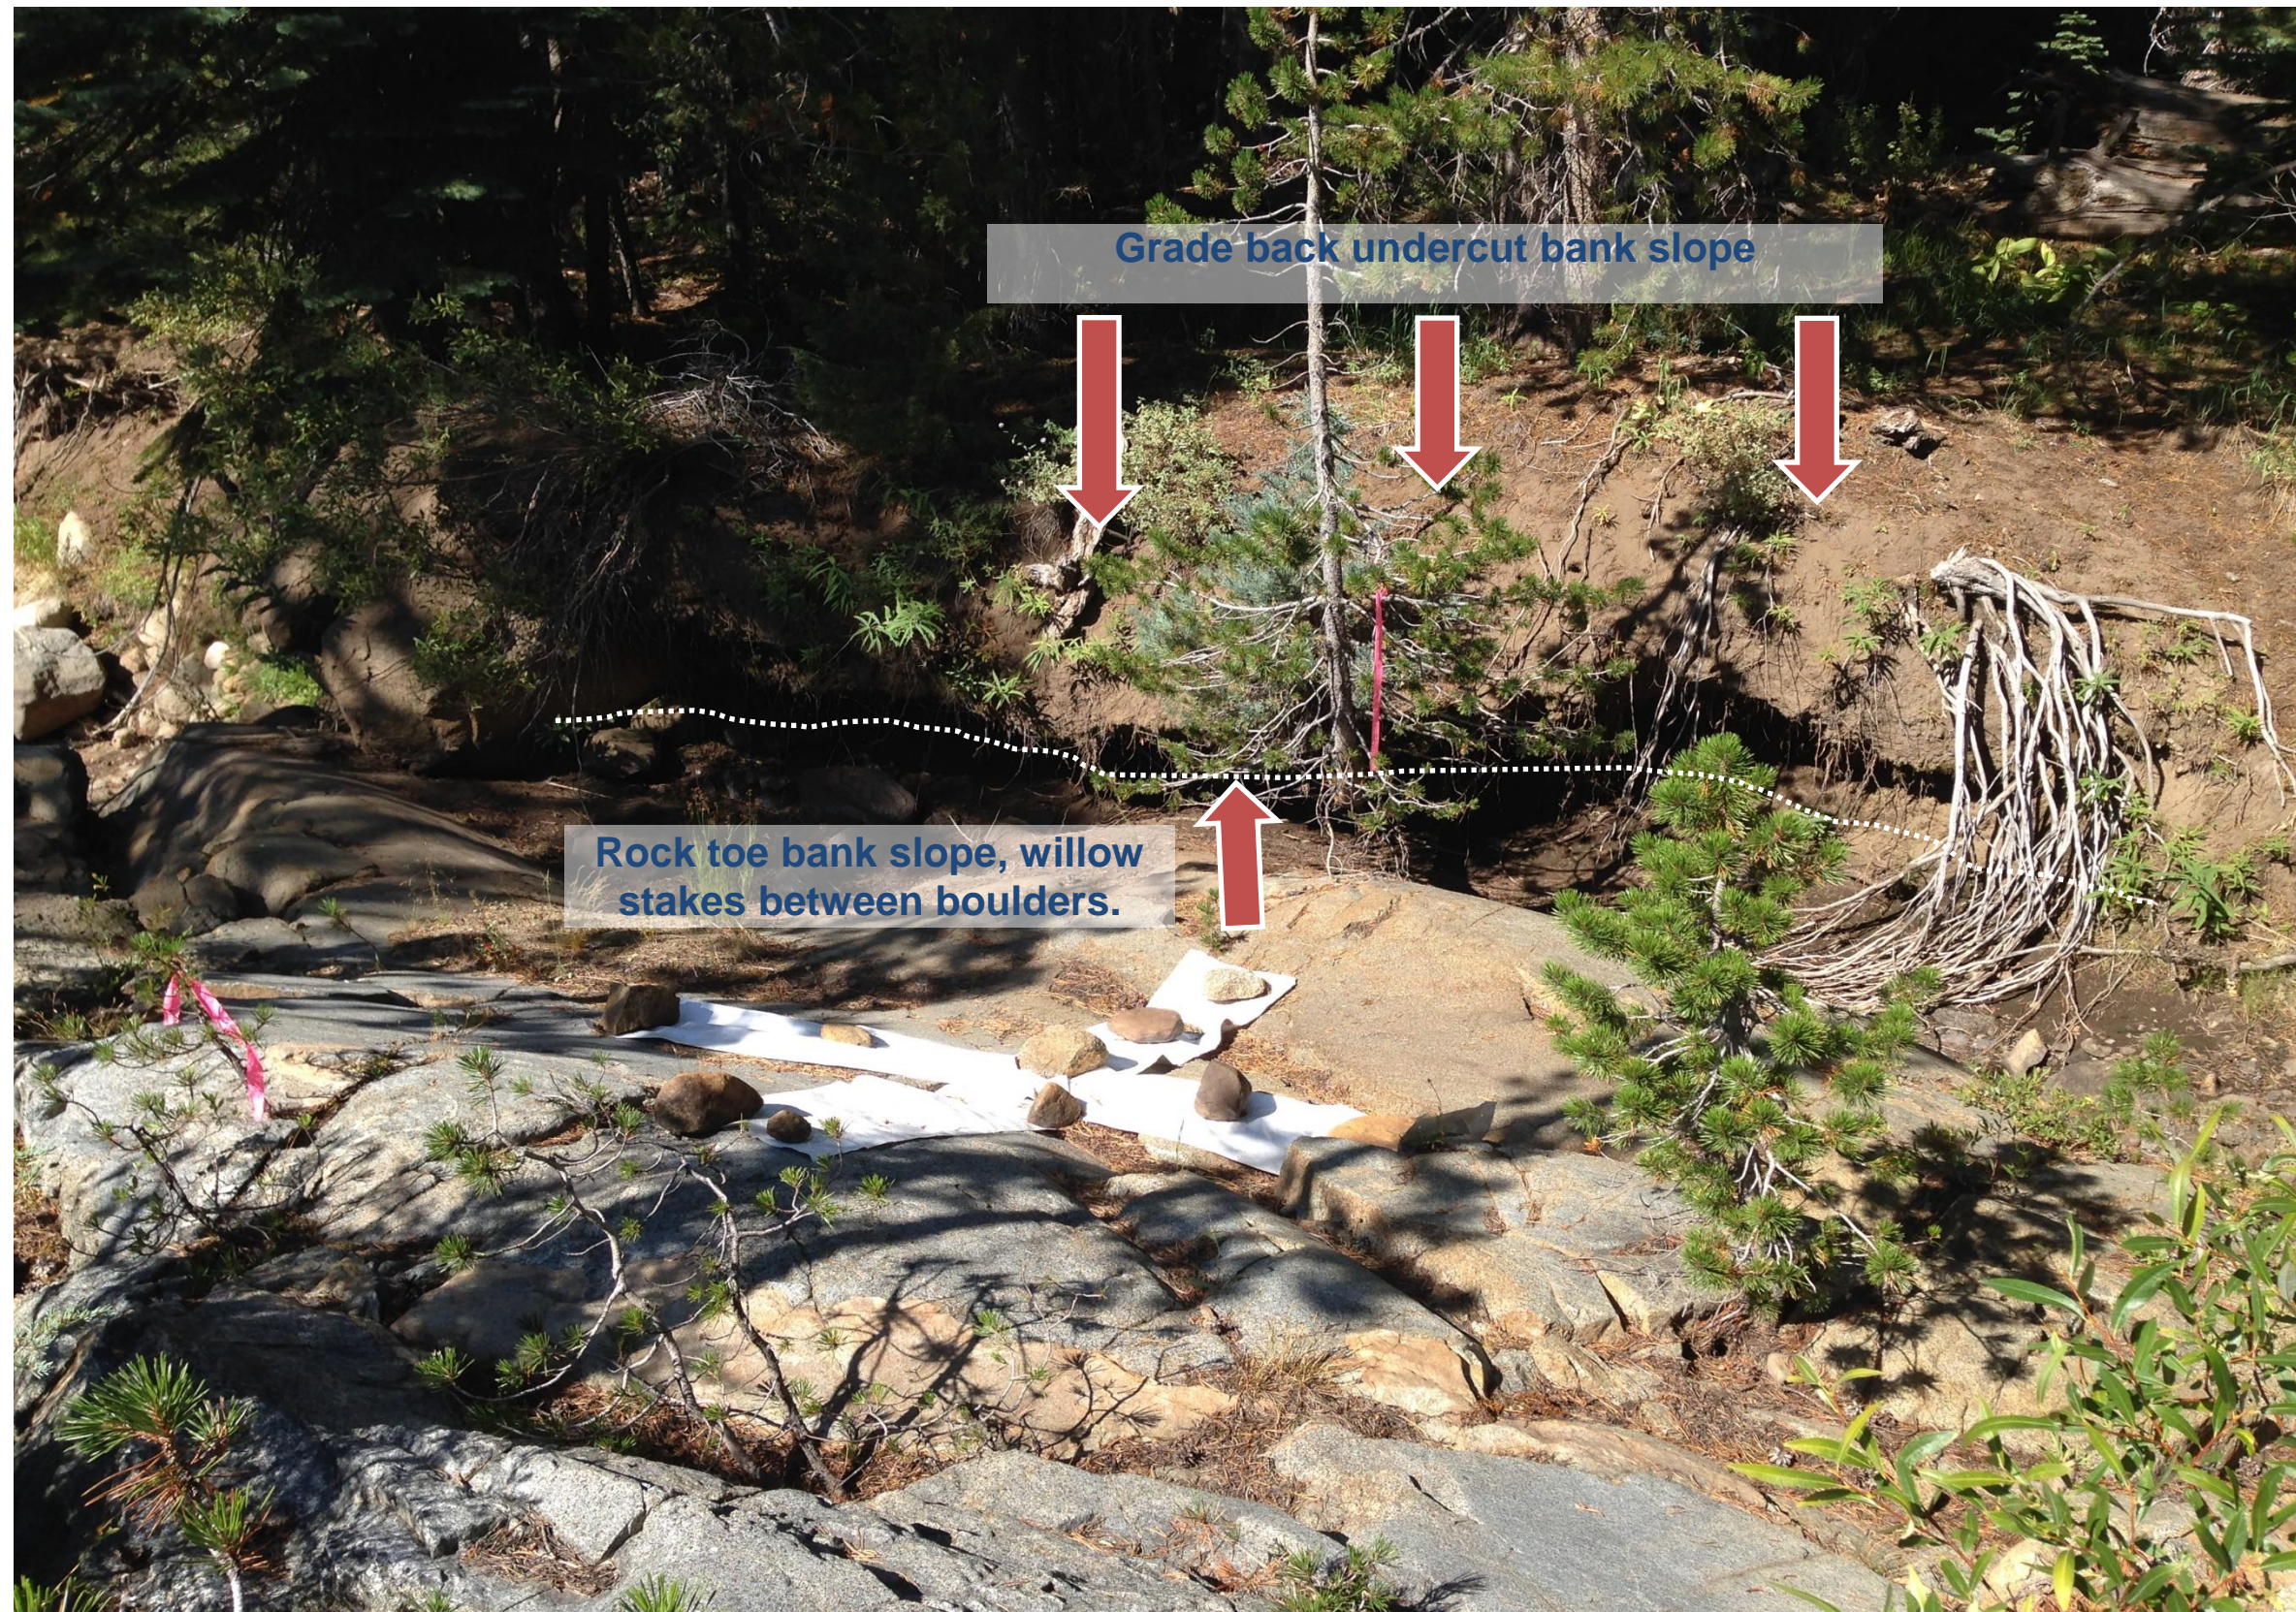
Figure 7. Upper Site – Treatment Area U-7: RB 0+60 to 1+08

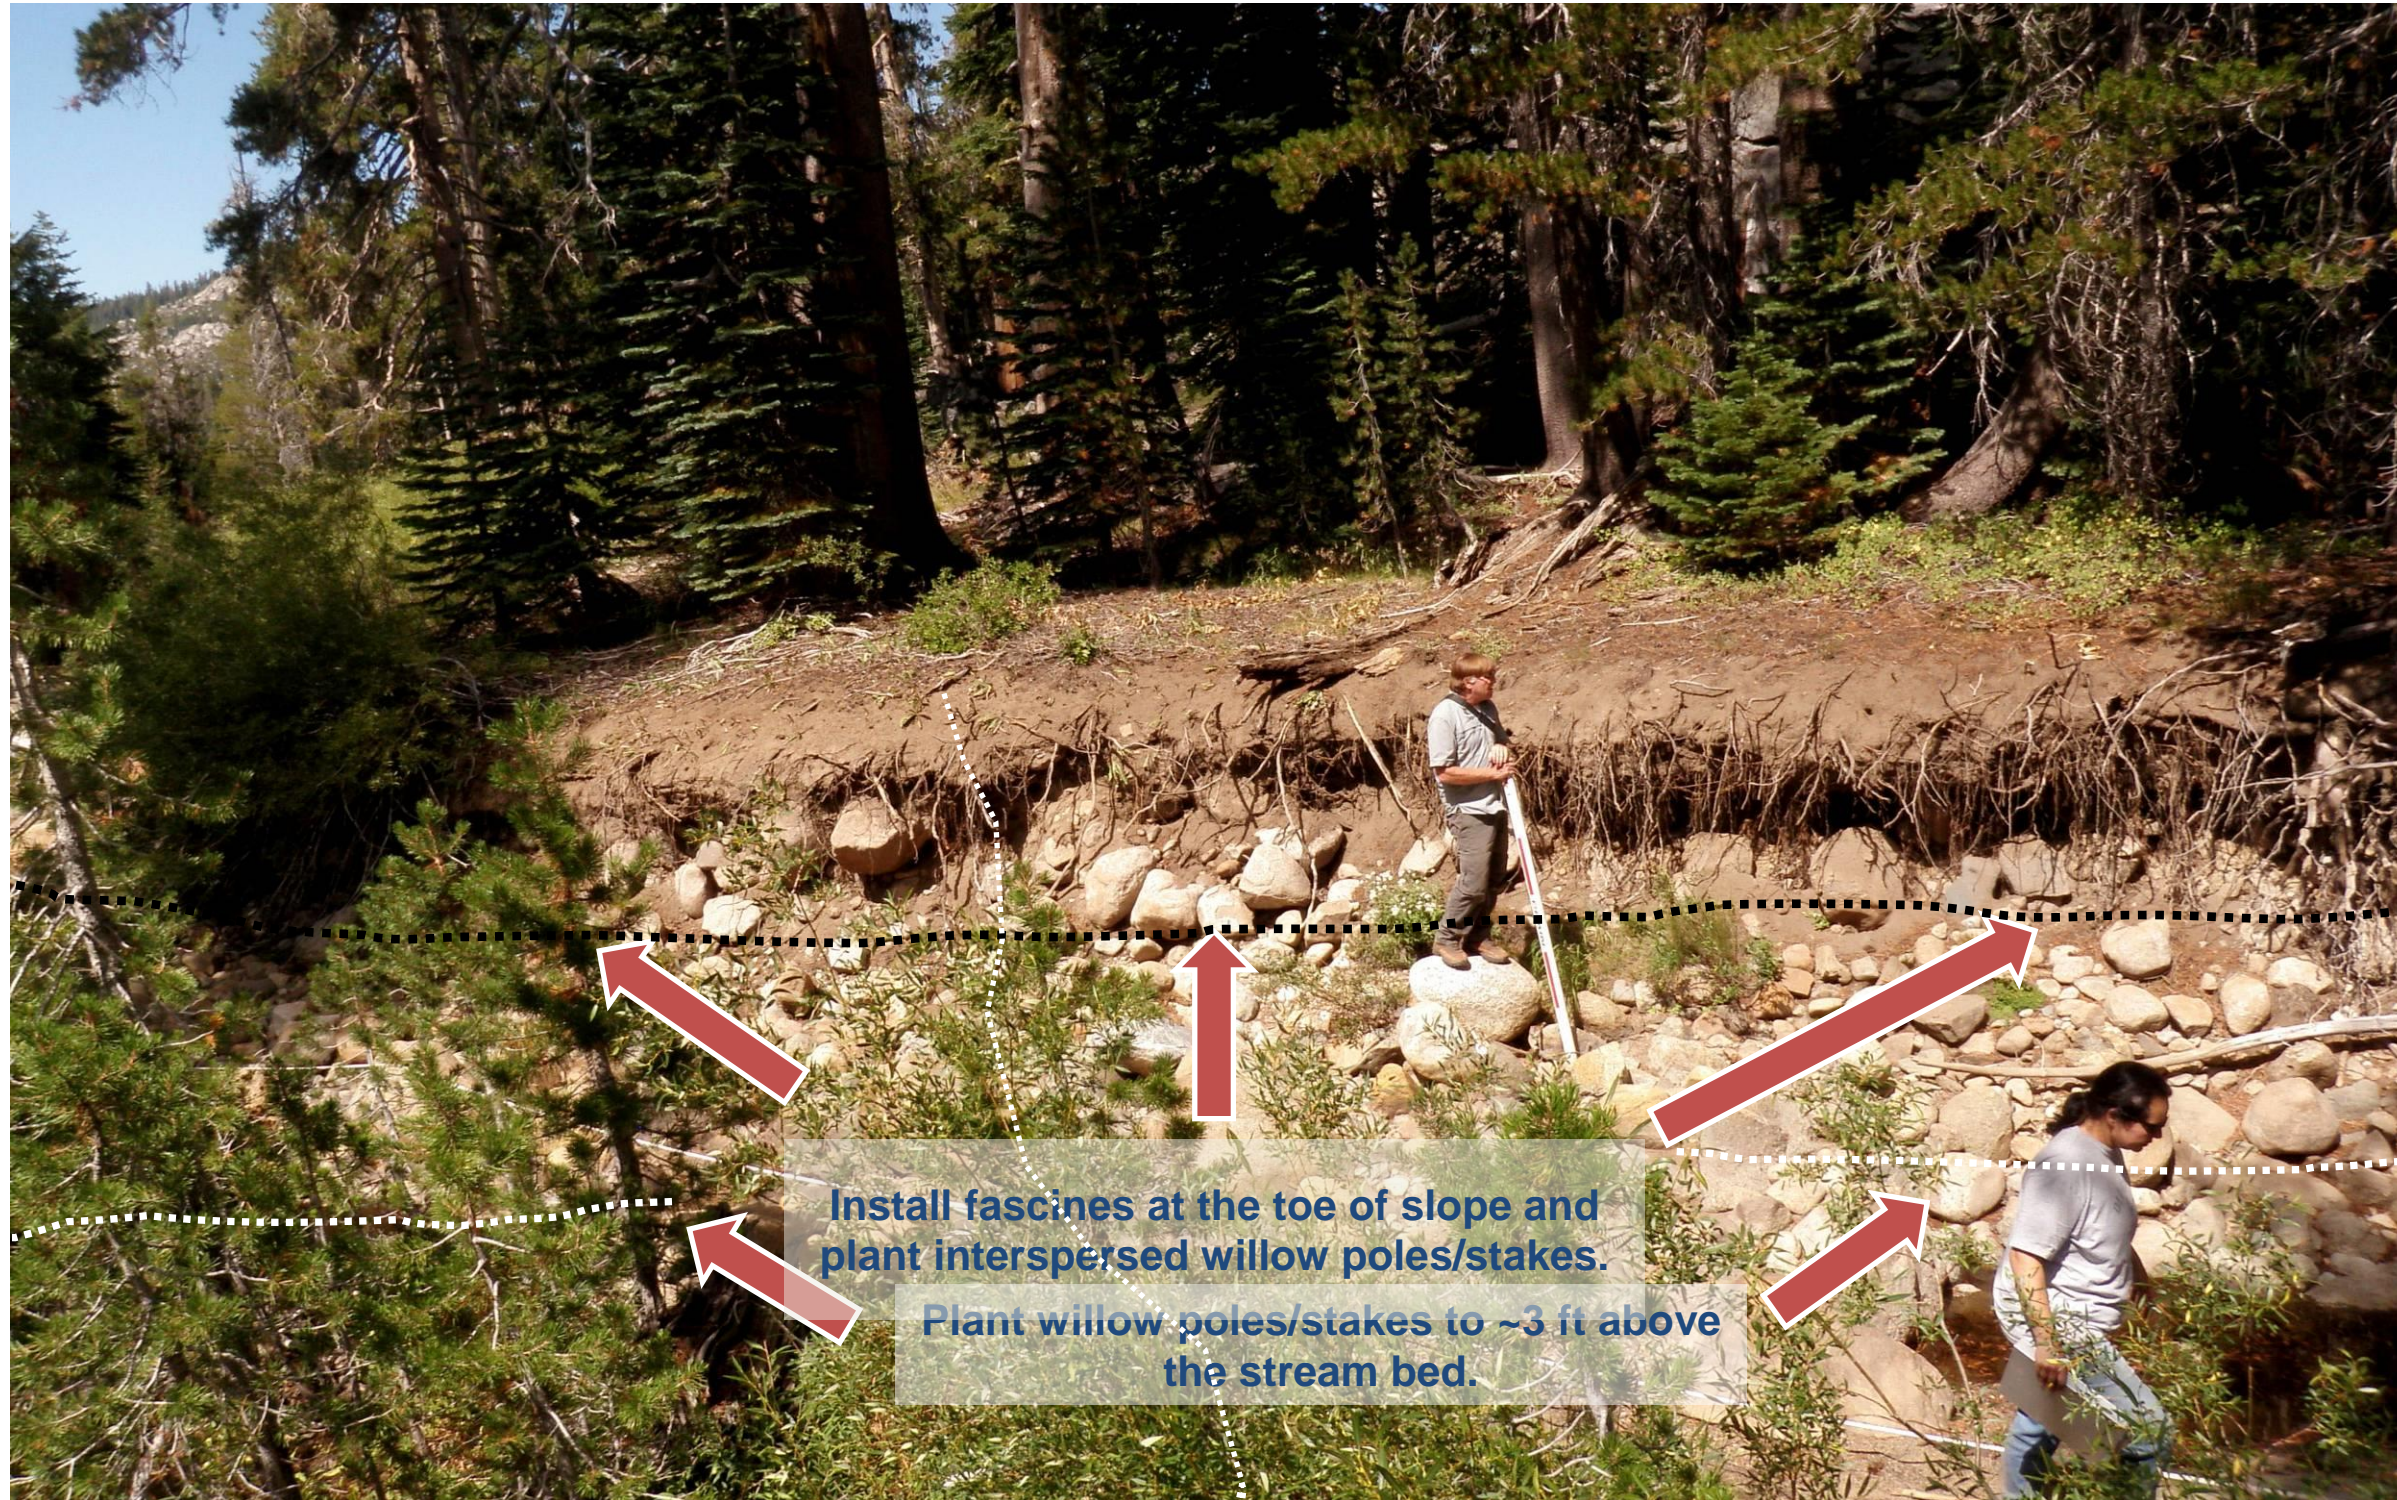
Figure 8 Upper Site – Treatment Area U-8: RB 0+64 to 0+01

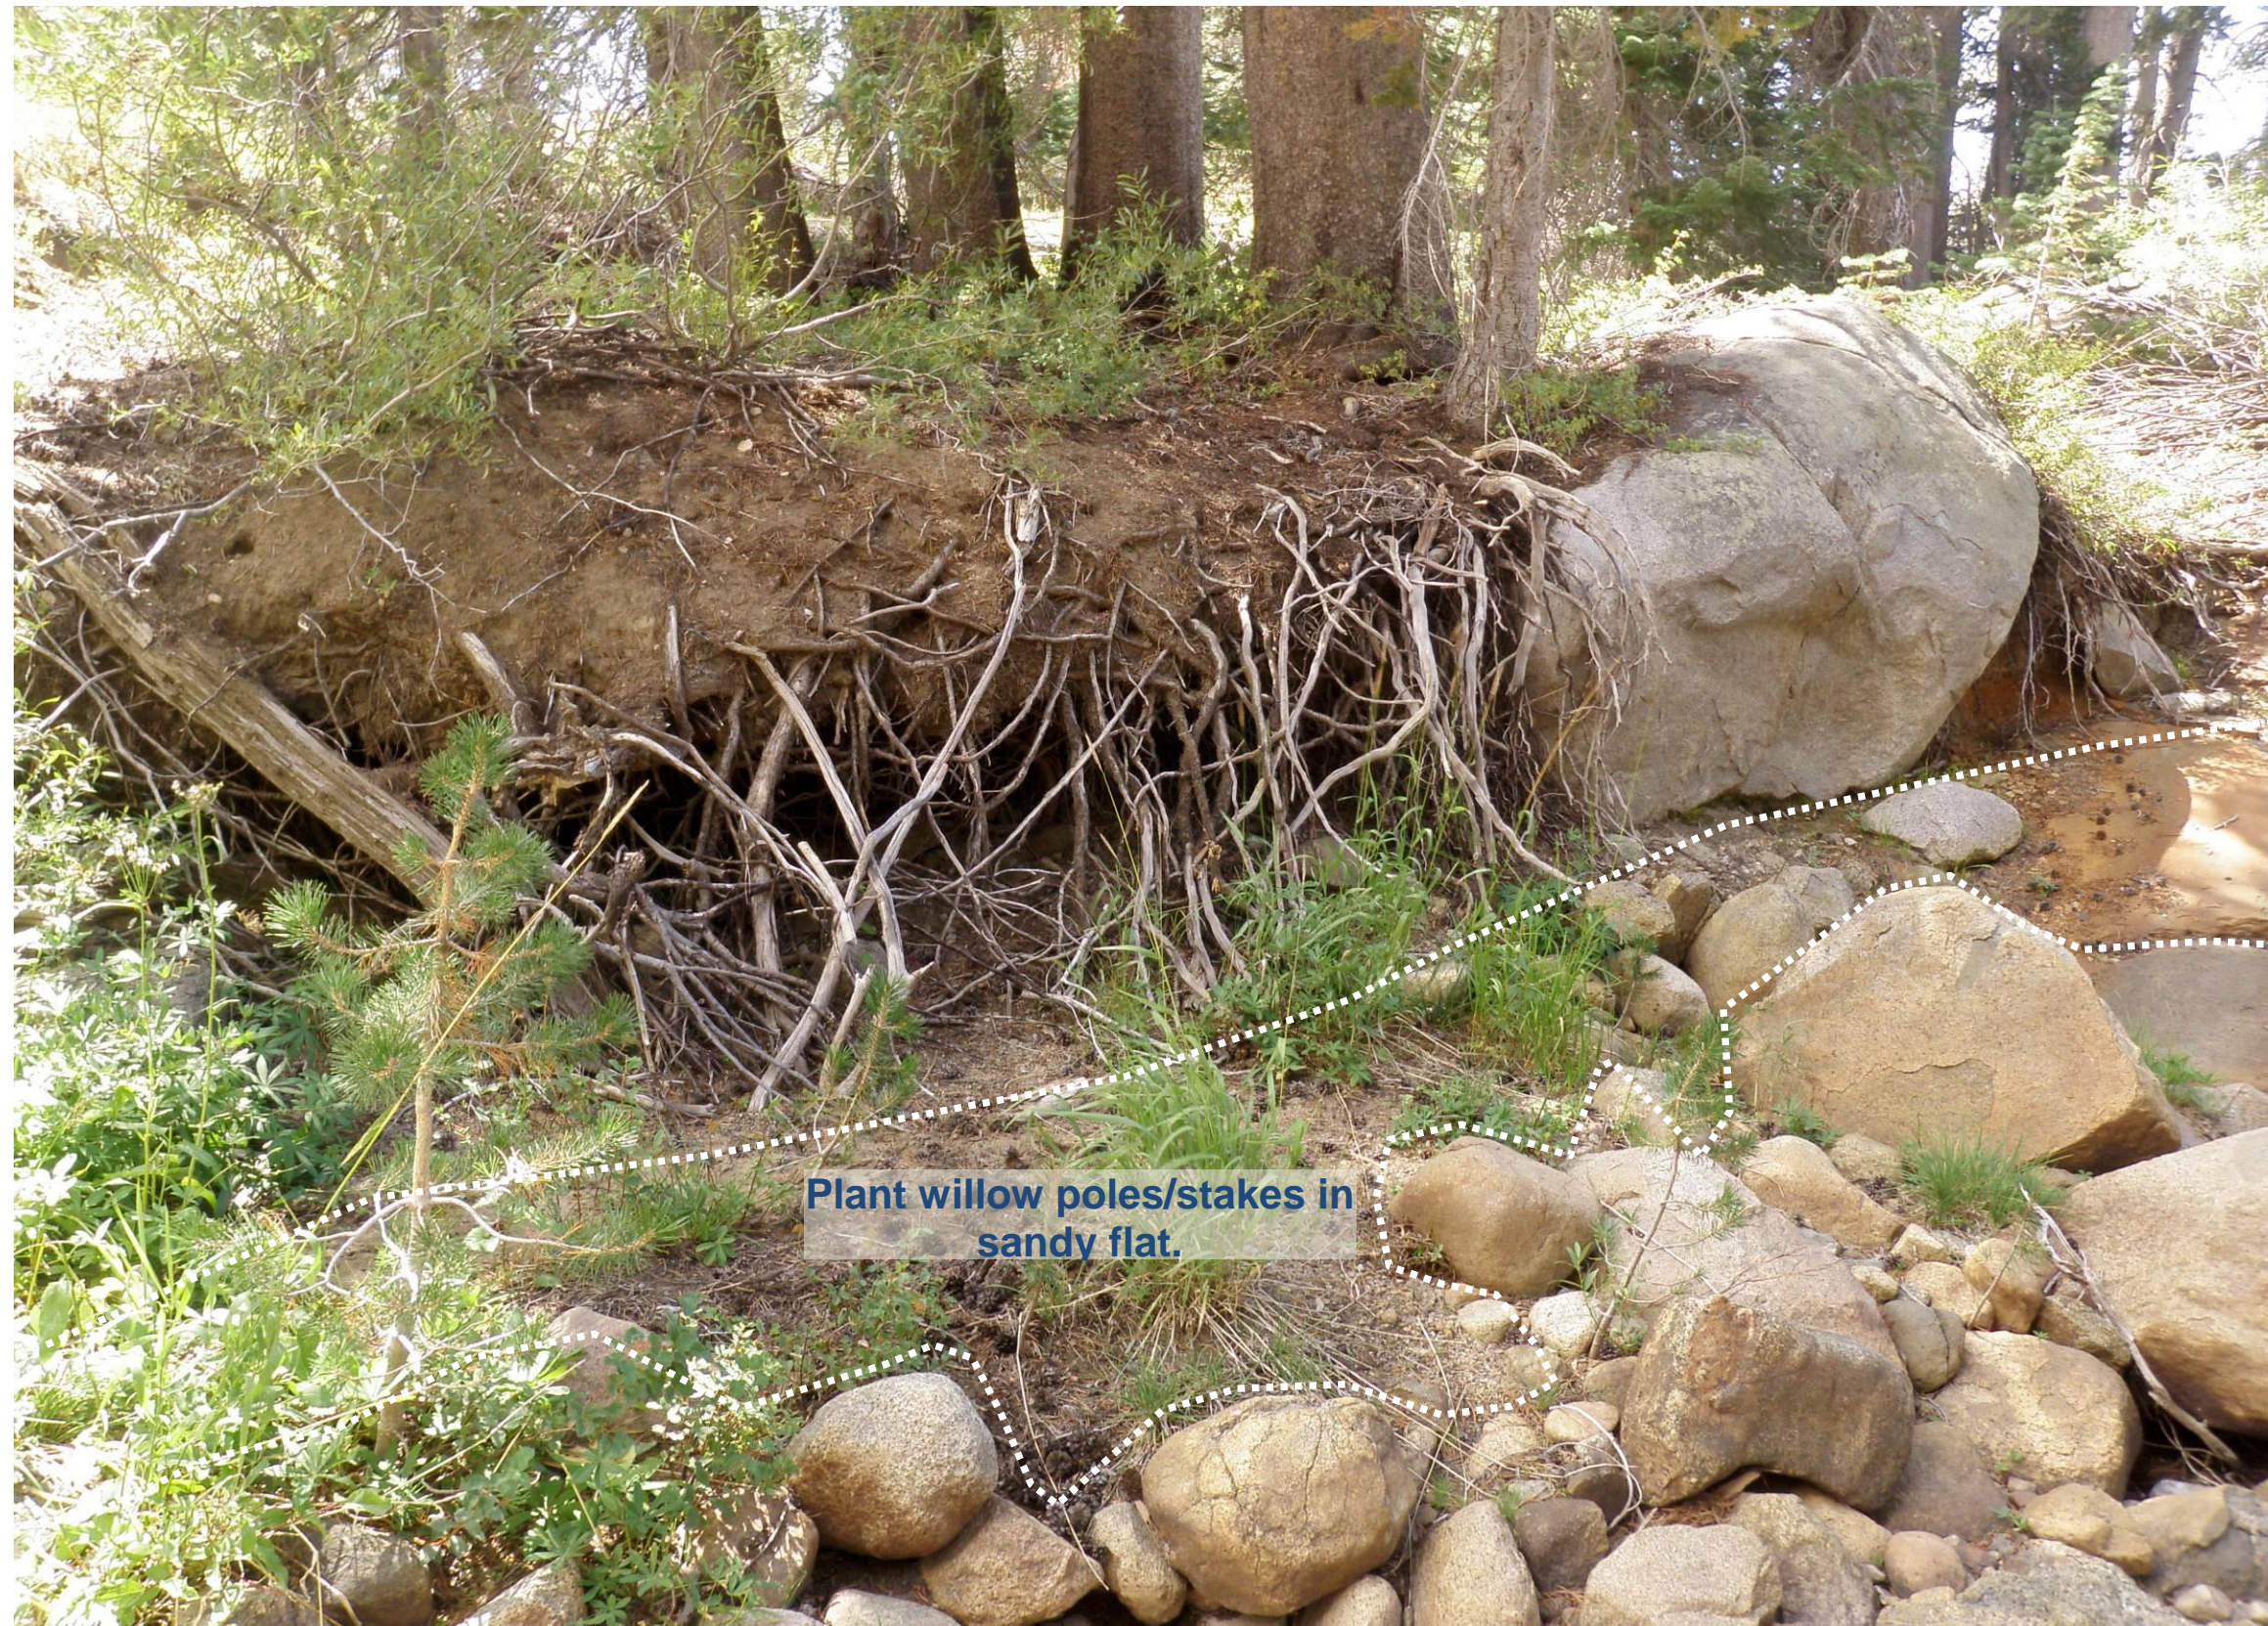
Figure 9 Upper Site – Treatment Area U-9: LB 0+48 to 0+12
