Caples Spillway Channel Stabilization Plan

El Dorado Hydroelectric Project
(FERC No. 184)

March 2018

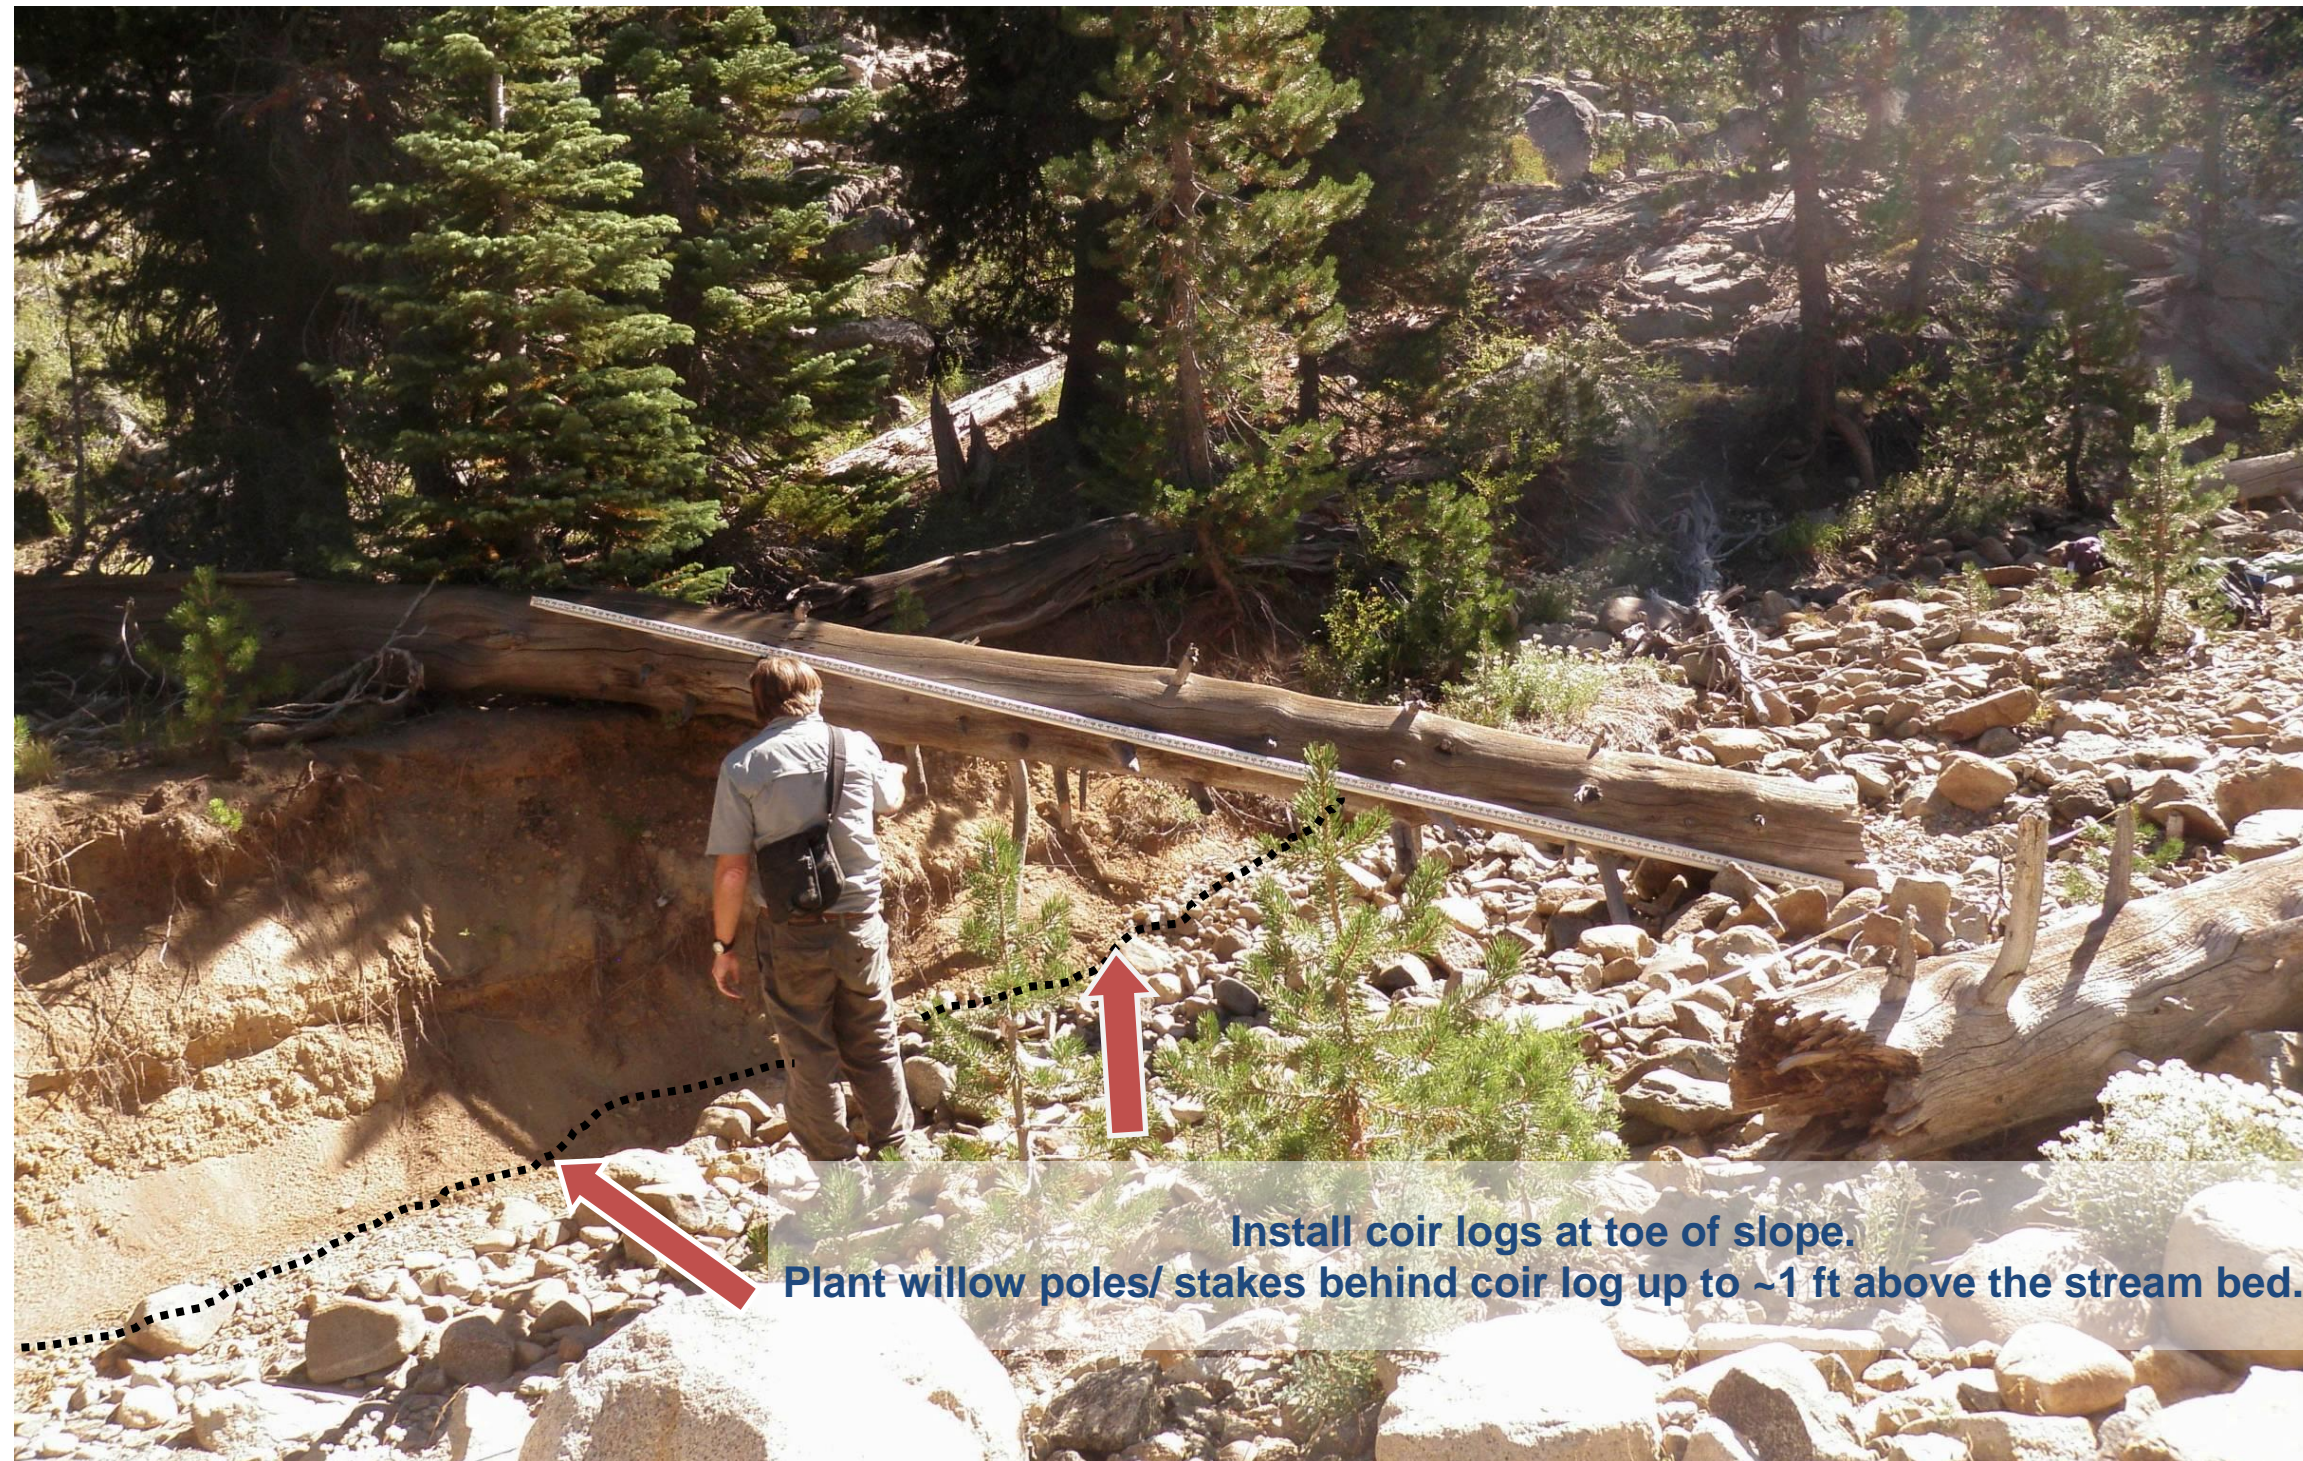
Figure 9a Lower Site – Treatment Area L-1: RB 8+48 to 7+74 (Photo 1 of 2)

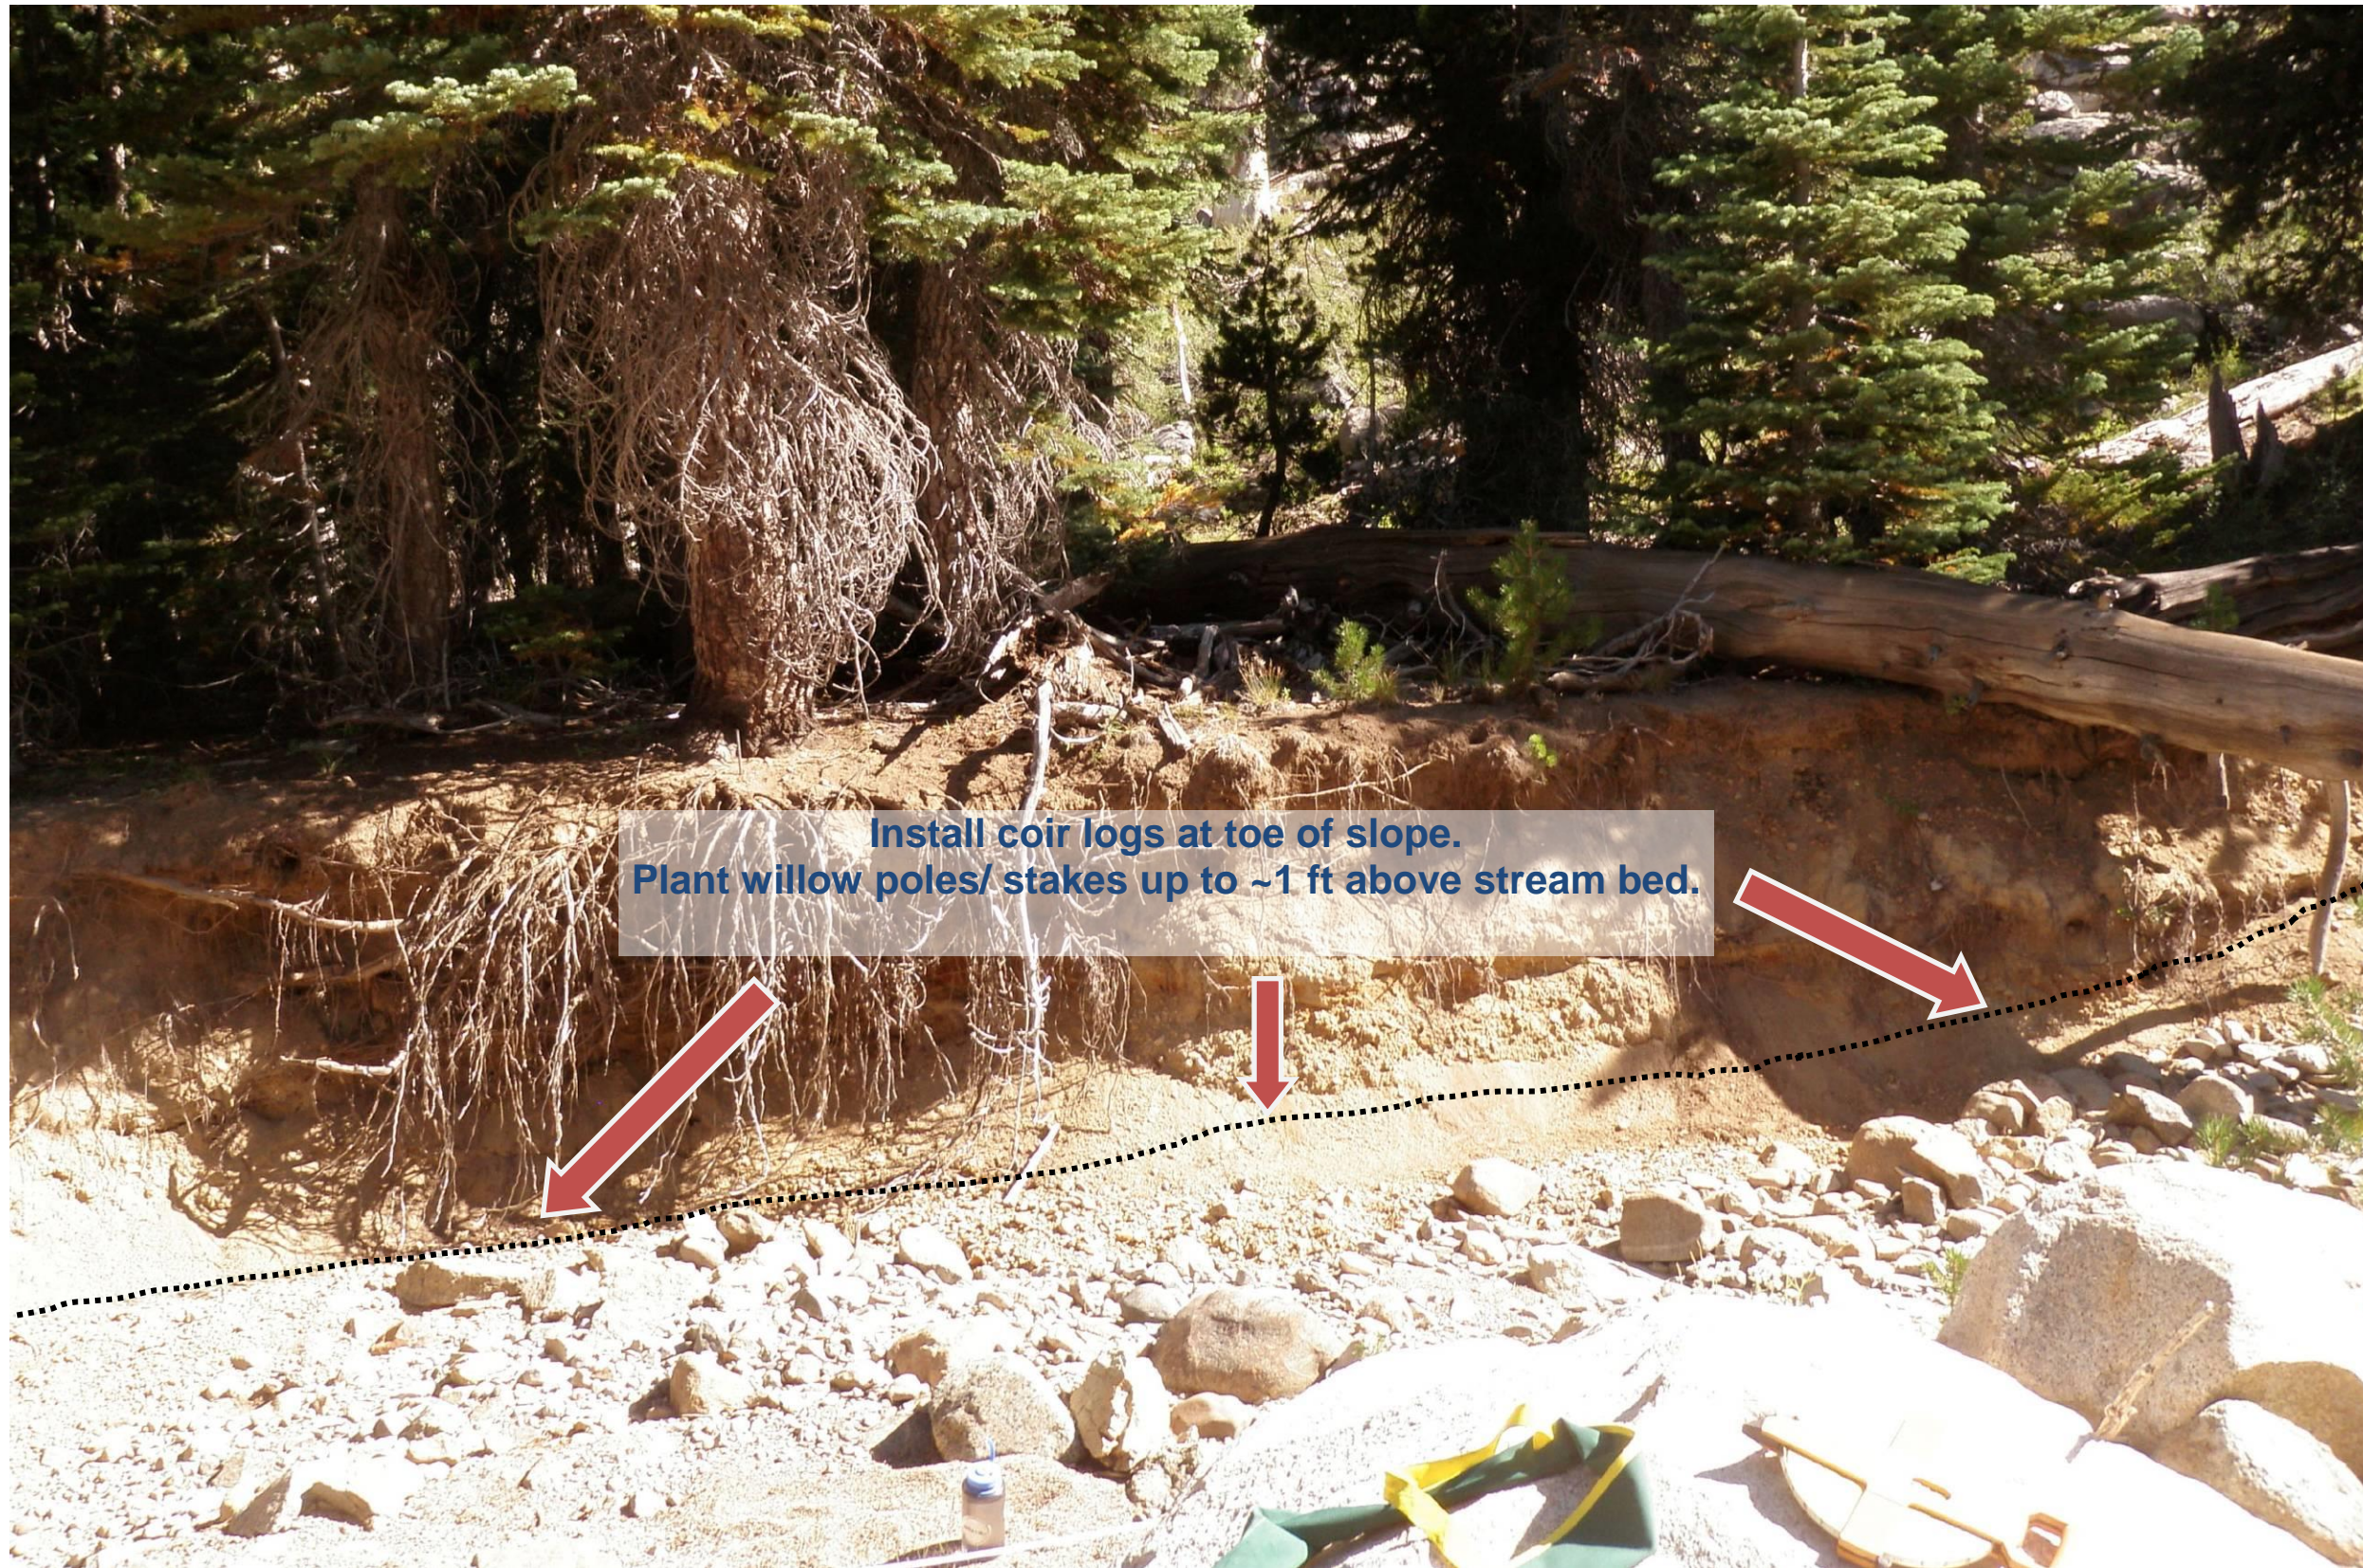
Figure 9b Lower Site – Treatment Area L-1: RB 8+48 to 7+74 (Photo 2 of 2)

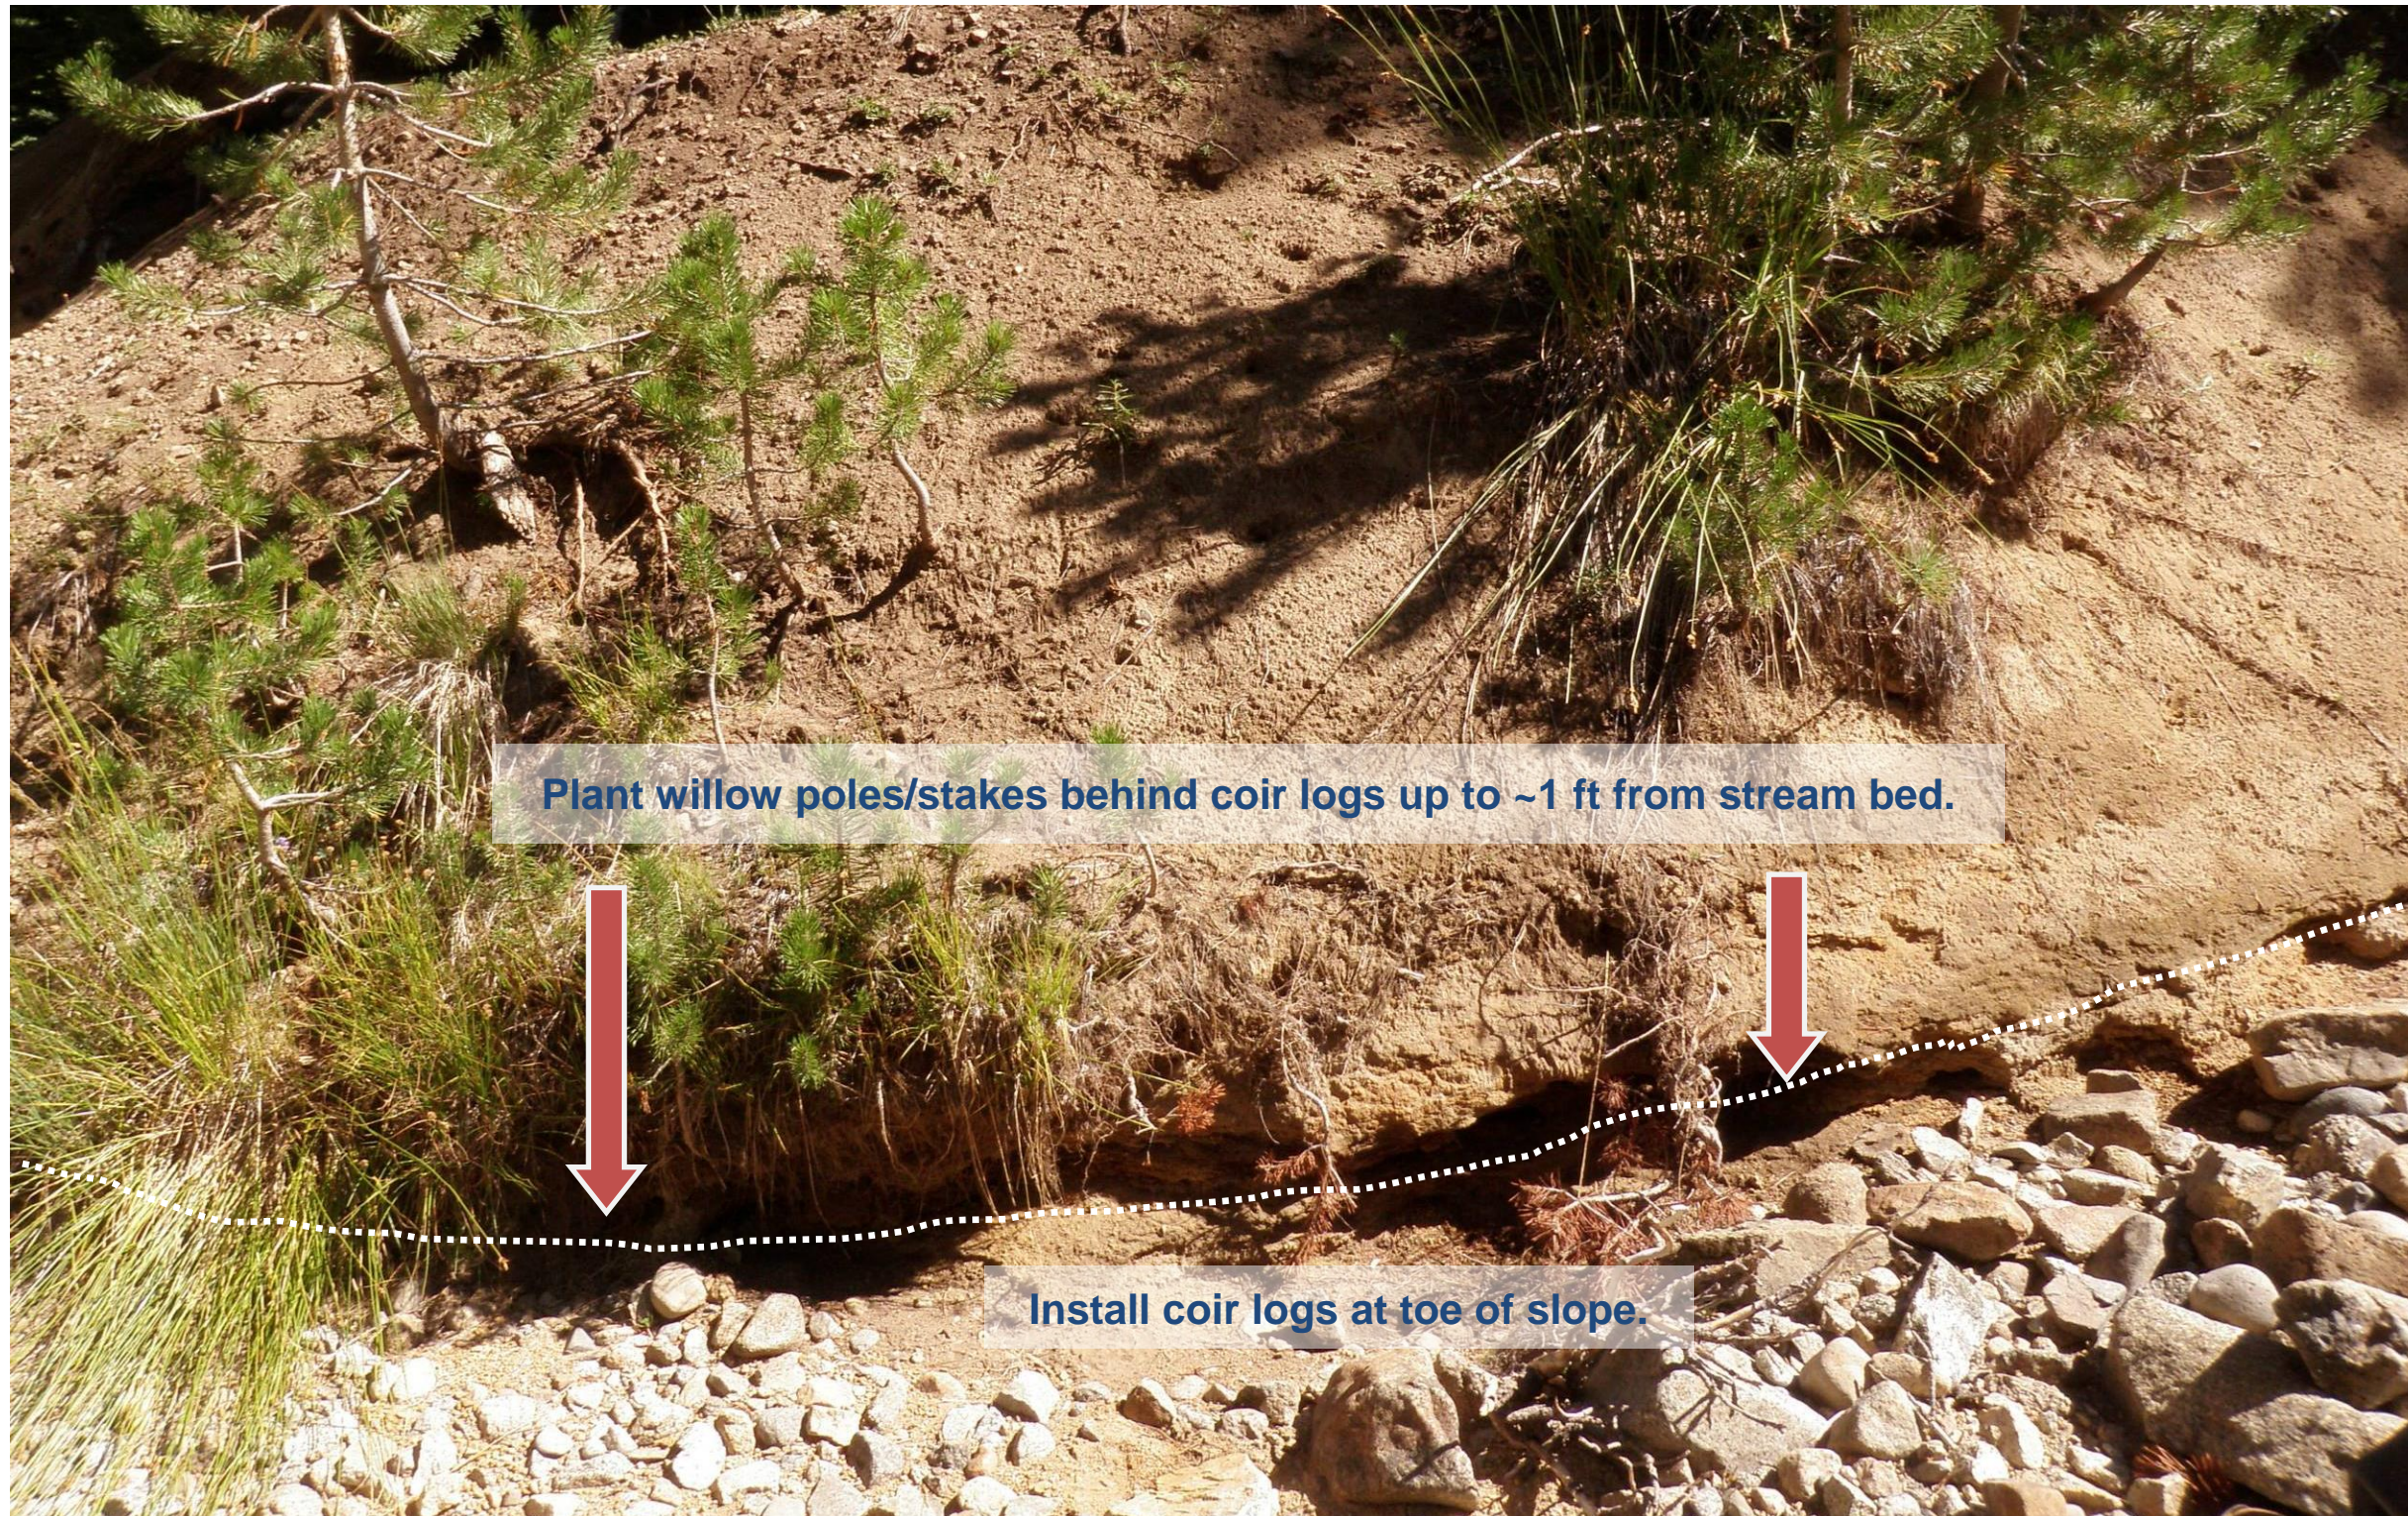
Figure 10 Lower Site – Treatment Area L-3: RB 7+38 to 7+02

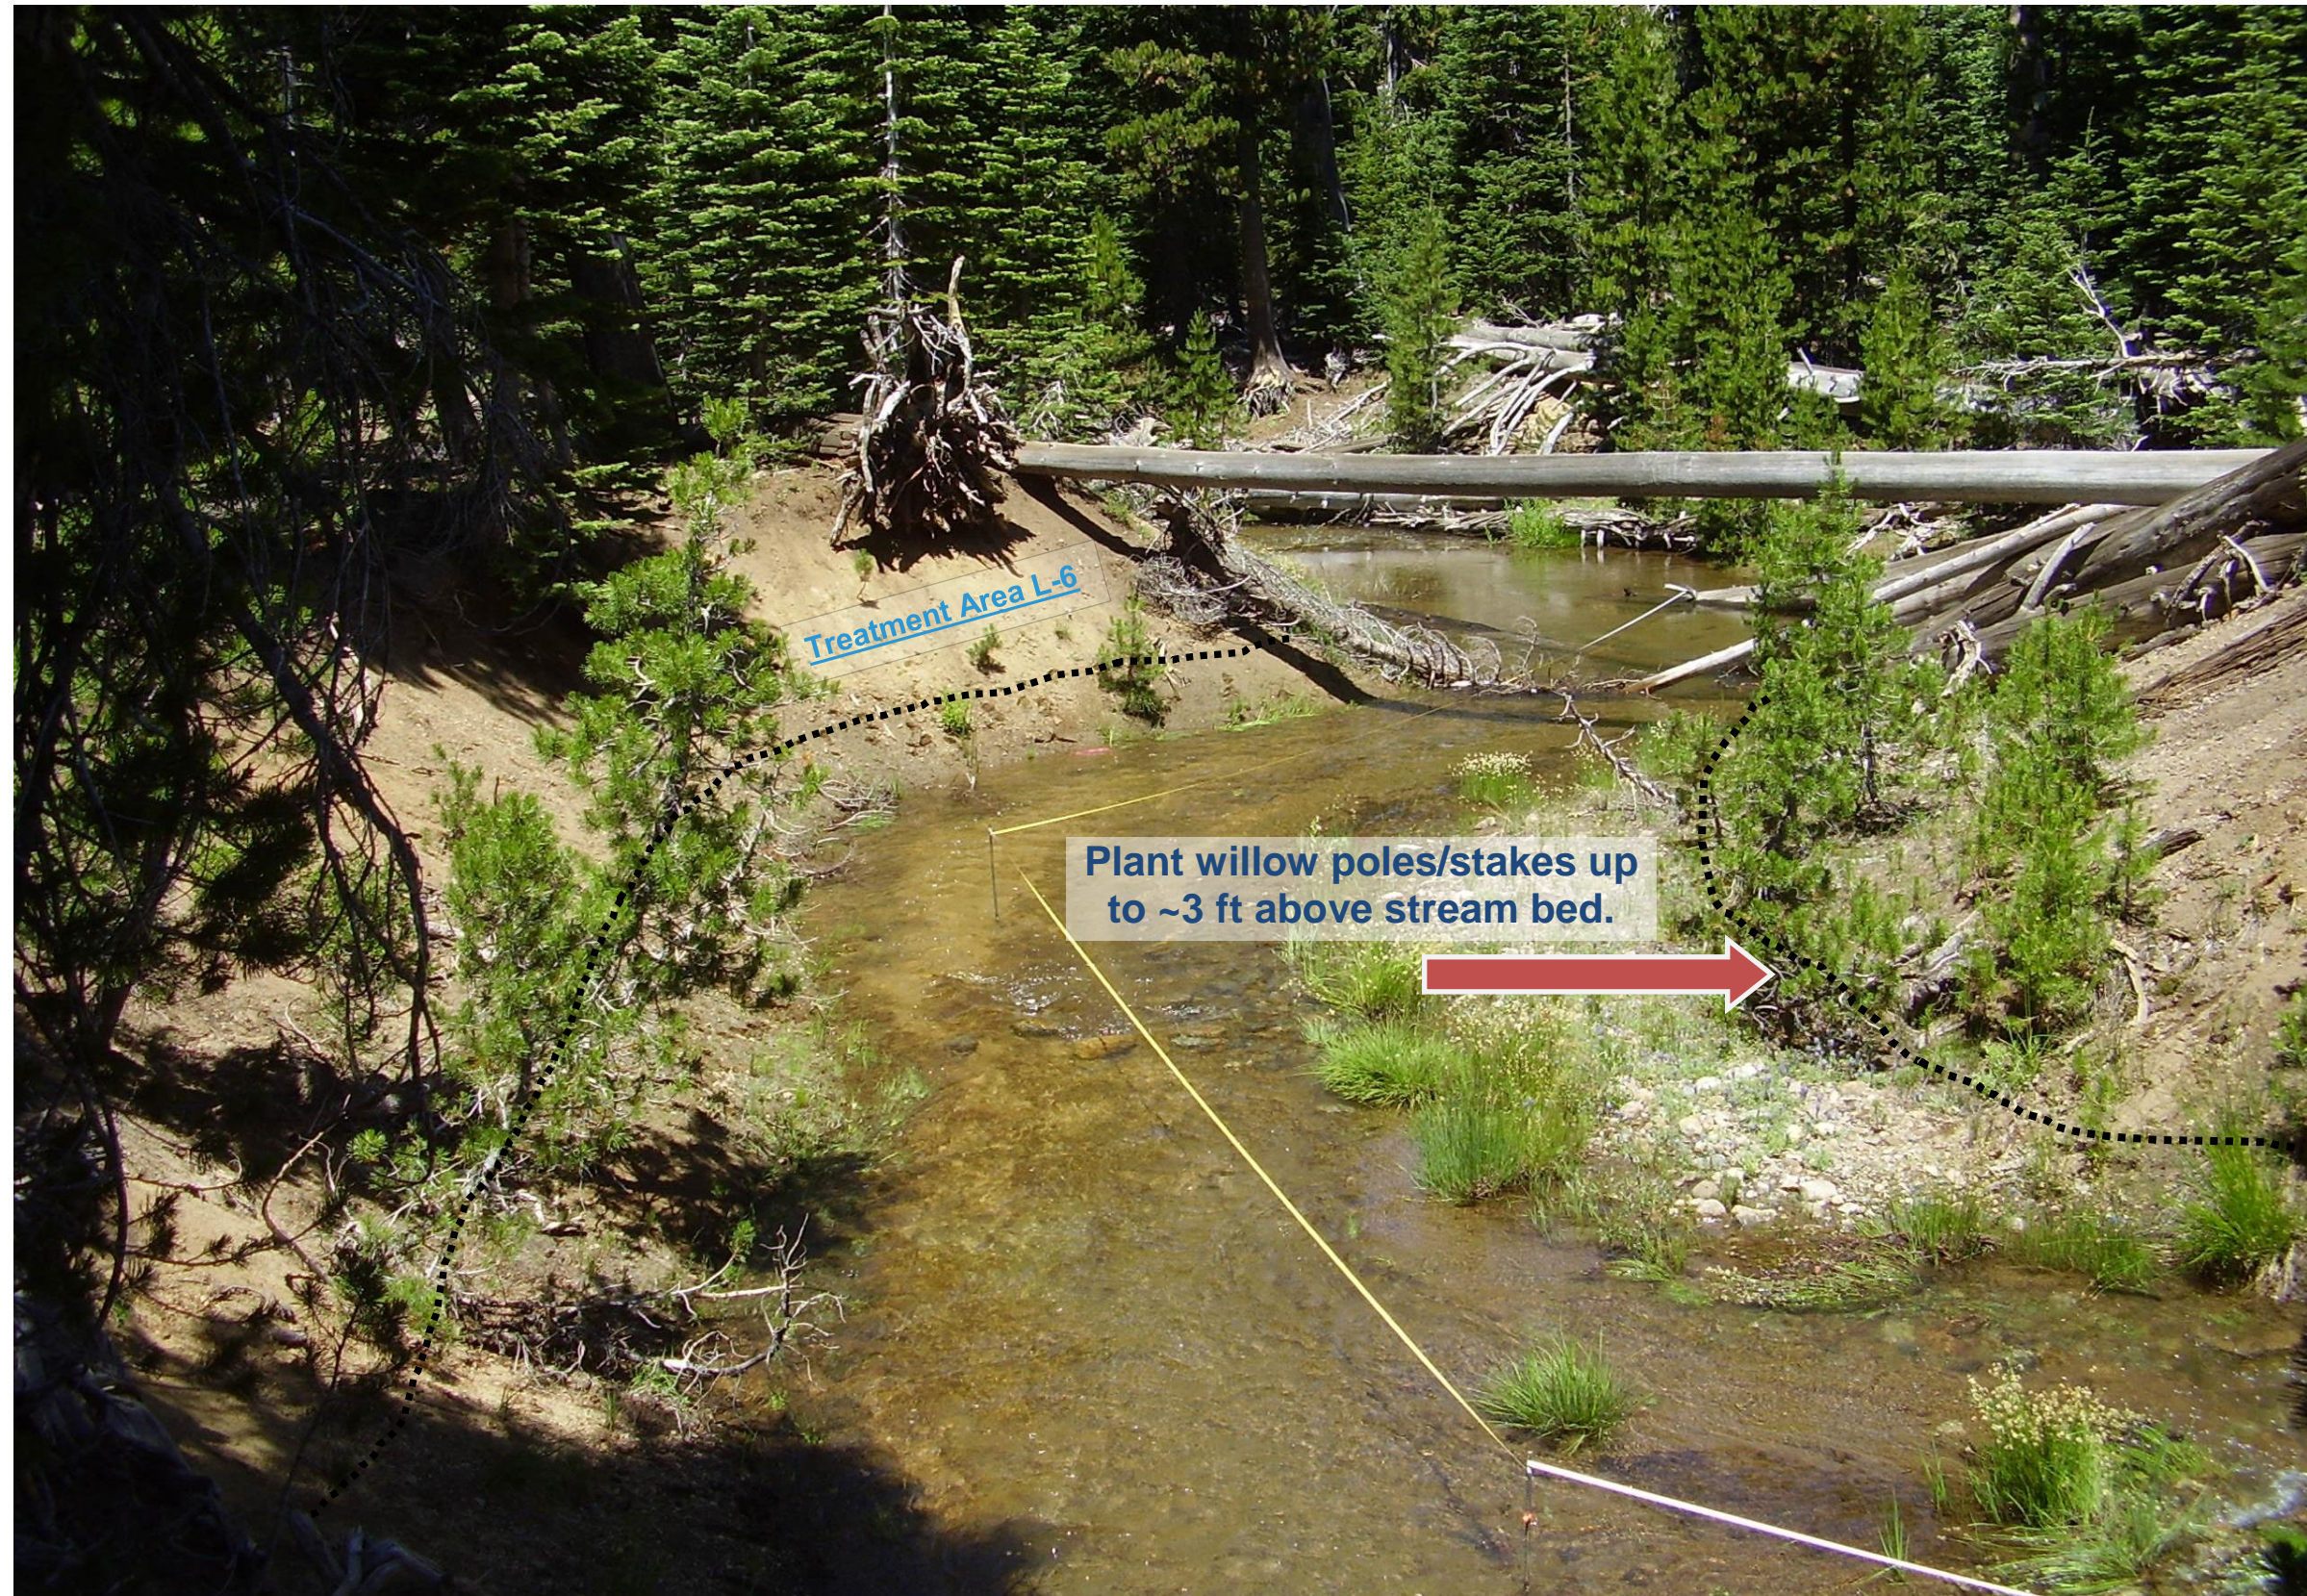
Figure 11 Lower Site – Treatment Area L-4: RB 6+48 to 5+91 (upstream end)
Note: Left bank (left side of photo) is Treatment Area L-6, with details depicted in Figures 13a and 13b.

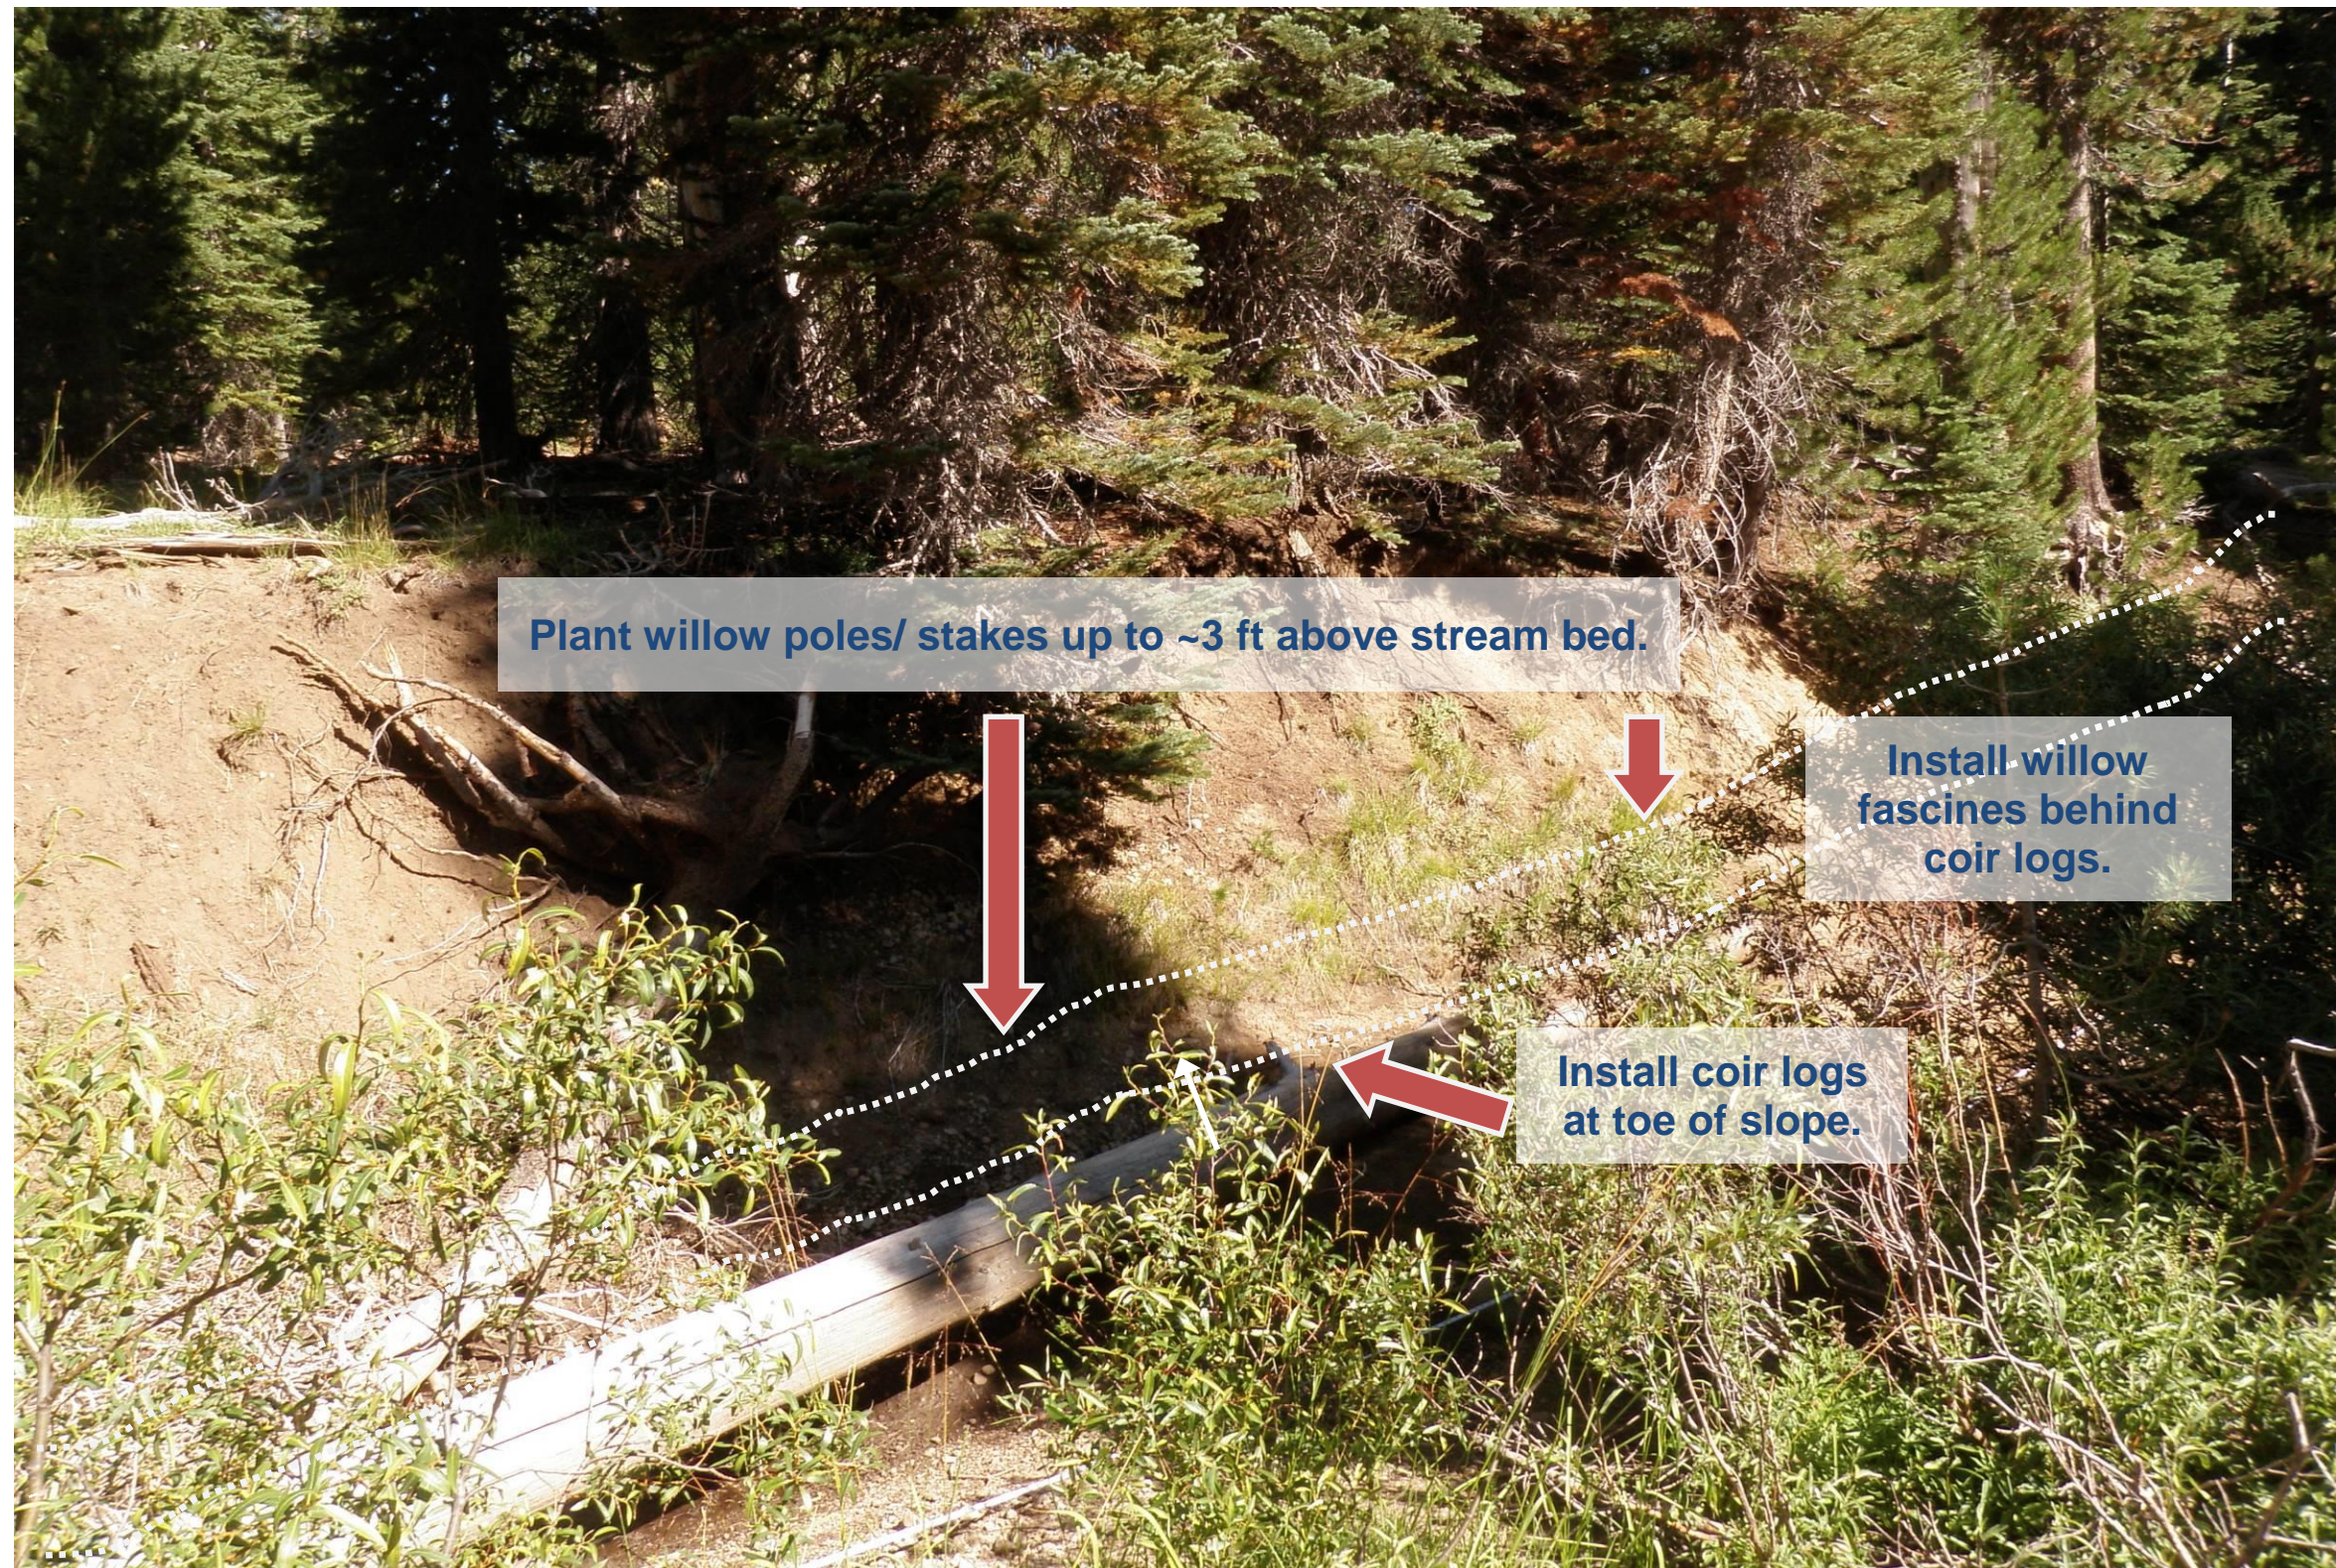
Figure 12 Lower Site – Treatment Area L-5: RB 5+91 to 5+04

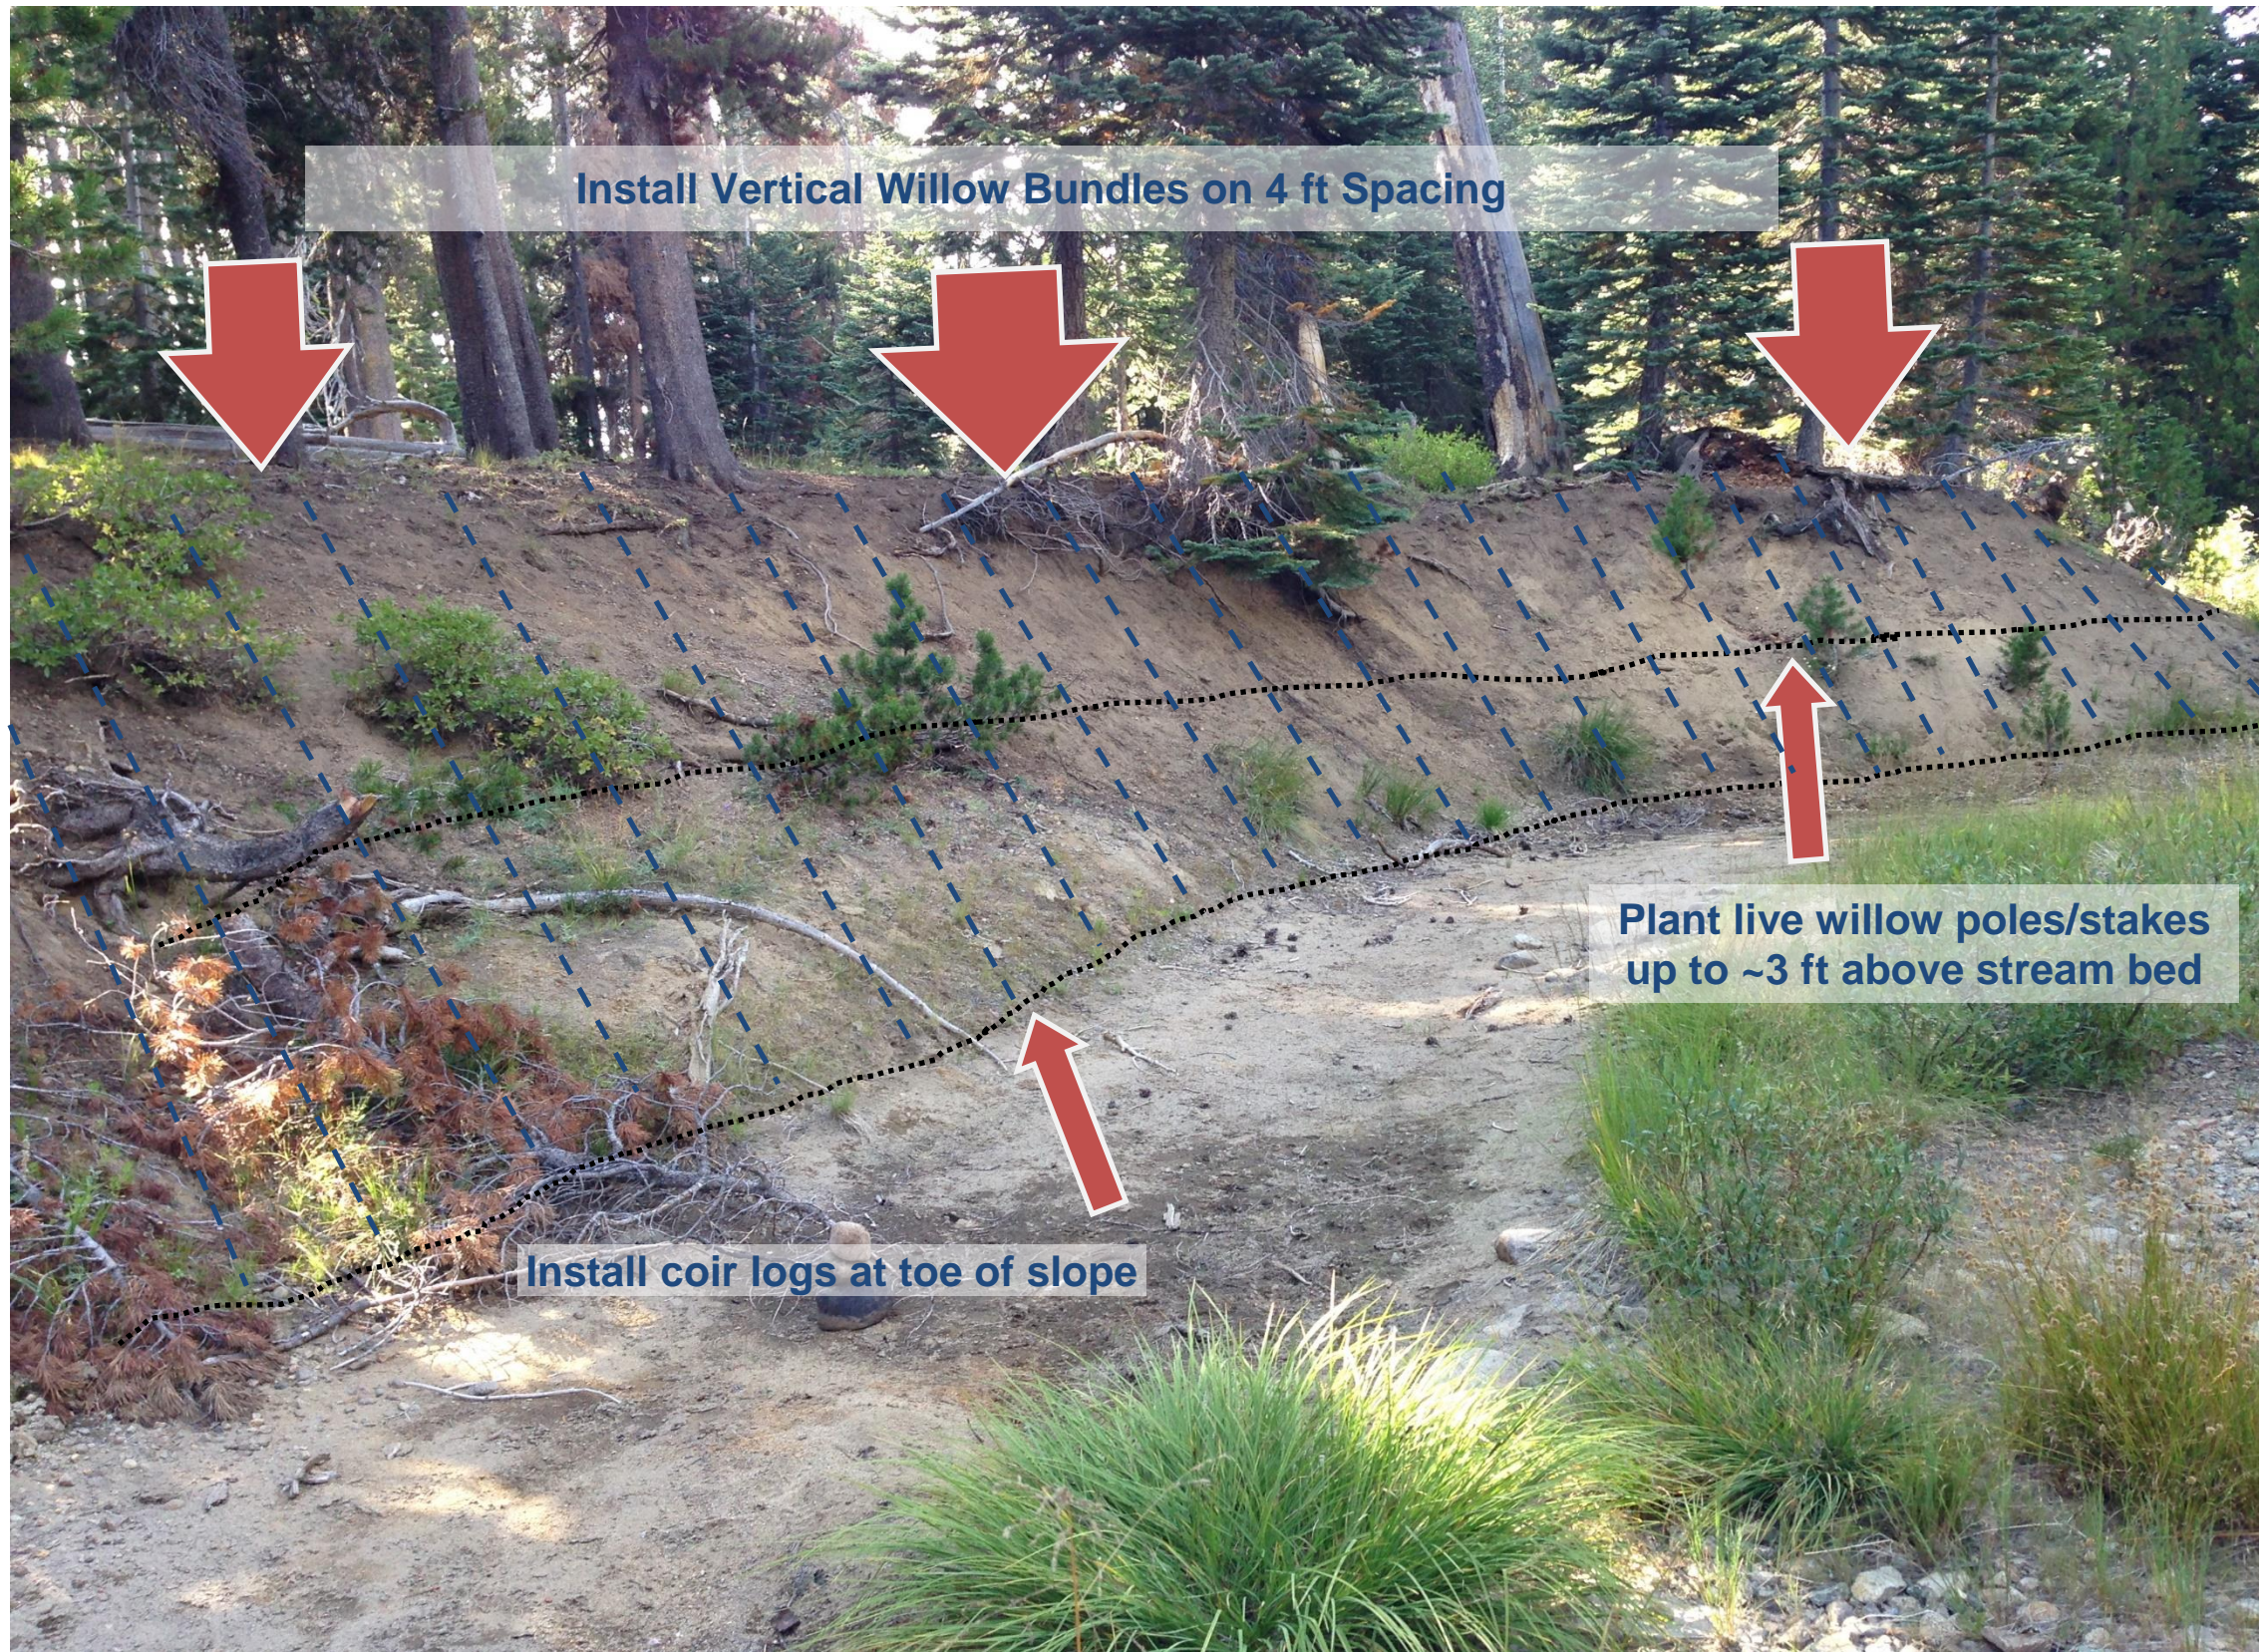
Figure 13. Lower Site - Treatment Area L-6: LB 7+25 to 6+23
