Caples Spillway Channel Stabilization Plan

El Dorado Hydroelectric Project
(FERC No. 184)

March 2018

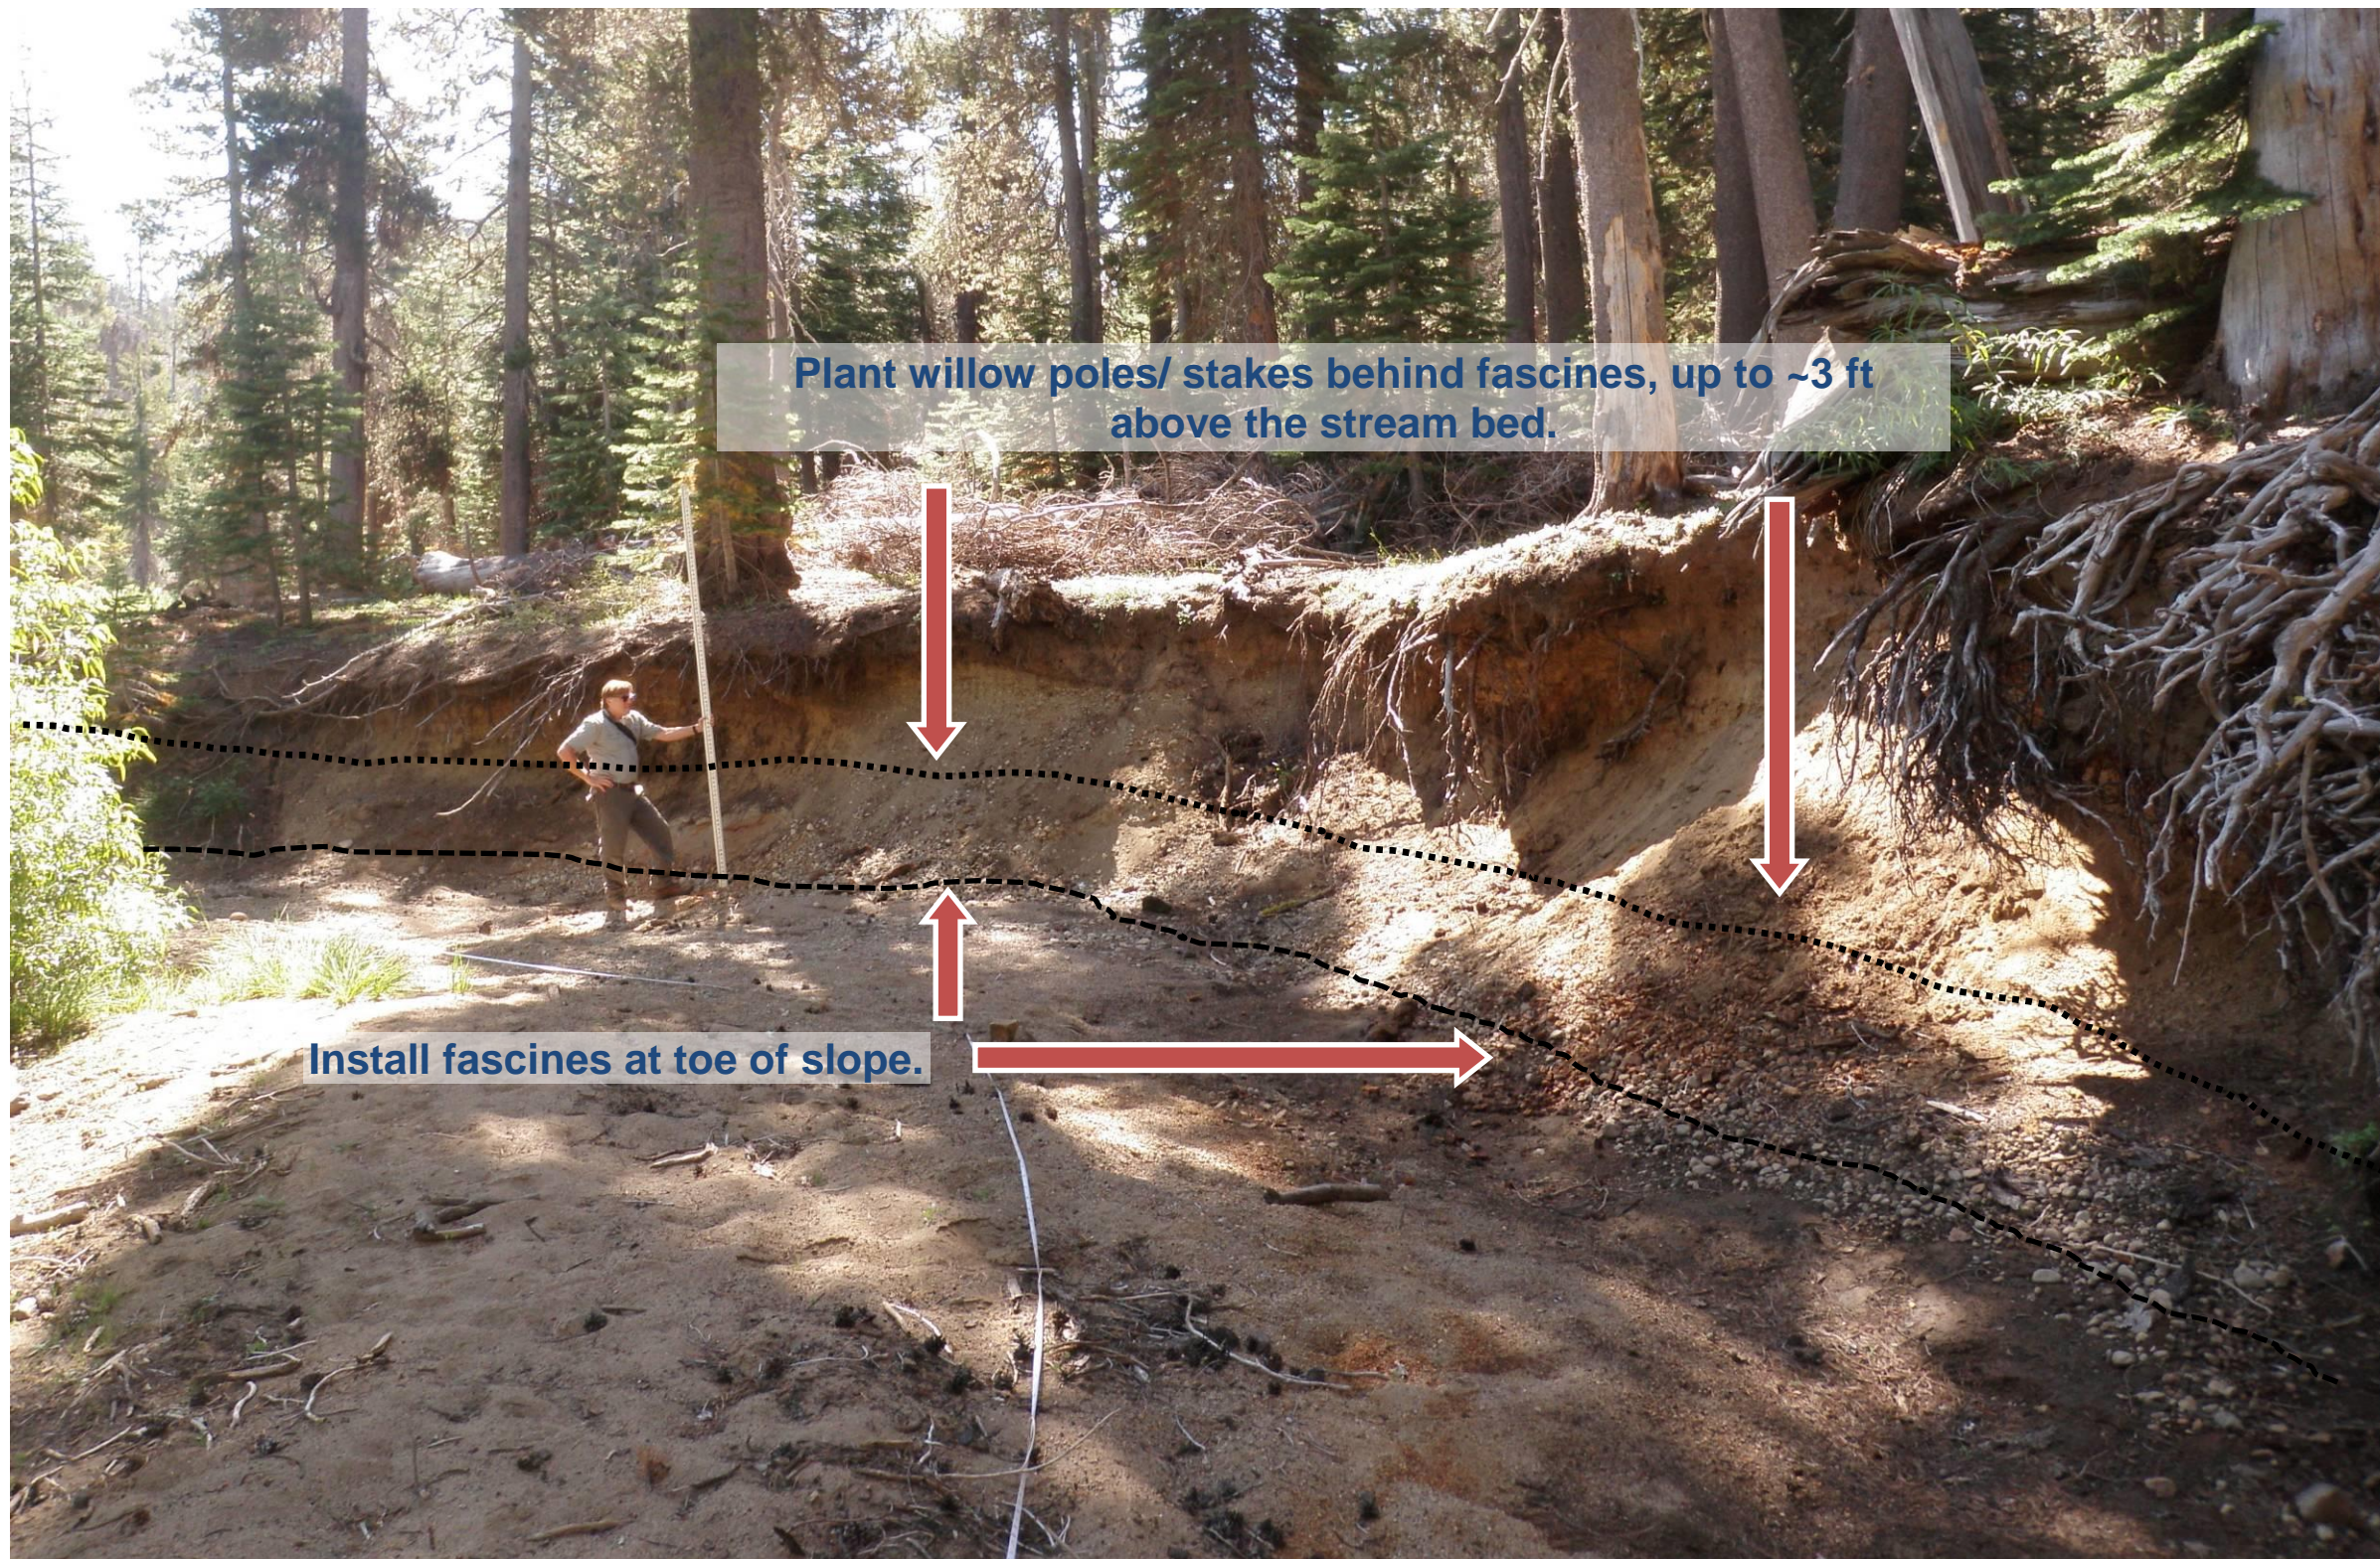
Figure 14 Lower Site - Treatment Area L-7: LB 5+20 to 4+13 (Photo 1 of 4)

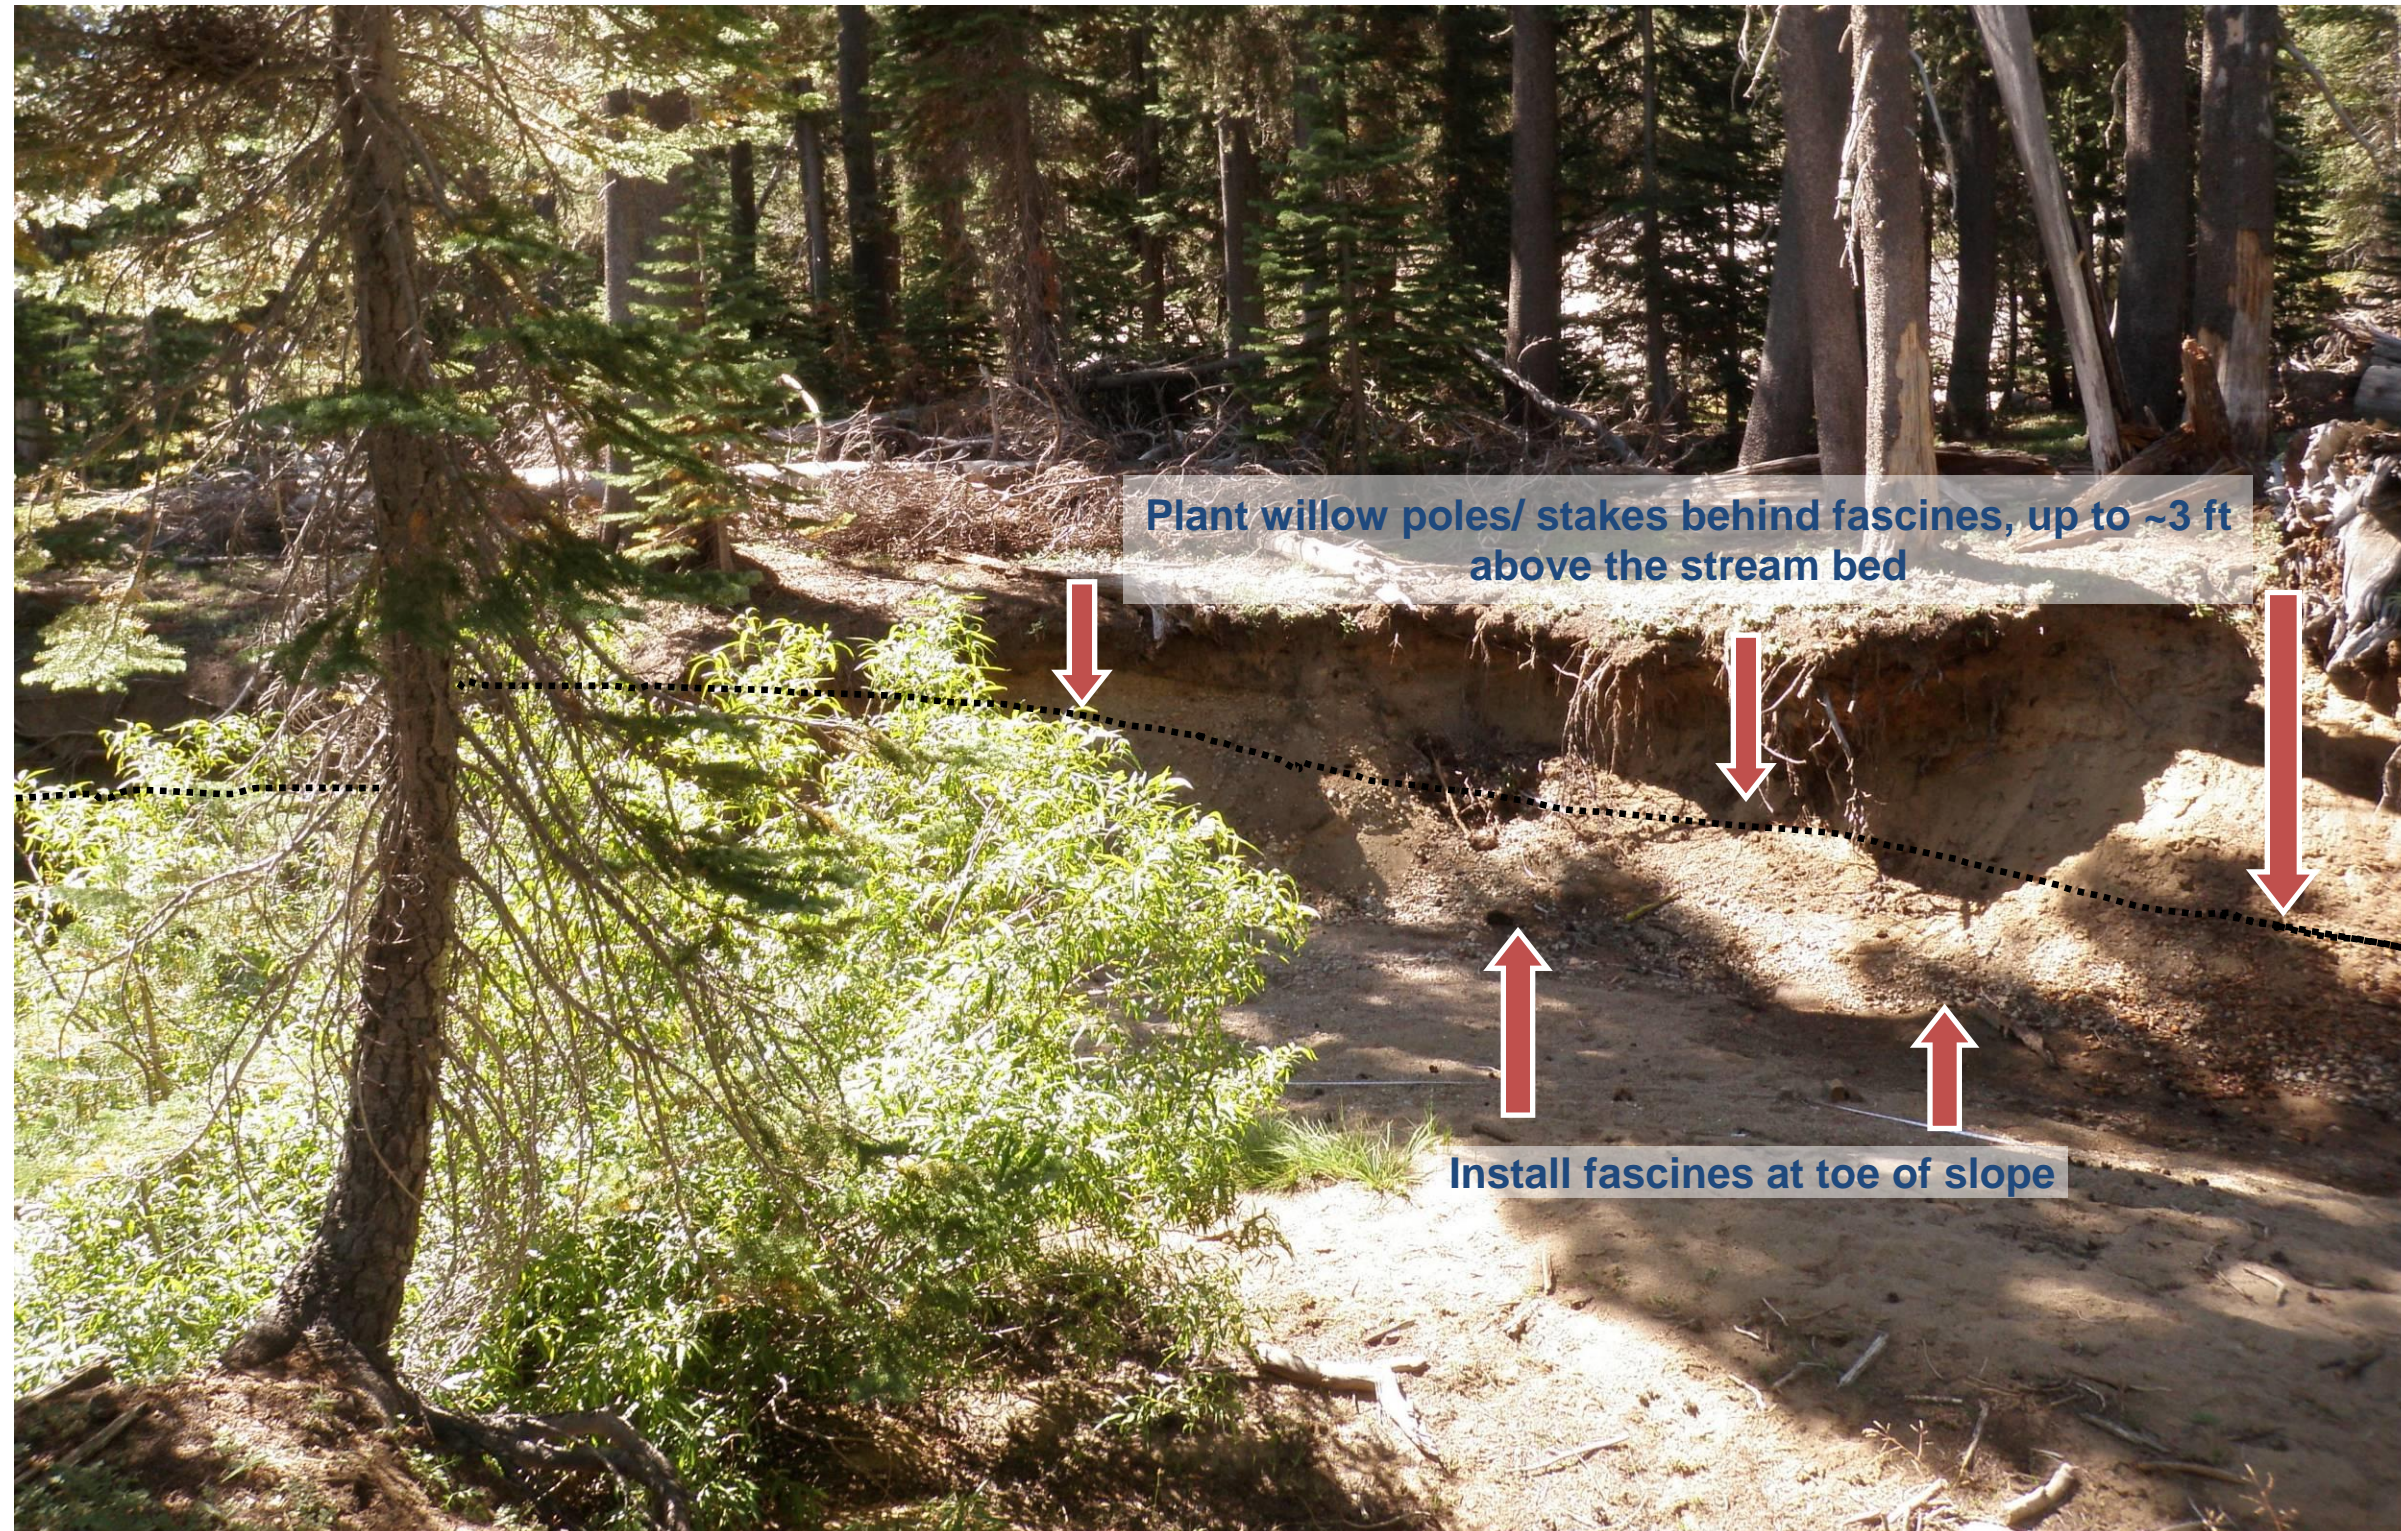
Figure 14b Lower Site - Treatment Area L-7: LB 5+20 to 4+13 (Photo 2 of 4)

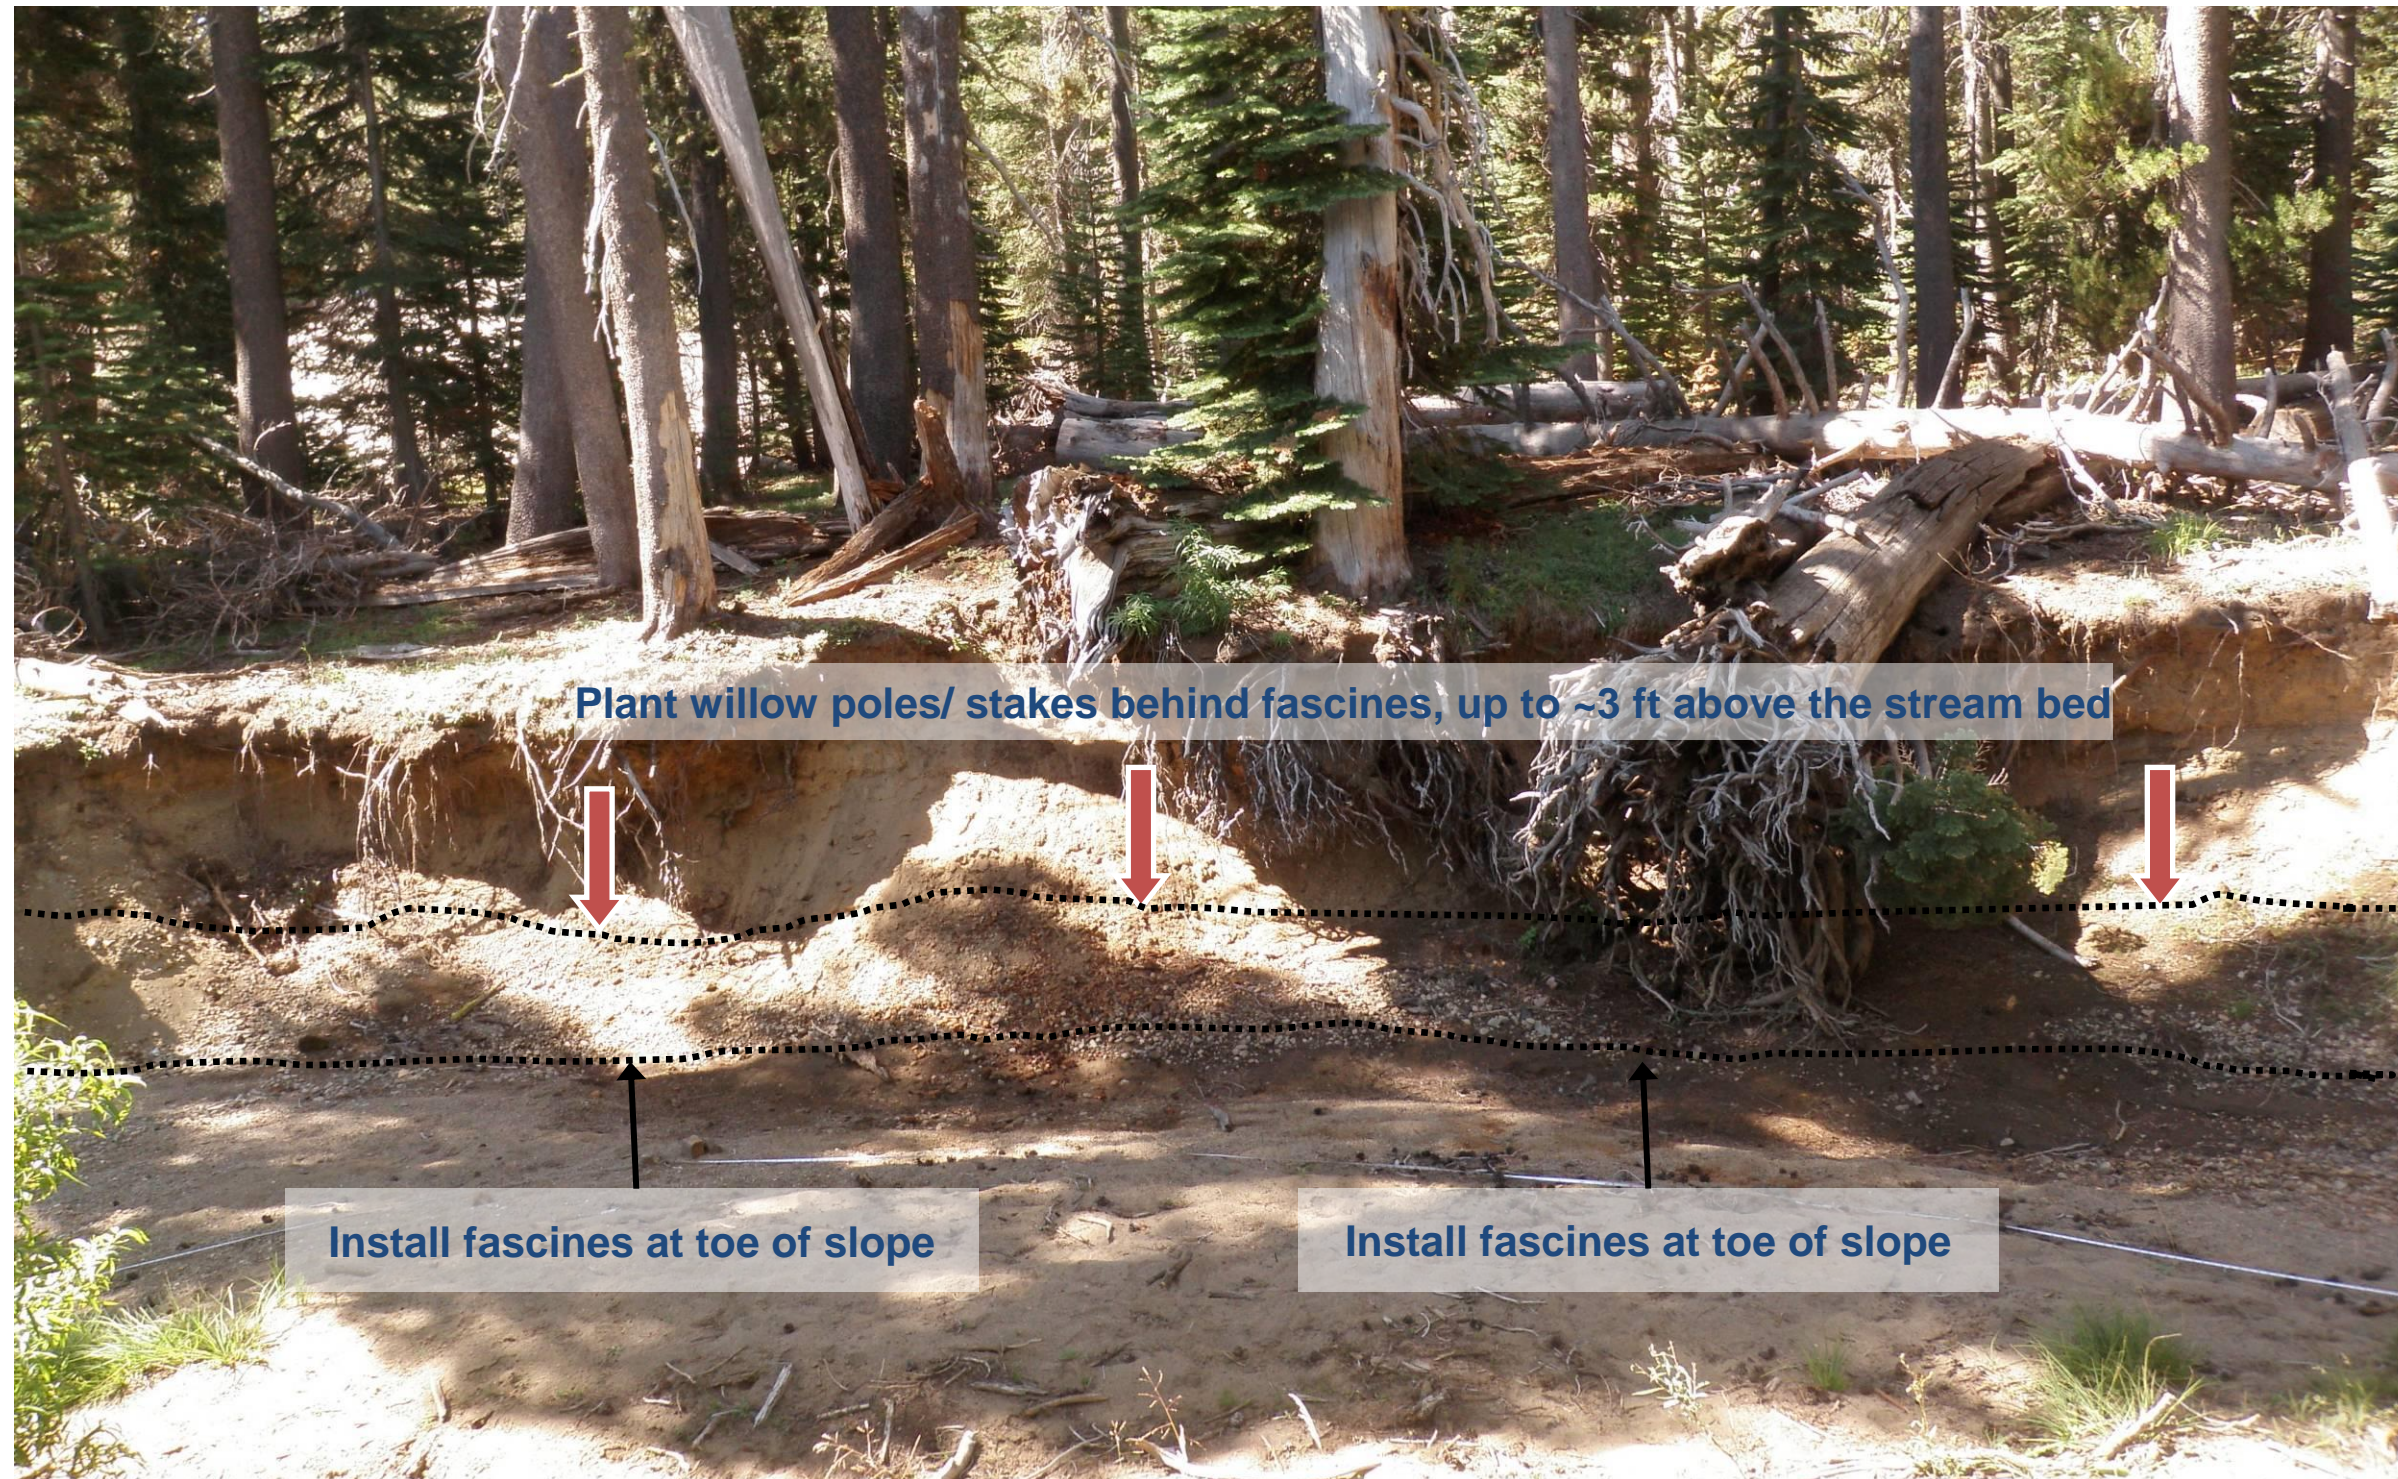
Figure 14c Lower Site - Treatment Area L-7: LB 5+20 to 4+13 (Photo 3 of 4)

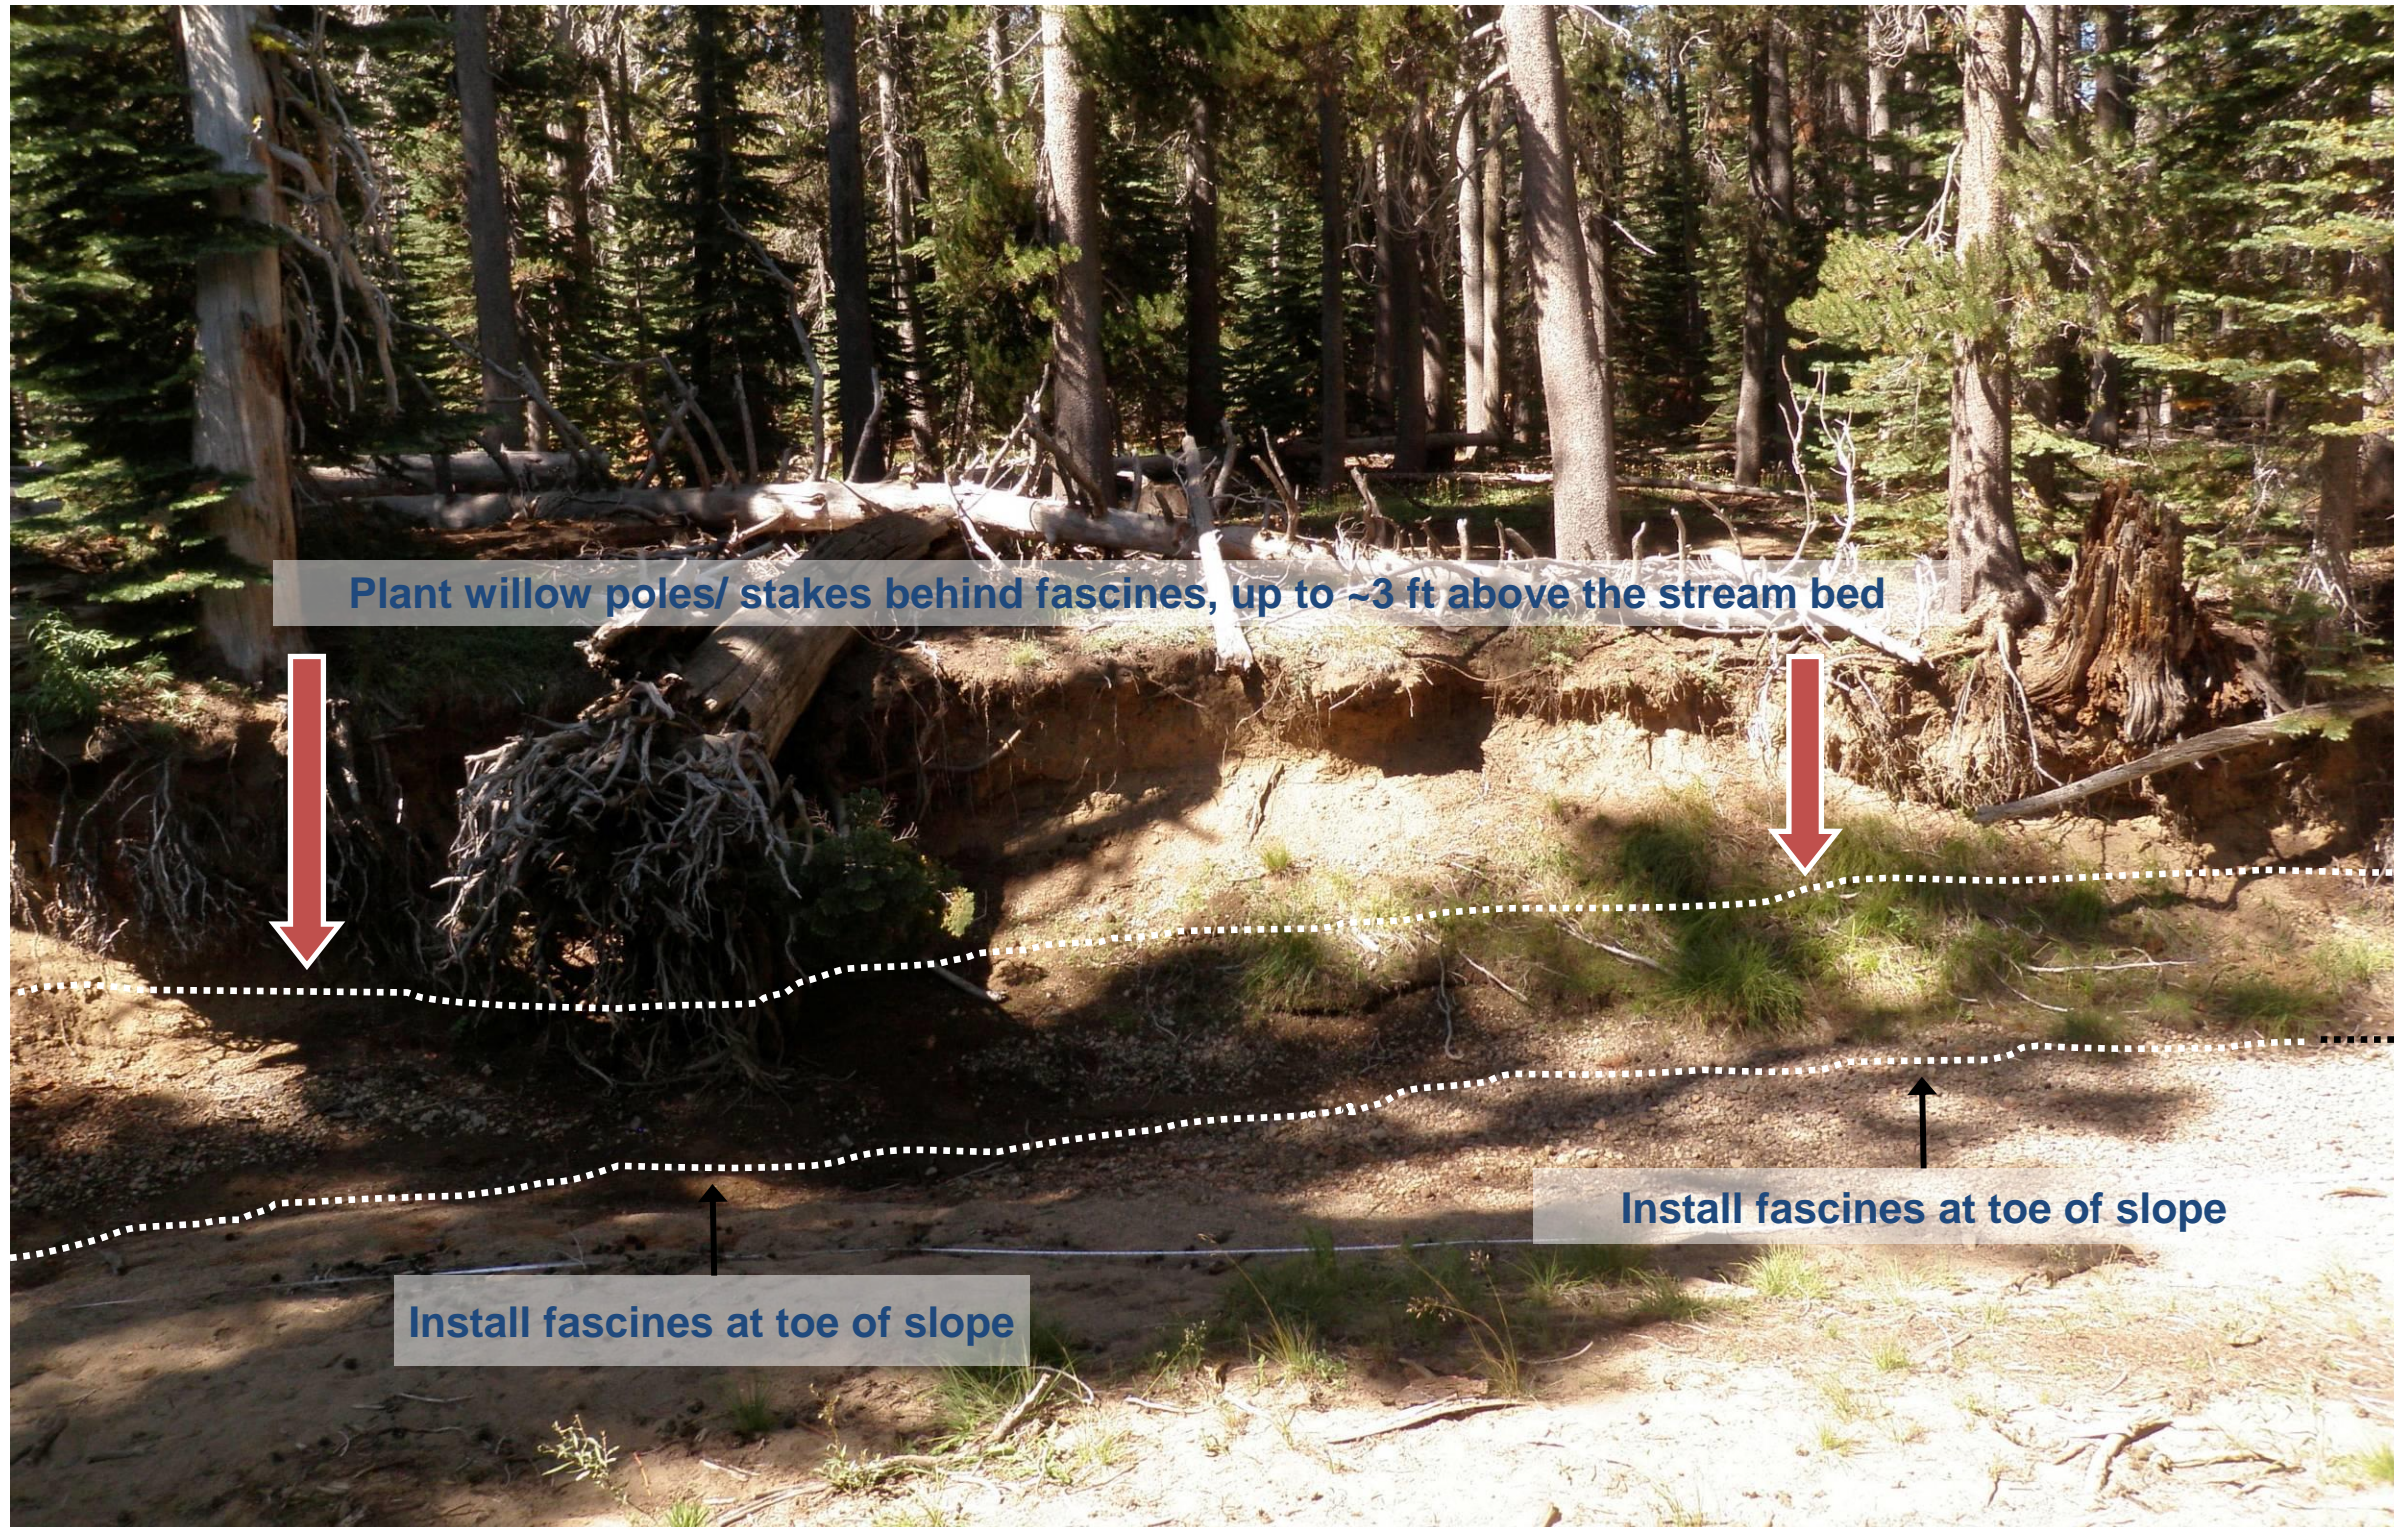
Figure 14d Lower Site - Treatment Area L-7: LB 5+20 to 4+13 (Photo 4 of 4)

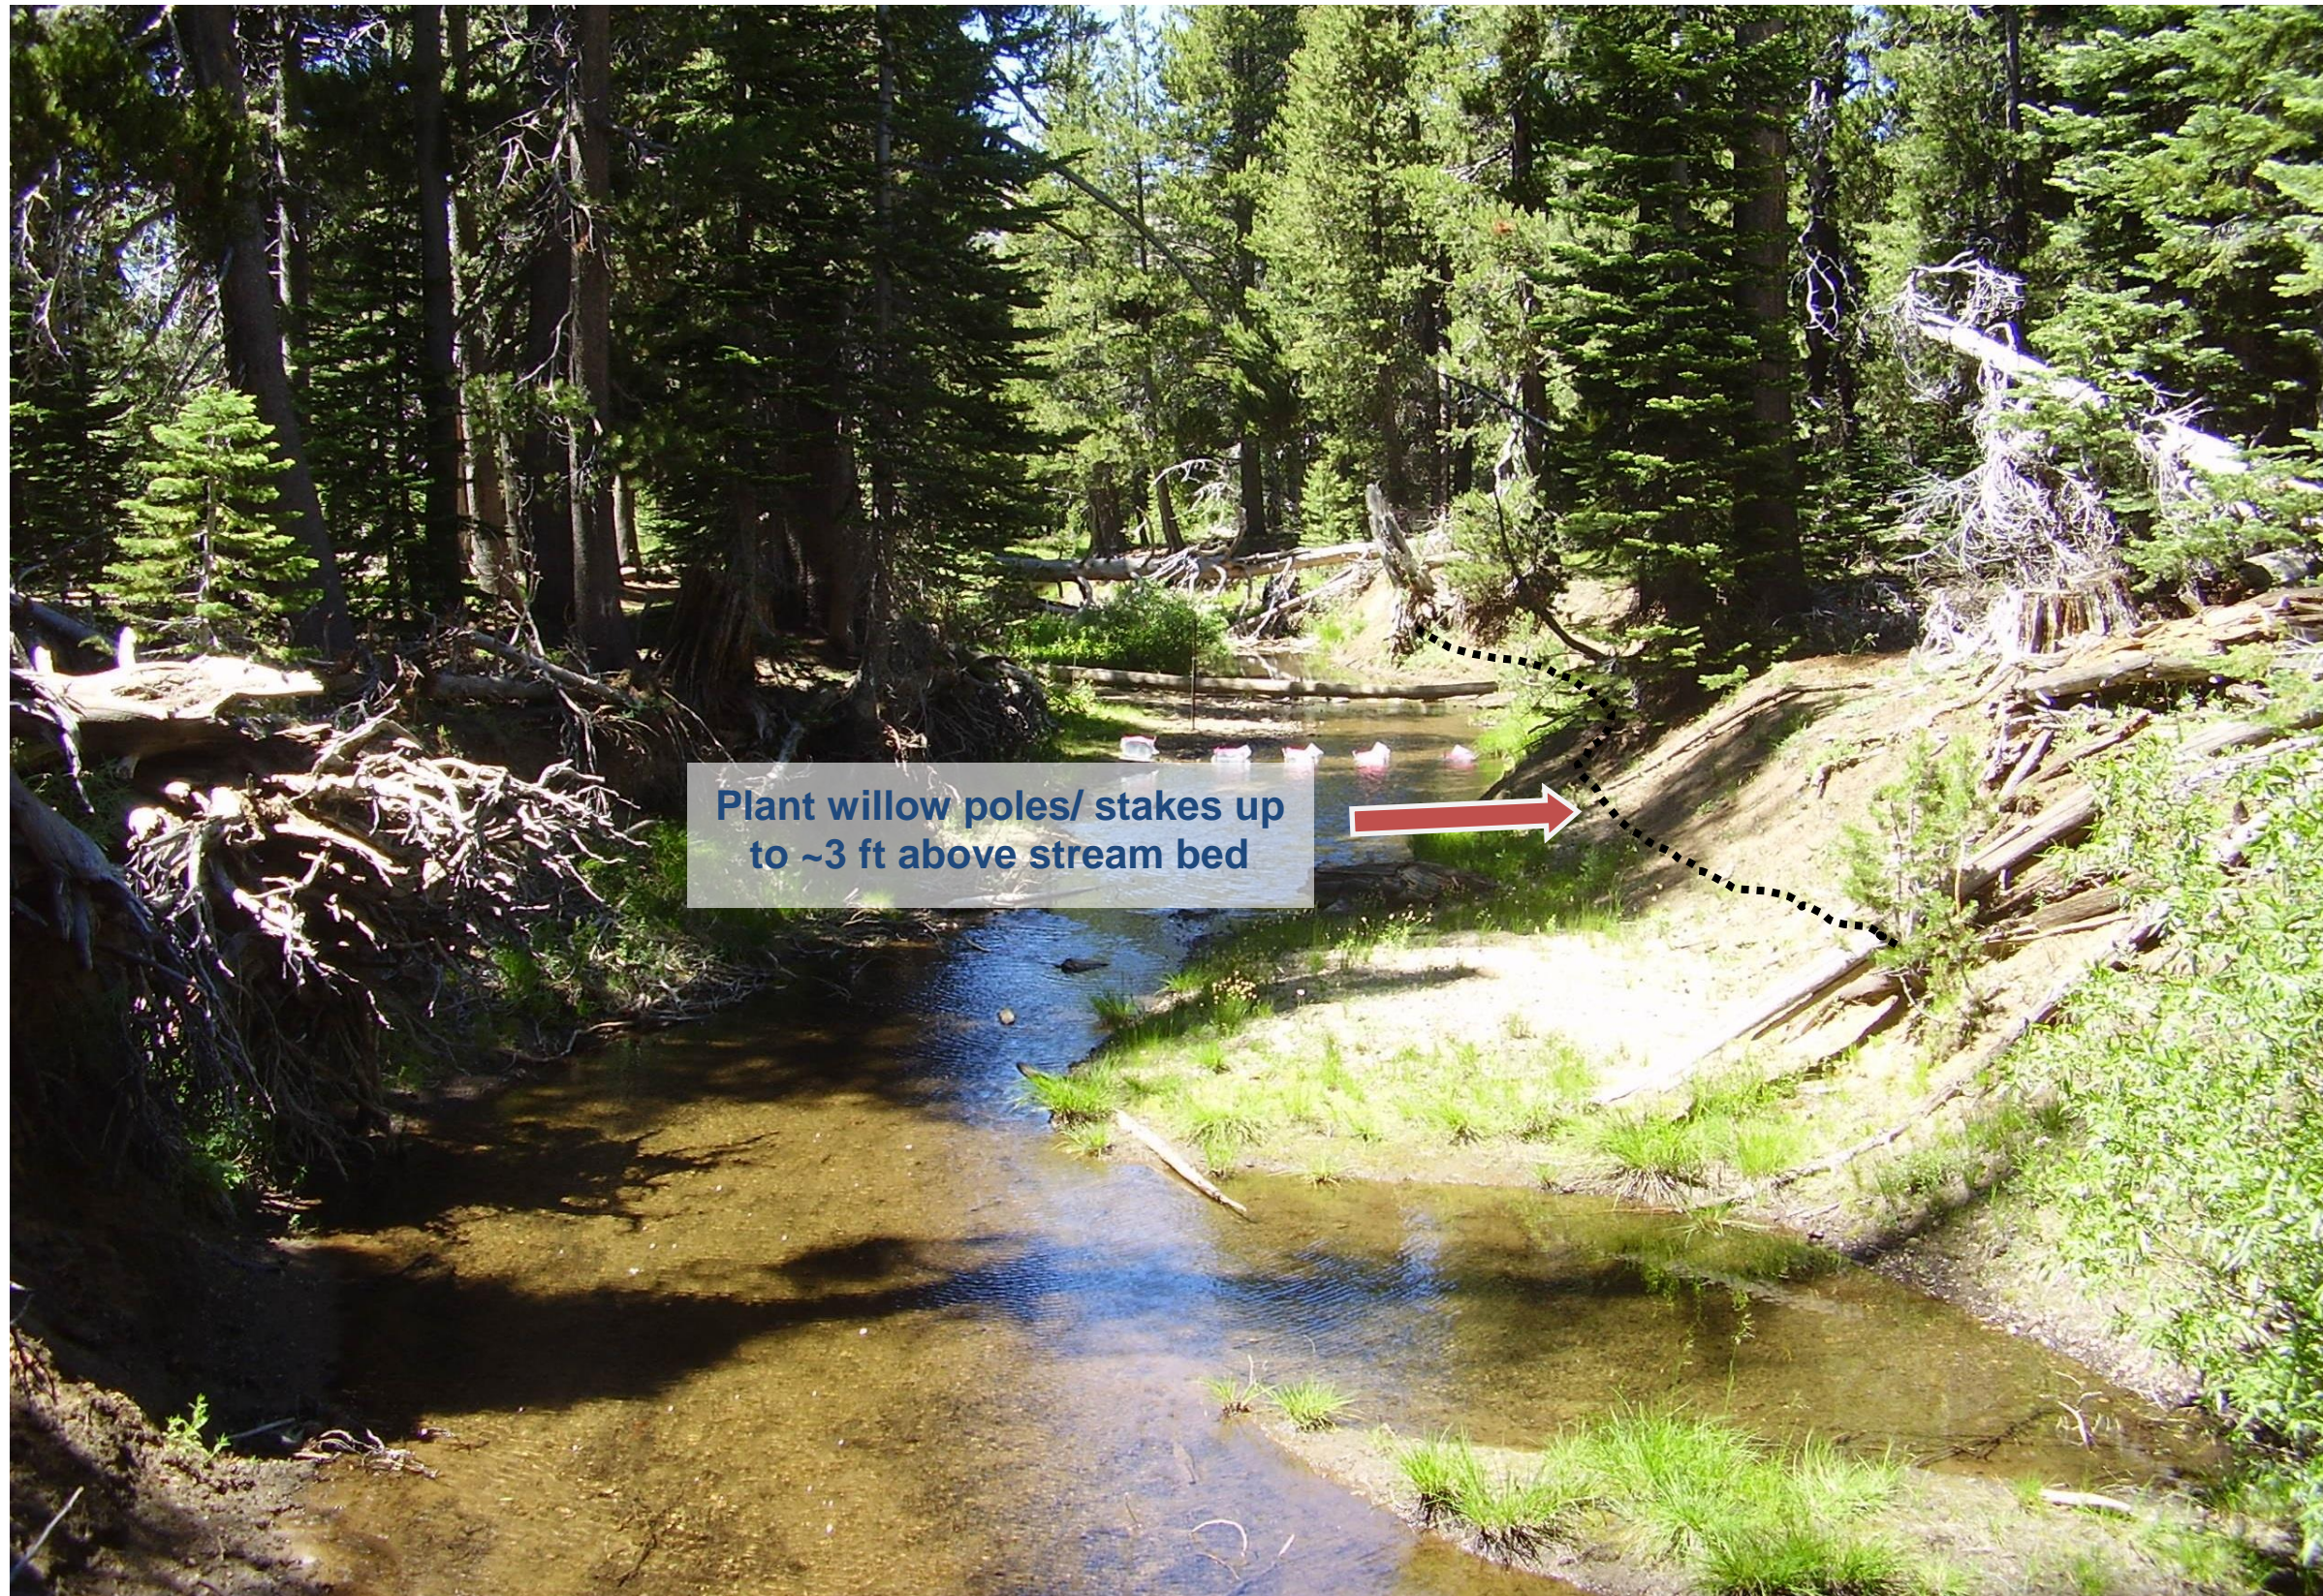
Figure 15 Lower Site – Treatment Area L-8: RB 5+04-4+15

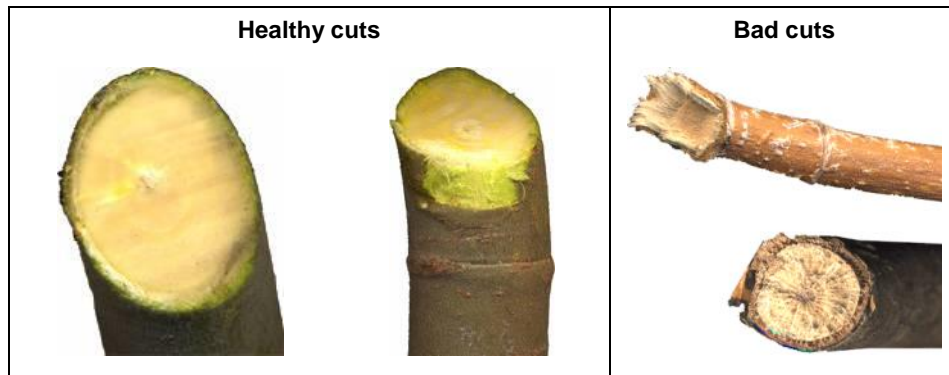
- > **The cut should be smooth, moist and light tan with a green layer** around it. If the inside of the stem is dry and rough or dark gray, dark brown, or black, don't use it or cut higher on the pole.

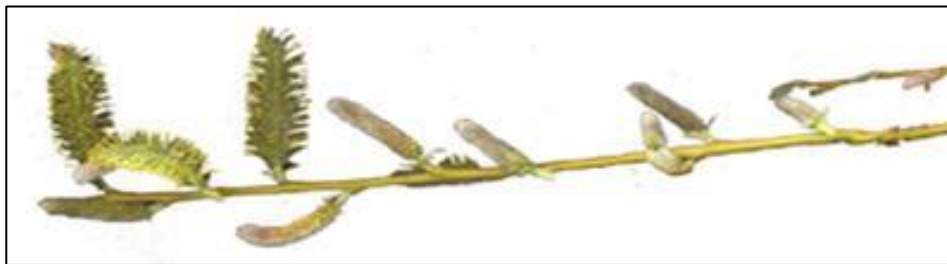
- > If the end of the branch is **thin and flimsy or laden with buds**, cut it off.

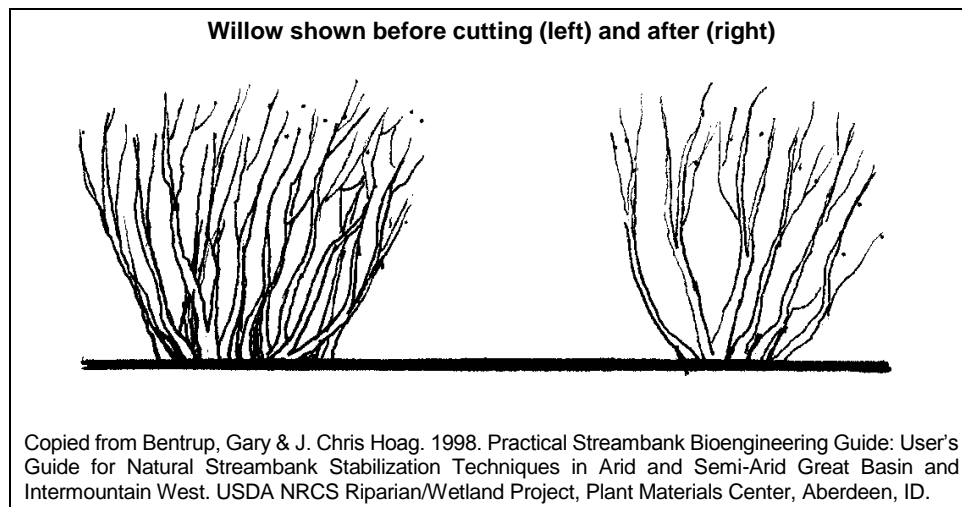
- > **Do not cut more than 35%** of the tree/shrub to prevent overharvesting.

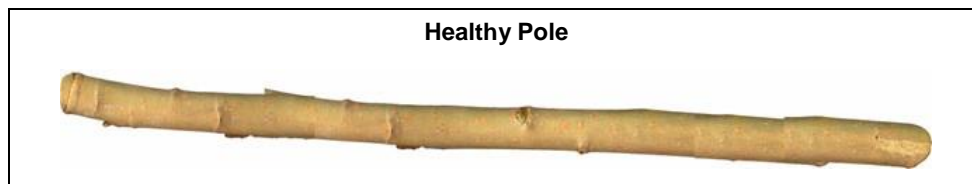
- > **Tie the poles/stakes into bundles** to transport them easily, if necessary.
- > **Remove any remaining leaves.**
