# SWANSON HYDROLOGY + GEOMORPHOLOGY

DRAFT Final Report

## ESMERALDA CREEK RESTORATION AND STABILIZATION PLAN for El Dorado Irrigation District

June 2008

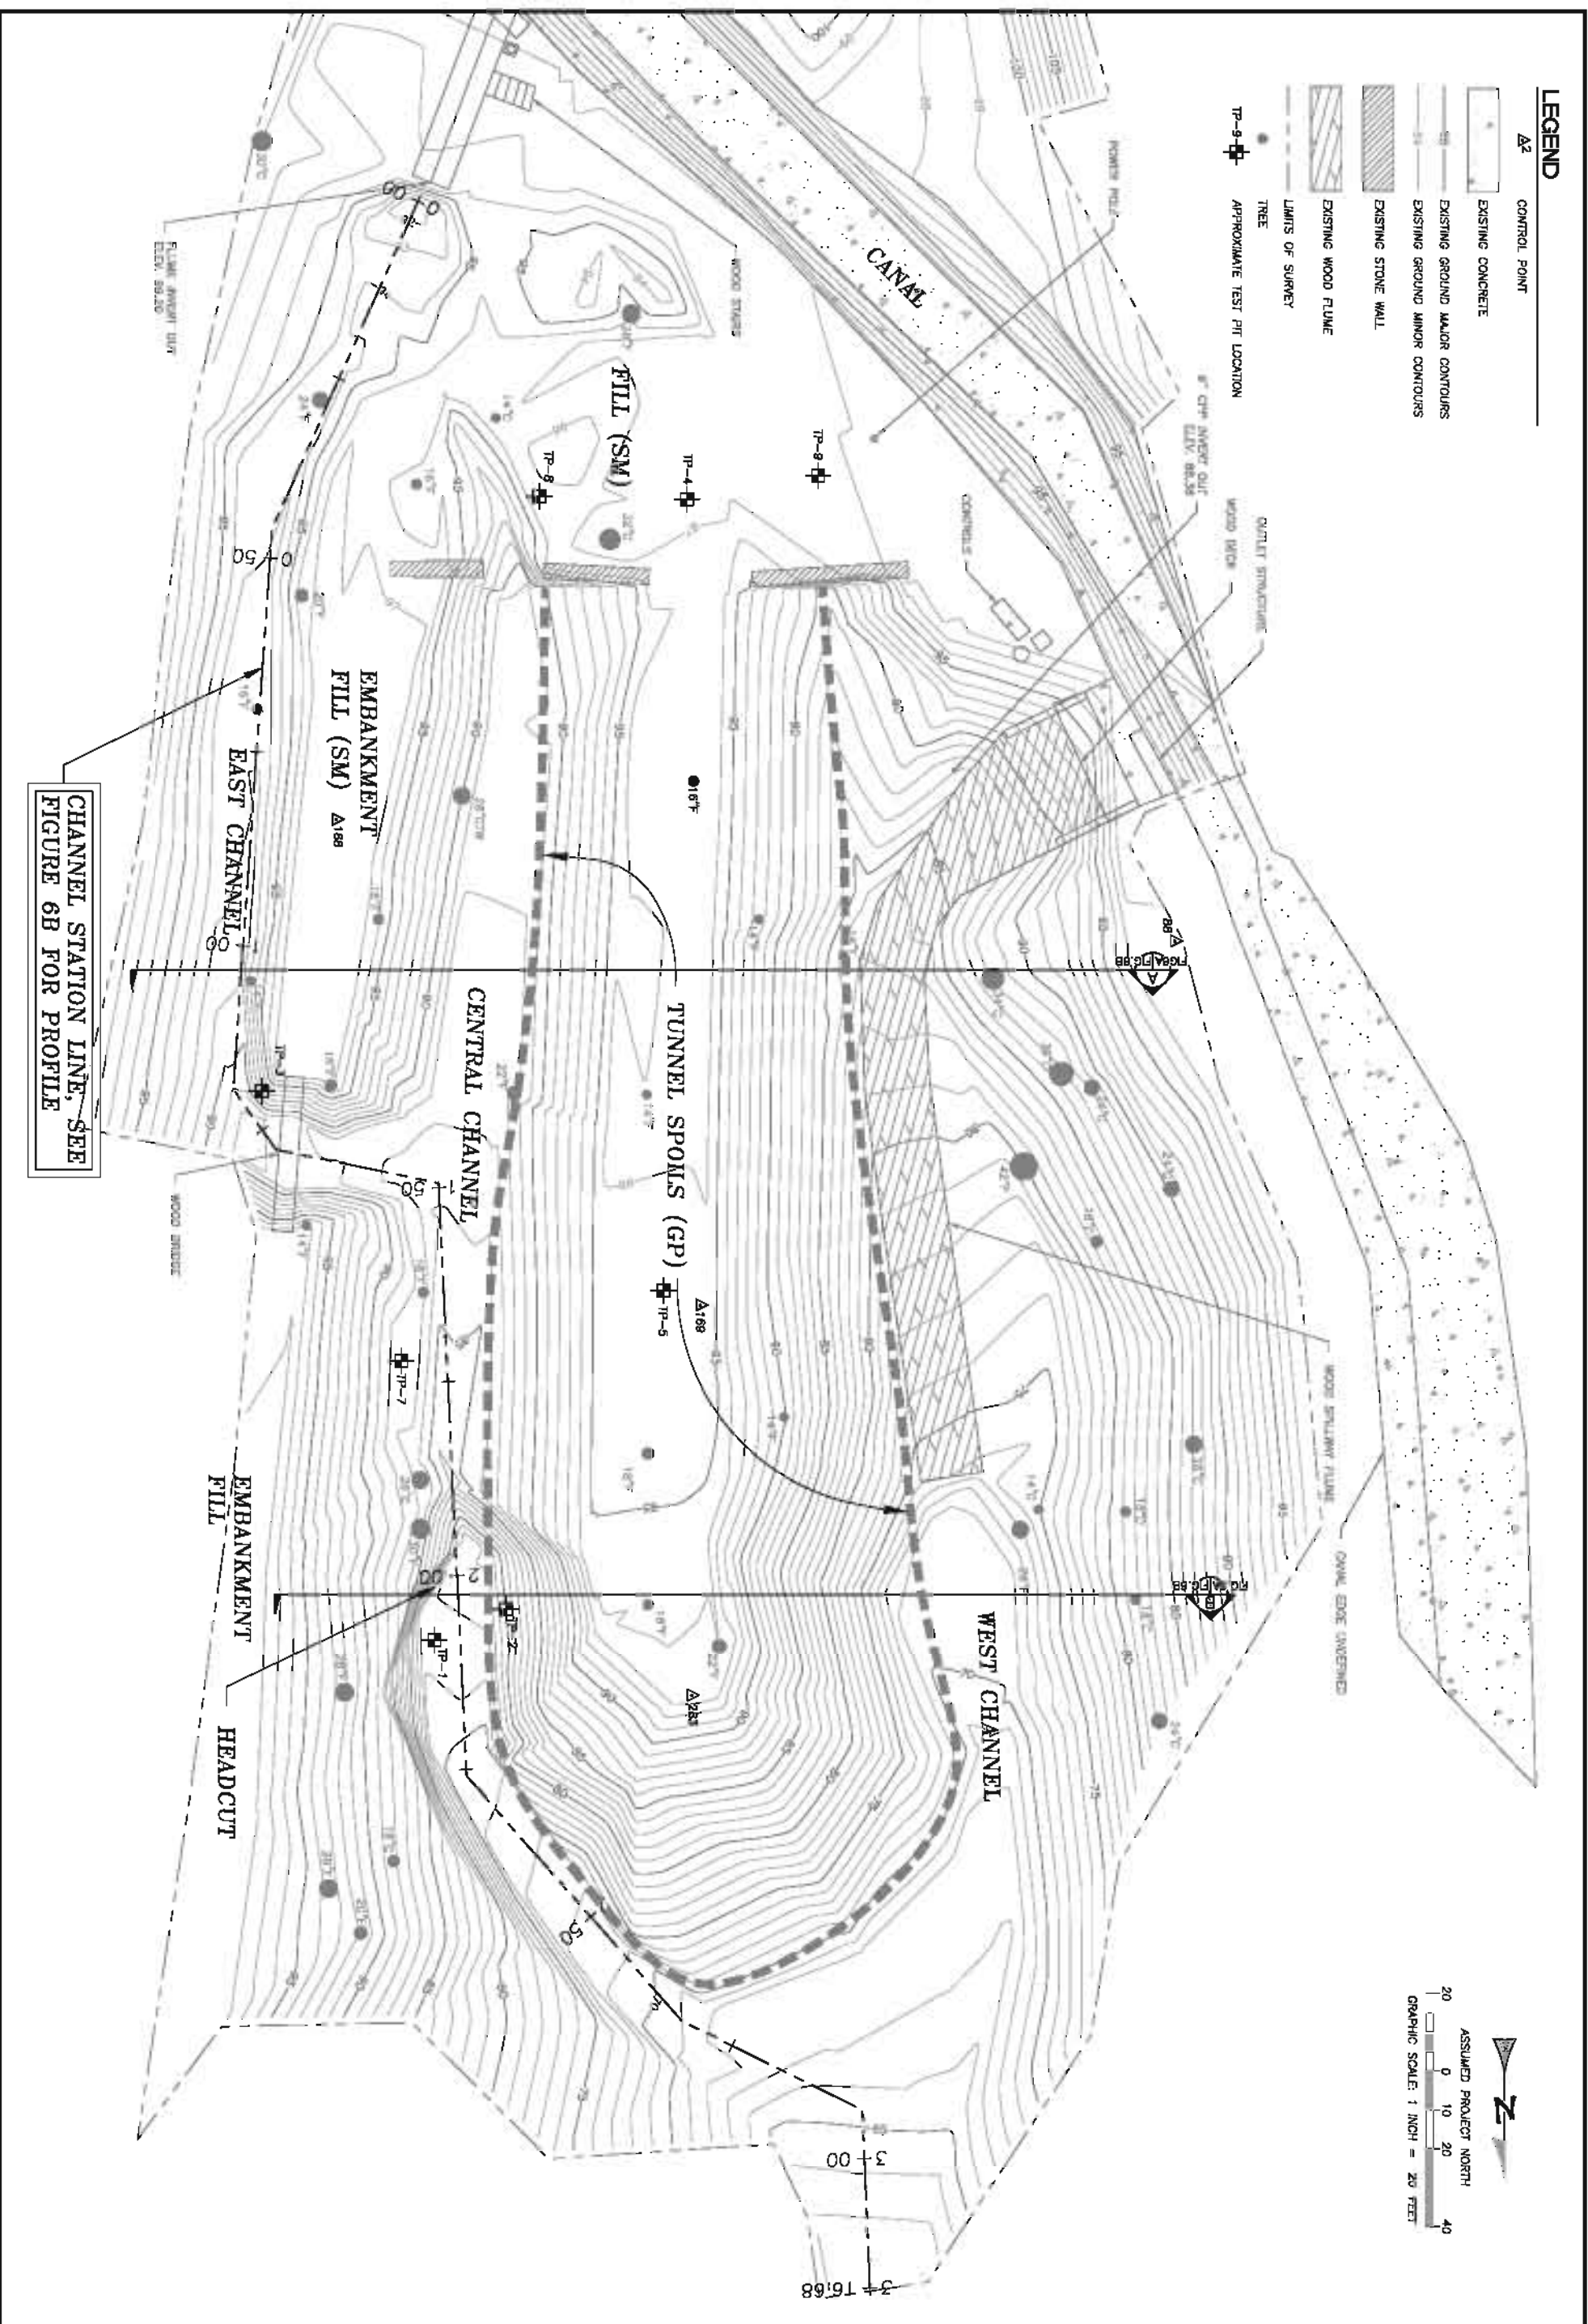
Approximately 120 feet downstream of the East-Central confluence, the Central Channel joins the West Channel, which emanates from the canal spillway (**Photo 12**). This juncture is at the downstream end of the reach and the Esmeralda Creek channel is in good, functioning condition at this location. It is important note that throughout Reach 6 most of the stream flow goes subsurface, resurfacing at the downstream end. This is likely because the channel alignments have been highly altered and there has been a significant amount of porous fill material placed in this reach. A more thorough description of channel morphology is provided in Section 2.4.
