Oyster Creek Stabilization Project
Post-construction Monitoring Report – Year 4

Prepared for:
El Dorado Irrigation District

Prepared by:
Horizon Water and Environment
Contact: Robin Hunter
(203) 848-9977
rohunter@montrose-env.com

January 2024

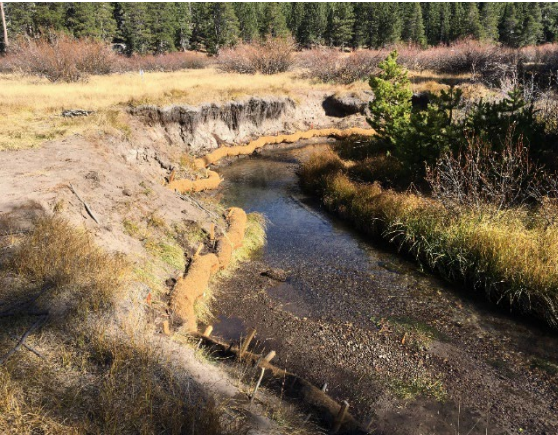
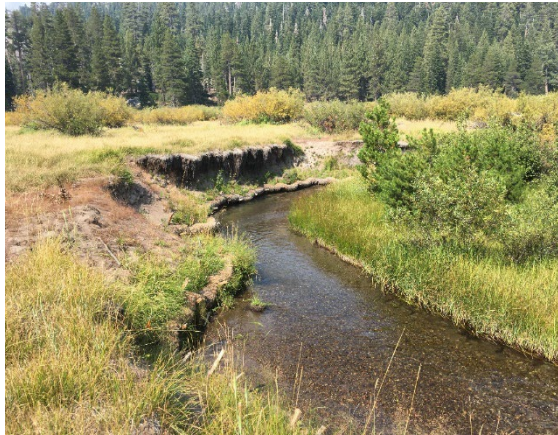
Photo No. 1A		Photo No. 1B		Photo No. 1C	
Date: 10/24/2019	Year: 0	Date: 8/28/2020	Year: 1	Date: 8/7/2023	Year: 4
Description: Oyster Creek post-construction, facing north.		Description: Oyster Creek facing north.		Description: Bank vegetation density has increased along the lower bank.

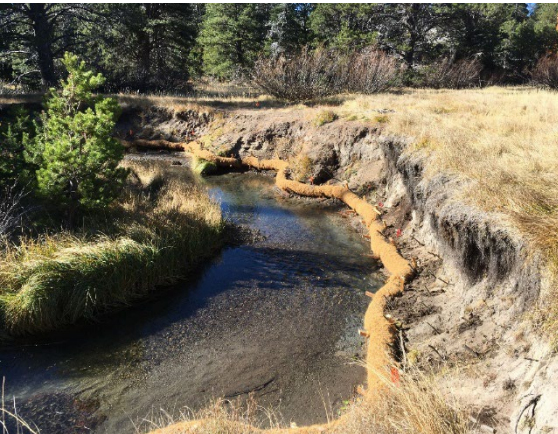
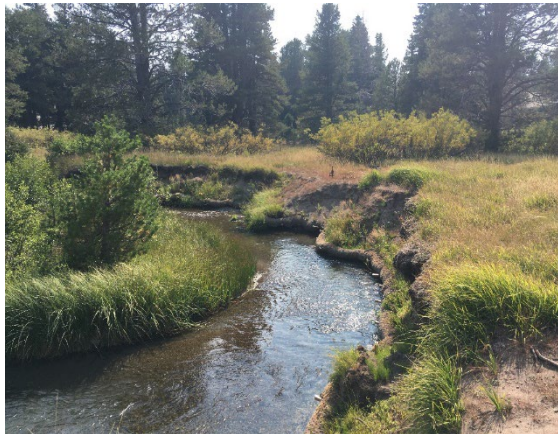
Photo No. 2A		Photo No. 2B		Photo No. 2C	
Date: 10/24/2019	Year: 0	Date: 8/28/2020	Year: 1	Date: 8/7/2023	Year: 4
Description: Oyster Creek post-construction, facing south.		Description: Oyster Creek facing south.		Description: The bank toe appears to be aggrading with the upper slope stable.

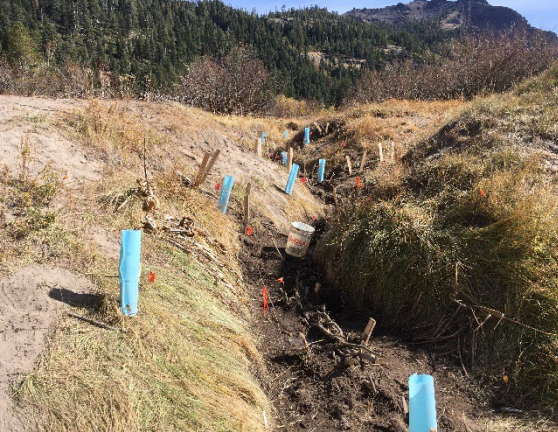
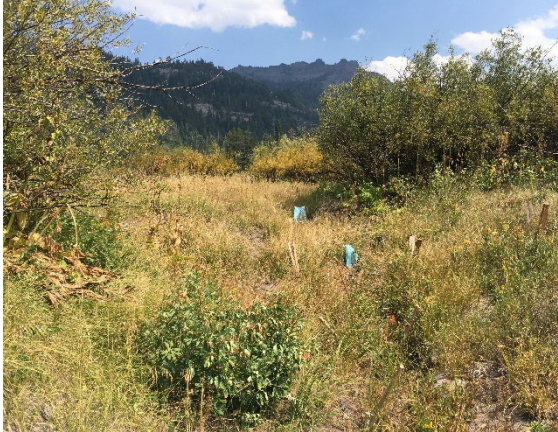
Photo No. 4A		Photo No. 4B		Photo No. 4C	
Date: 10/24/2019	Year: 0	Date: 8/28/2020	Year: 1	Date: 8/7/2023	Year: 4
Description: North tributary, pre-construction, facing southeast.		Description: North tributary, facing southeast.		Description: North tributary – dense herbaceous vegetation covers both banks.

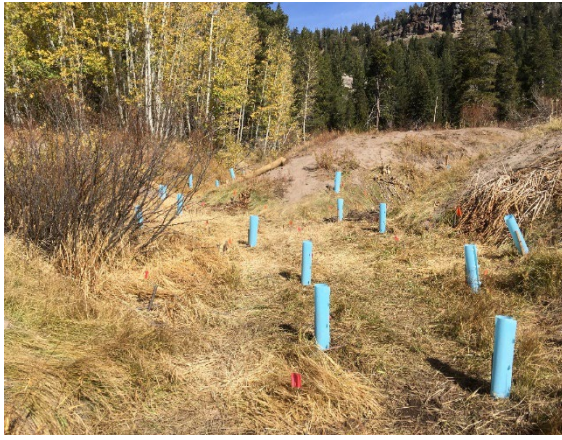
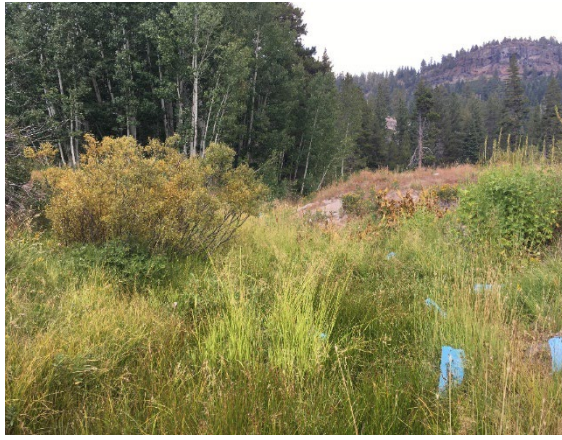
Photo No. 5A		Photo No. 5B		Photo No. 5C	
Date: 10/24/2019	Year: 0	Date: 8/28/2020	Year: 1	Date: 8/7/2023	Year: 4
Description: North tributary, pre-construction, downstream extent of project, facing upstream.		Description: North tributary at the downstream extent of project, facing upstream.		Description: An aspen stand continues to expand on the right bank and into the main tributary.

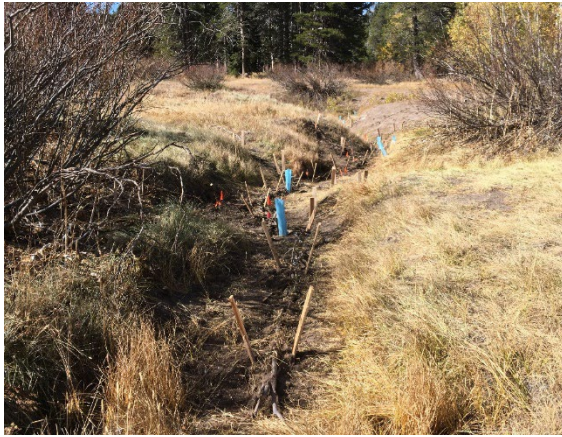
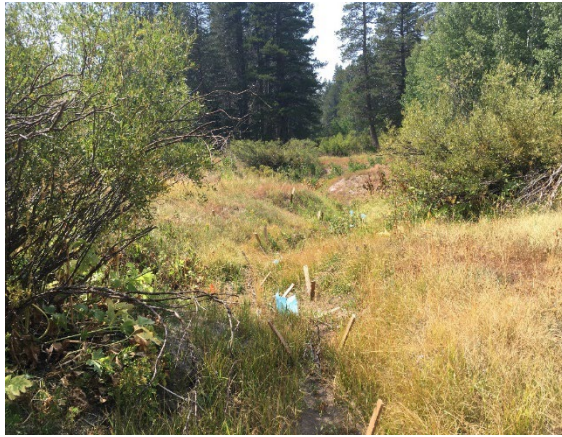
Photo No. 6A		Photo No. 6B		Photo No. 6C	
Date: 10/24/2019	Year: 0	Date: 8/28/2020	Year: 1	Date: 8/7/2023	Year: 4
Description: North tributary, post-construction, facing east.		Description: North tributary, facing east.		Description: North tributary is densely vegetated with a mix of native herbaceous species.
