EL DORADO IRRIGATION DISTRICT

Caples Spillway Channel Sensitive Site Investigation Project 184 Geomorphology Monitoring

FEBRUARY 2010

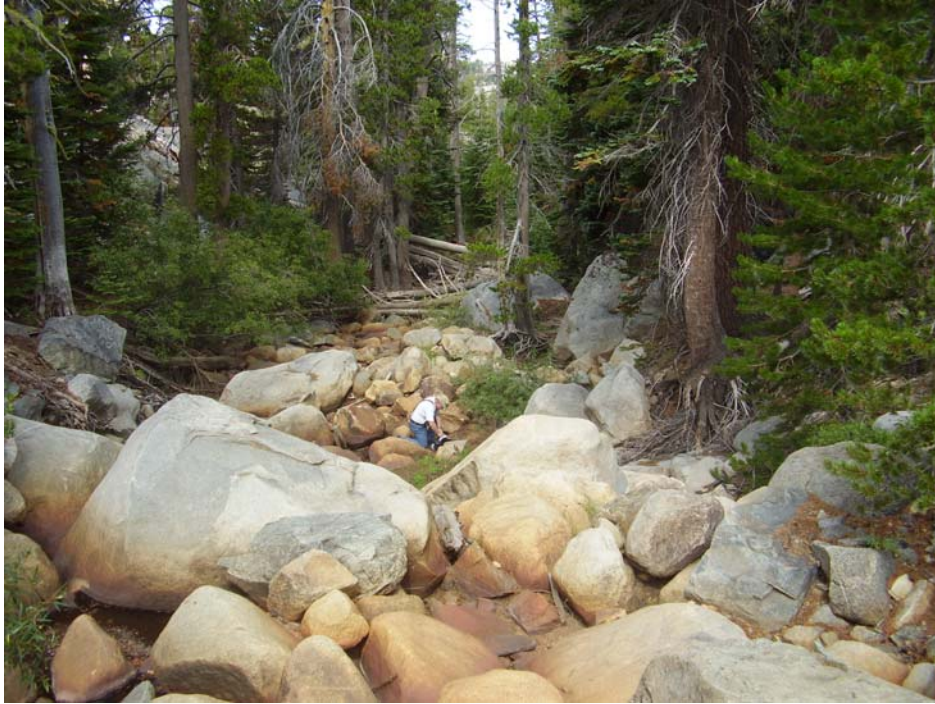
Figure 2-2 Cascade channel type. Location is approximately 700 ft downstream from the auxiliary spillway. View is downstream.

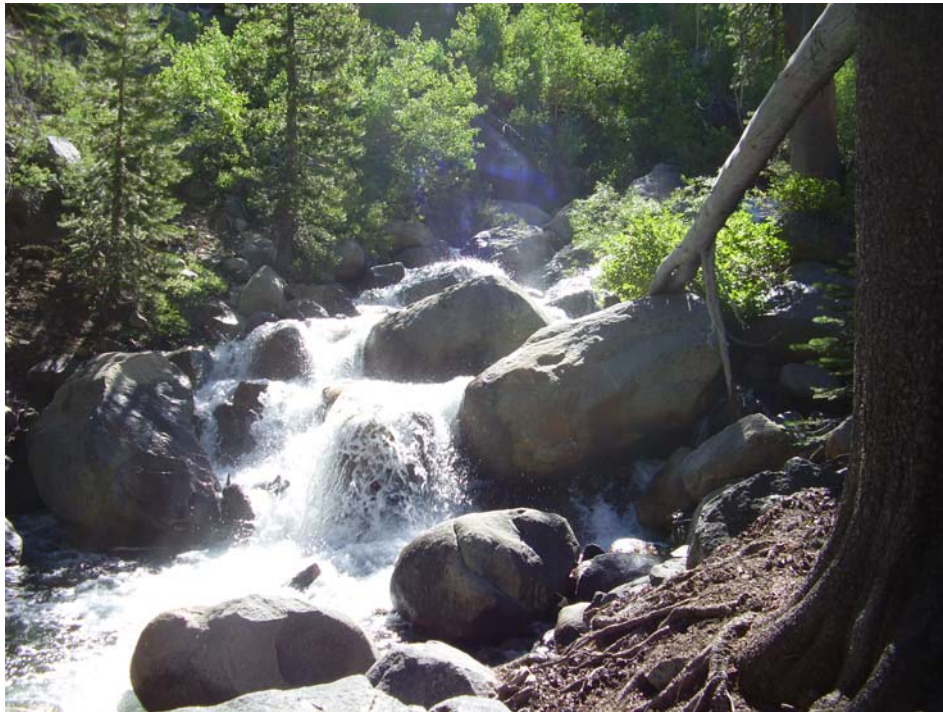
Figure 2-3 Cascade channel type. Flow is 30 cfs, upstream view.

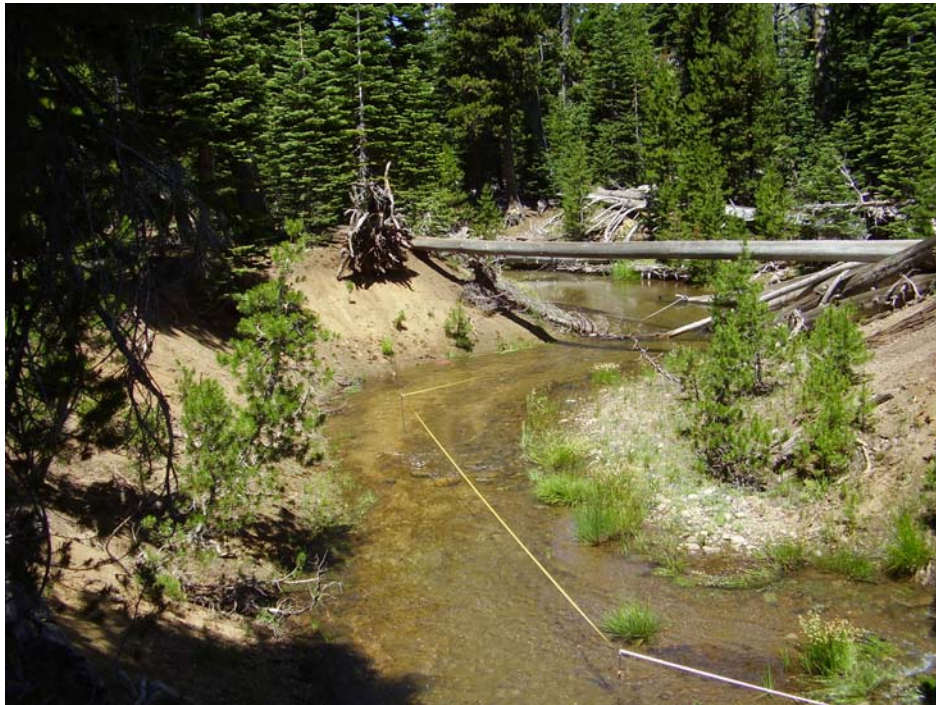
Figure 2-4 Pool-Riffle channel type in lowermost 840 ft section of channel. Note the meander planform and the bar on the inside of the meander against the right bank. (flow is 10 cfs, view downstream)

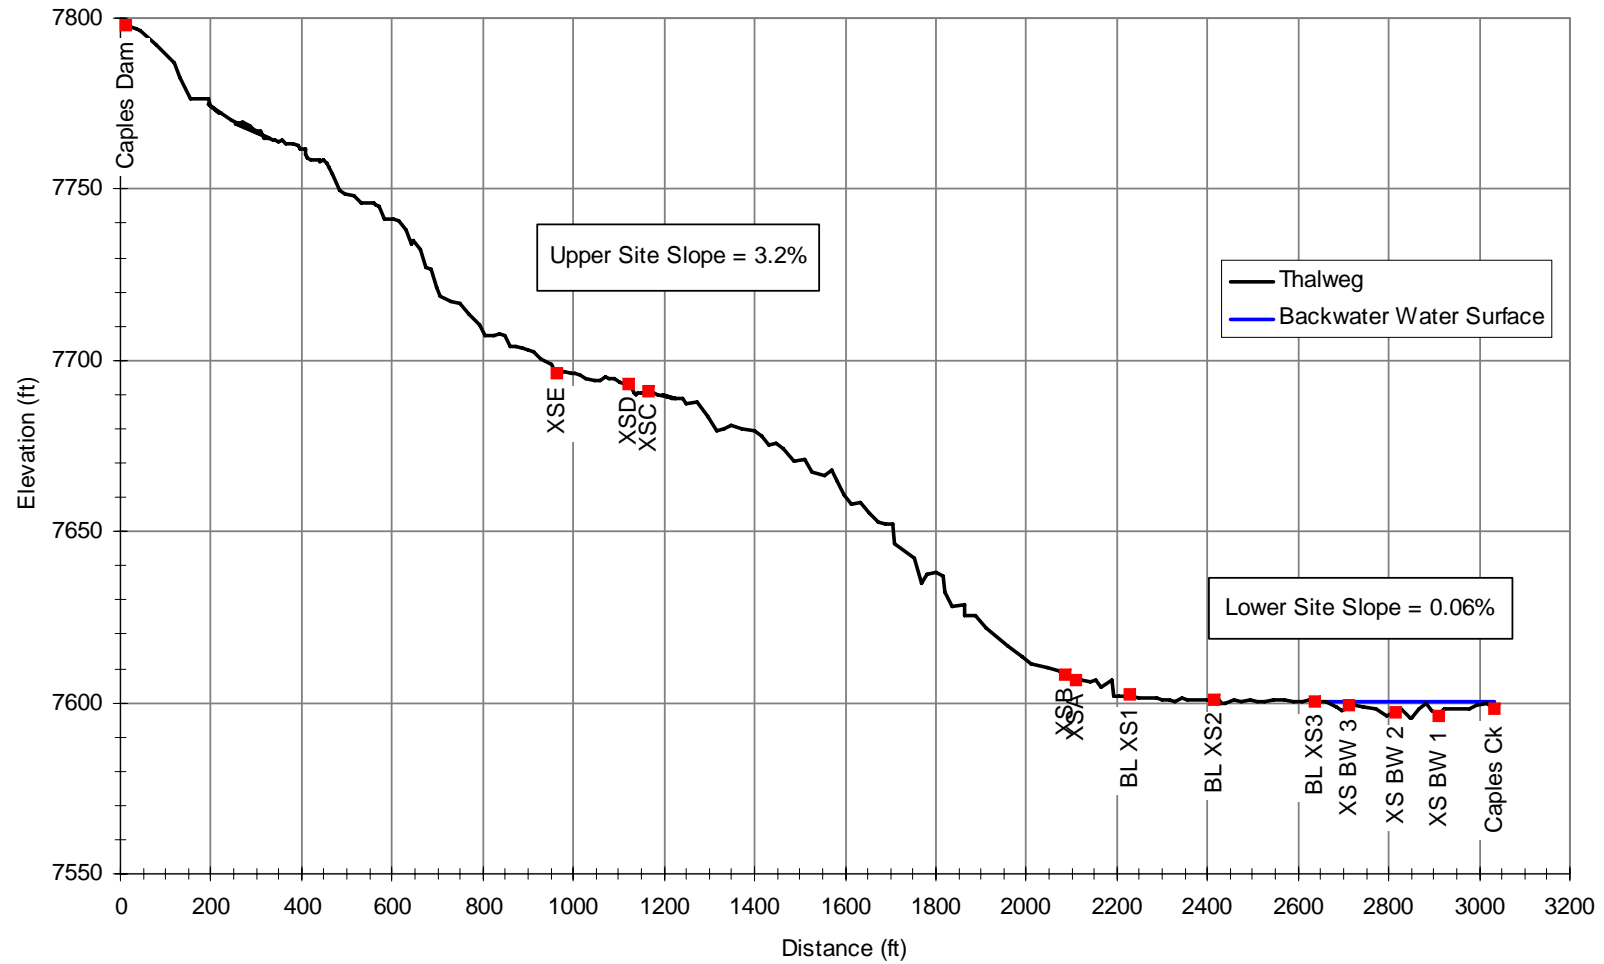
Figure 2-10 Caples spillway channel longitudinal profile

Twelve channel cross-sections were surveyed to characterize channel morphology and for input into a hydraulic model. The cross-sections are plotted in Appendix A. Figure 2-10 shows the locations of the surveyed cross-sections on the longitudinal profile (also see Figure 2-1).

Three cross-sections were surveyed within the upstream erosion site (approximately stations 960 ft, 1100ft, and 1175 ft downstream of the dam spillway, see Figure 2-10). Nine of the cross-sections were surveyed in the lower 950 ft of the pool-riffle channel between the confluence with Caples Creek, upstream to the transition into the cascade channel. Three of the cross-sections located in the pool-riffle reach were originally surveyed in August 1999 in support of EID relicensing studies (BLXS1, BLXS2, and BLXS3). These 1999 cross-sections were located in the field and re-surveyed by ENTRIX in 2007. The latest survey shows that these three cross-sections have remained essentially unchanged in the 8-year period between 1999-2007 (see comparison cross-section plots in Appendix A).

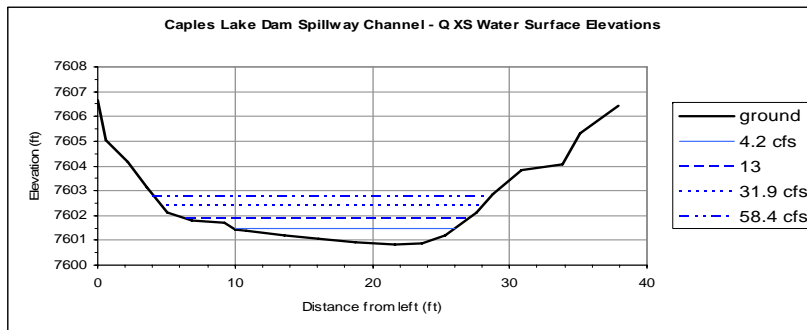
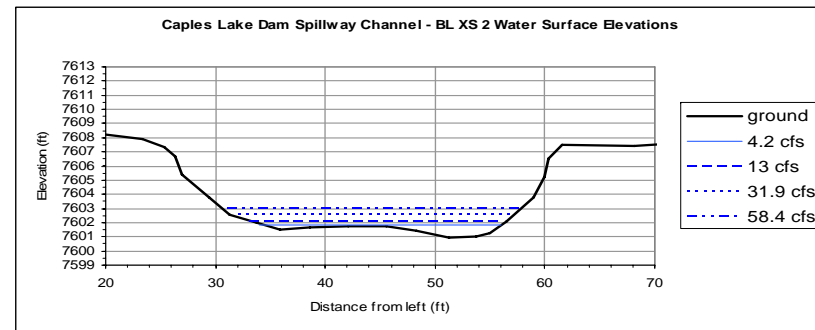
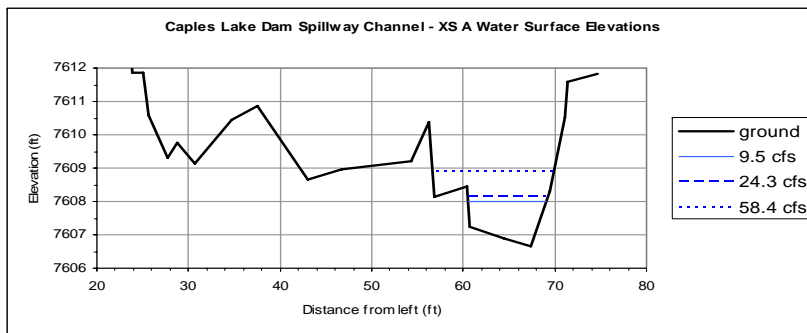
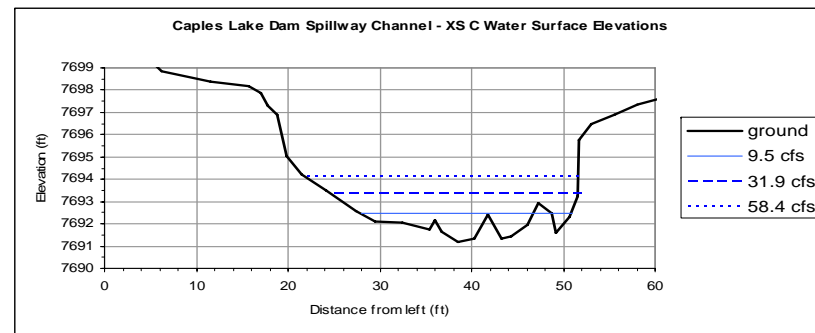
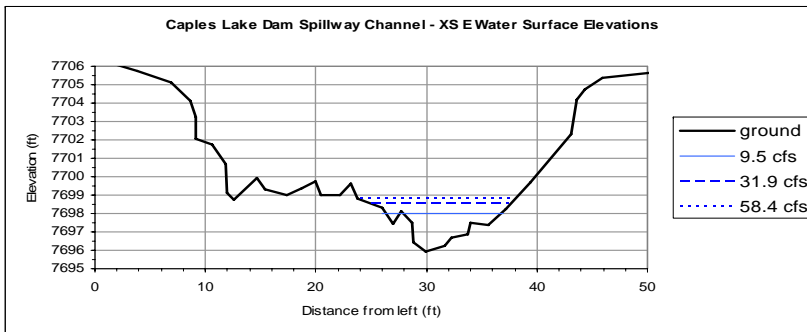
Water surface elevations at each of the three flow releases were recorded at the five installed staff gages (two at the upper and three at the lower erosion sites), surveyed with an auto-level, and tied into the elevations of the 2007 ground survey of cross-sections. Figure 3-4 (also see Appendix A) shows the observed water surface elevations at each of the flow releases. At the highest 58 cfs release, mean flow depths at each of the cross-sections are approximately 2 ft, and the water surface is at least 4 ft from the top-of-bank at most cross-sections. Examples of flow conditions and water surface elevations for the controlled flow releases are provided in field photos in Appendix B.

Figure 3-4 Water surface elevations at five monitoring cross-sections (XS C and E are upper erosion monitoring site; xs Q, xs 2, and xs A are the lower erosion monitoring site)

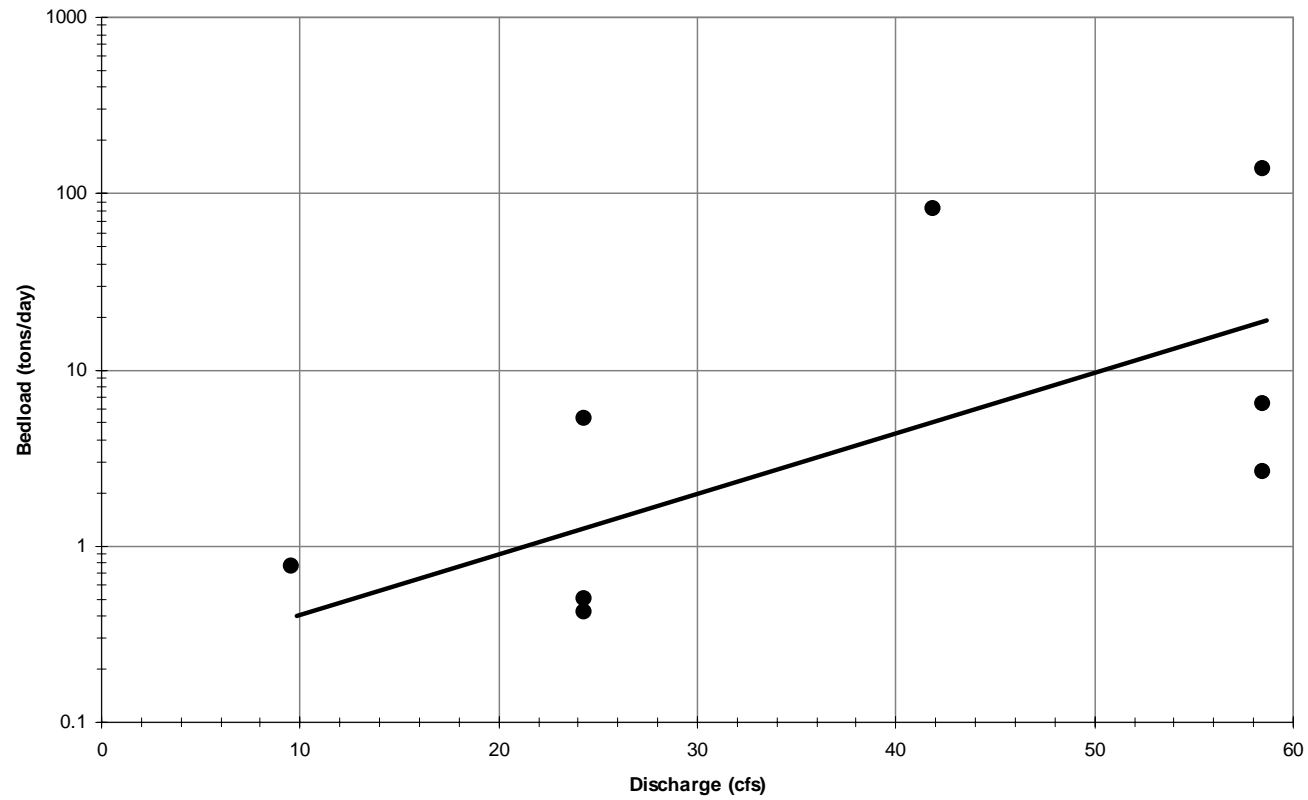
Figure 4-4 Caples dam spillway channel bedload transport rating curve. Based on July 2009 measured data from Helly-Smith samples

Because of the problems with the bedload trap samplers, bedload transport results are based on the eight measurements collected with the Helley-Smith samplers. The bedload transport rate (in tons/day), and particle size gradations of the samples are reported in Table 4-1. A sediment transport rating curve showing bedload transport vs. discharge with a best-fit trend line is displayed in Figure 4-4.

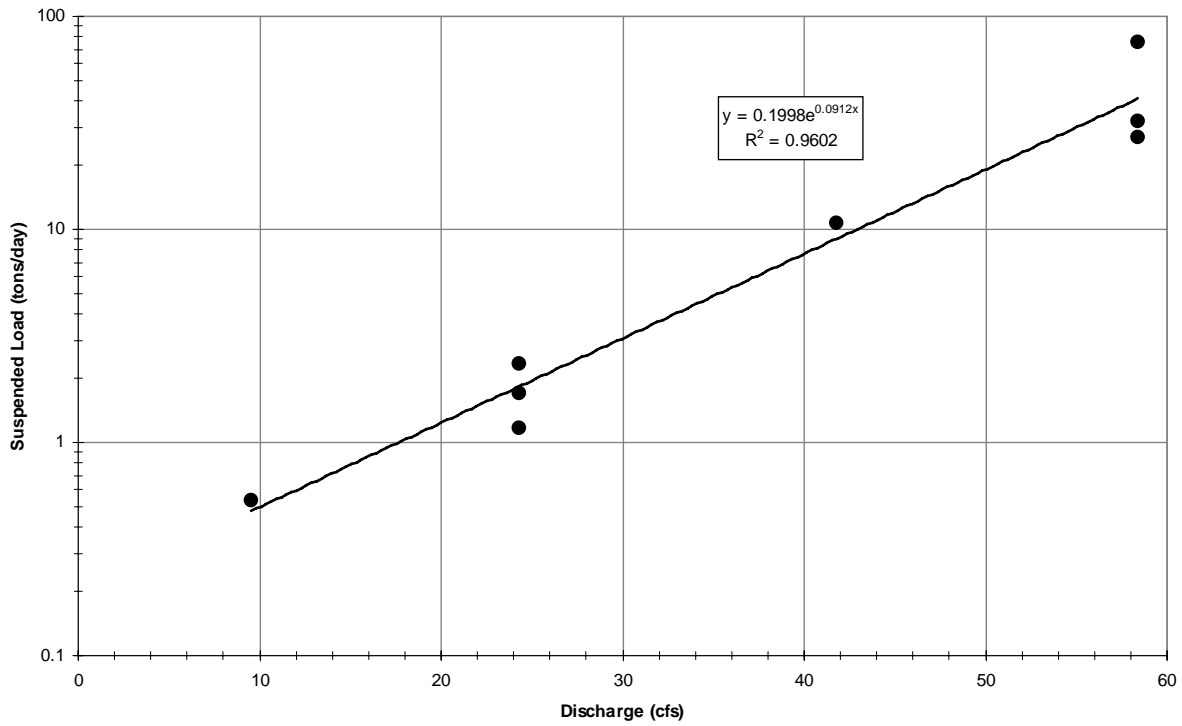
Figure 4-5 Suspended sediment load rating curve. Caples dam spillway channel July 2009

Suspended load measurements were made at each of the flow releases throughout the lower erosion monitoring site. A suspended load rating curve showing the rate of transport vs. discharge with an exponential trendline is presented in Figure 4-5. Suspended load increases from 0.5 tons/day at a flow of 9.5 cfs to over 60 tons/day at a flow of 58 cfs. In general, the median particle size of the suspended load increases with increasing discharge from silt size sediment to fine sand (Figure 4-6).

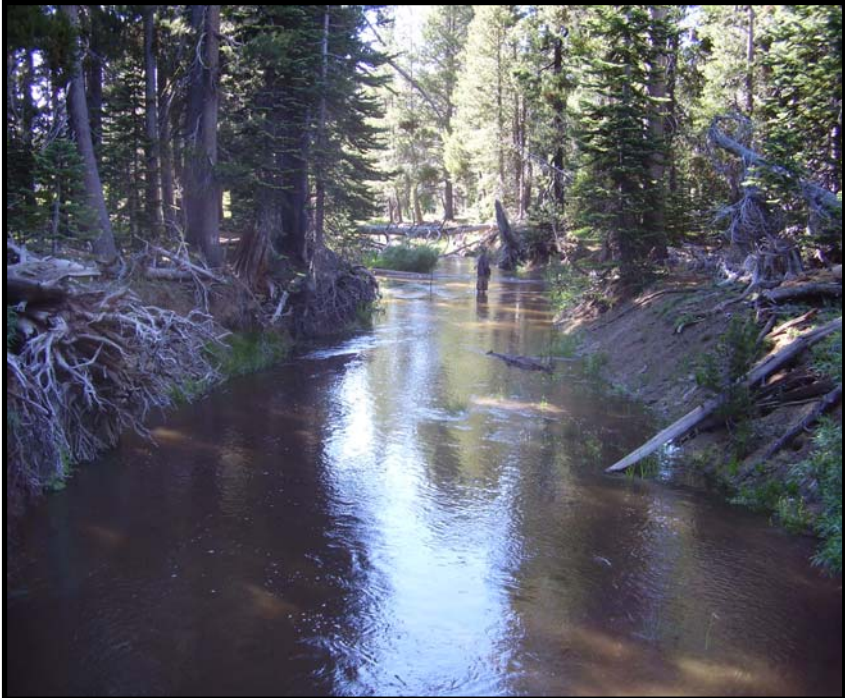
Downstream of Staff Gage 2, looking toward XS Q, at 25 cfs (top) and 58 cfs (bottom)

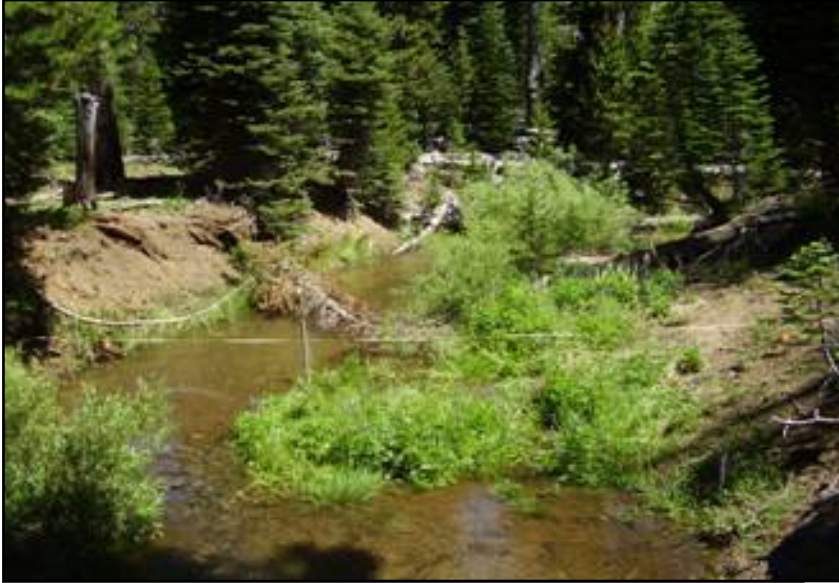
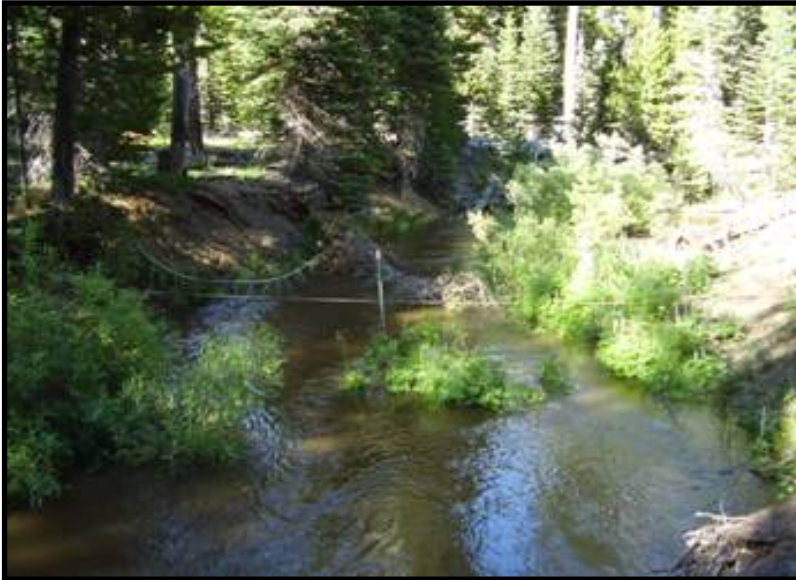
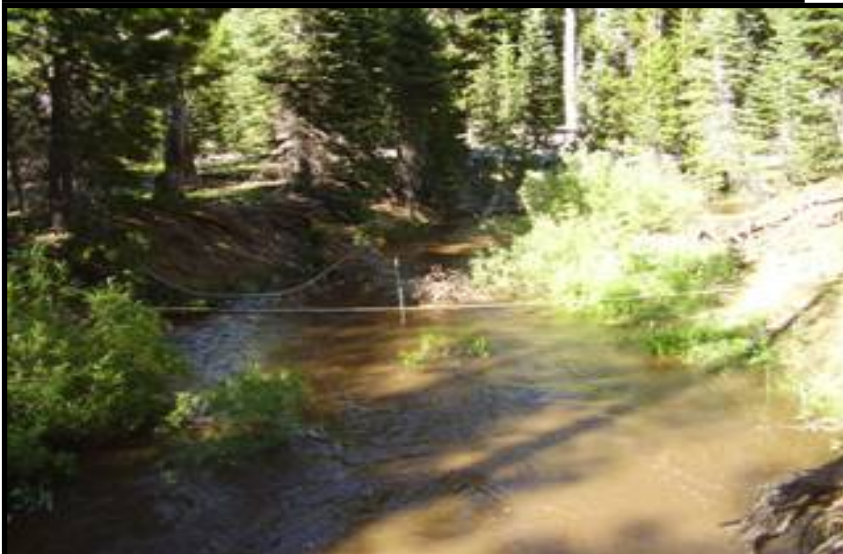
Staff Gage 2 upstream view at 10 cfs (Top), 24 cfs (middle), and 58 cfs (bottom)

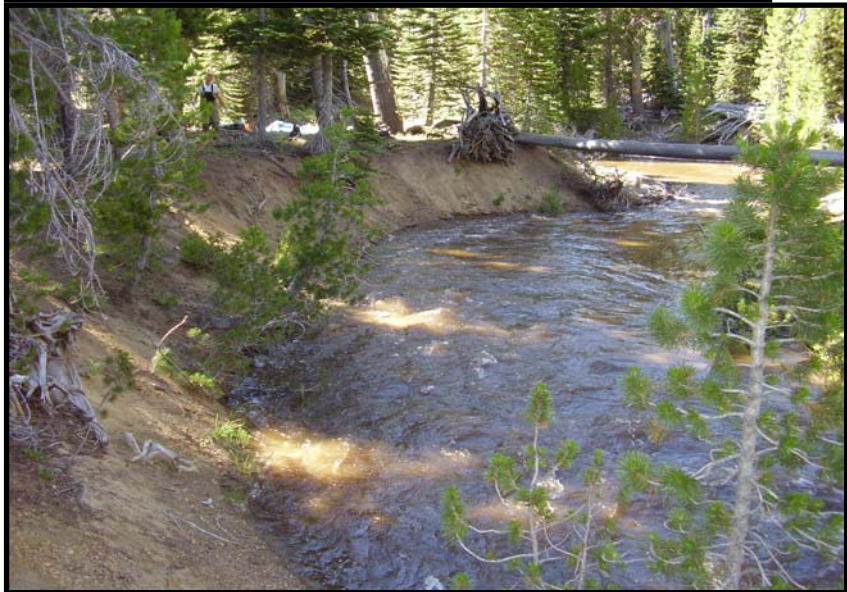
Below large woody debris jam at 10 cfs (top), 24 cfs (middle), and 58 cfs (bottom)

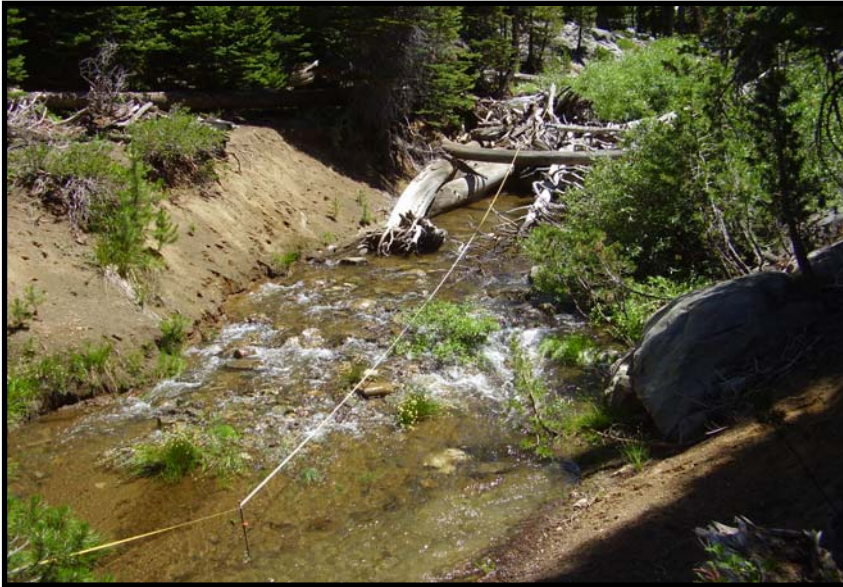
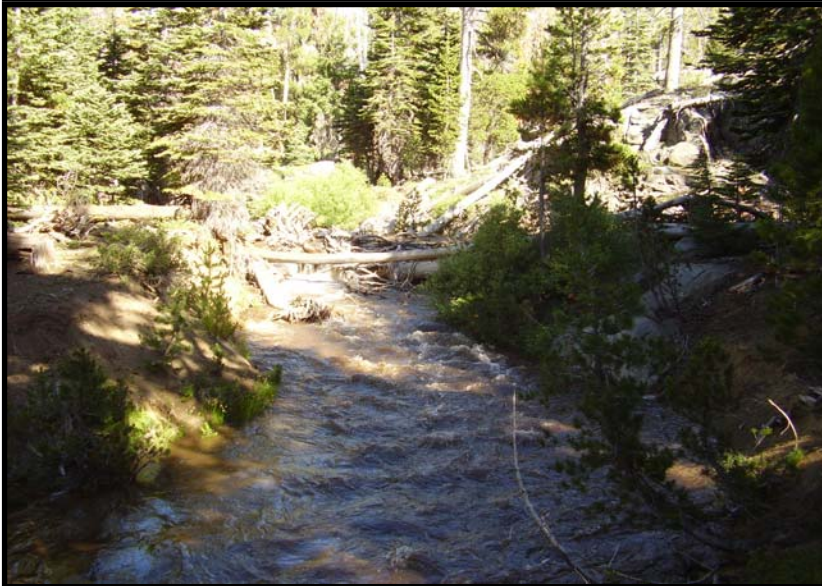
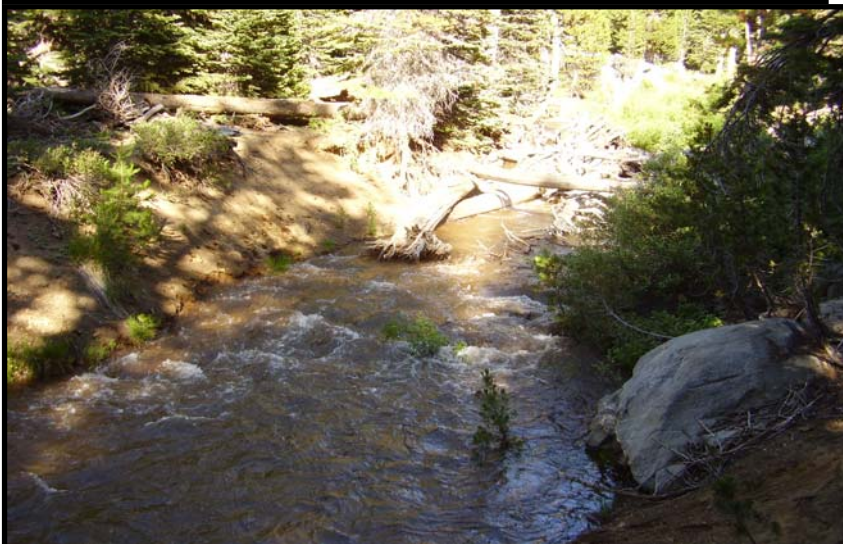
Below large woody debris jam, view upstream at 10 cfs (top), 28 cfs (middle), and 58 cfs (bottom).

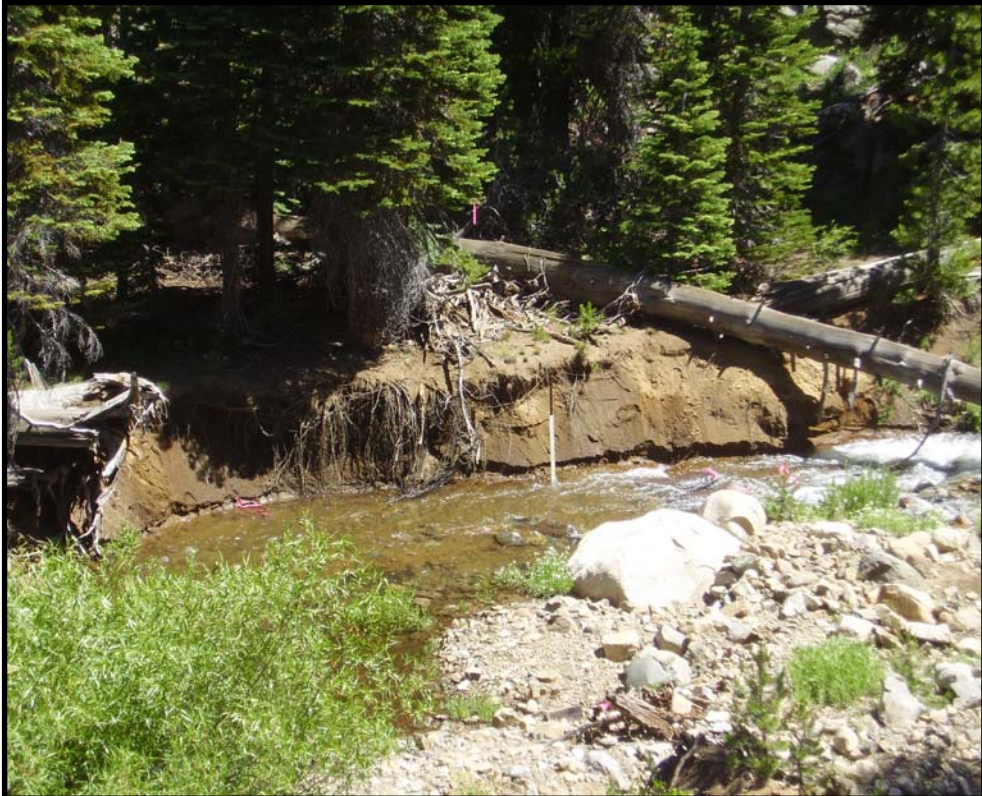
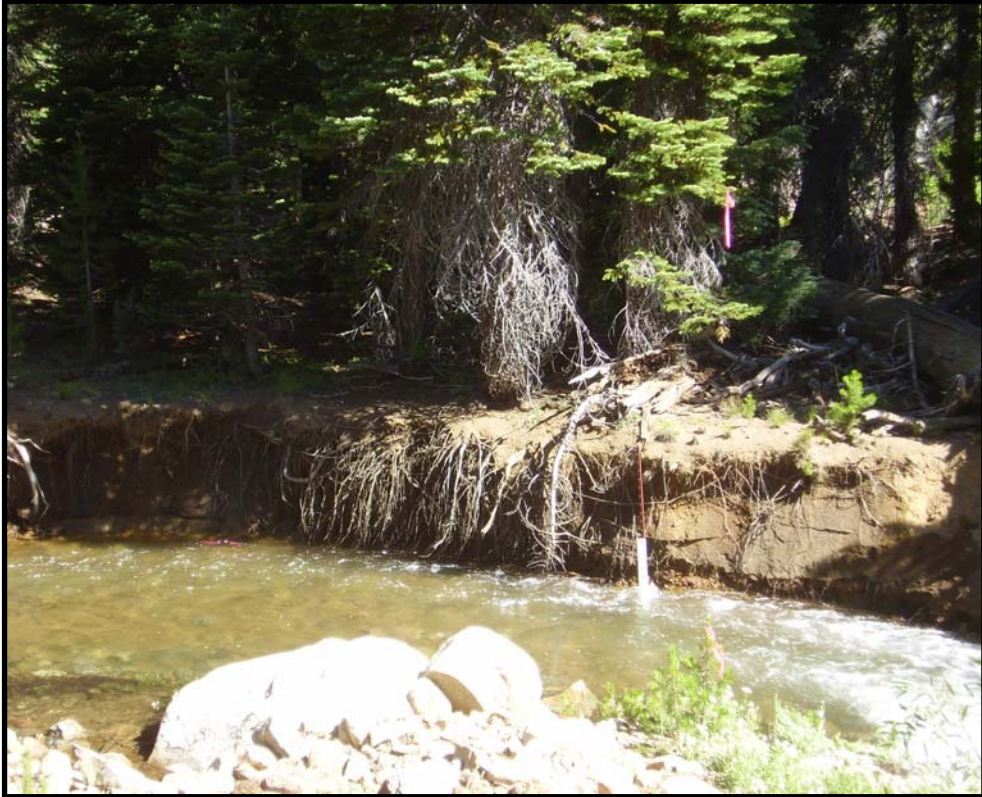
Right bank above large woody debris jam, staff gage 3 at 9.5 cfs (top) and 24 cfs (bottom)

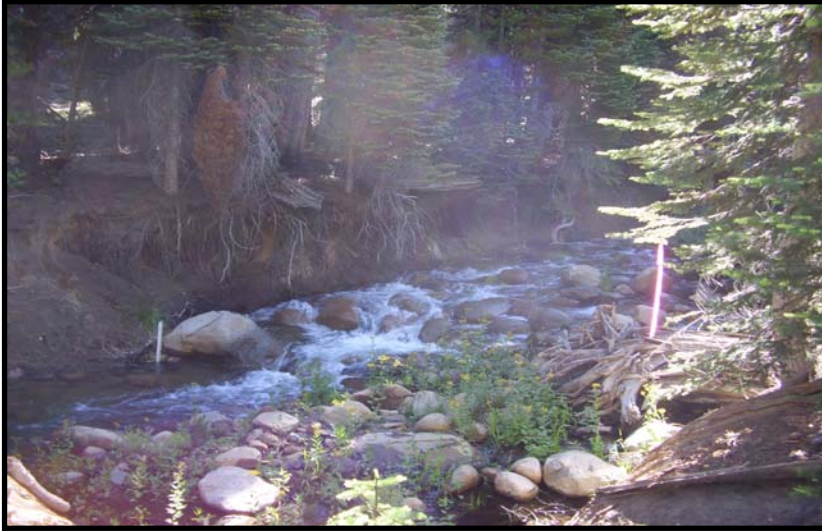
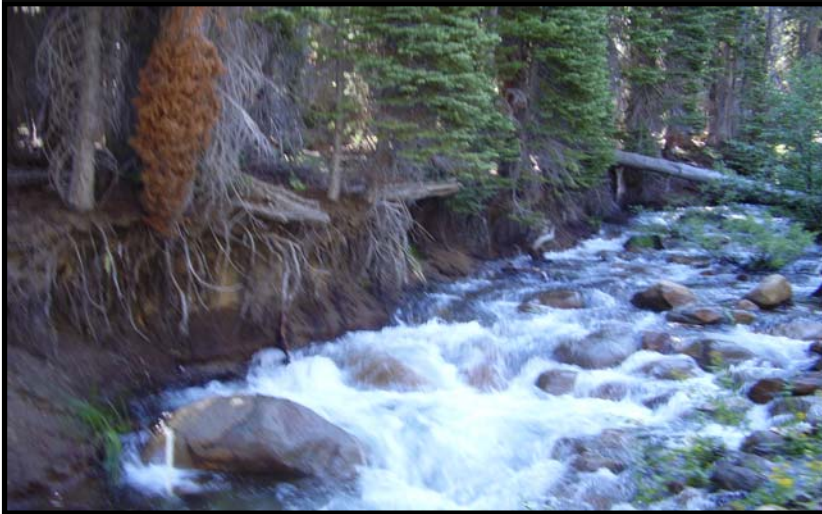
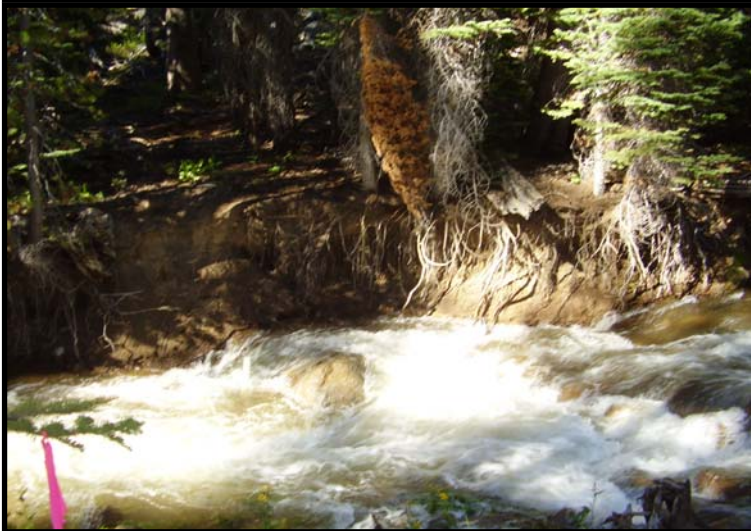
Staff gage 5, right bank view upstream at 9.5 cfs (top),
24 cfs (middle), and 58 cfs (bottom)

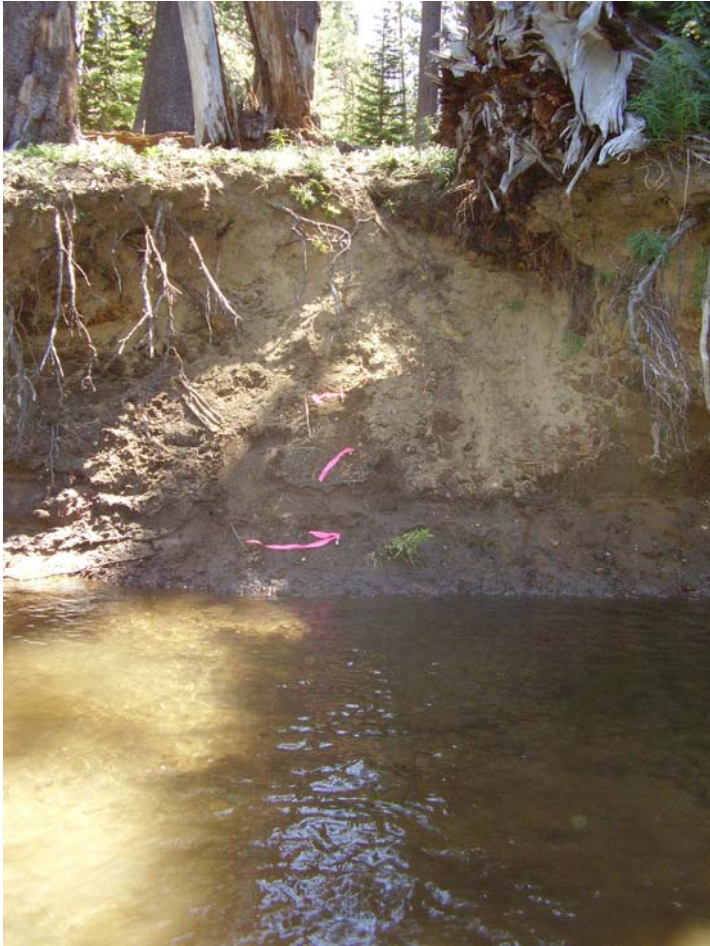
Pin ID	Site	Height Above Leakage Flow Water Surface (ft)	Cumulative Bank Retreat After 9.5 cfs* (ft)	Cumulative Bank retreat After 24 cfs* (ft)	Cumulative Bank retreat After 58 cfs* (ft)
Pin 1	1	1.2	0.01	0.01	0.01
Pin 2	2	0.8	0.03	0.13	0.38
Pin 3	2	1.2	0.14	0.26	0.72
Pin 4	3	0.6	0.0	0.55	0.97
Pin 5	4	0.6	0.14	0.48	0.93
Pin 6	4	1.3	0.04	0.45	0.74
Pin A	5	0.5	n.a.	n.a.	0.27
Pin B	5	2.0	n.a.	n.a.	0.04
Pin C	5	2.7	n.a.	n.a.	0.08

Erosion pins A, B, C (arranged vertically on left bank) installed just prior to the 58 cfs release. No photo available for post-flow release.
