Oyster Creek Sensitive Site Monitoring Report

prepared for
El Dorado Irrigation District

August 2009

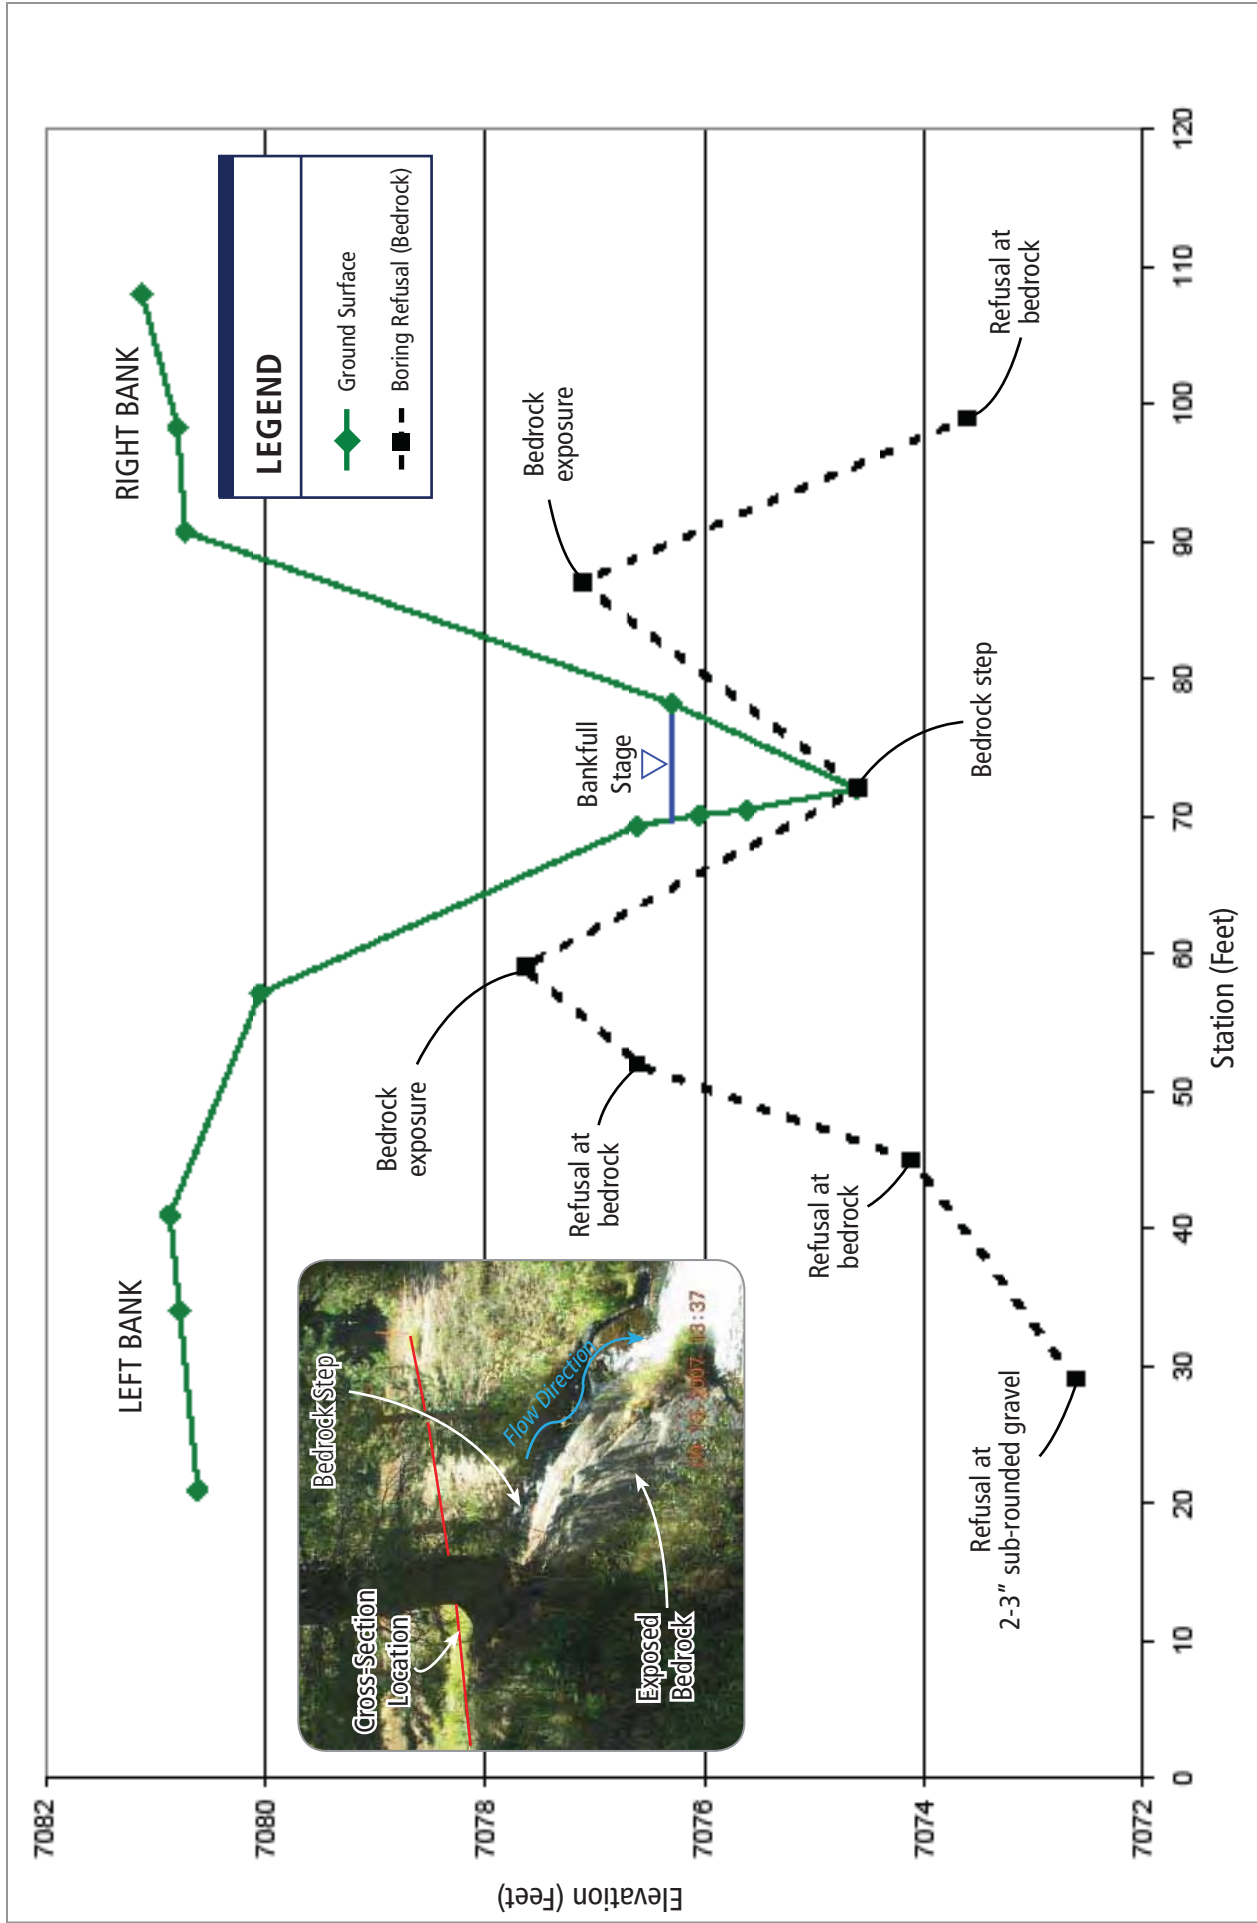
FIGURE 4-5: Cross-section showing subsurface investigation results at the bedrock step.

The only headcut identified in the main Oyster Creek channel is the bedrock step at the Reach 5/6 transition. Bedrock at this location provides grade control for upstream reaches of Oyster Creek and is important for long-term channel stability. A reconnaissance-level subsurface investigation was conducted at the bedrock step to examine the extent and elevation of bedrock adjacent to the channel. Bedrock elevations adjacent to the active channel were estimated by measuring depth to bedrock in augured holes and at surface exposures along a cross-section. These data were referenced to topographic data collected at the cross-section (Figure 4-5). Surface bedrock exposures were found on both the left and right banks of the channel at 7 and 13 feet of distance from the thalweg, respectively. Both of these exposures were found to be elevated above the bedrock at the thalweg by approximately 3 feet. These exposures confine the channel to the current alignment, suggesting that flanking and subsequent headcut initiation is unlikely to occur. Because of the importance of this location with respect to long-term channel stability, it should be monitored through repeated cross-section survey as a component of License Condition 37.9, Geomorphology (*Continuing Evaluation of Representative Channel Areas*) (FERC, 2006).

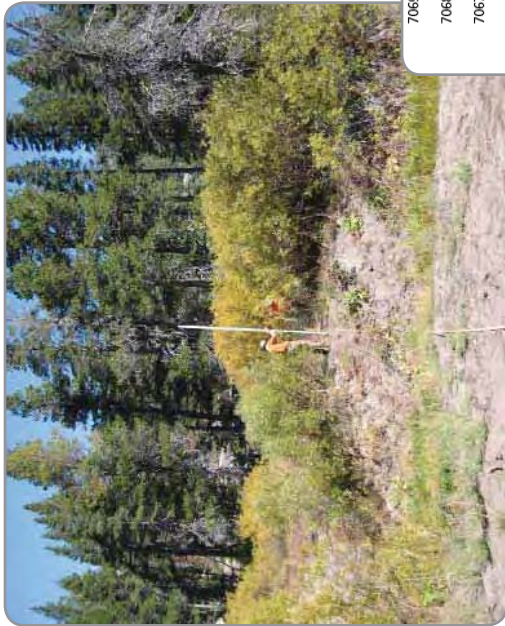
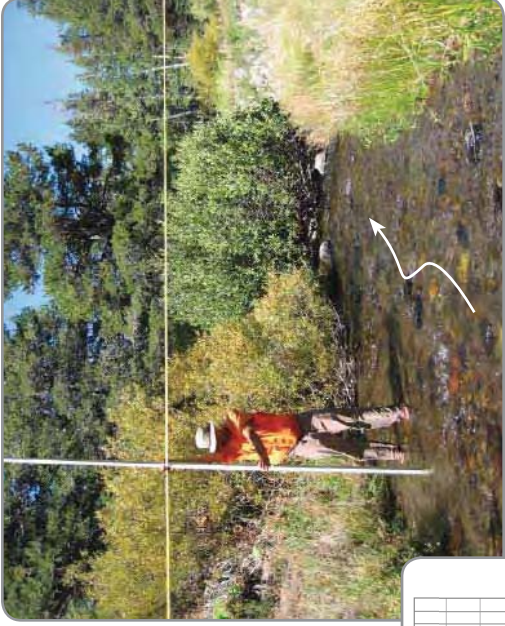
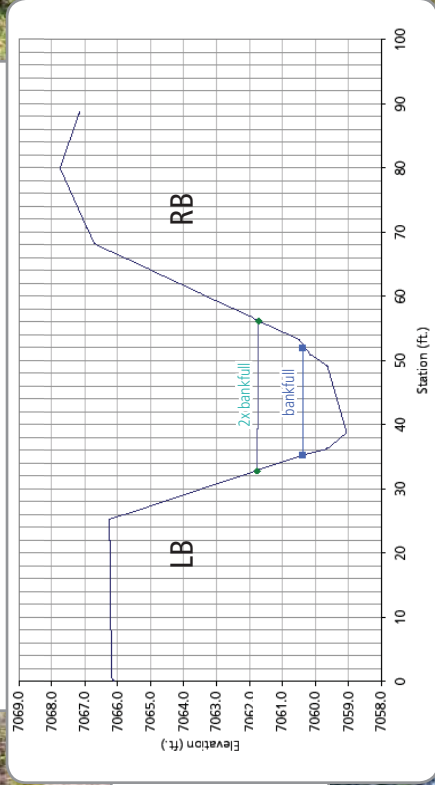
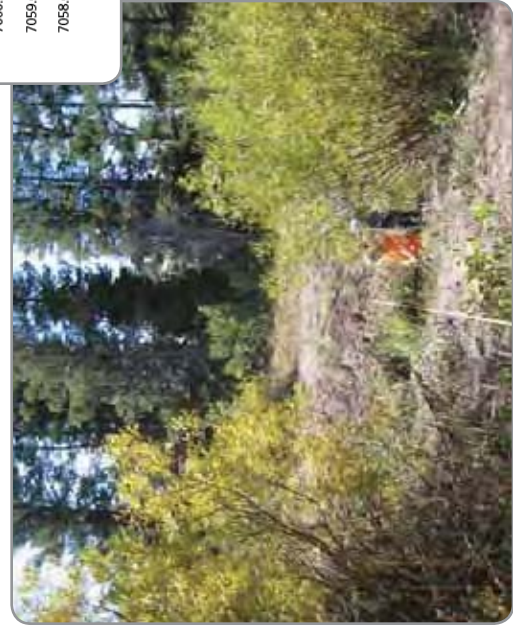
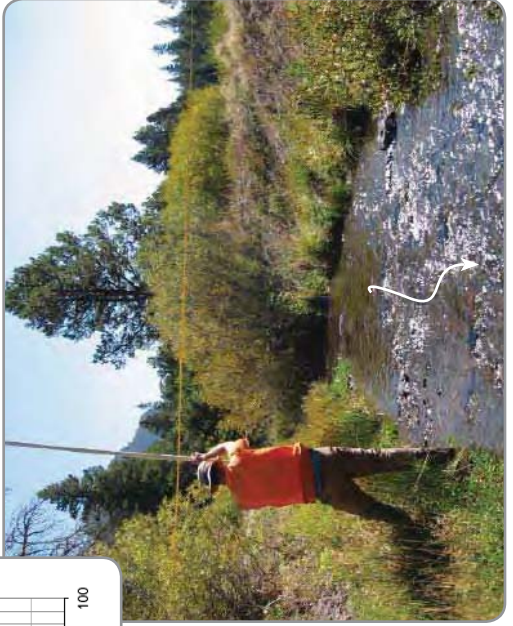
Cross Section 1

$W_{bkfl} = 16.7$ ft.

$D_{bkfl} = 1.3$ ft.

W/D Ratio = 12.5

FIGURE 4-7a: Cross-section survey results. W_{bkfl} = Bankfull width; D_{bkfl} = Depth at Bankfull; W/D = Width to Depth at bankfull.

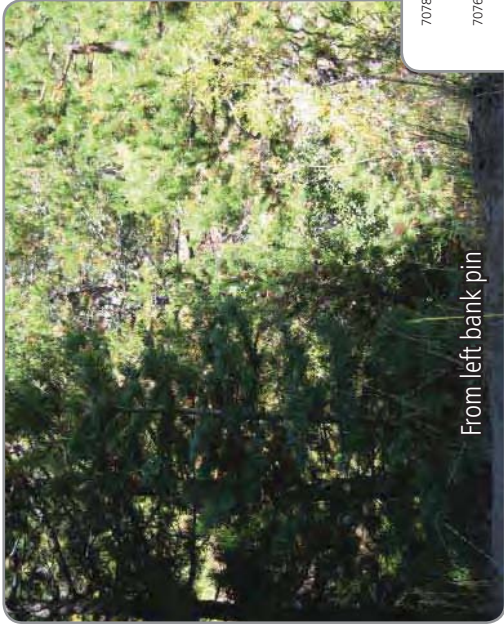
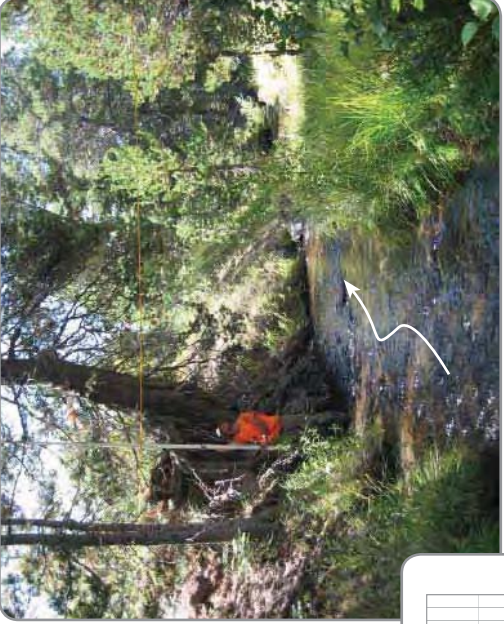
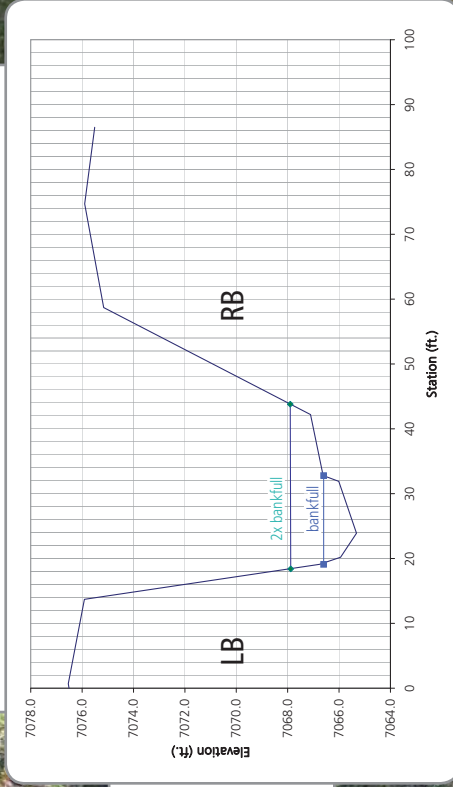
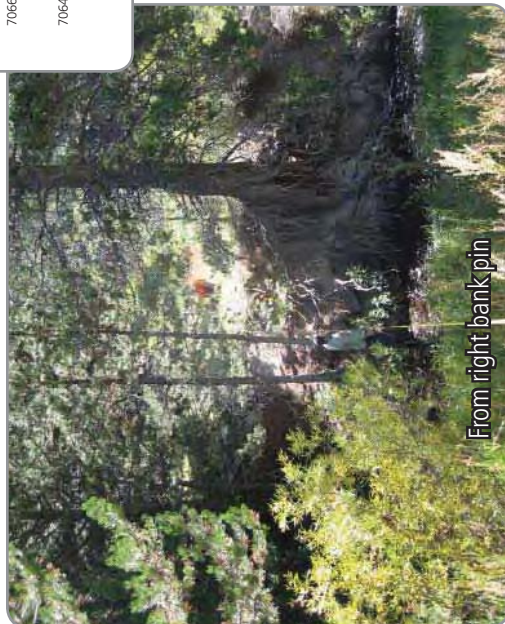
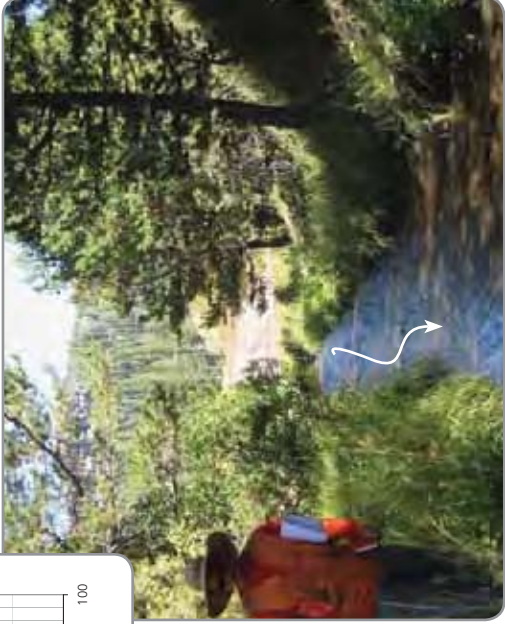
Cross Section 2 RS 30+25

$W_{bkfl} = 13.7 \text{ ft.}$

$D_{bkfl} = 1.3 \text{ ft.}$

$W/D \text{ Ratio} = 10.7$

FIGURE 4-7b: Cross-section survey results. W_{bkfl} = Bankfull width; D_{bkfl} = Depth at Bankfull; W/D = Width to Depth at bankfull.

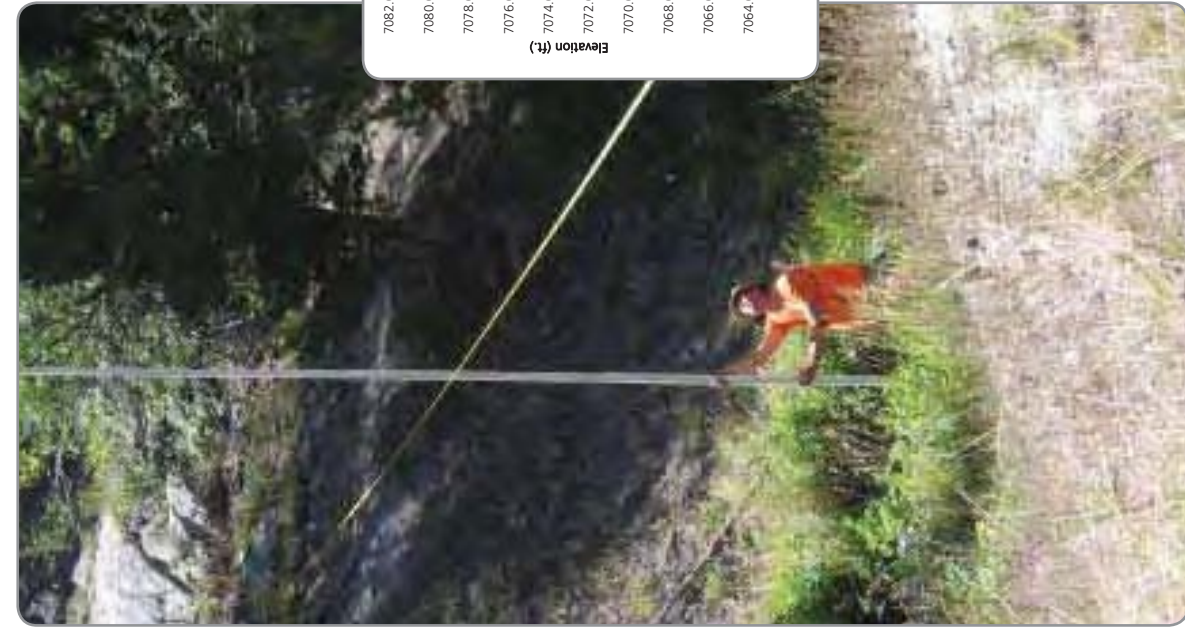
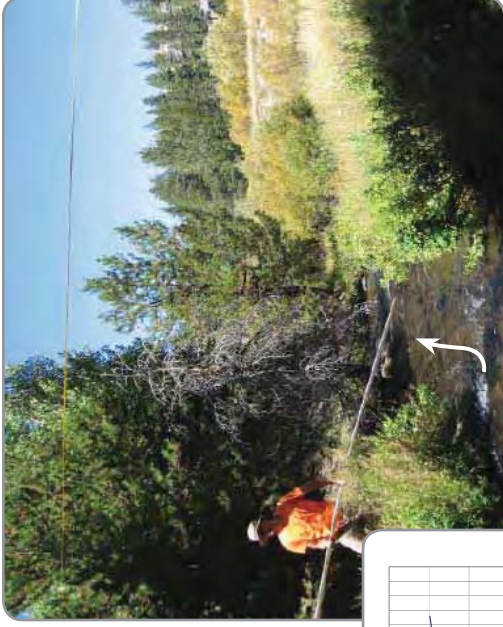
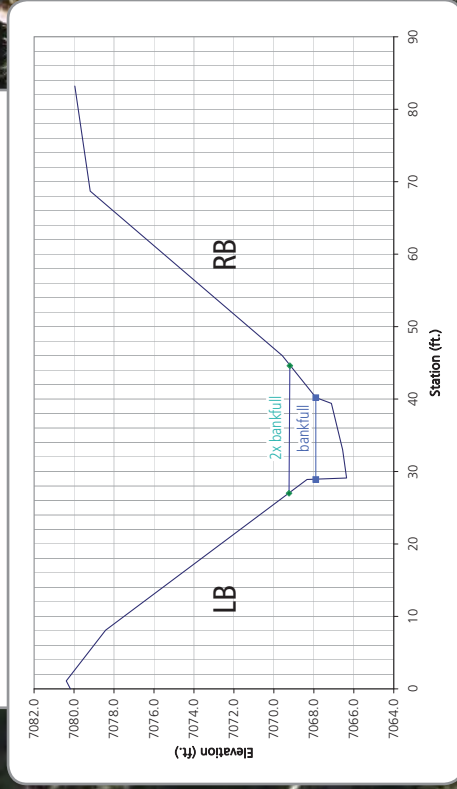
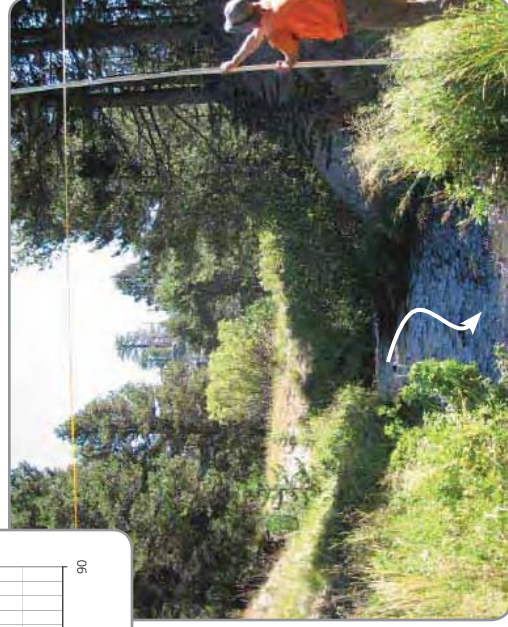
Cross Section 3

$W_{bkfl} = 11.3 \text{ ft.}$

$D_{bkfl} = 1.3 \text{ ft.}$

$W/D \text{ Ratio} = 8.4$

FIGURE 4-7c: Cross-section survey results. W_{bkfl} = Bankfull width; D_{bkfl} = Depth at Bankfull; W/D = Width to Depth at bankfull.

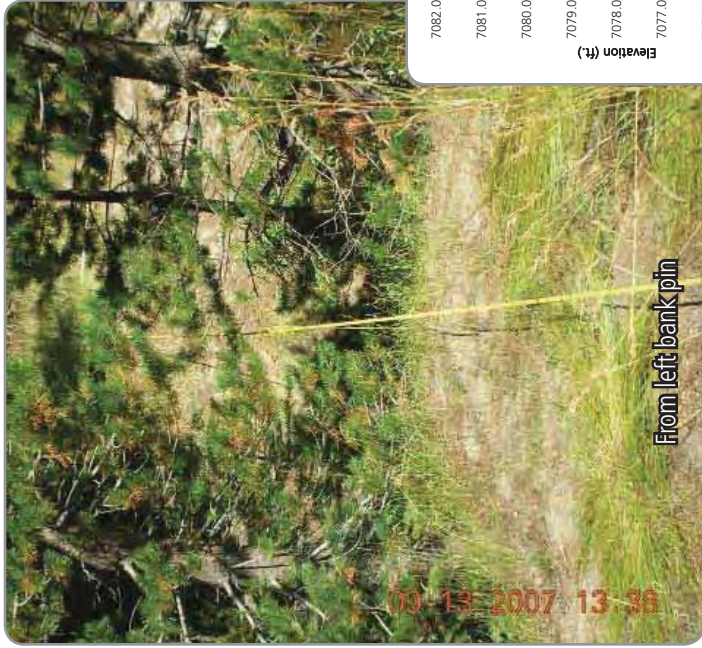
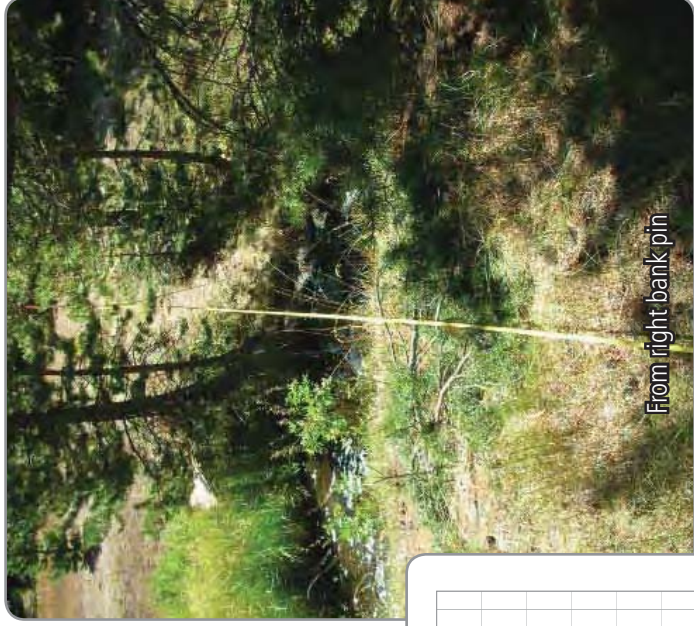
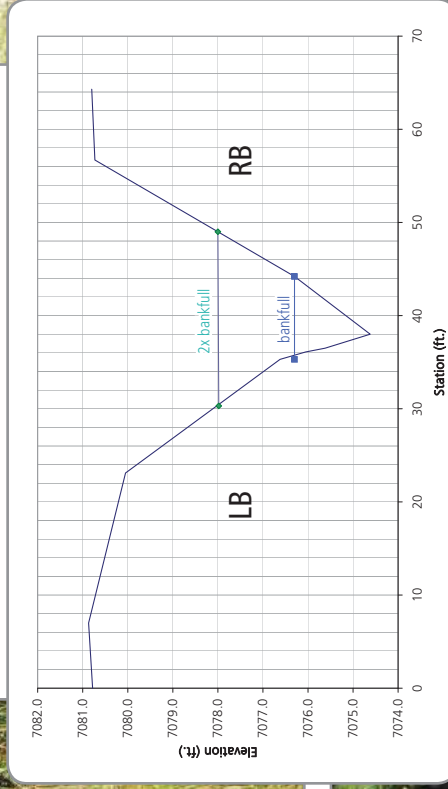
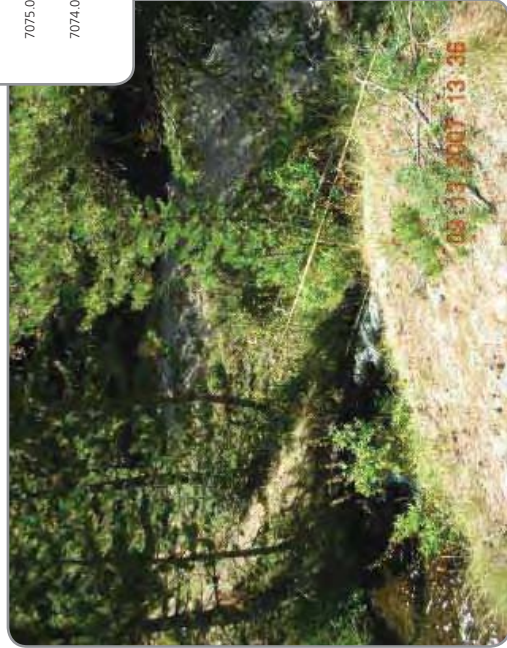
Cross Section 4

$W_{bkfl} = 8.9 \text{ ft.}$

$D_{bkfl} = 1.7 \text{ ft.}$

$W/D \text{ Ratio} = 5.3$

FIGURE 4-7d: Cross-section survey results. W_{bkfl} = Bankfull width; D_{bkfl} = Depth at Bankfull; W/D = Width to Depth at bankfull.

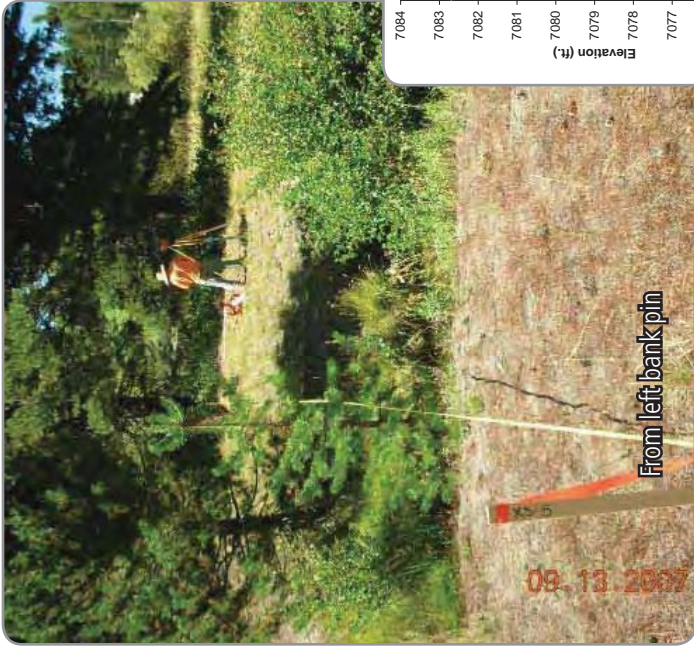
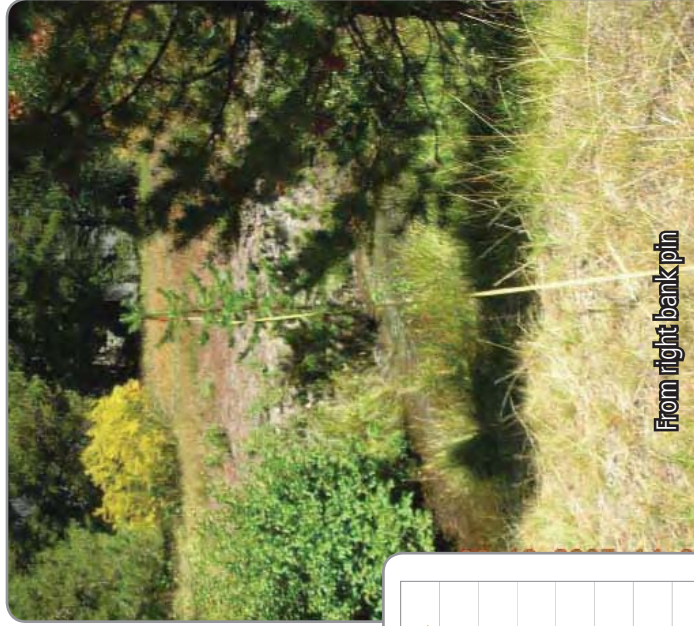
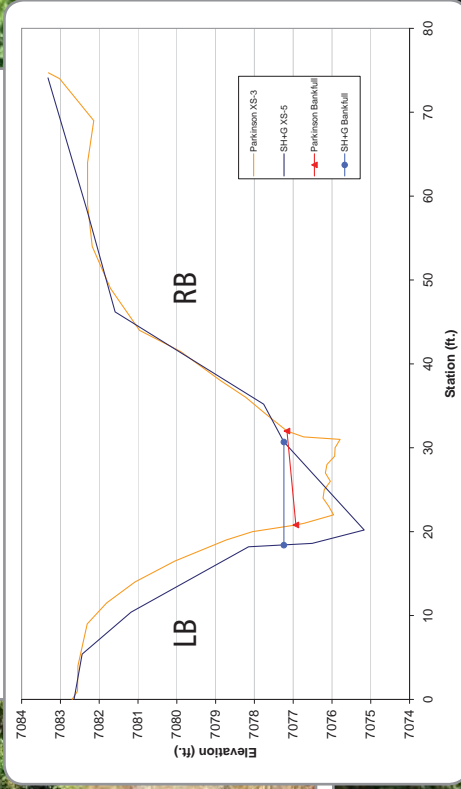
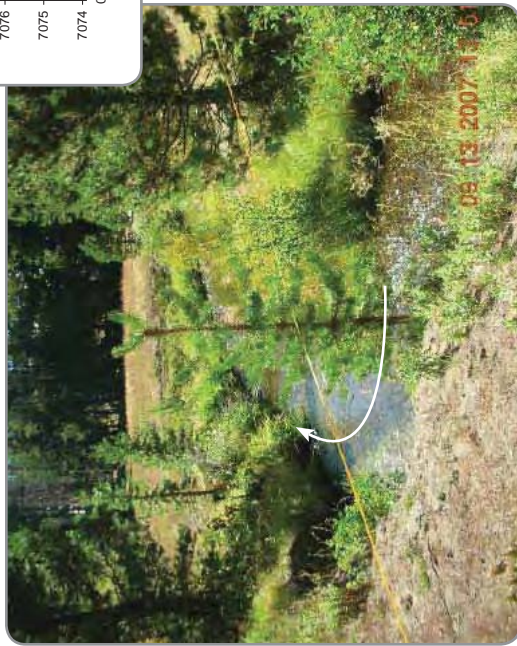
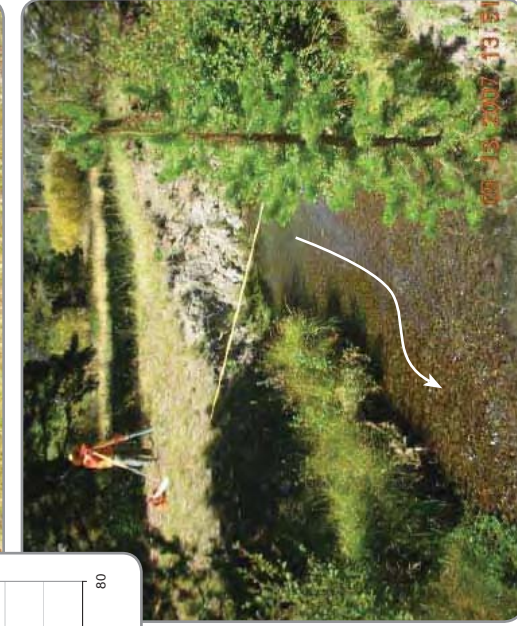
Cross Section 5 (Parkinson XS-1, 1999)

$W_{bkfl} = 12.3 \text{ ft.}$

$D_{bkfl} = 2.0 \text{ ft.}$

$W/D \text{ Ratio} = 6.1$

FIGURE 4-7e: Cross-section survey results. W_{bkfl} = Bankfull width; D_{bkfl} = Depth at Bankfull; W/D = Width to Depth at bankfull.

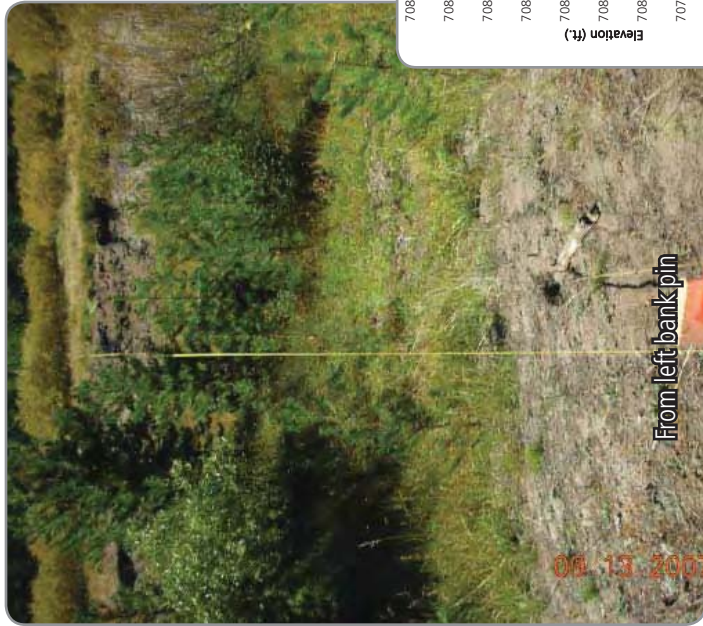
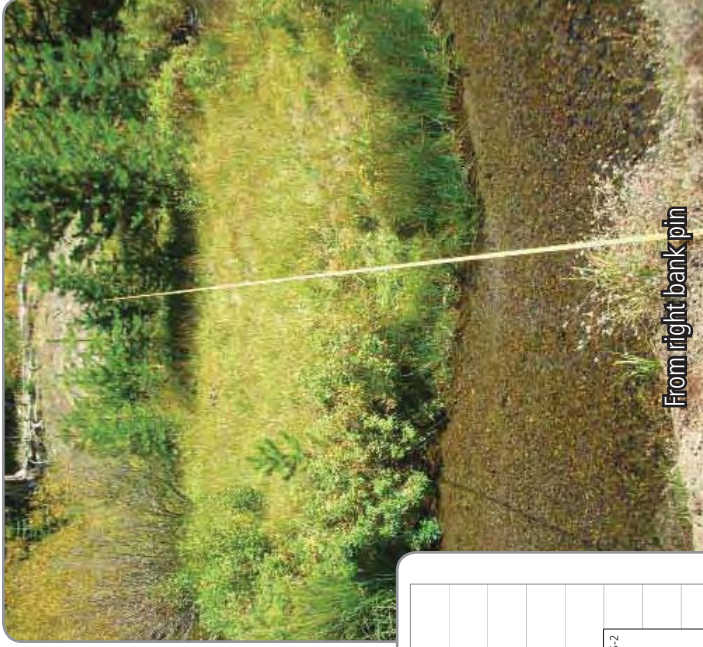
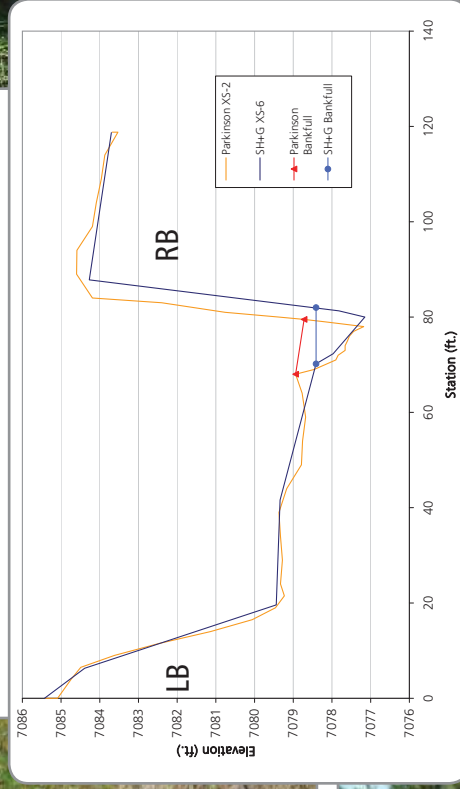
Cross Section 6 (Parkinson XS-2, 1999) RS 39+00

$W_{bkfl} = 11.8 \text{ ft.}$

$D_{bkfl} = 1.2 \text{ ft.}$

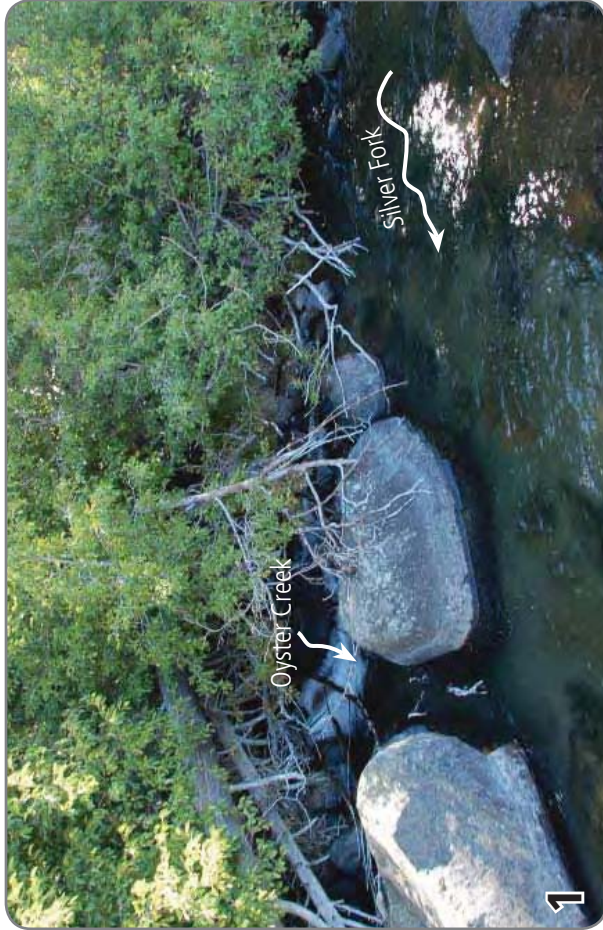
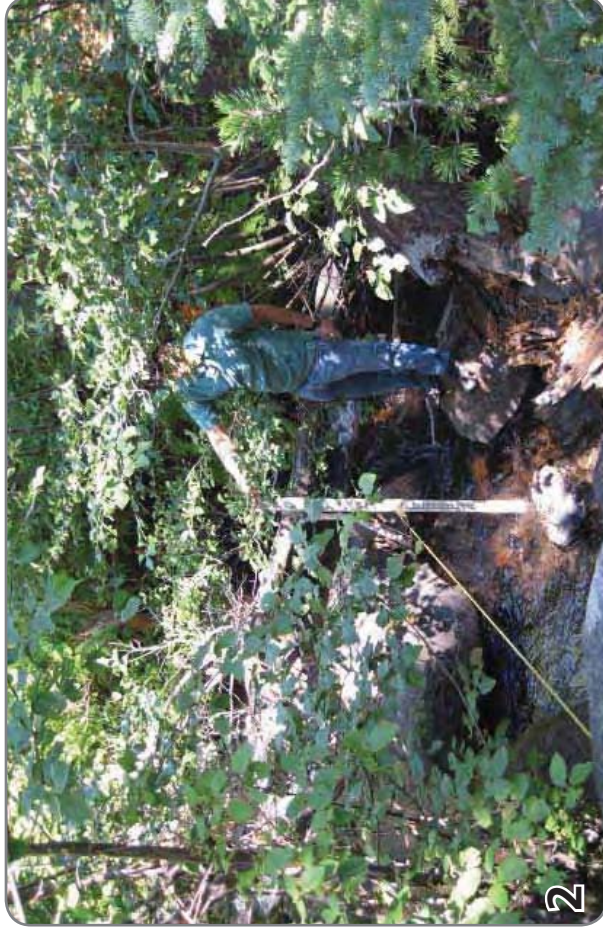
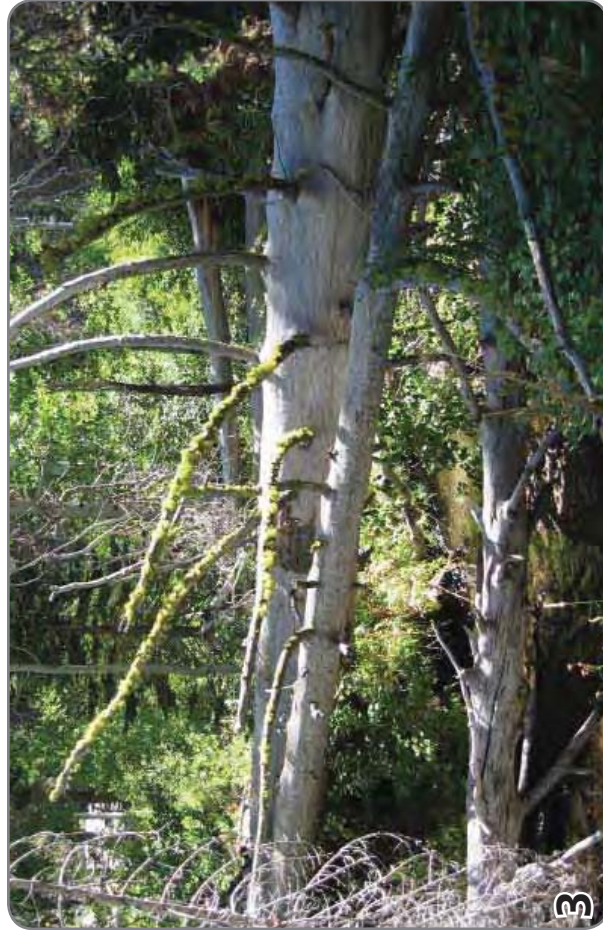
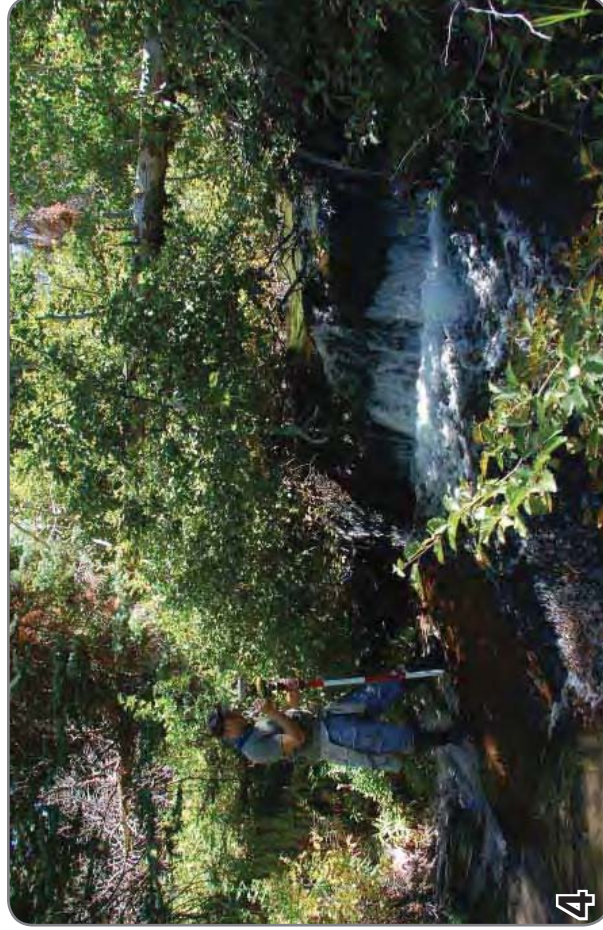
PHOTOS: (1) Oyster Creek - Silver Fork confluence **(2)** Reach 1 representative section **(3)** Large woody debris in Reach 1 **(4)** Exposed bedrock marking Reach 1/2 boundary.

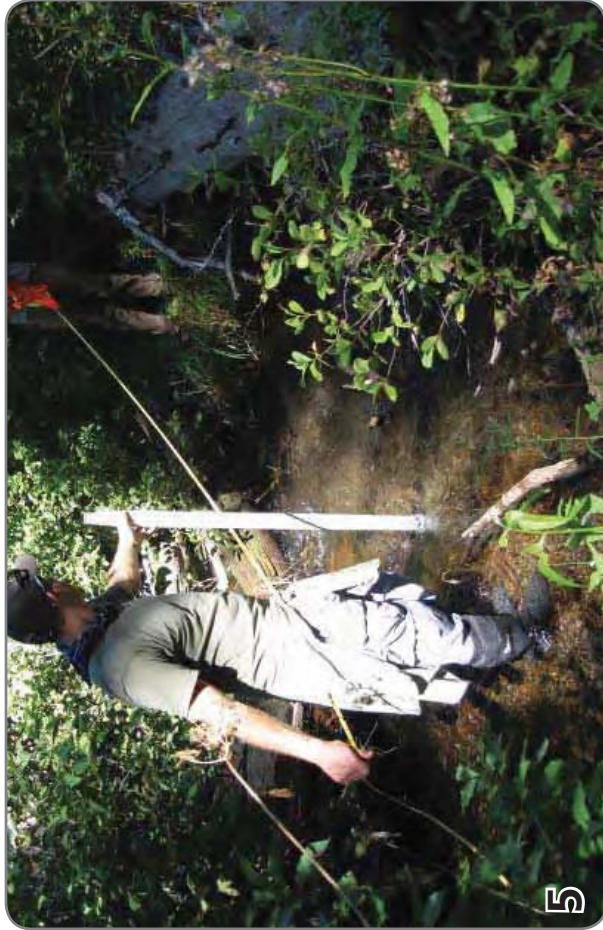
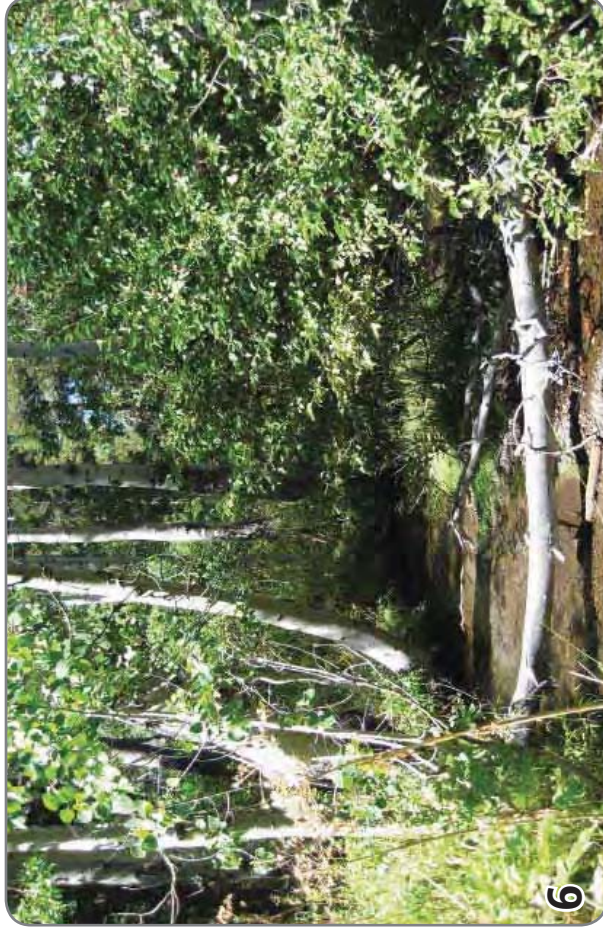
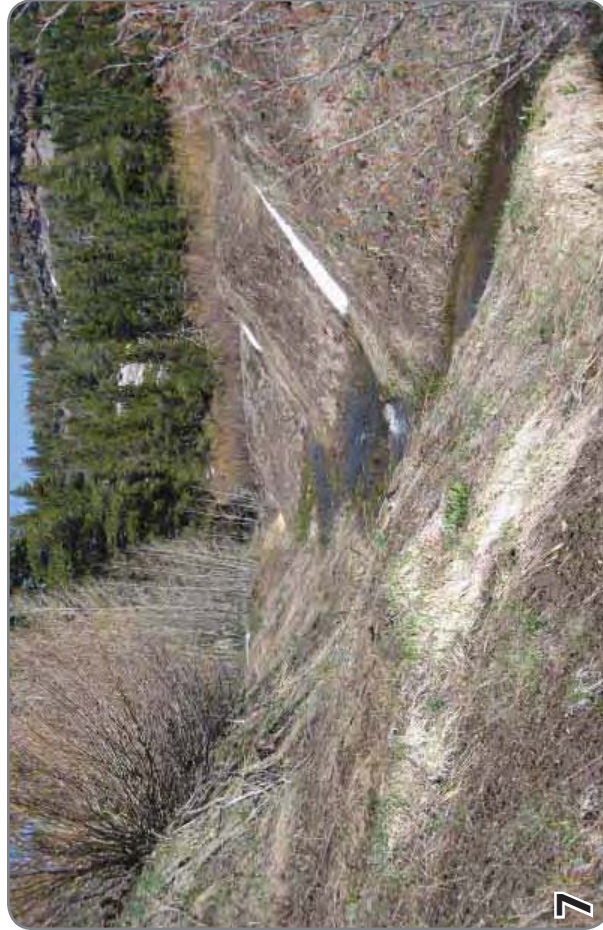
PHOTOS: (5) Reach 2 representative section (6) Aspen and alder are co-dominant on the banks of Reach 2 (7) North Tributary, Reach 4/5 boundary (8) Active headcut in the North Tributary main channel.

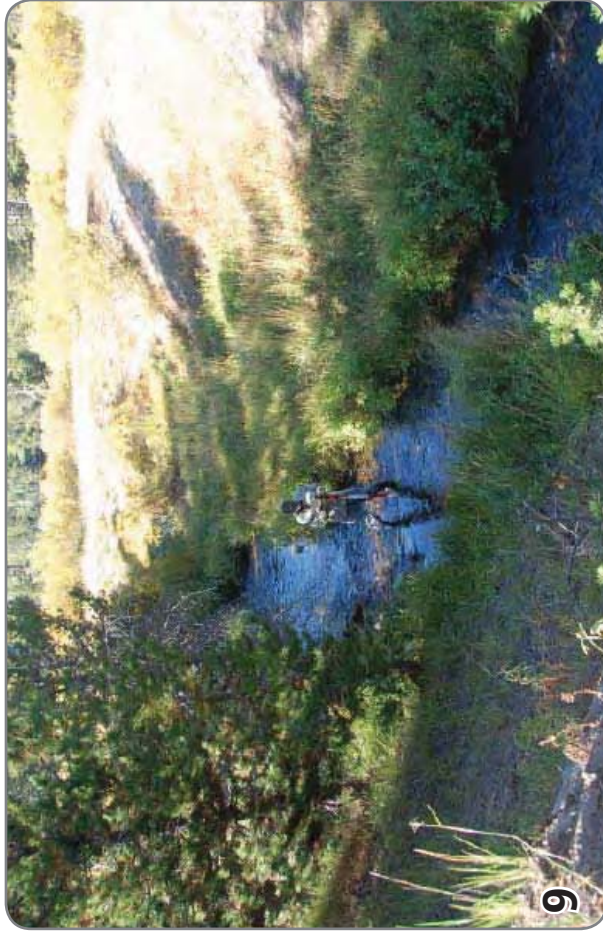
PHOTOS: (9) Typical section in Reach 5 (10) Bedrock step marking the Reach 5/6 boundary (11) Recruitment of large woody debris in Reach 6 due to local bank erosion (12) Steep cutbank opposite point bar in Reach 6.

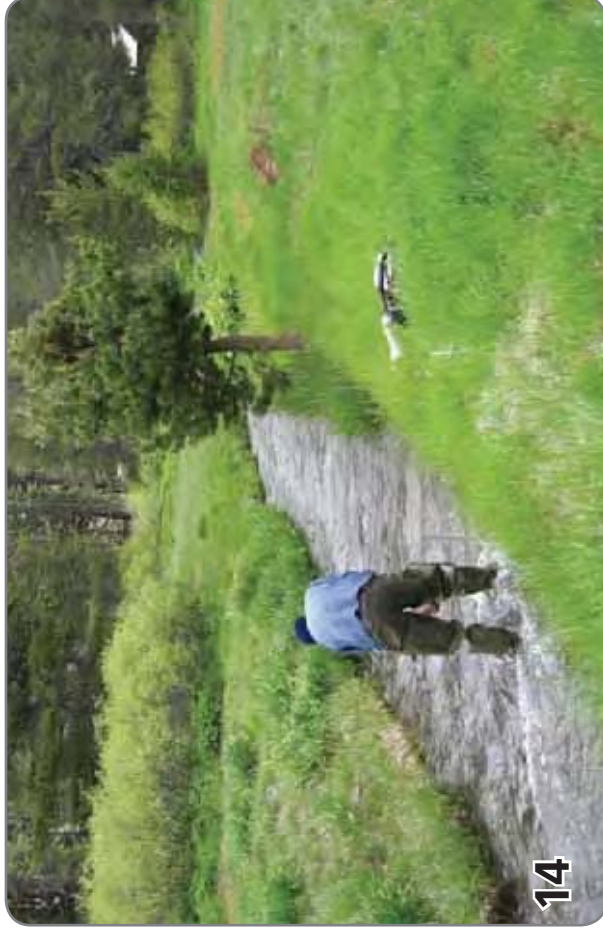
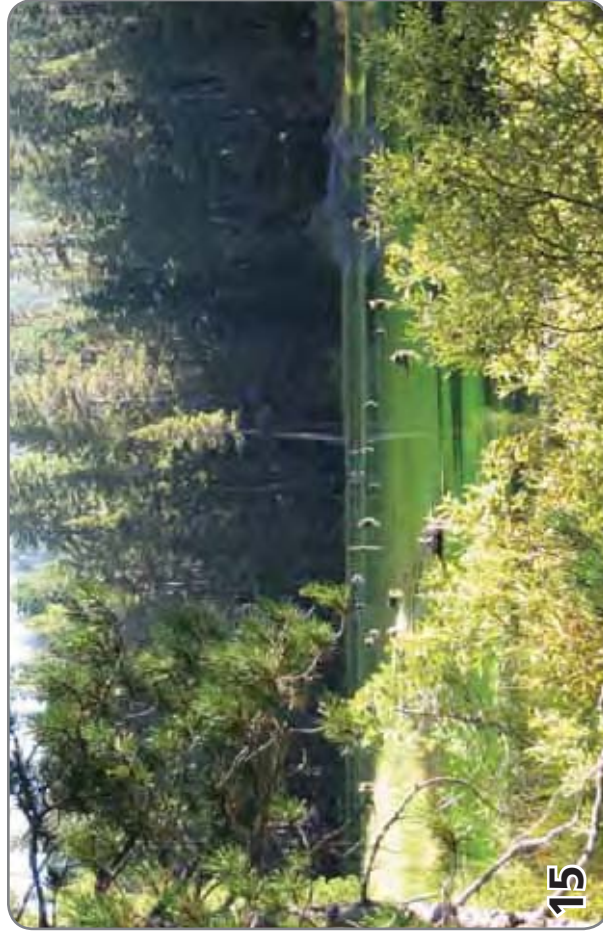
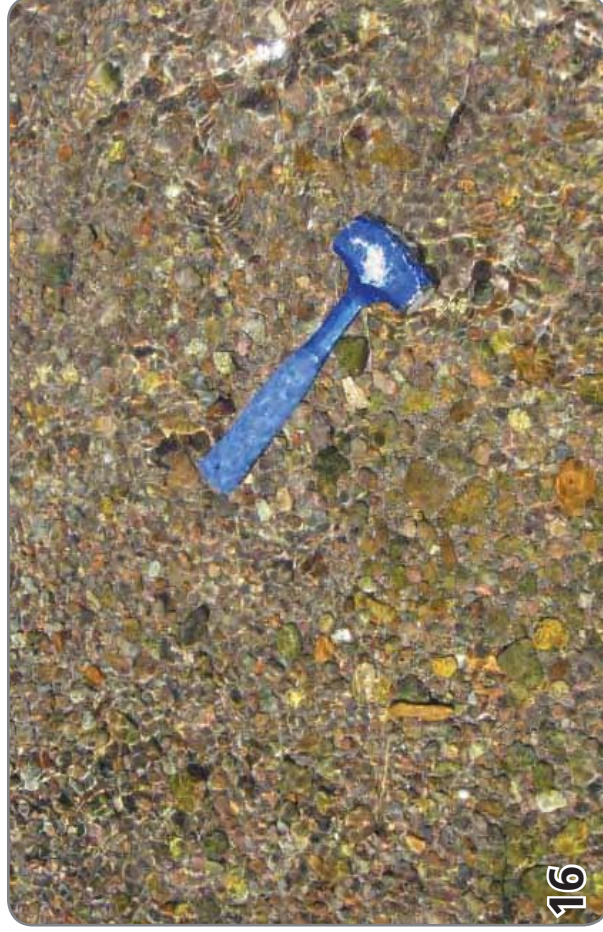
PHOTOS: (13) Oyster Creek crosses under SR 88 through two 36-inch corrugated metal pipes (14) Riparian meadow upstream of SR 88 (15) Oyster Lake (16) Example of bed particle size in middle and upper sampling sites (primarily medium sized gravels).

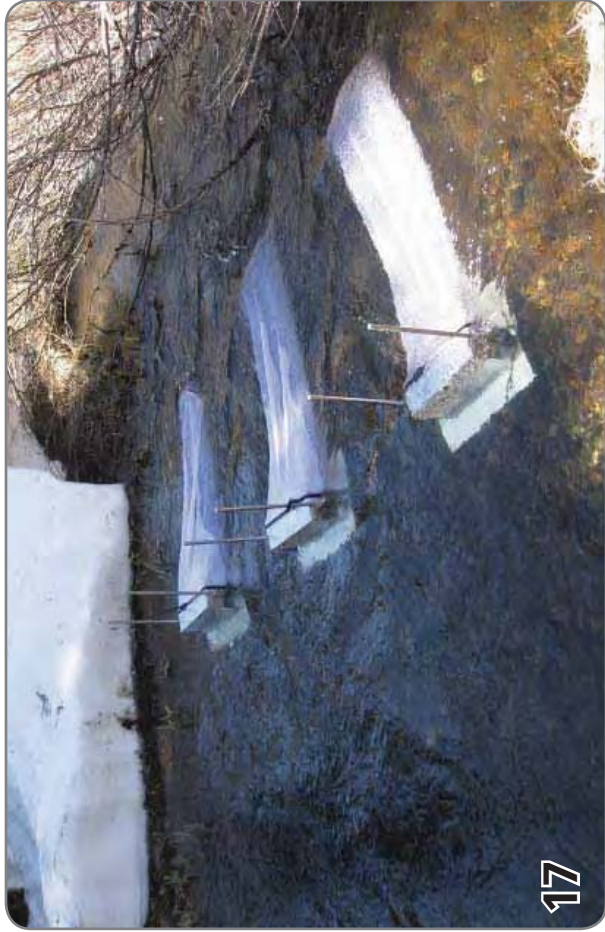
17

PHOTOS: (17) USFS portable bedload traps at Site E (18) Helley-Smith sediment sampling at Site E (19) Bedload trap at site D₁ (20) Examples of sediment samples from both sampling methods.

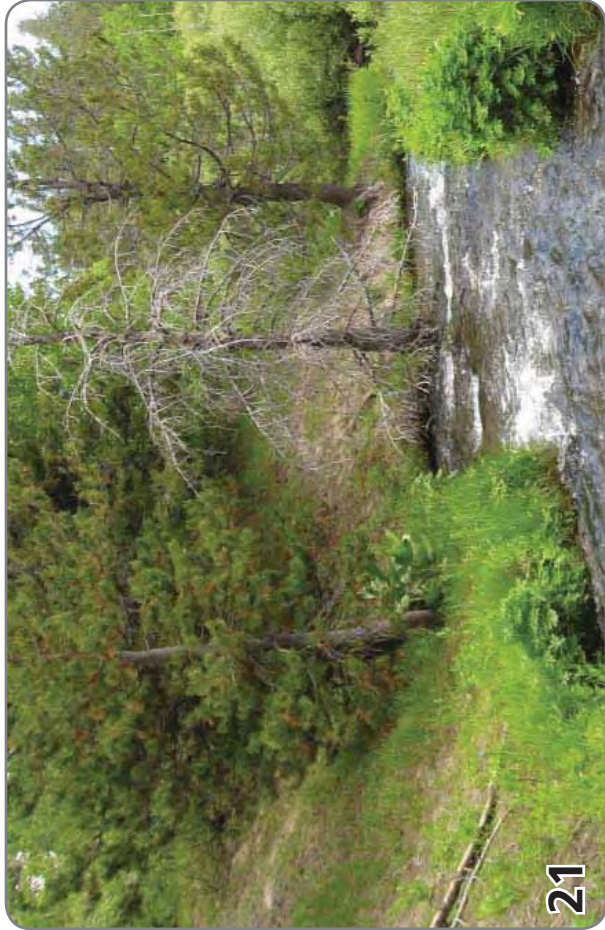
21

PHOTOS: (21) Mature trees rooted near the base level of the channel in Reach 5. (22) Trees rooted near the base of the channel in Reach 6 are significantly younger than those in Reach 5. Bank failure at this location (right side of photo) appears to be the result of toe scour. (23) Bank failure due to sapping. (24) Evidence of lateral migration (widening) in Reach 6.
