Re: FERC Project 184, Geomorphology

EID Project 184 Geomorphic Sites Assessment

Prepared for
El Dorado Irrigation District

December, 2002

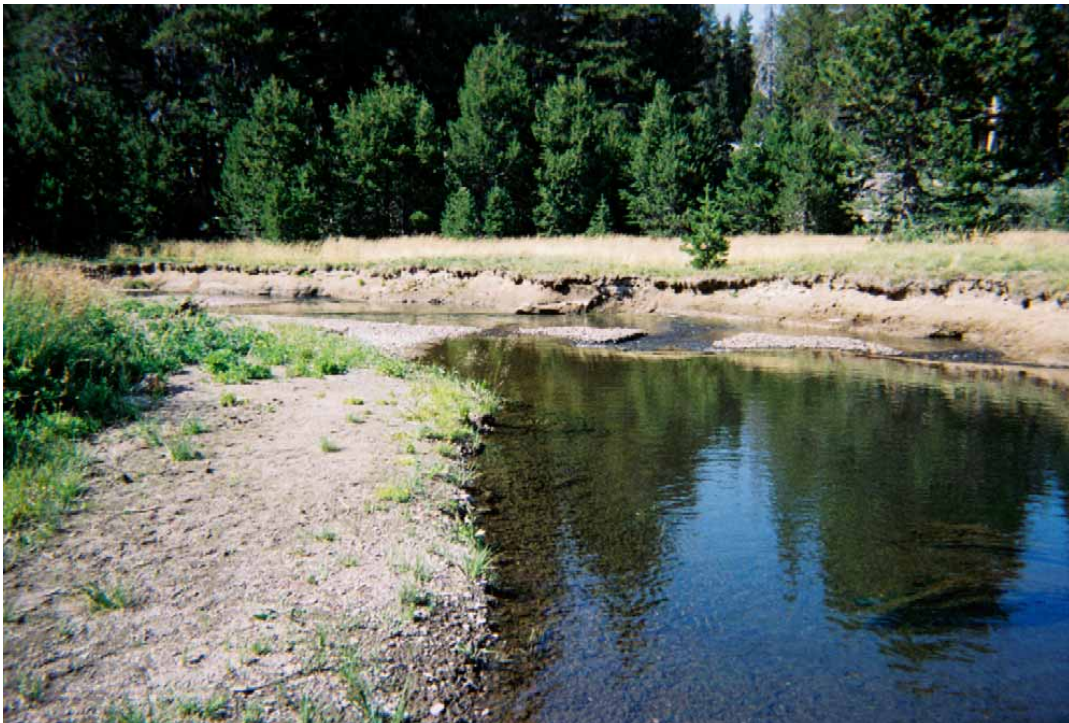
Caples Creek, downstream of Kirkwood Creek (site #12) is a C4 channel (Figure 4). Sinuosity, slope, entrenchment ratio, and width/depth ratio are typical for a C channel.

Figure 4: Caples Creek downstream of Kirkwood Creek (site #12), downstream view, August 2002

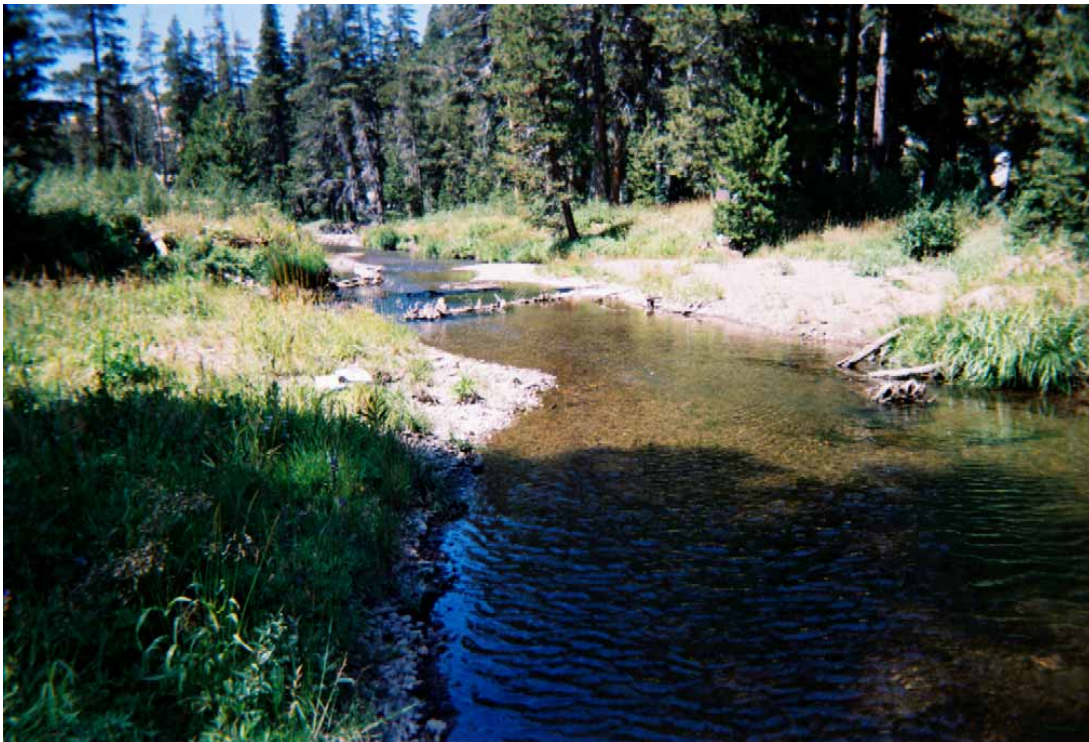
Caples Creek at the Girl Scout Access (site #2) is a C4 channel (Figure 5). Slope, entrenchment ratio, and width/depth ratio are typical for a C channel, although sinuosity is low (attributed to bedrock/boulder control). Cross section 3 has characteristics more like an E channel, but is less representative of the local reach than the other two cross sections.

Figure 5: Caples Creek at the Girl Scout access (site #2), downstream view, August 2002

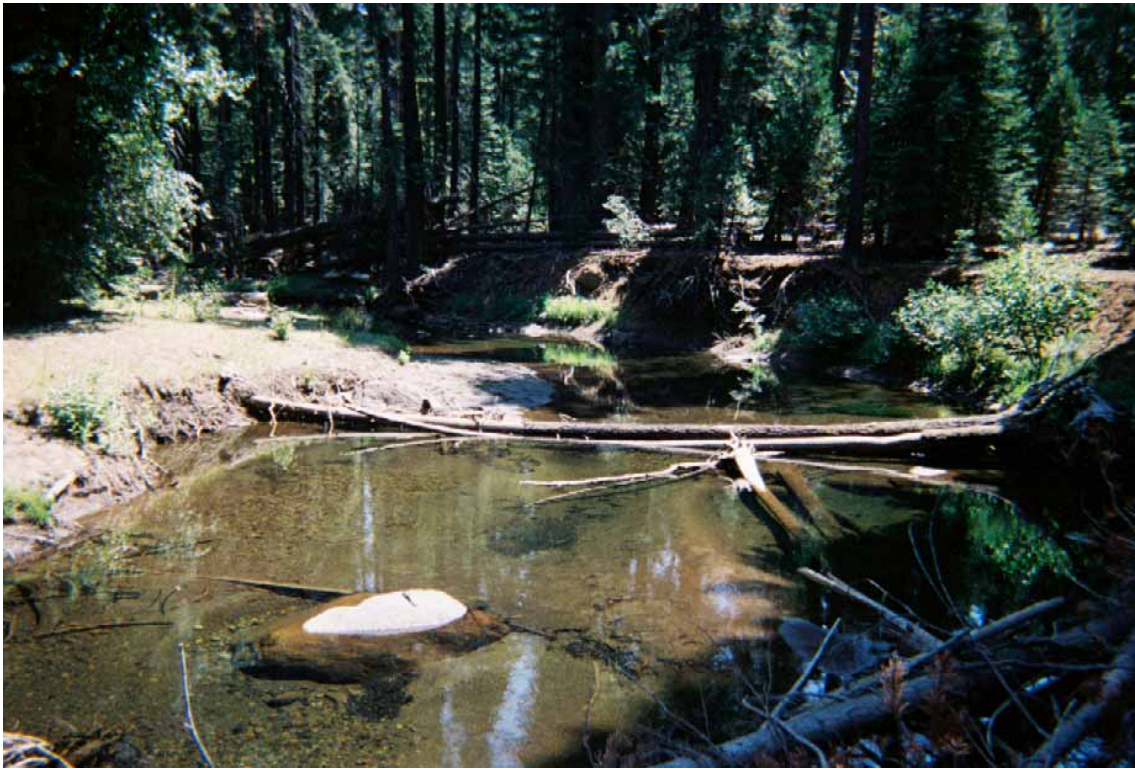
Caples Creek at Jake Schneider Meadow (site #15) is an F4 channel (Figure 6). Sinuosity, slope, entrenchment ratio, and width/depth ratio are typical for an F channel.

Figure 6: Caples Creek at Jake Schneider Meadow (site #15), upstream view, August 2002

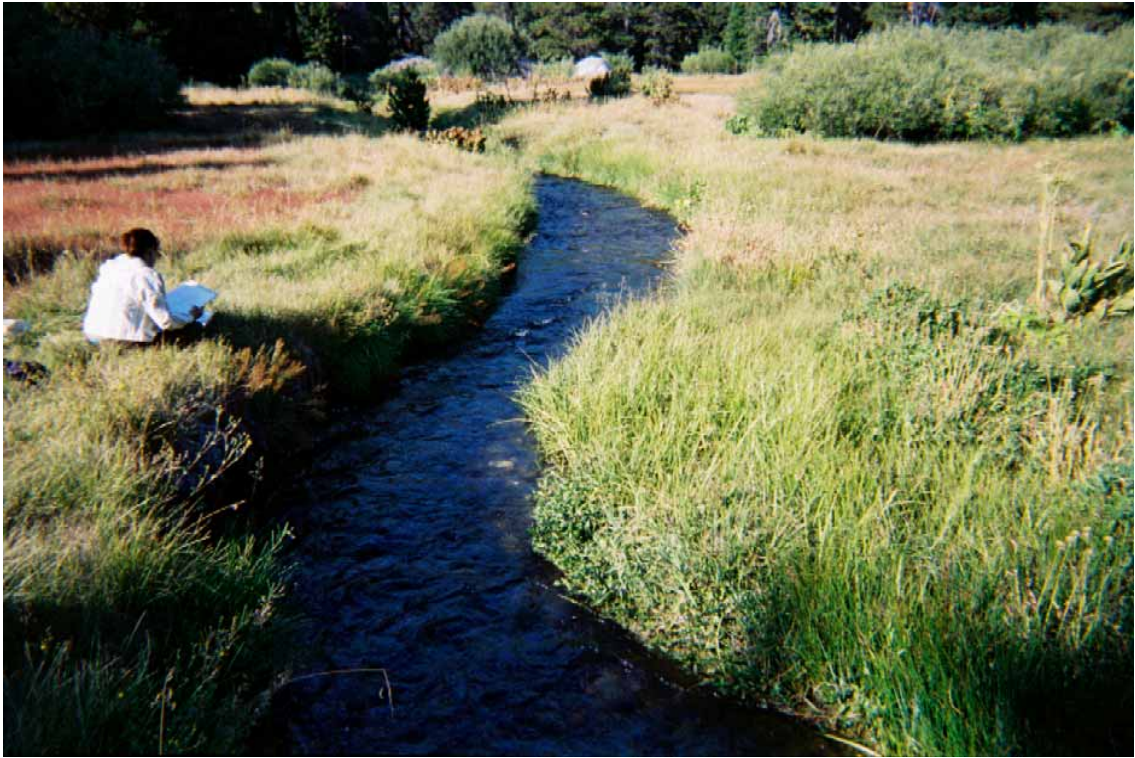
Oyster Creek, upstream of Highway 88 (site #18) is an E4 channel (Figure 7). Slope and entrenchment are typical for an E channel, although sinuosity is low and width/depth ratio is high for an E channel.

Figure 7: Oyster Creek upstream of Highway 88 (site #18), downstream view, August 2002

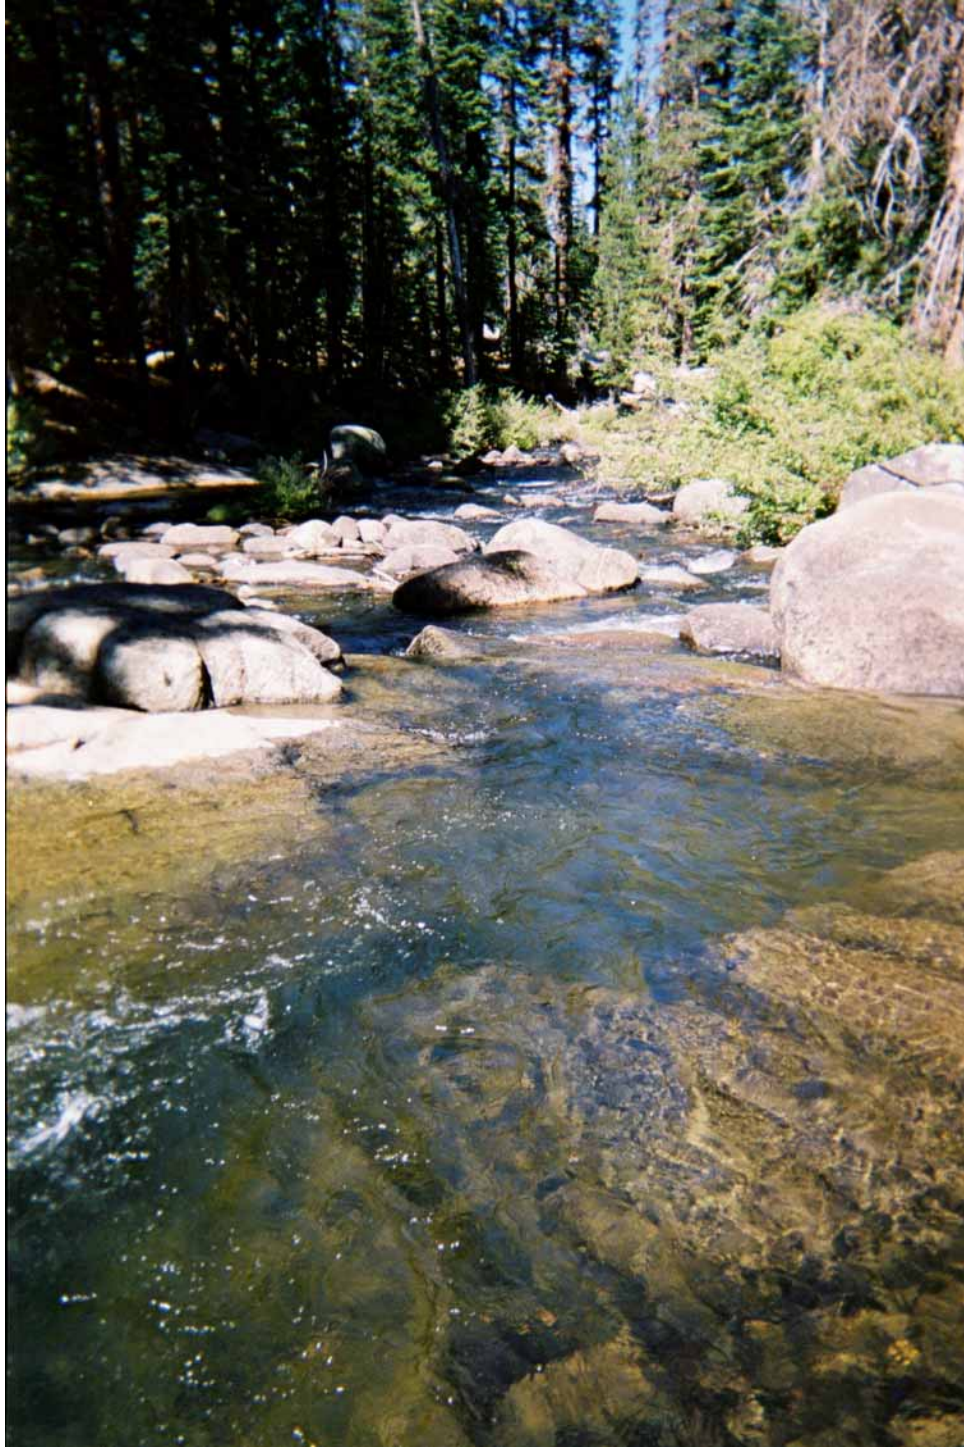
The Silver Fork, at West Campground (site #21) is a B4c channel (Figure 9). Entrenchment, slope, width/depth are typical for Bc channels, although sinuosity is low (attributed to bedrock control).

Figure 9: Silver Fork American River at West Campground (site #21), downstream view, October 2002

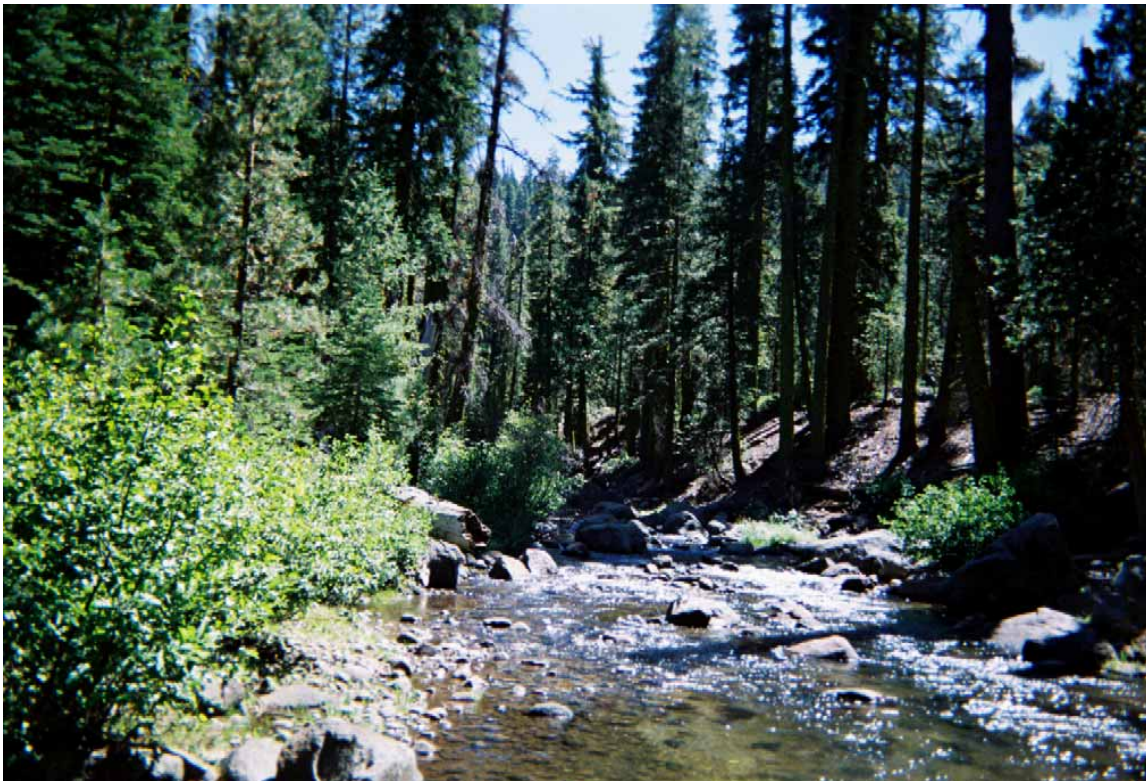
The Silver Fork at Forgotten Flat (site #17) is a B4c channel (Figure 10). Sinuosity, slope entrenchment, and width/depth are all typical for Bc channels.

Figure 10: Silver Fork at Forgotten Flat (site #17), upstream view, September 2002

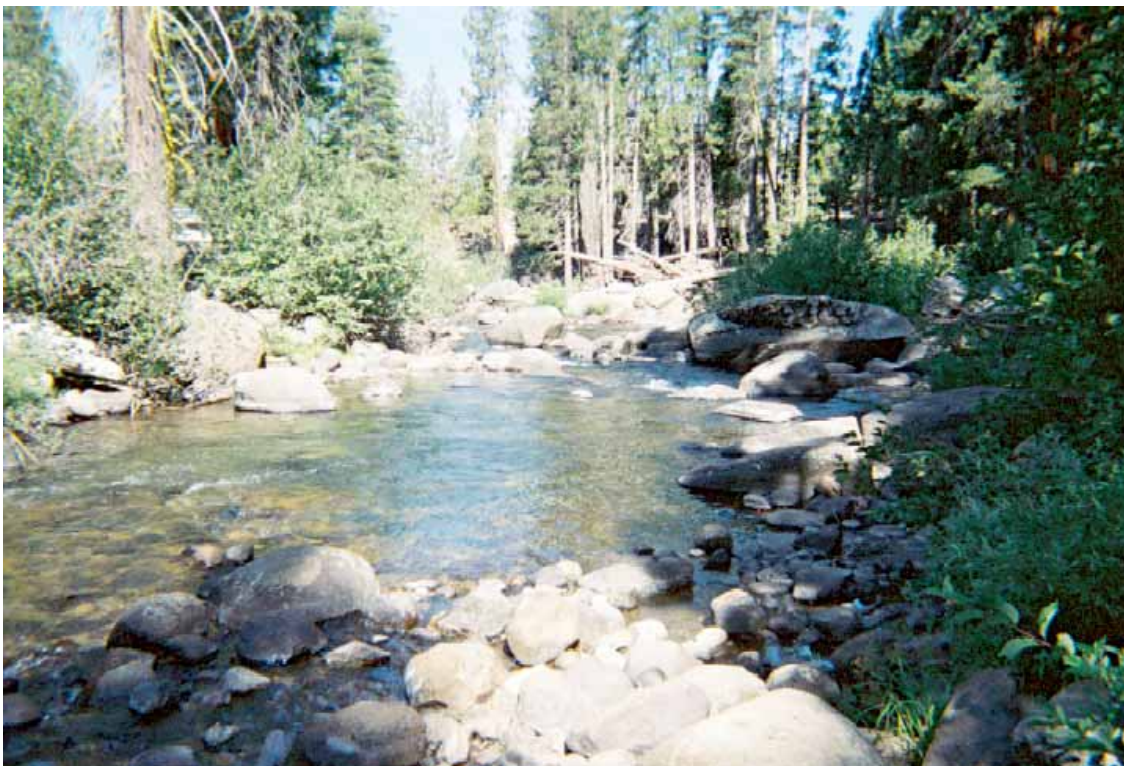
The Silver Fork, upstream of Fitch Rantz bridge (site #3) is a B3 channel (Figure 11). Sinuosity, slope entrenchment, and width/depth are all typical for B3 channels.

Figure 11: Silver Fork upstream of Fitch Rantz Bridge (site #3), downstream view, August 2002

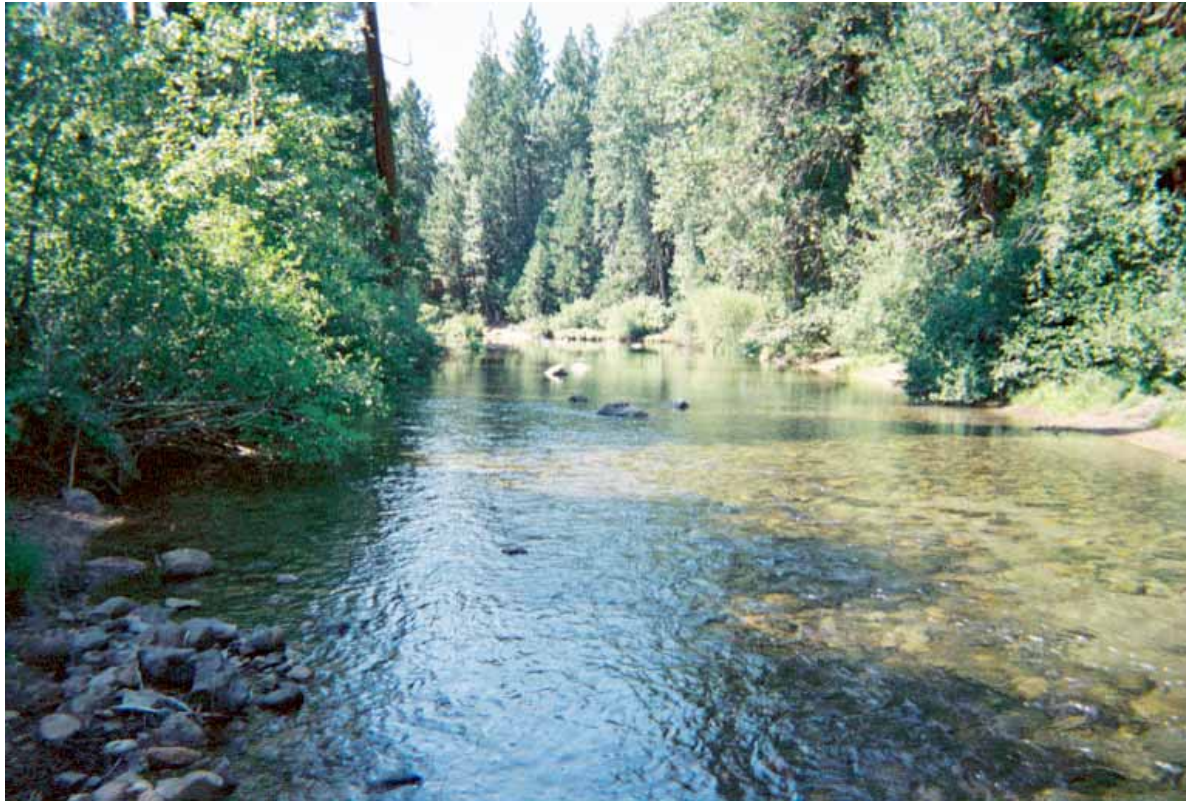
The Silver Fork at China Flat (site #16) is a B4c channel (Figure 12). Slope, entrenchment, and width/depth are typical for Bc channels, although sinuosity is low.

Figure 12: Silver Fork at China Flat (site #16), downstream view, August 2002

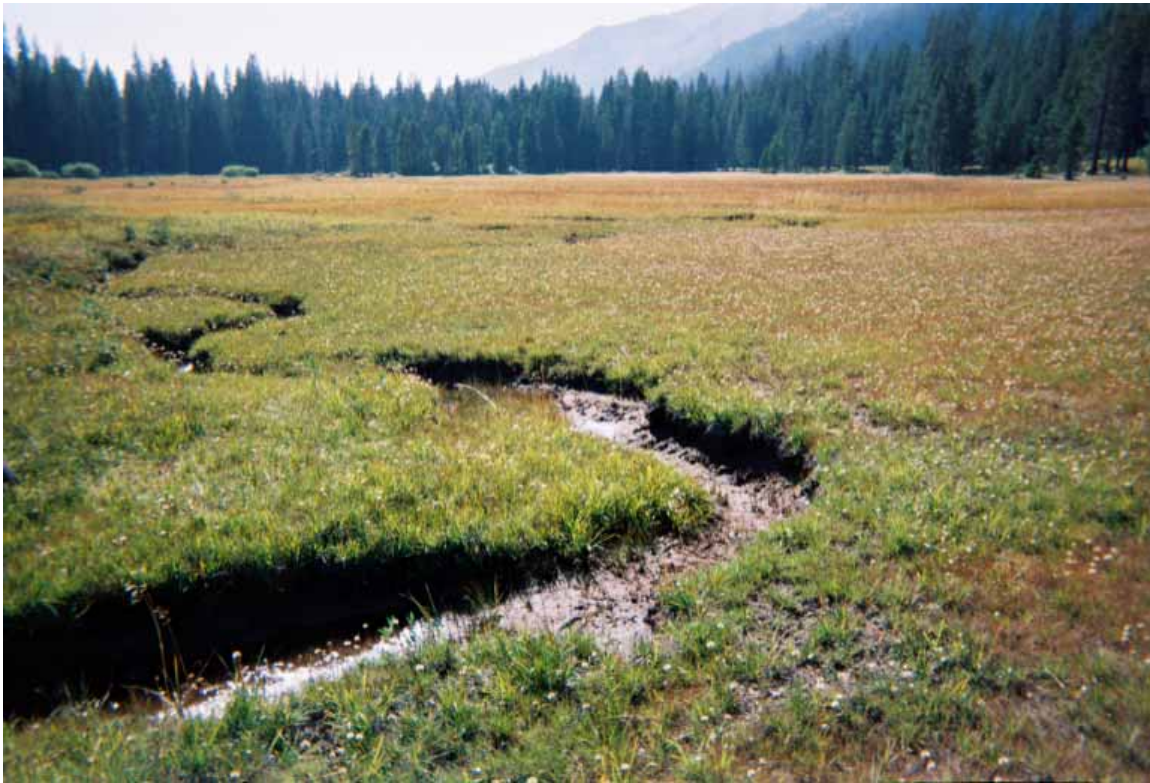
The South Fork at Audrian Meadow (site #9) is an E6 channel (Figure 14). The sinuosity, slope, and entrenchment ratio are typical of E channels, although some areas have low width/depth ratio. Figure 9

Figure 14: South Fork at Audrian Meadow (site #9), downstream view, August 2002

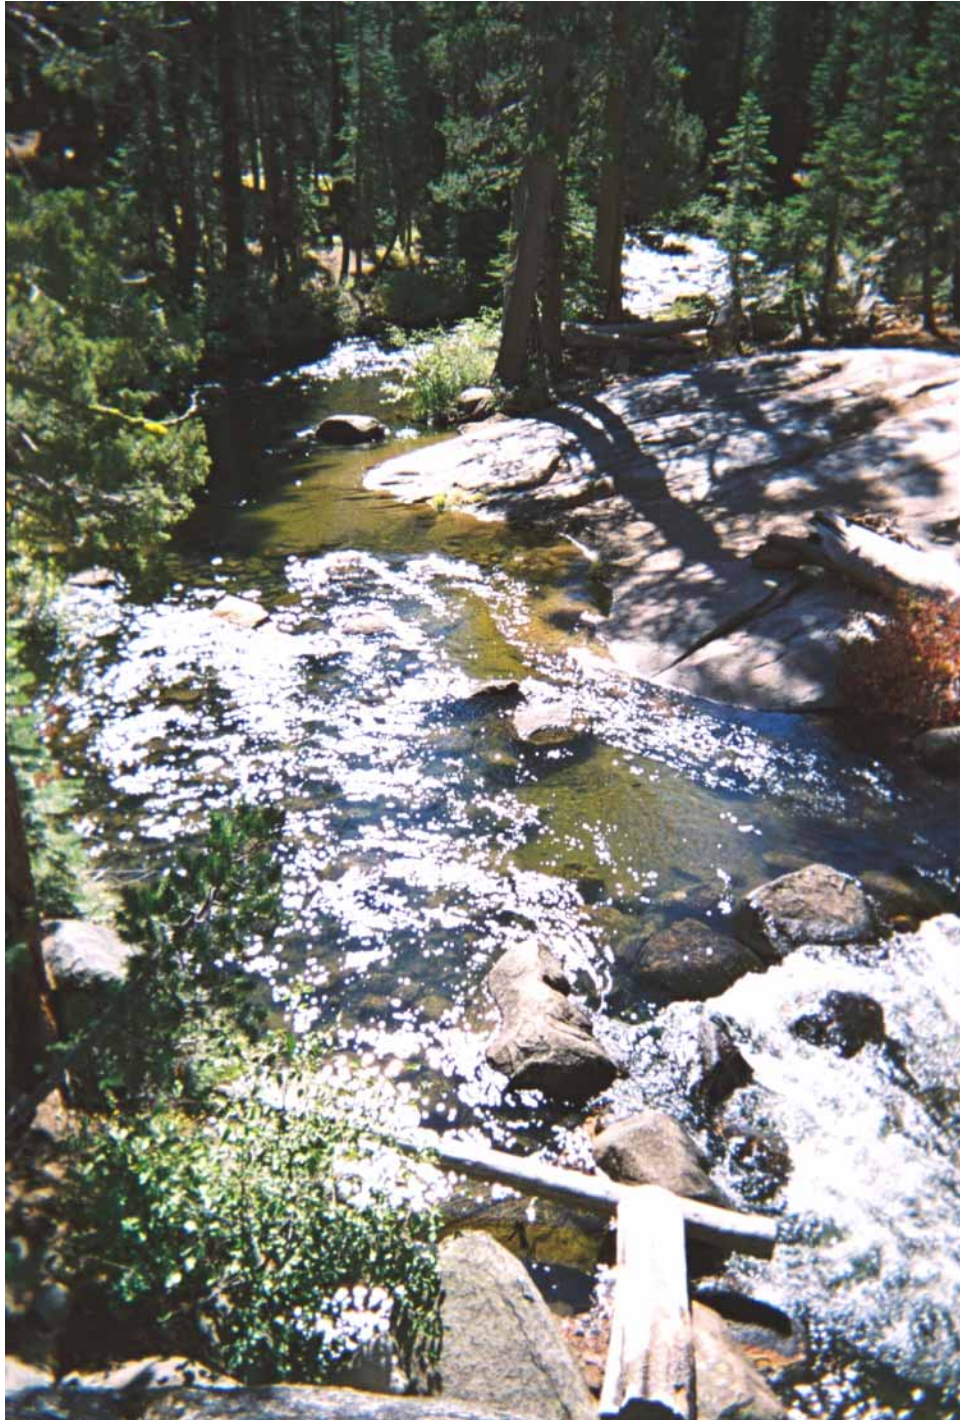
The Silver Fork is a non-sensitive site that has very low bank erosion hazard and good channel stability. Bedrock and boulder control provides lateral and vertical control (Figure 28), with limited gravel and cobble deposits. This riffle-run reach is in the reach closest to, and downstream of, Silver Lake dam. Based on topography, geology, and valley type, it seems likely that the natural channel was a B channel. The high sediment transport capacity is evident from the armored bed of small cobble to large gravel and the lack of bar deposits. No signs of active aggradation or degradation are evident at the site. Small overbank floodplain areas exist between bedrock outcrops and confining valley walls. Hydraulic scour pools occur, but there is little specific evidence (either scour or debris) of the 1997 flood. Long-term Project releases of sediment-free water may have led to a coarsening of the bed substrate and lack of fine sediment.

Figure 28: Silver Fork American River at west campground (site #21), upstream view, October 2002

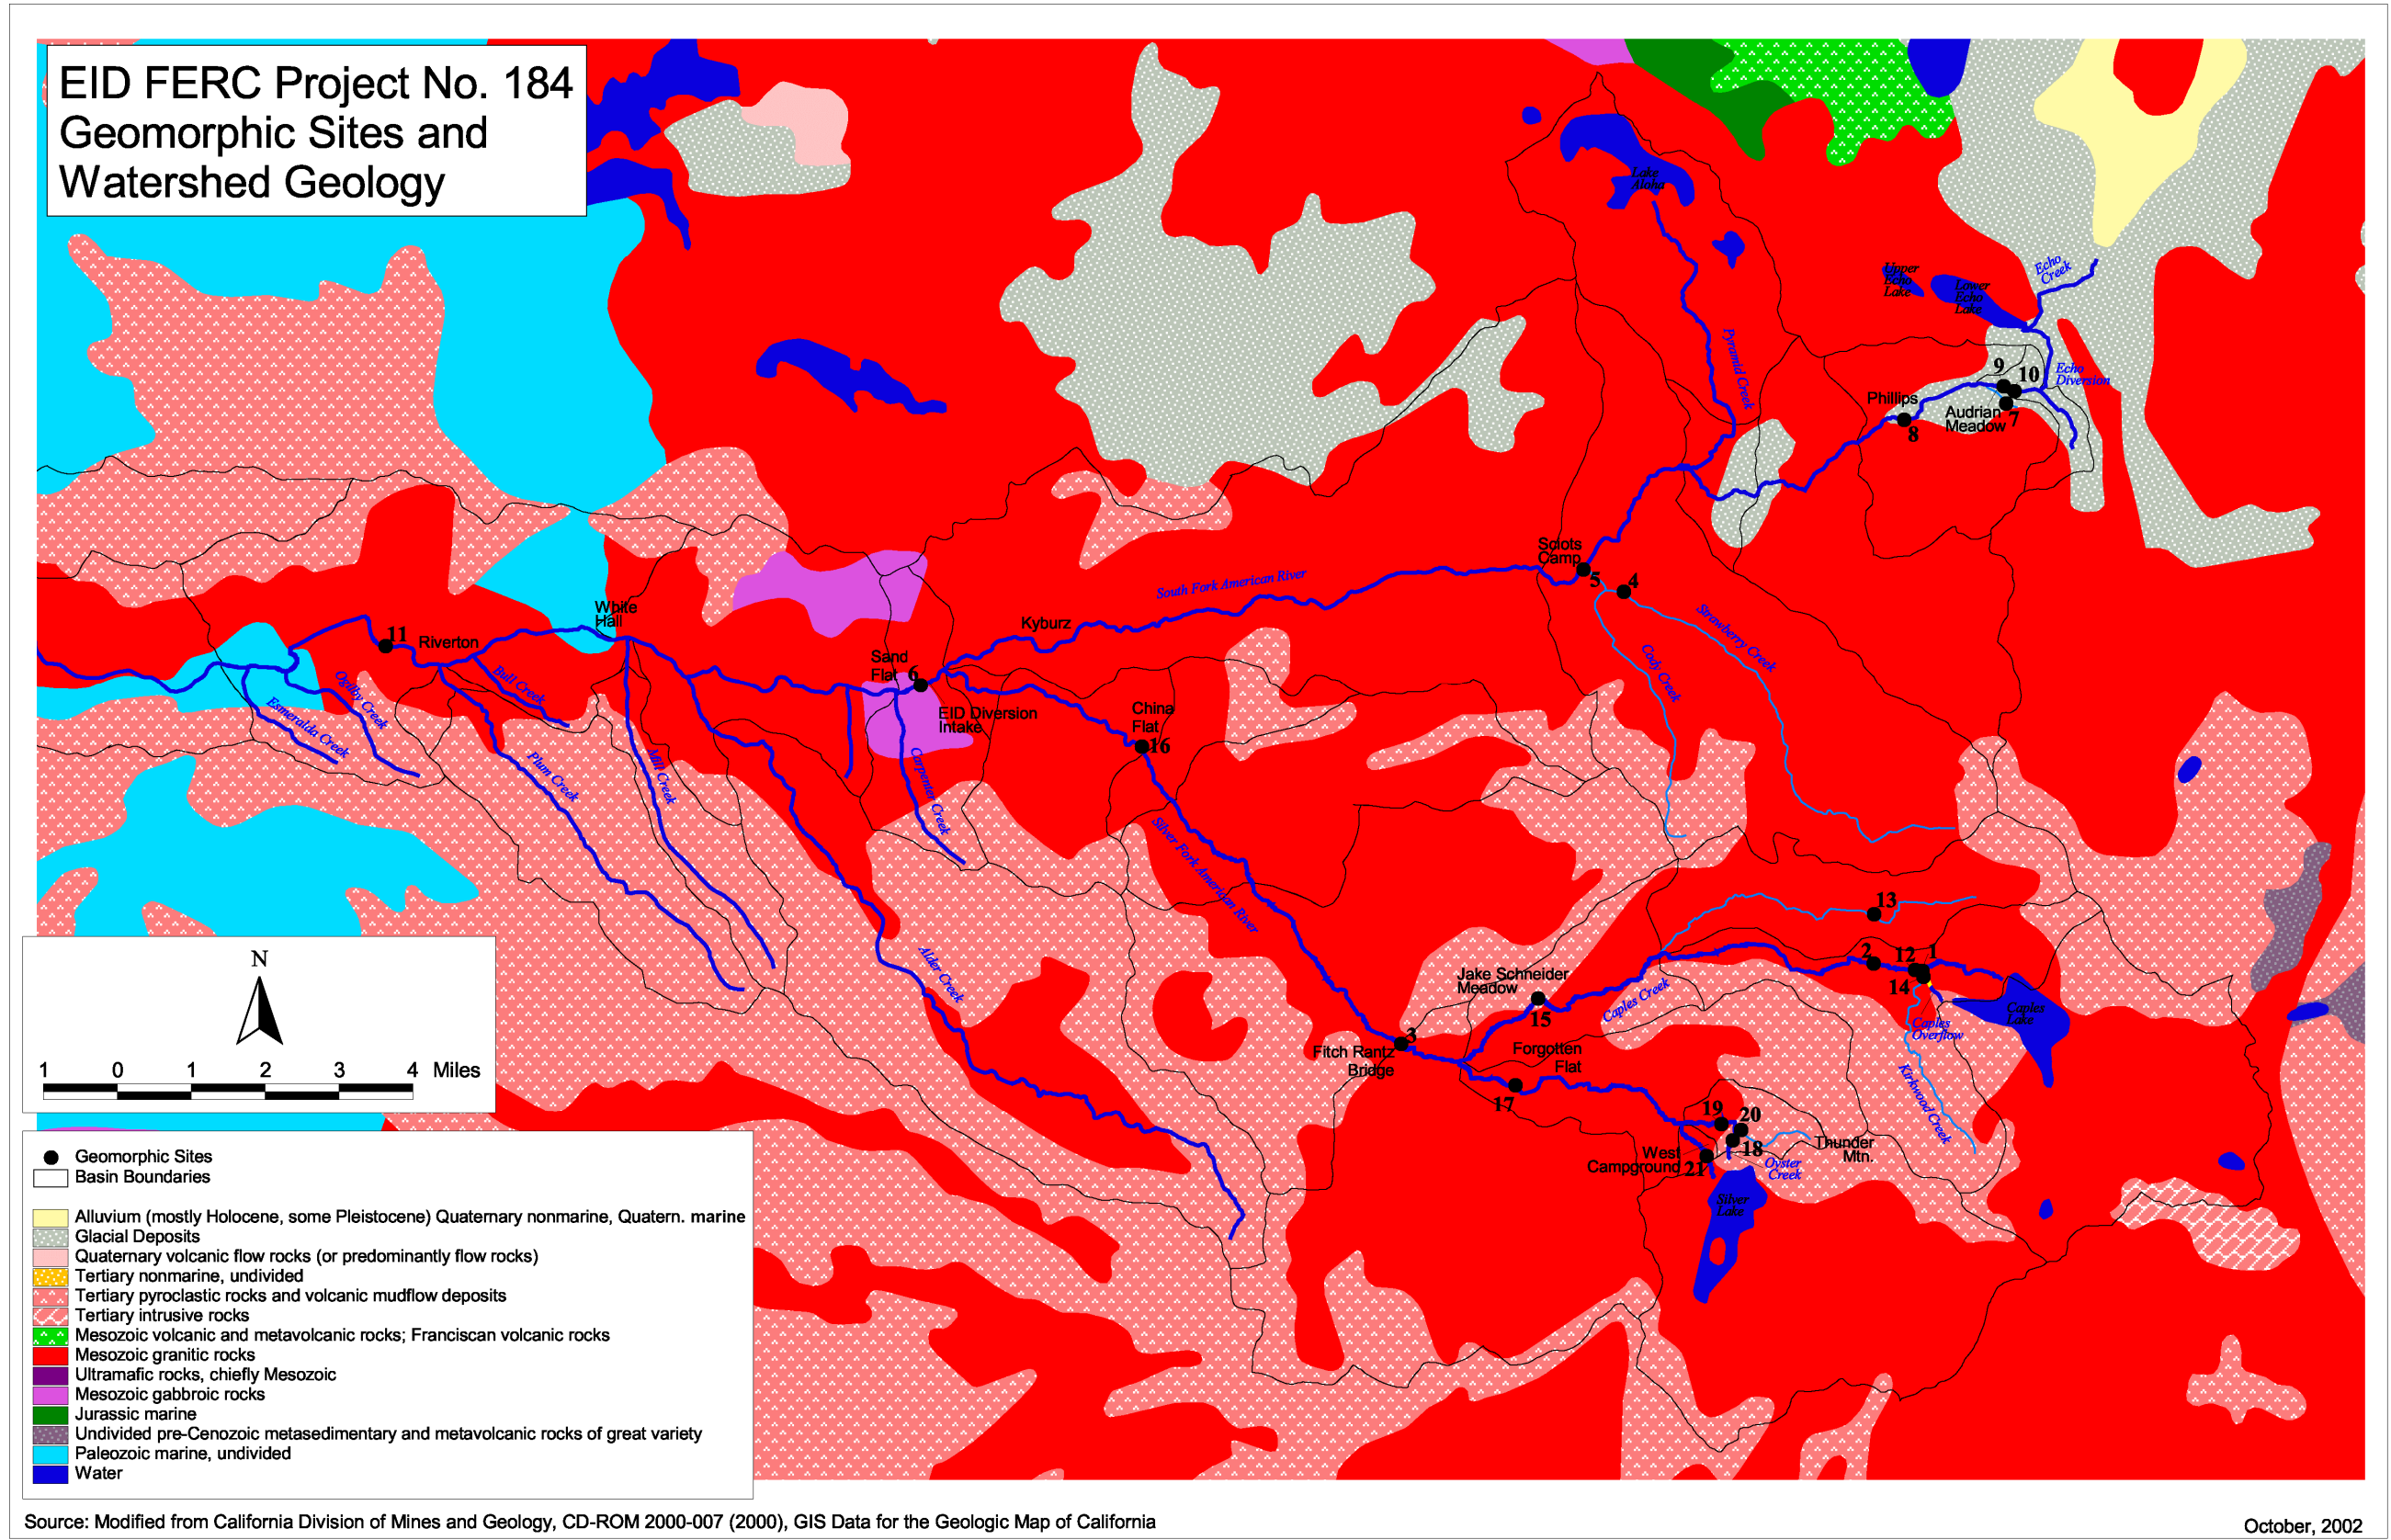
A review of generalized surface geology in the study area (Figure 45) also supports the conclusion that Project reservoirs have not trapped considerable amounts of sediment. This conclusion is partially due to the reservoirs' high elevation position within the glaciated landscape. All four reservoirs are near their watershed crests, with small, but highly productive runoff conditions. Lake Aloha and lower Echo Lake have contributing drainage areas denimated by eroded granite bedrock (Figure 45). Caples Lake has a contributing drainage basin with primarily eroded granite bedrock, a side from the small percentage of area (near the reservoir) in volcanic pyroclastic deposits and some ridge top moraines (Figure 45). Silver Lake likewise is fed by natural runoff within a basin almost entirely of eroded granite bedrock, with minor extent of volcanic and glacial deposits (Figure 45). There is a significant difference between the Caples Lake and Silver Lakes drainage basin from that of the un-regulated Kirkwood Creek basin (Figure 45); Kirkwood Creek local geology is almost entirely volcanic pyroclastics and mudflow units.

Figure 45. South Fork of the American River Watershed Geology
