- Final -
2010 Annual Noxious Weed Monitoring Report

El Dorado Hydroelectric Project
FERC Project 184

El Dorado Irrigation District

Prepared by
EN2 Resources, Inc.

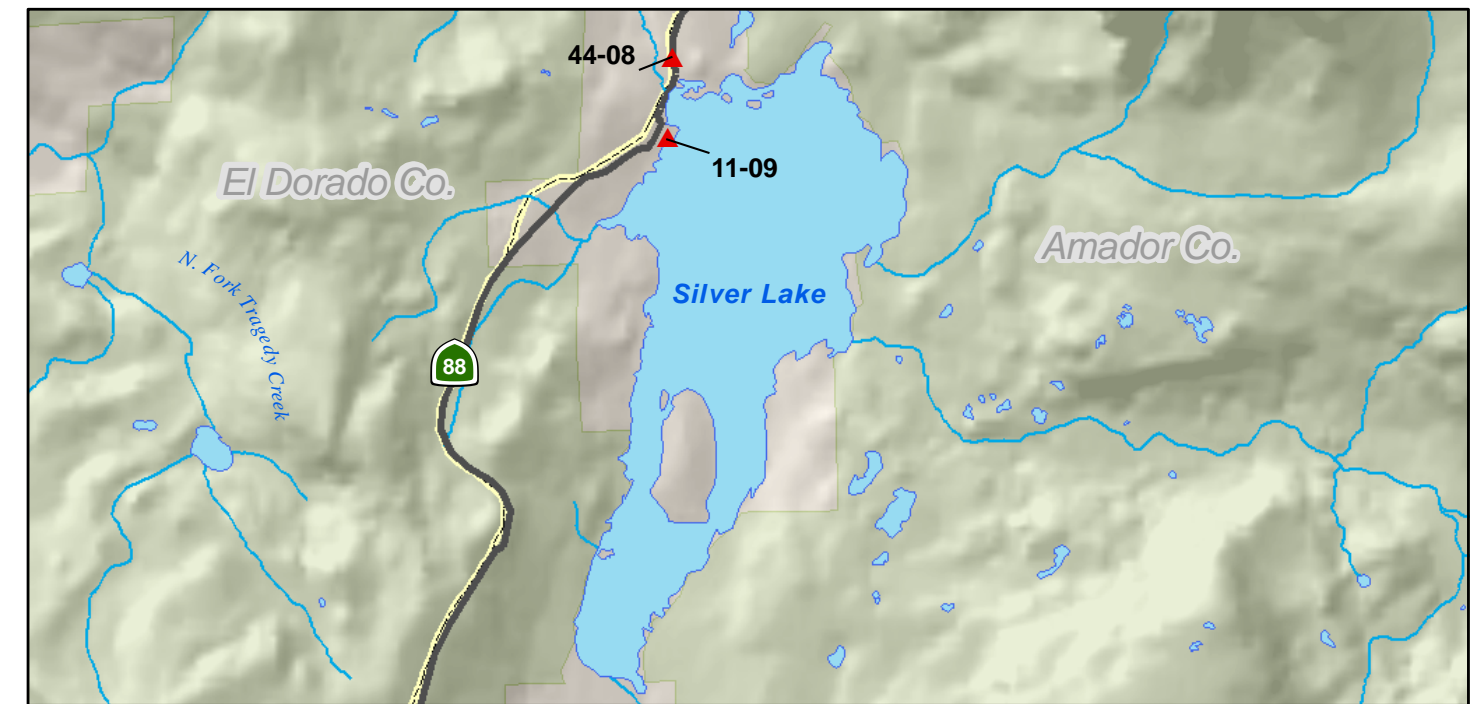
Figure 2. Noxious Weed and Rare Plant Occurrences

2010 Survey - FERC Project 184
Page 3 of 3
