2011 Monitoring Report

Riparian Vegetation Recruitment Monitoring FERC Project 184

February 2012

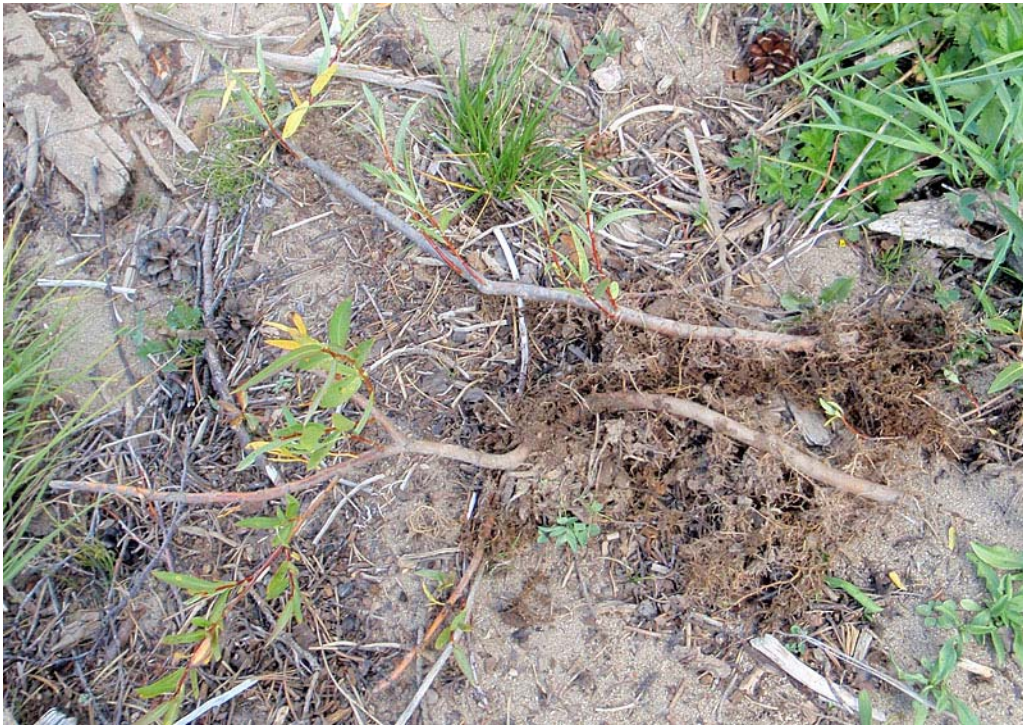
Exhibit 2

Examples of willow cuttings/branches that washed downstream and rooted on a point bar at Caples Creek site 11. Several rooted cuttings were observed in this study area; clonal propagation may be an important aspect of willow recruitment in this system.

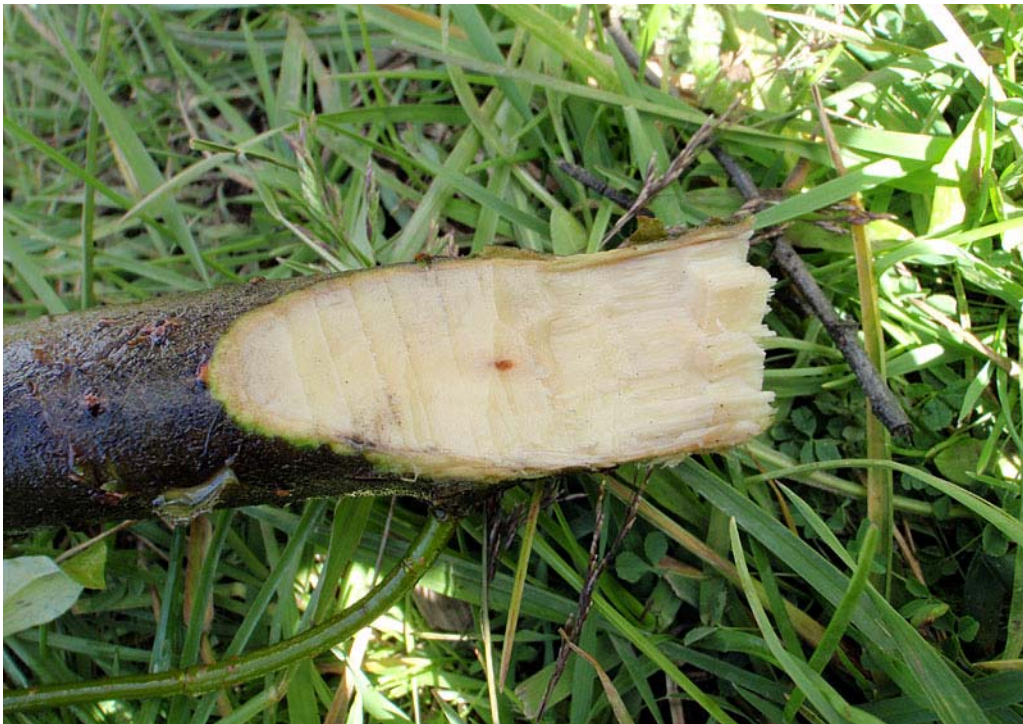
Willow cutting (cut recently by beavers) recently deposited along a fluvial surface at Caples Creek site 12
